Listed Building Application – The Old Ship King Street  
ARUNDEL BN18 9BJ

# Repair and remedial work to front flint elevation and roof repairs

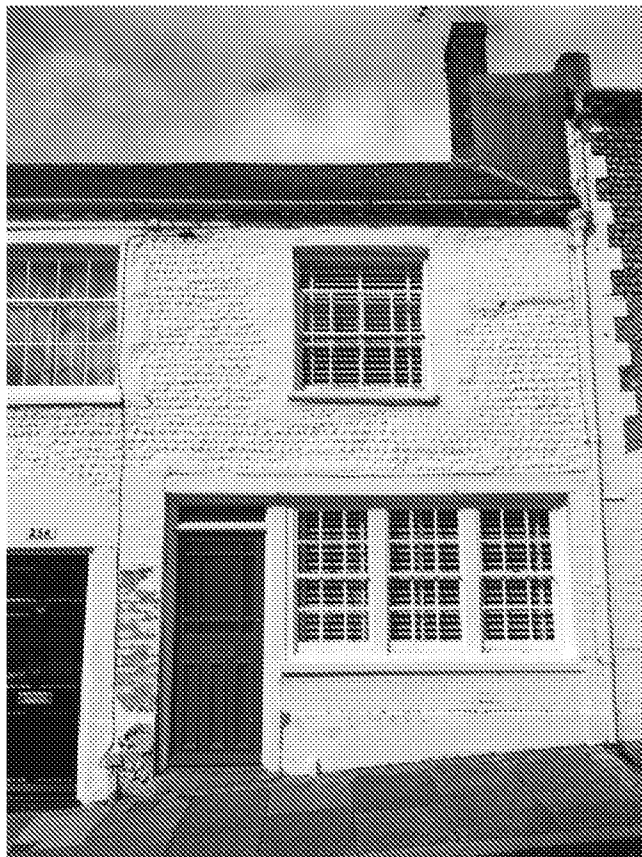
Front elevation of The Old Ship depicting bulging flintwork and failed plinth render.

The elevation is typical of King Street being a terraced cottage with mainly ‘beach pebble’ flints laid to course of quite even size with brick quoins to the opening and elevation perimeters. Lintels over the openings are timber to the ground floor, showing some decay and brick arch to the first floor with possible timber inner lintel. Detail at pavement level is a

rendered plinth over brickwork probably to resist damp penetration in an earlier period. The elevation has been decorated over the years with what is likely a non-breathable product which has not aided the construction. Neighbouring properties are a mixture of natural flint and paint elevations. See below.

From past experience and knowledge of the neighbouring properties it is likely the beach pebbles have been repointed in the past because the lime mortar was showing signs of weathering and possible damp penetration. This is probably a superficial surface treatment leaving the weak, structural, bedding mortar as existing. Once the now failing surface pointing is removed it is likely that sections of bedded flint will be dislodged and require rebedding. From experience it is likely the background is chalk blocks internally with a chalk rubble infil. This usually remains intact so the outer flints can be rebuilt.

We propose checking the soundness of all flint areas to the front elevation and removing any loose paint and pointing and this will reveal any areas of flint which are in danger of falling away from the wall. If we find the previous repoint mortar is a modern, hard sand/cement mix we will remove this also. We will undertake this carefully in 60 x 60cm sections rebuilding/repointing as we go starting from the bottom and working upwards so as the base is always supported.

The inner backing will need to be assessed as we progress but we do not envisage any major issues. We will review introducing some stainless steel ties [ not visible ] to assist tying the outer flint to the inner chalk at suitable spacings.

The flints will be salvaged and reused, coursed as original and with photographic evidence to refer to. The mortar mix is proposed as Mike Wye course unhaired traditional lime mortar which we have found to be a good match to local lime mortars. Care to be taken working in excessive heat and cold.

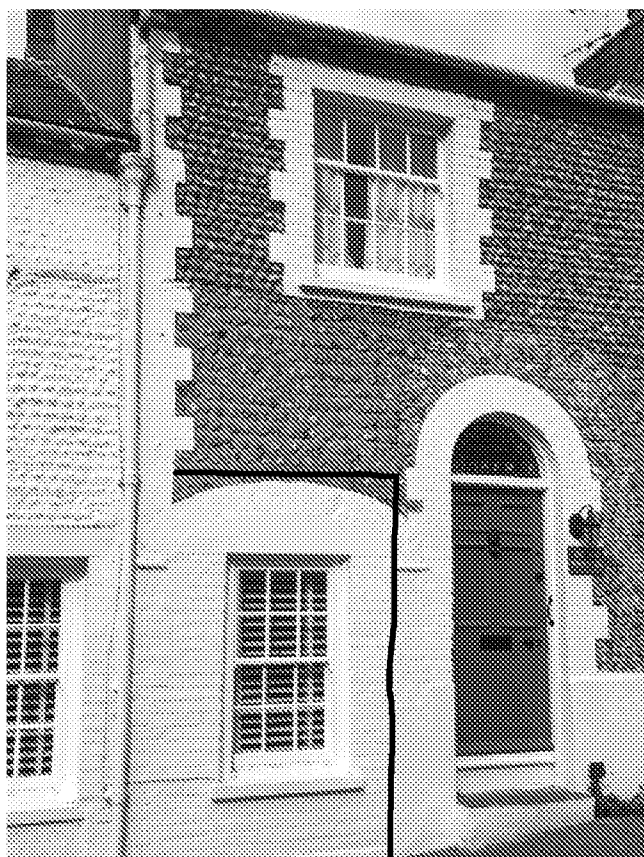
The Old Bakehouse – property adjoining to the north

The window to the left of this door is owned by our client as The Old Bakehouse has a flying freehold over this room. However, it is unaffected by this application as the remedial work applies to the flintwork only.

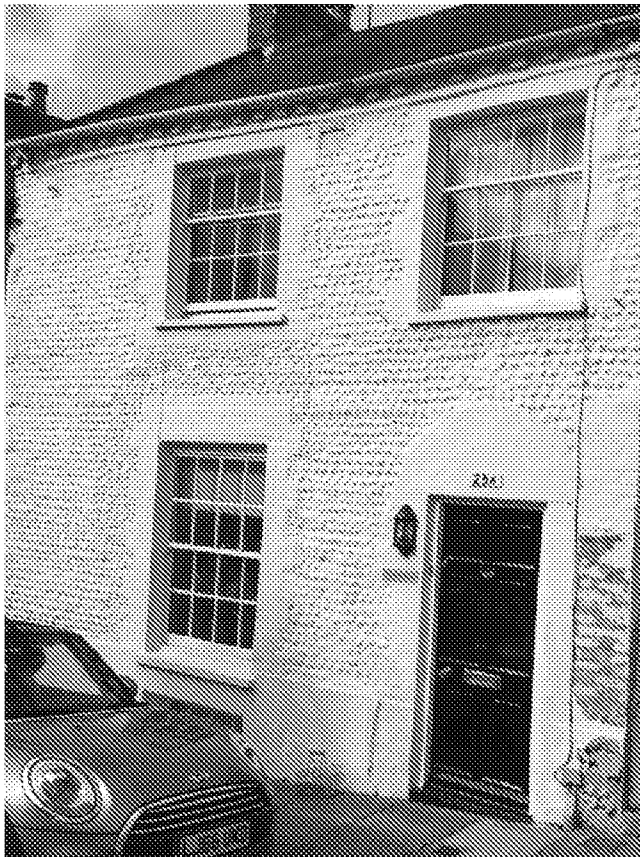
25a King Street, adjoining property to the south.

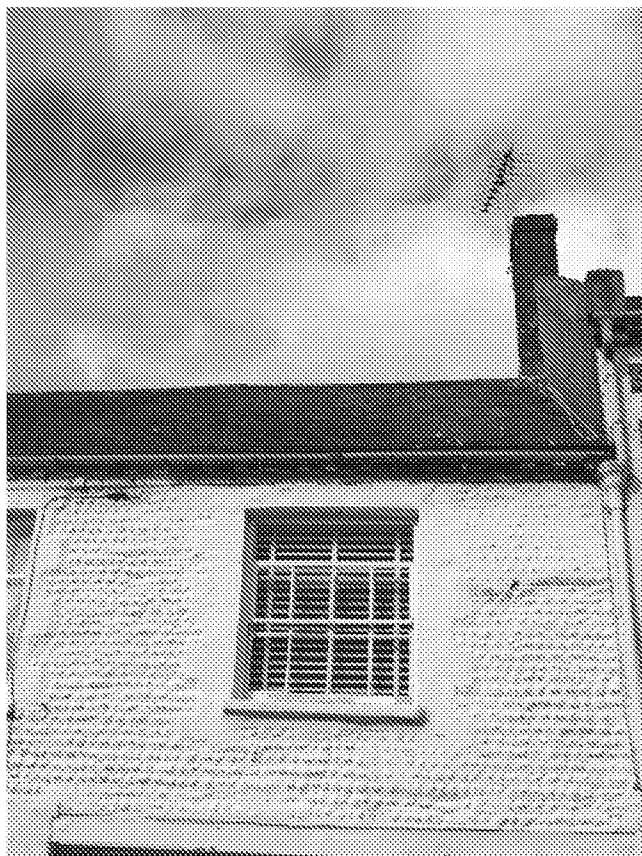
Further close up of failing flint mortar
