**Structural Inspection Report**  
**Bevin Bevin & Co. Ltd.**  
**Brewery Hill, Arundel**  
**West Sussex**

Ref.:2361  
08 March 2012  
Rev –

## Introduction

Paul Tanner Associates have been instructed by T Hollister (Chertsey) Ltd. to visit the site, carry out a visual inspection of existing buildings and to report in connection with a proposed redevelopment scheme by Martin Critchell Architects.

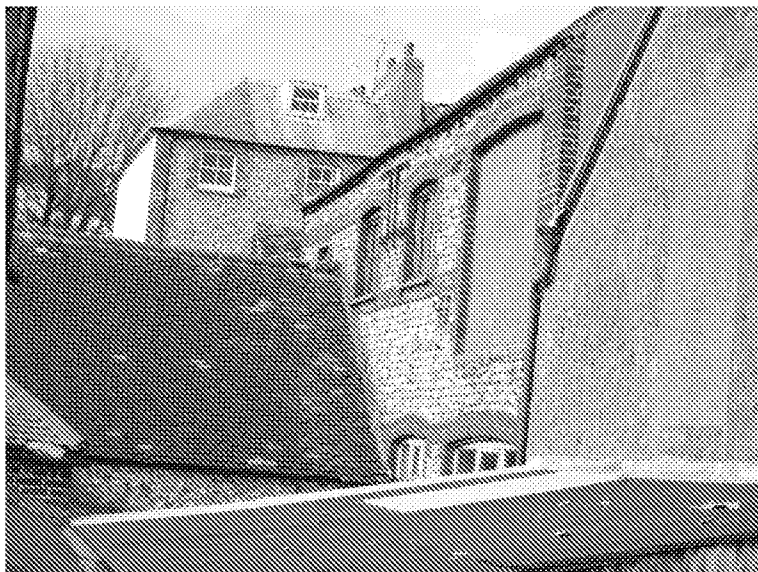
A view of the west elevation of Building 1 as shown in Figure 1 with Building 2 in the foreground illustrates the form of construction.

**Figure 1 - West flank wall of Building 1 and rendered gable of Building 2. Note wall and roof construction, together with bulging wall line at roof level.**

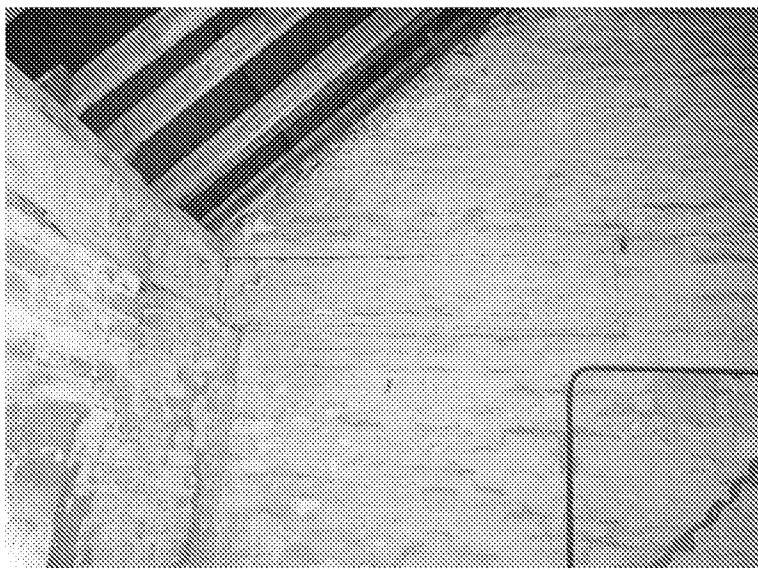
In terms of condition, there is some roof spread and displacement of wallplates as shown in Figure 2. There is also cracking of the walls, particularly at corners of the building above first floor level. Cracking in the south east corner of the building is most pronounced as shown in Figures 3 and 4.

**Figure 2 - North West Corner Cracking and Wallplate Movement**

Structural strengthening and repairs to the roof, south gable wall, tying in the flank walls, crack repairs and bonding, repairs to decayed timbers, floor strengthening, making good to brickwork and flintwork.

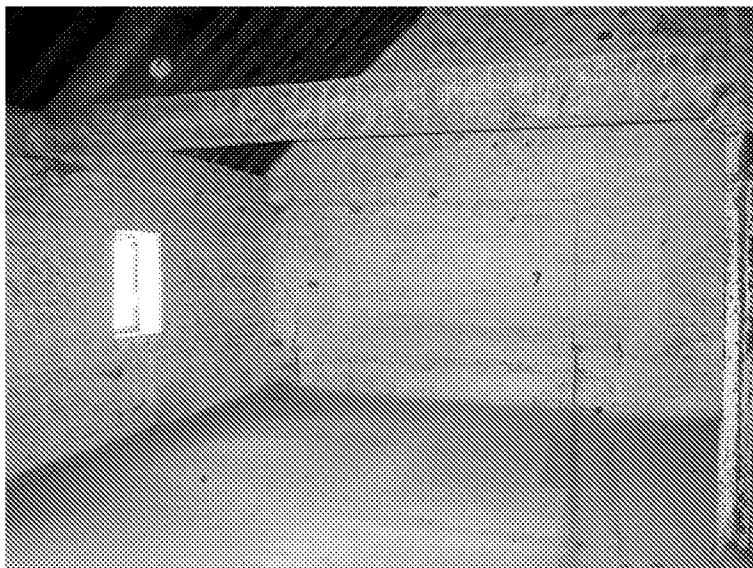
**Figure 3 - South east corner cracking at second floor level**

The south gable wall will need to be reinstated and repairs made throughout its height.

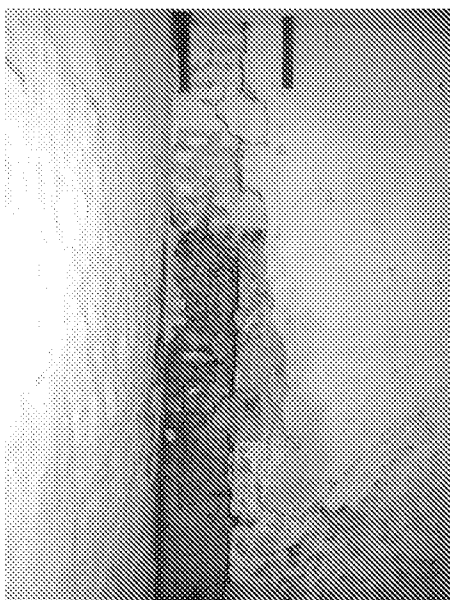
**Figure 4 - Cracking on first floor level in south east corner, flank wall to left of picture**

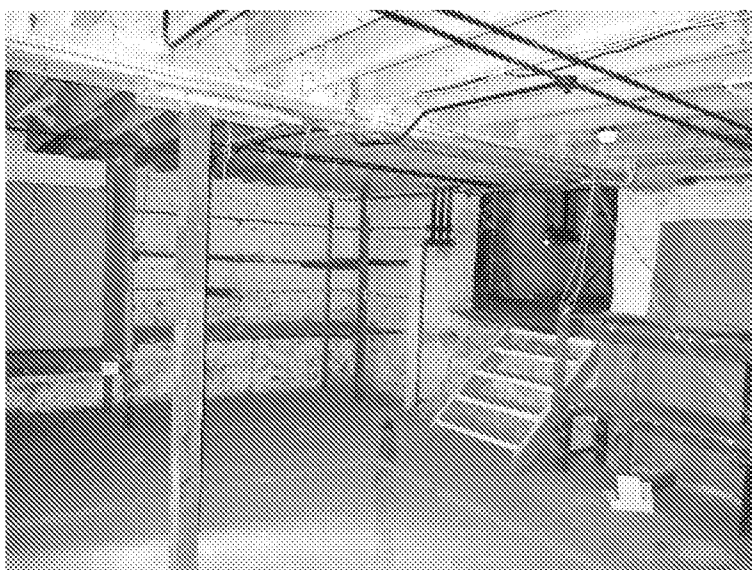
The first floor is formed from a central principal beam, with common joists spanning between the beam and flank walls. A makeshift timber prop has been added to support the centre of the principal beam as shown in Figure 5.

**Figure 5 - Building 2 semi-basement showing propping of principal beam and steps up to Building 1 ground floor level.**

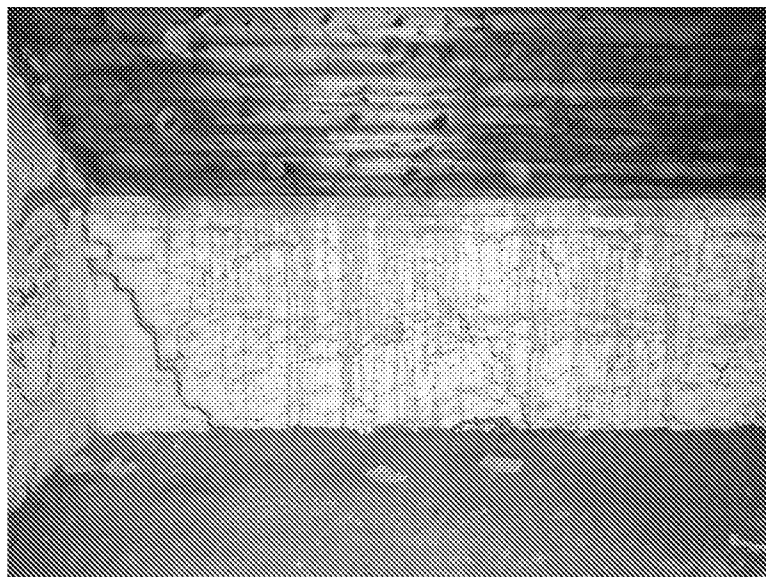
In terms of condition, there is some roof spread and displacement of the southern wallplate. There is also cracking of the walls, particularly at corners of the building above first floor level and at windows in the south and east elevations. Cracking and roof spread in the south east corner of the building is most pronounced as shown in Figure 6. There is also separation between the spine wall and front wall above the first floor.

**Figure 6 - Cracking, roof spread and water entry at south east corner on second floor**

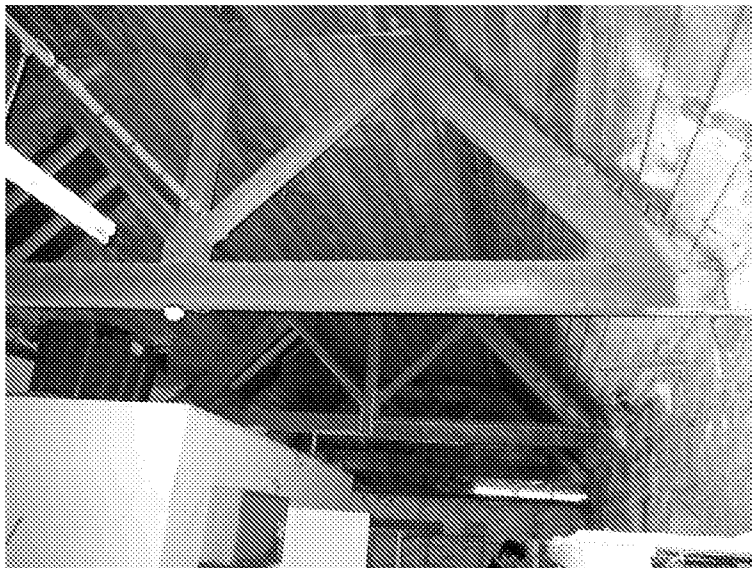
In terms of condition, there has been considerable water entry along the roof valley to Building 1 and also on the north side. There is extensive timber decay and some of the principal beams have been propped where their ends have decayed in the past.

**Figure 7 - Looking east in Building 3, indicating roof structure and water entry**

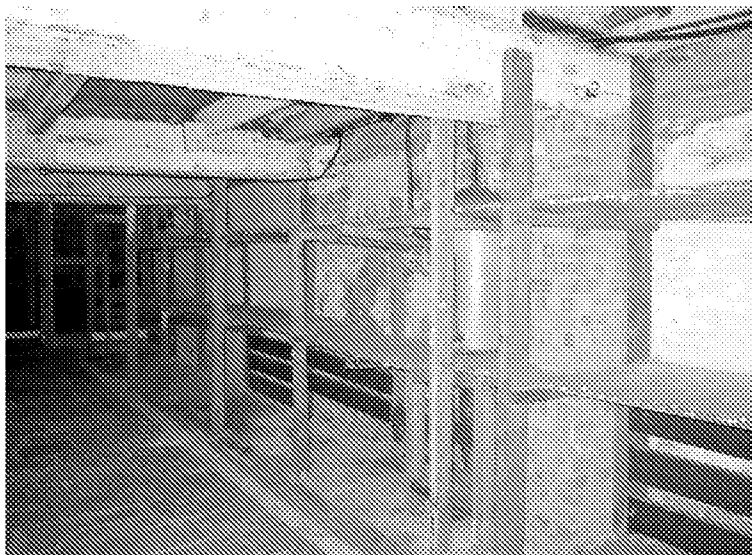
**Figure 8 - Looking west on the ground floor of Building 3, illustrating propped first floor beam and water entry. Retaining wall is to right of photograph.**

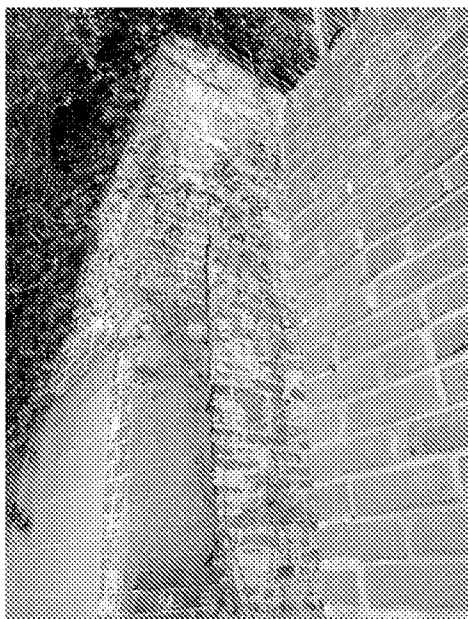
The east end of Building 3 extends beyond Building 1, and the south wall is heavily overgrown with vegetation and is separating from the east wall as shown in Figure 9.

**Figure 9 - East end of front and side wall of Building 3, showing vegetation growth and vertical cracking**

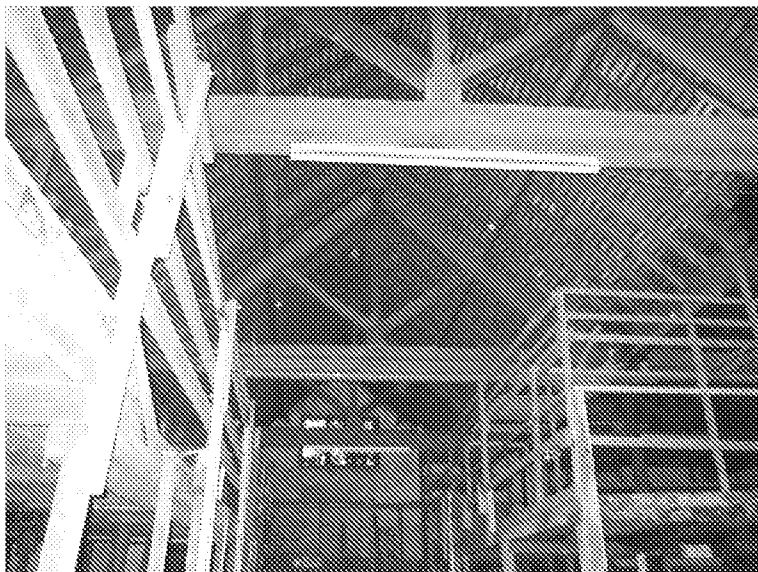
**Figure 10 - Building 4 central roof looking towards the west gable wall.**

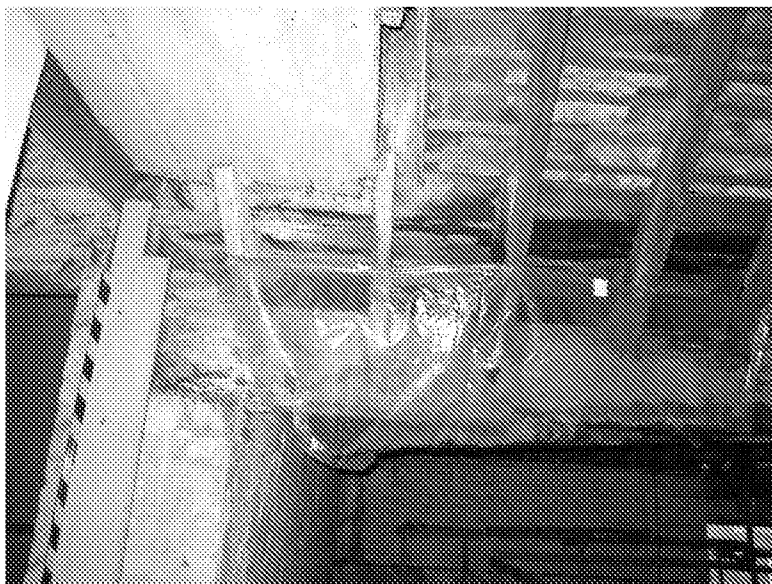
In terms of condition, there has been considerable water entry along the roof valleys and at the wallplates. There is also extensive decay in many areas as illustrated in Figures 11 to 13. Figure 12 indicates cracking at the support end of a steel beam carrying the south end of the two central roof trusses.

**Figure 11 - Water entry and decay to valley area.**

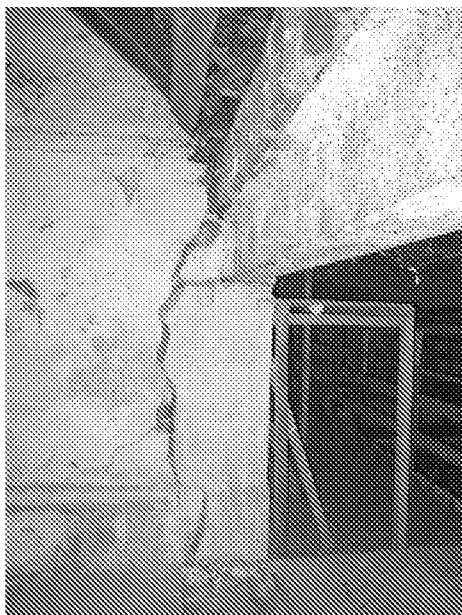
**Figure 12 - Cracking of support to steel beam carrying roof trusses**

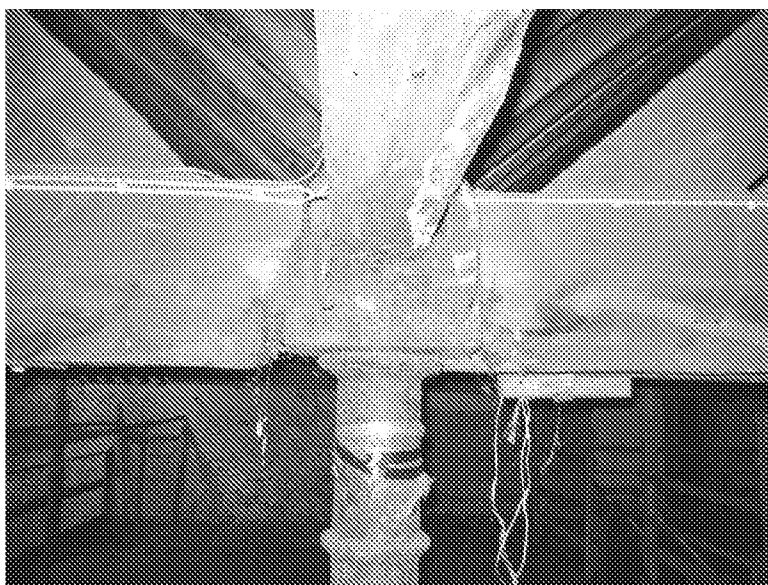
Some of the truss tie beams have been propped where their ends have decayed in the past as shown in Figure 13.

**Figure 13 - Cast iron column head showing decay of roof truss tie beam ends (Beam on left has been propped with a steel post).**

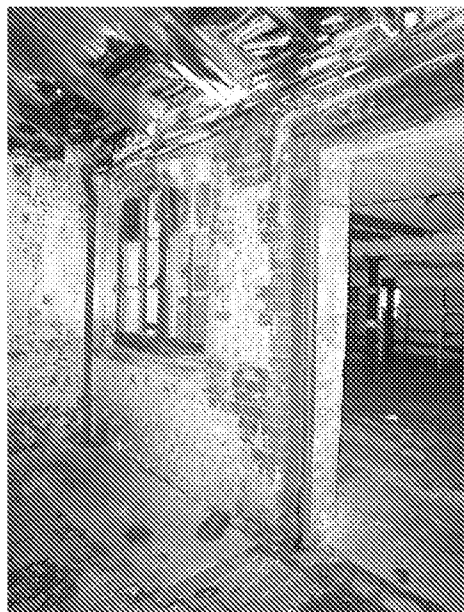
In terms of condition, the roof is poorly constructed and there is considerable water entry and decay against the listed building as shown in Figure 14.

**Figure 14 - Roof 6 support on listed building west wall**

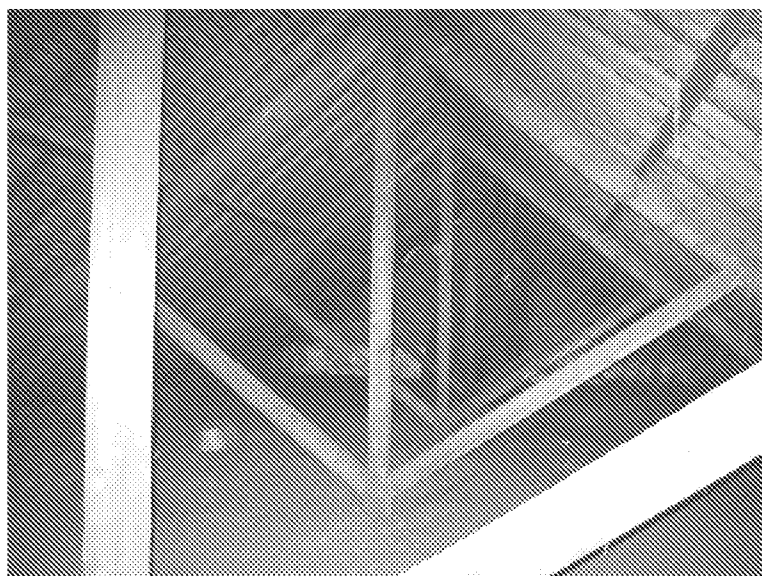
**Figure 15 - Building 10 roof void looking towards the west gable wall**

In terms of condition, there is some water entry and decay to the roof timbers. There has also been quite extensive vegetation entry.

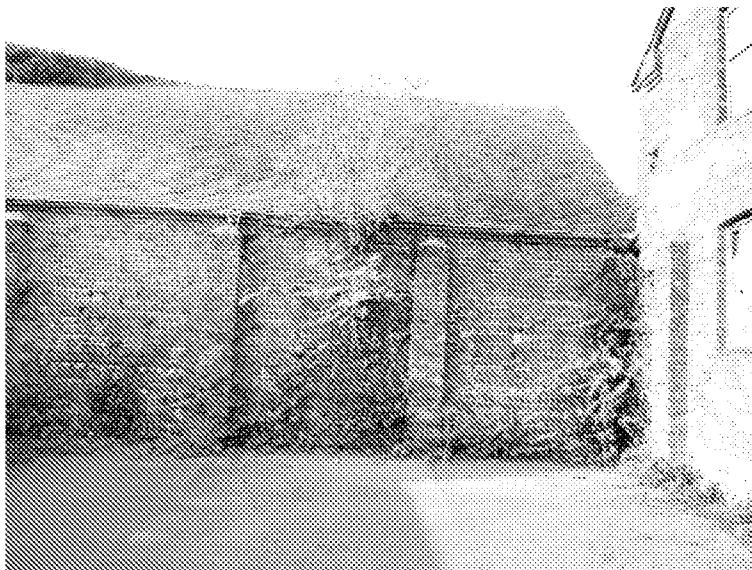
Externally, the south elevation is visible from the adjacent garages area as shown in Figure 16, indicating vegetation growth, disturbance of brickwork and in-filled former openings.

**Figure 16 - Building 10 south elevation.**

The east gable wall of Building 10 would be retained. This appears to be constructed from brickwork in English bond with occasional flints and two blocked up openings on the ground floor. Suitable strengthening and support would be required to incorporate this wall into a new building.

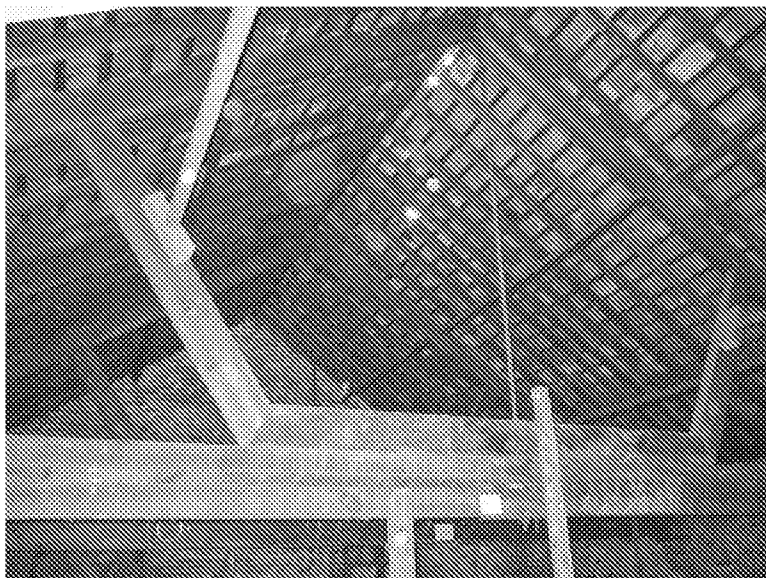
**Figure 17 - Building 11 roof looking towards west gable wall**

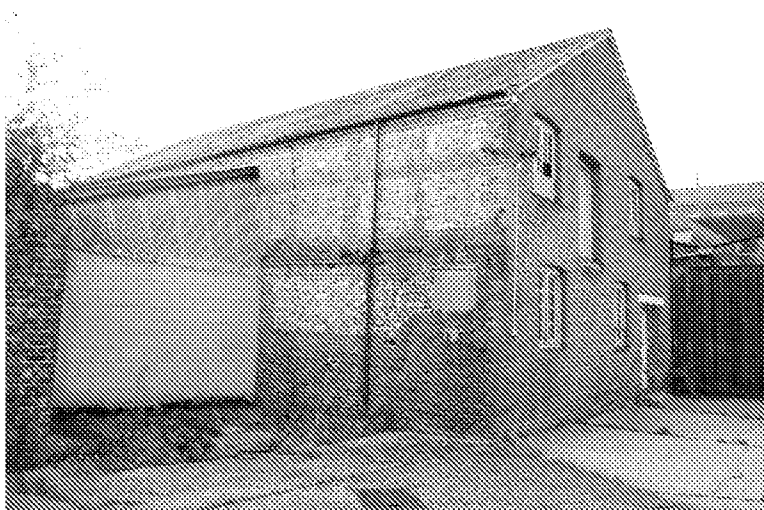
In terms of condition, there is local cracking of the walls, and a substantial full height crack in both the south and north walls which also passes through the ground floor paving as shown in Figures 18 and 19. There is noticeable subsidence in the east part of the building, and this extends northwards into Building 9 and south into Buildings 12 and 13.

**Figure 18 - Building 11 east gable and south flank wall showing cracking in flank wall.**

There is an area of settlement and possible subsidence to the south and west, affecting Buildings 9 to 13. This aspect should be investigated and resolved as part of the new development design.

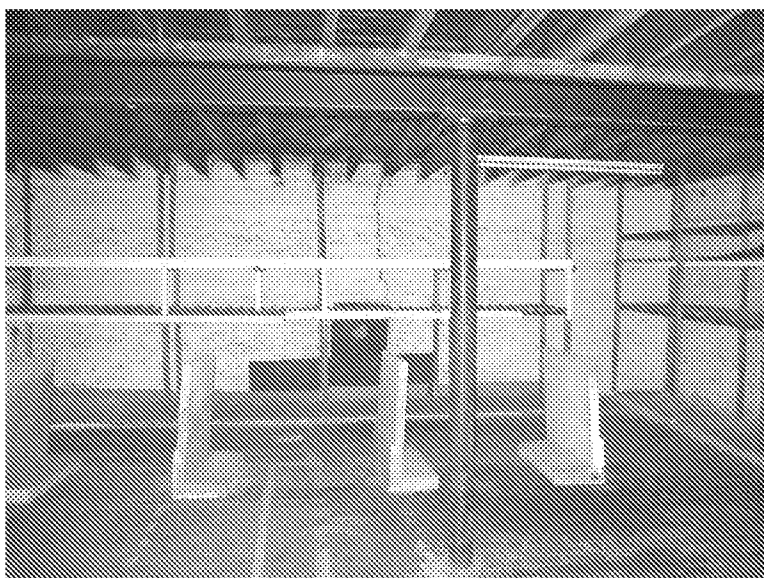
**Figure 19 - Building 11 interior showing steel supports to first floor and cracking in north flank wall beyond.**

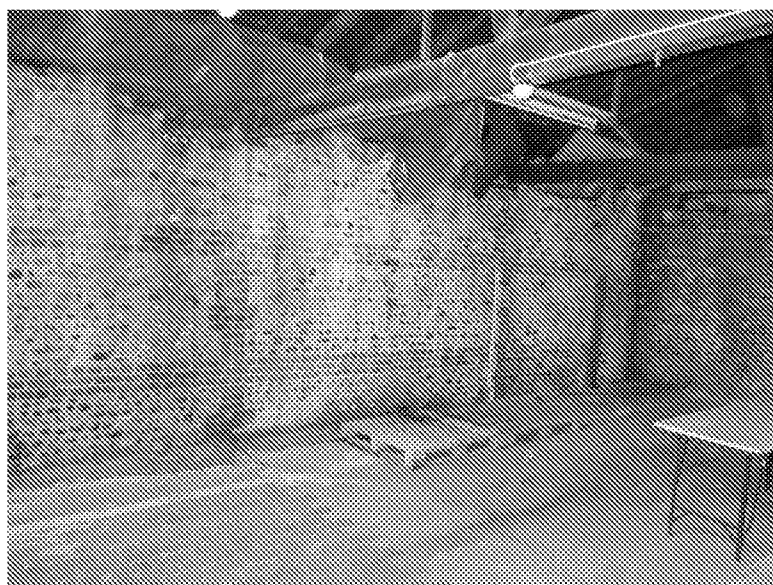
In terms of condition, the cracking noted in Building 11 extends through the north and south walls and the ground floor slab. Water has entered through the roof and decay to rafter ends and roof trusses is present as shown in Figure 20.

**Figure 20 - Building 12 looking at north wall of Building 13. Note water entry and decay.**

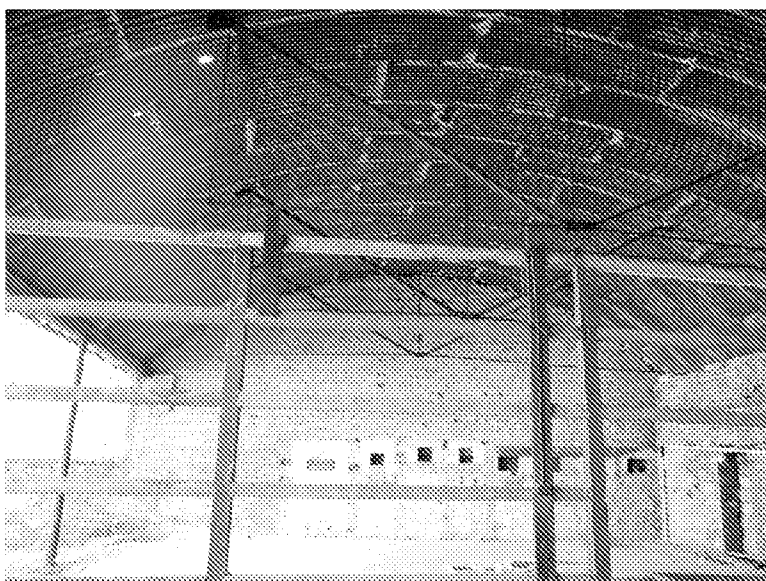
In terms of condition, the cracking noted in Buildings 11 and 12 extends through the north wall. Water has entered through the roof and decay to wallplates, main beams and roof truss corrosion is present as shown in Figure 21.

**Figure 21 - Building 13 interior**

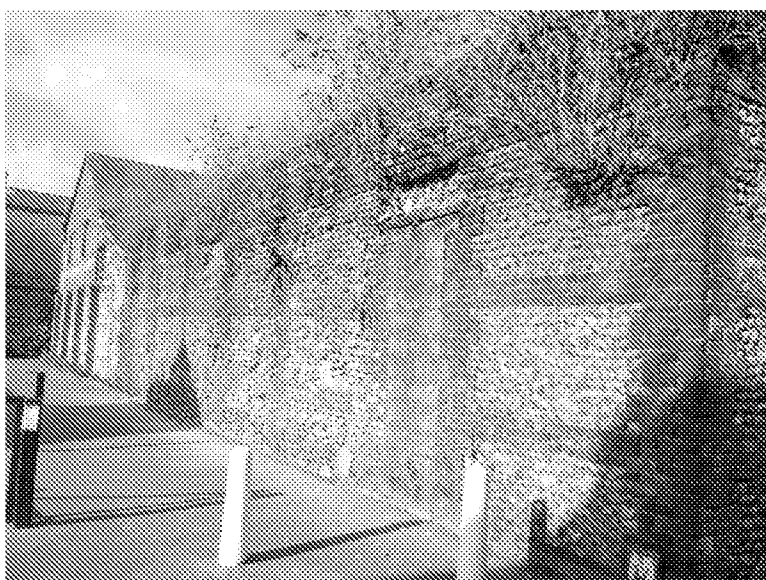
The west wall is visible from the adjacent garages site and the wall has vegetation growth and loss of materials as shown in Figure 22.

**Figure 2 - West wall of Building 13 showing vegetation growth and loss of masonry facing**
