CLEARVIEW SURVEYS LIMITED  
OLD BARN FARM ROAD  
THREE LEGGED CROSS  
Tel: [REDACTED]

Project name :  
**11260A FORD ROAD**

Date :  
**21/01/2019**

Site:  
Contact Name:  
Department:  
Road: **FORD ROAD**  
Town: **ARUNDEL**  
County:  
Telephone:  
Fax:  
Mobile:  
E-mail:

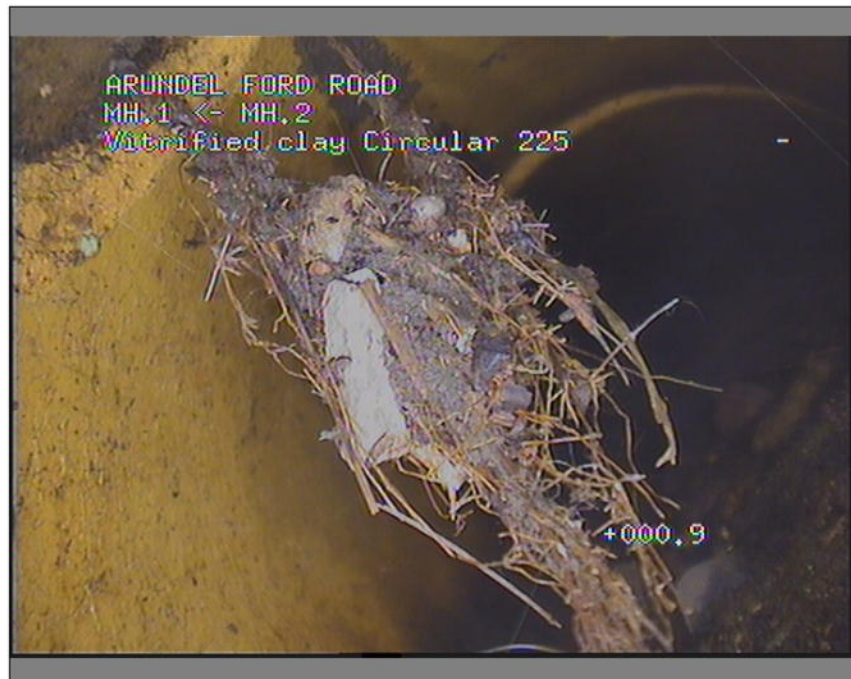
Photo: 1\_1\_6\_A.JPG  
0.9m, Roots, mass, 10% cross-sectional area loss

Comment : **HIGH PRESSURE JETTING AND RE SURVEYING REQUIRED**

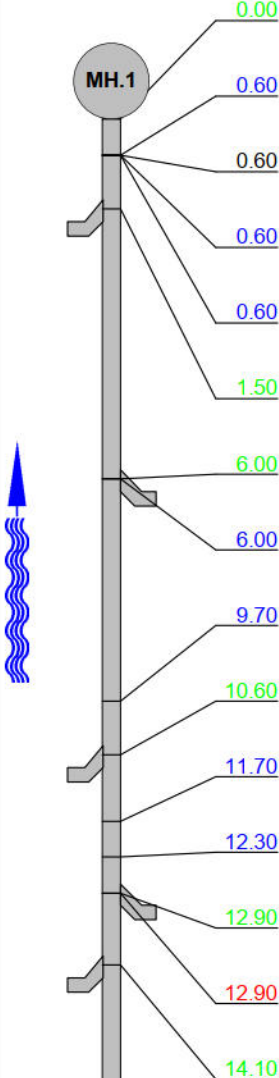
| 1:126 Position<br>Depth: 1.28 | Code | Observation | Grade | |
|---|---|---|---|---|
| | S01 RM | Roots, mass, 10% cross-sectional area loss, Start | (Serv) 3 | <br>1.5 m |
| | CXI | Connection intruding, at 2 o'clock, diameter 100mm, intrusion 40% | (Constr) 4 | |
| | CXI | Connection intruding, at 9 o'clock, diameter 100mm, intrusion 25% | (Constr) 4 | |
| | DER | Settled deposits, coarse, 5% cross-sectional area loss | (Serv) 3 | <br>6 m |
| | DER | Settled deposits, coarse, 10% cross-sectional area loss | (Serv) 3 | |
| | CXI | Connection intruding, at 3 o'clock, diameter 150mm, intrusion 30% | (Constr) 4 | |
| | RTJ | Roots, tap at joint | (Serv) 4 | |
| | S02 DER | Settled deposits, coarse, 20% cross-sectional area loss, Start | (Serv) 4 | <br>10.6 m |
| | CXI | Connection intruding, at 9 o'clock, diameter 150mm, intrusion 25% | (Constr) 4 | |
| | H | Hole in drain/sewer, from 11 to 1 o'clock | (Struct) 4 | |
| | CXI | Connection intruding, at 3 o'clock, diameter 150mm, intrusion 20% | (Constr) 3 | <br>12.9 m |

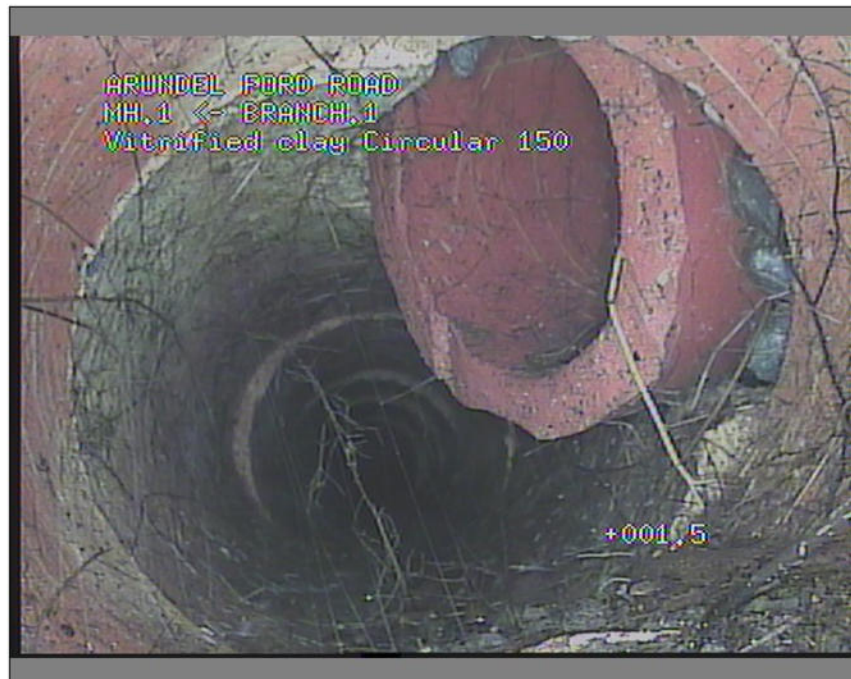
Photo: 4\_4\_17\_A.JPG  
 1.5m, Connection intruding, at 2 o'clock, diameter 100mm, intrusion 40%

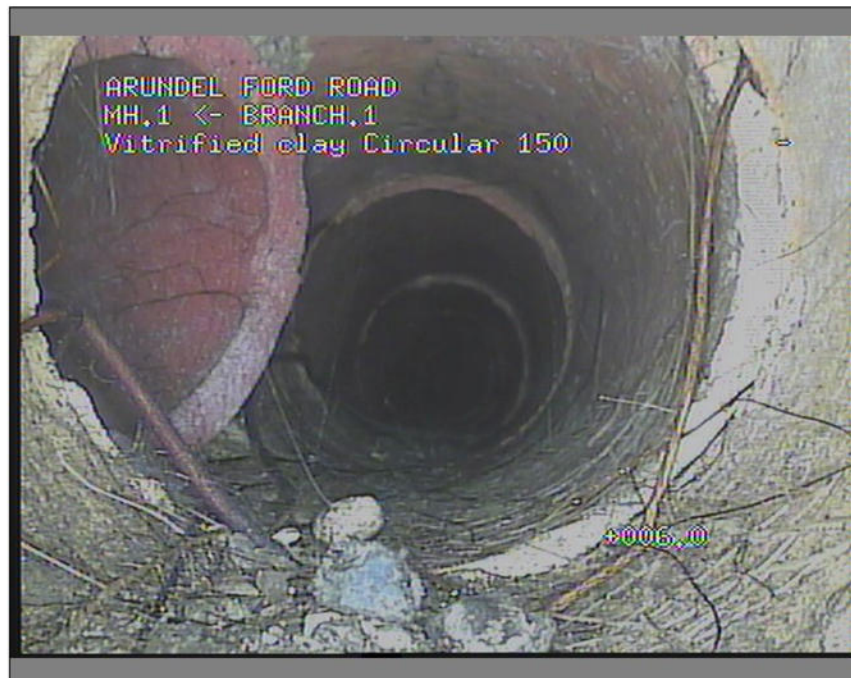
Photo: 4\_4\_18\_A.JPG  
6m, Connection intruding, at 9 o'clock, diameter 100mm, intrusion 25%

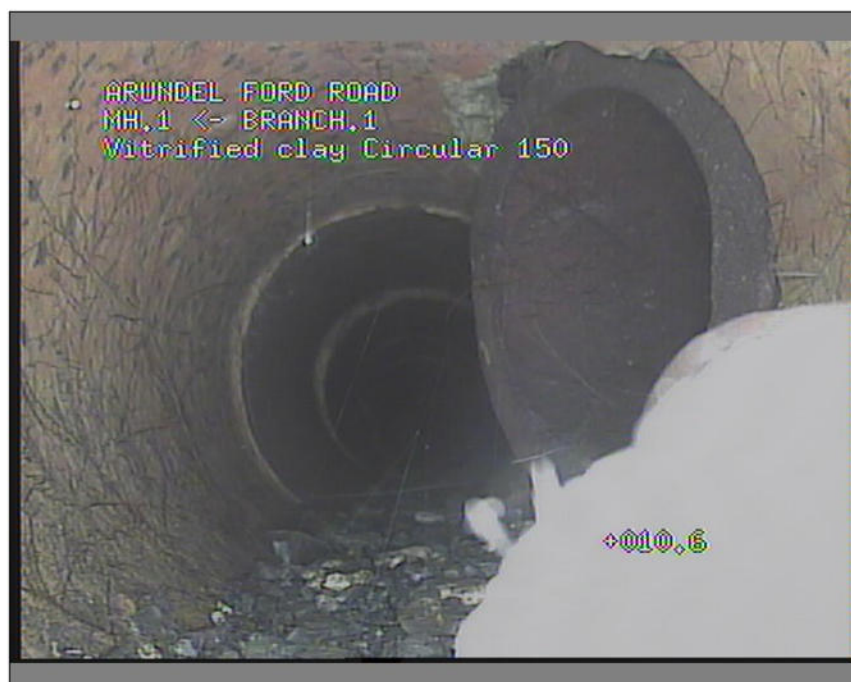
Photo: 4\_4\_21\_A.JPG  
10.6m, Connection intruding, at 3 o'clock, diameter 150mm, intrusion 30%

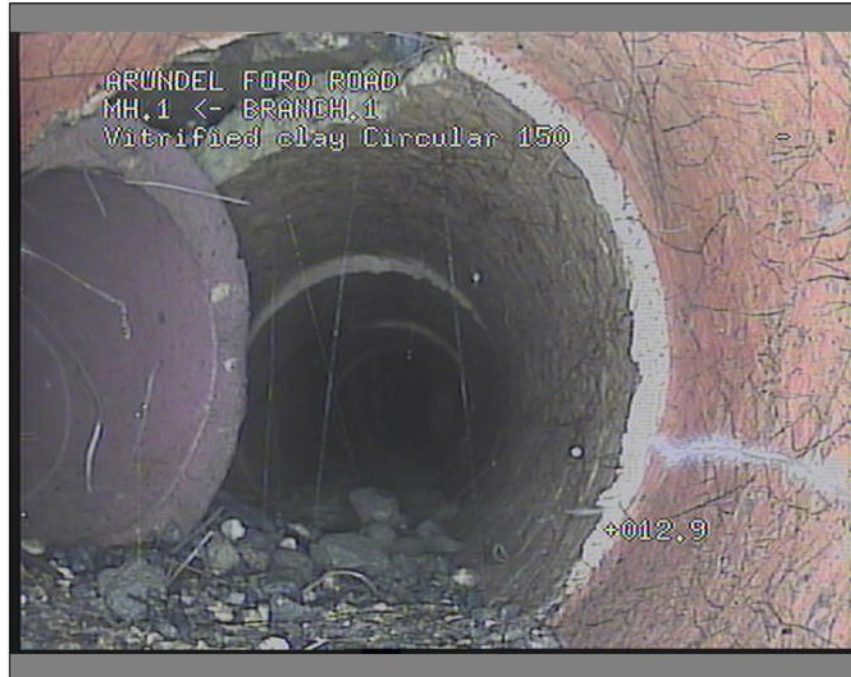
Photo: 4\_4\_24\_A.JPG

12.9m, Connection intruding, at 9 o'clock, diameter 150mm, intrusion 25%

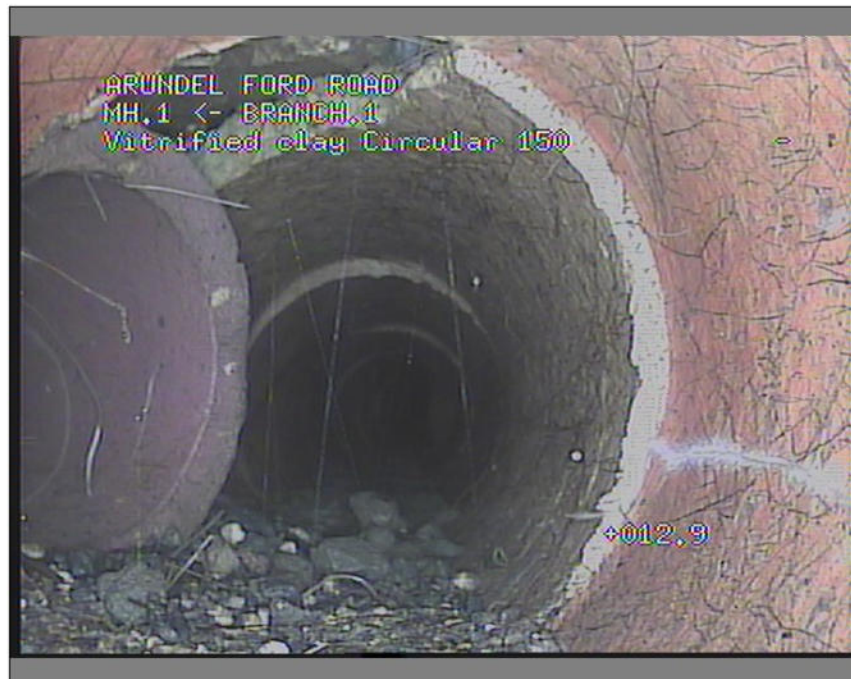
Photo: 4\_4\_25\_A.JPG

12.9m, Hole in drain/sewer, from 11 to 1 o'clock

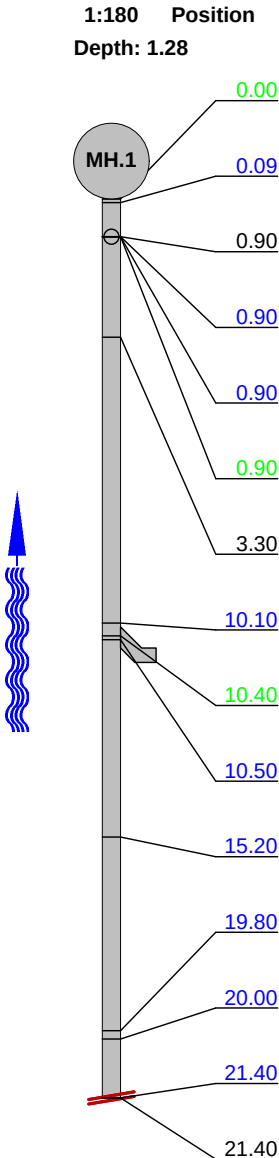
| 1:180 Position<br>Depth: 1.28 | Code | Observation | Grade |
|---|---|---|---|
| 0.90 | S01 DES | Settled deposits, fine, 35% cross-sectional area loss, Start | (Serv) 4 |
| 0.90 | RM | Roots, mass, 10% cross-sectional area loss | (Serv) 3 |
| 10.10 | RM | Roots, mass, 20% cross-sectional area loss | (Serv) 5 |
| 10.50 | DESJ | Settled deposits, fine at joint, 60% cross-sectional area loss | (Serv) 4 |
| 15.20 | S02 RM | Roots, mass, 10% cross-sectional area loss, Start | (Serv) 3 |
| 20.00 | RM | Roots, mass, 25% cross-sectional area loss | (Serv) 5 |
| 21.40 | SA | Survey abandoned Remarks: DUE TO MASS ROOTS AND DEBRIS | (Misc) 0 |

| Comment : | <b>HIGH PRESSURE JETTING AND RE SURVEYING REQUIRED</b> |

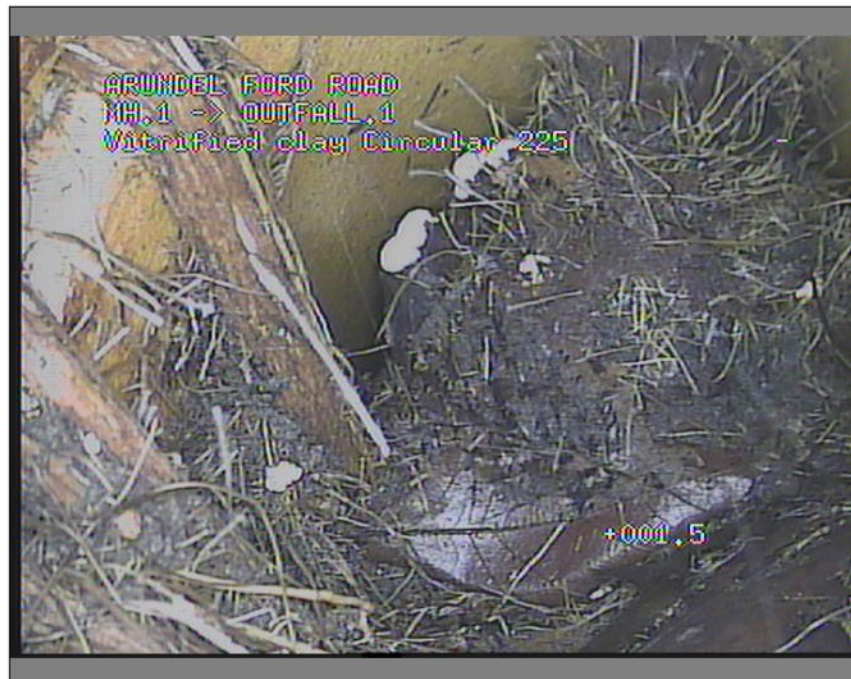
| 1:50<br>Depth: 1.28 | Position | Code | Observation | Grade | |
|---|---|---|---|---|---|
| | 1.50 | RTJ | Roots, tap at joint | (Serv) 4 | |

Photo: 6\_6\_54\_A.JPG  
1.5m, Roots, tap at joint

Comment : **HIGH PRESSURE JETTING AND RE SURVEYING REQUIRED**

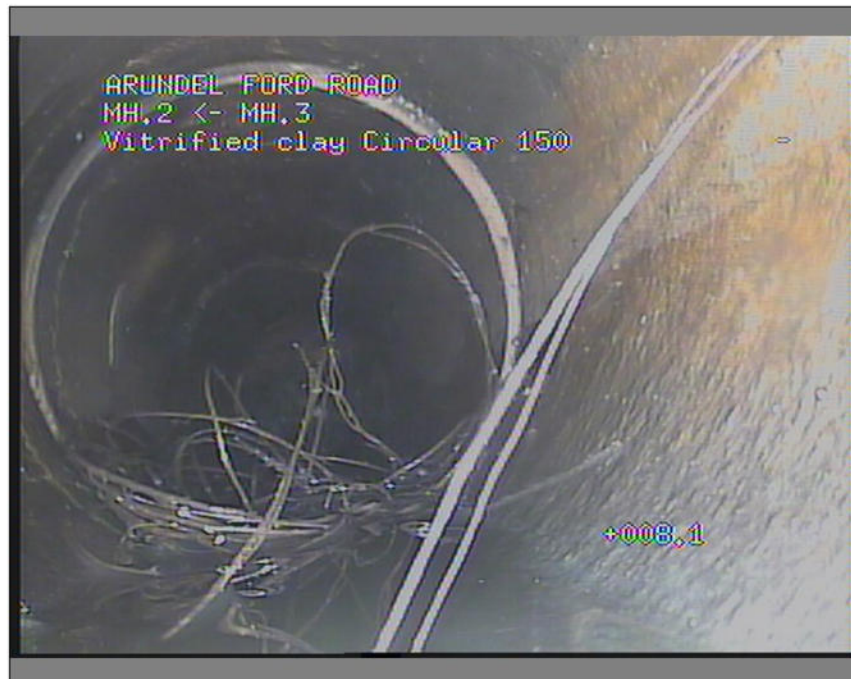
Photo: 8\_8\_70\_A.JPG  
8.1m, Roots, mass at joint, 10% cross-sectional area loss

Comment : **HIGH PRESSURE JETTING REQUIRED**

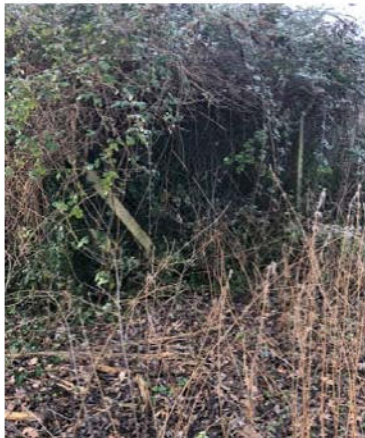
ROUGH LOCATION OF MH.3  
BEYOND FENCE LINE AND WITHIN VEGITATION
