# Description of Works

**44 Tarrant Street**

**Arundel**

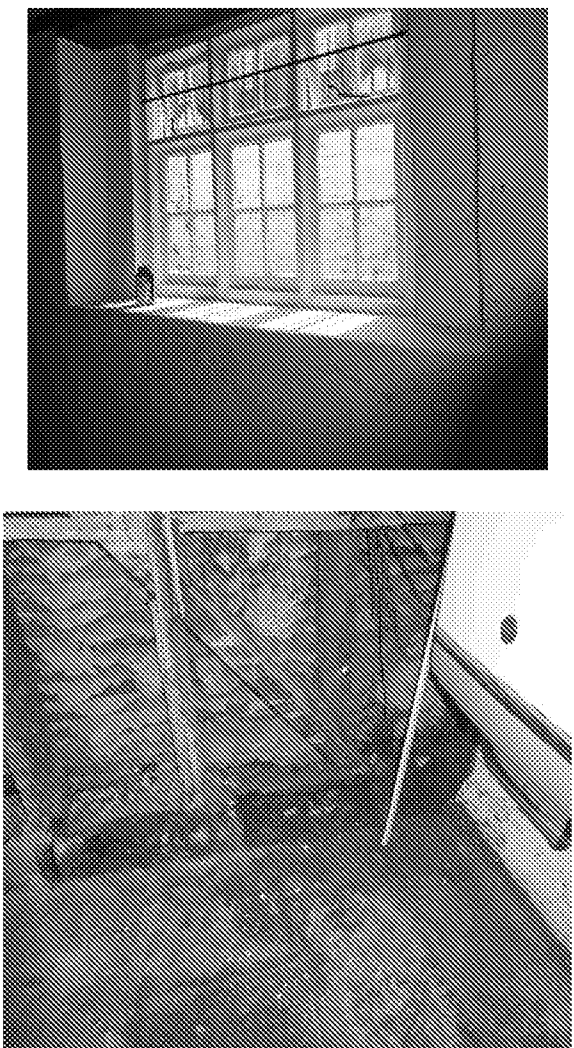
| Breakfast Room | | |
|---|---|---|
| Walls | <div>Existing</div> <div>Paint, flaking, part-plastered masonry<br/>Plastered reed and plaster collapsing at south end</div> <div></div> | <div>Proposed</div> <div>Plastering as Schedule 1,2,3</div> |

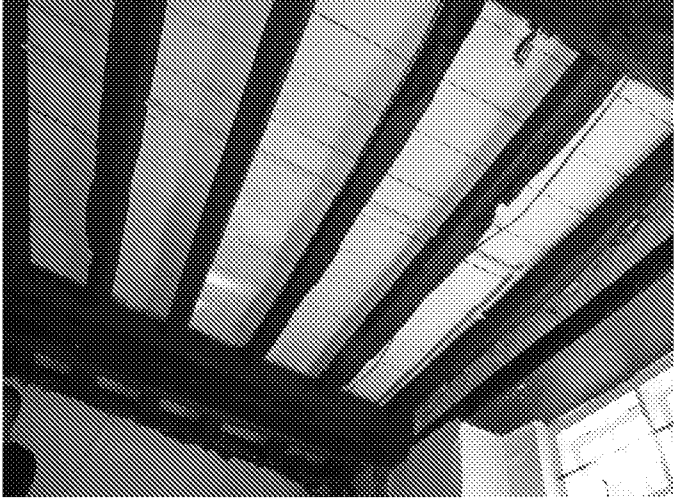
| <p>Ceiling</p> | <p>Existing</p> <p>Exposed floor joists. All in adequate condition</p> | <p>Proposed</p> <p>Plasterboard on battens between exposed joists.</p> |

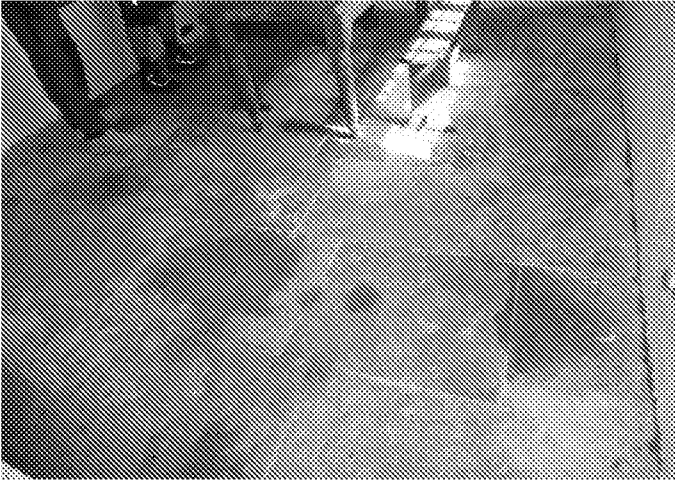
| <p>Floor</p> | <p>York stone laid evenly on bare soil.<br/>High moisture content.</p> | <p>Lift, number, and relay exactly as existing on dpm and insulation if level permit.</p> |

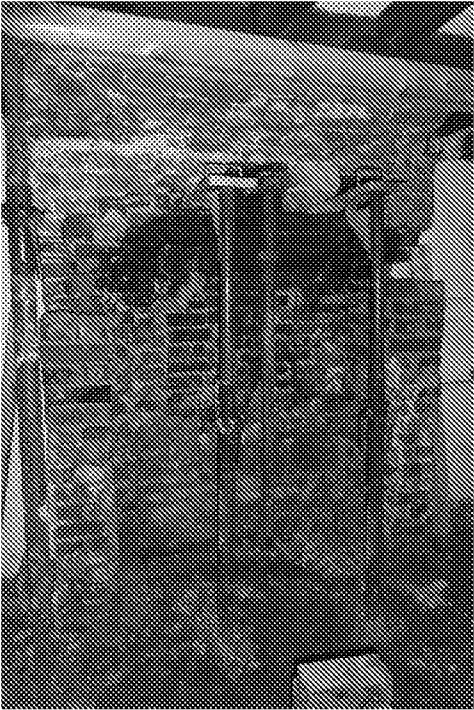
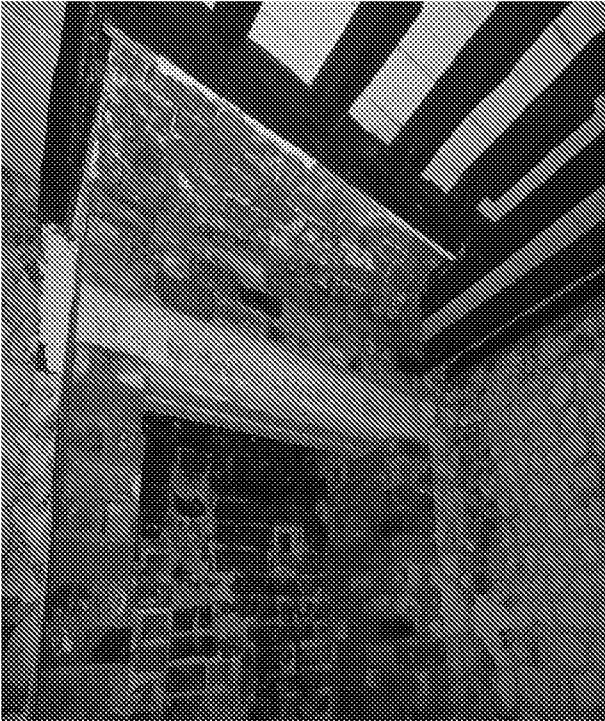
| Breakfast Room | | |
|---|---|---|
| Other | <p>Chimneystack collapsing. 50mm mild steel bar supporting opening. Rusty, deflected, dangerous</p> | <p>Rebuild reveals in existing bricks, 3no. 75 x 150 RC lintels up to hearth corbelling. To be plastered as original.</p> |

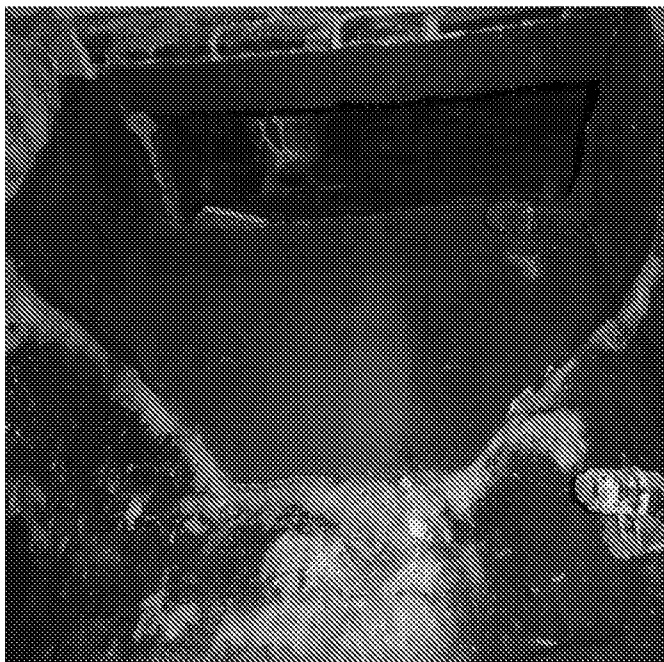
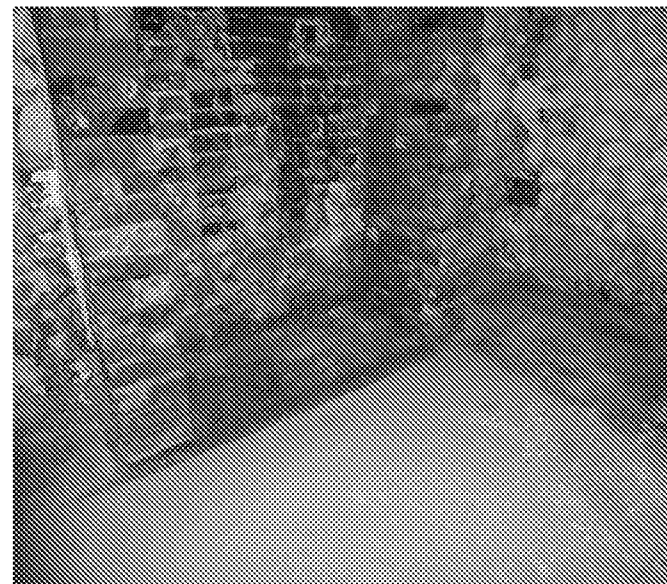
| Breakfast Room | | |
|---|---|---|
| | Modern condensing boiler mounted on wall. | Relocate boiler to be confirmed. |

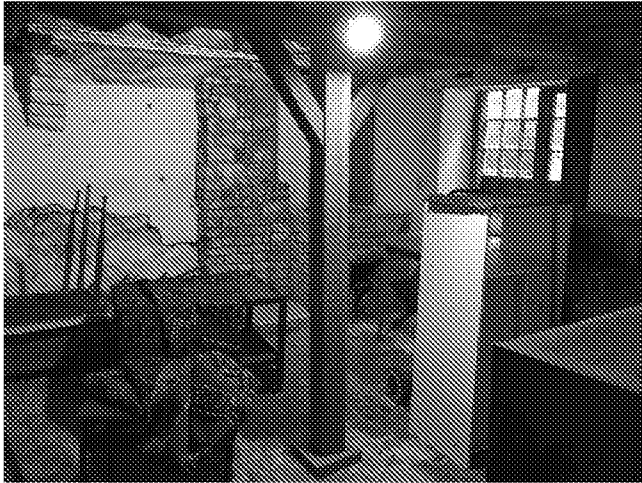
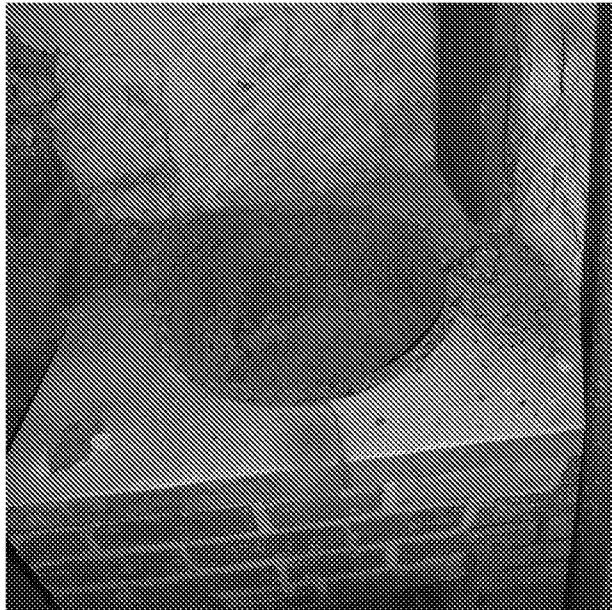
Painted and part plastered masonry all walls.

Replaster as schedule, methods 1,2,3.

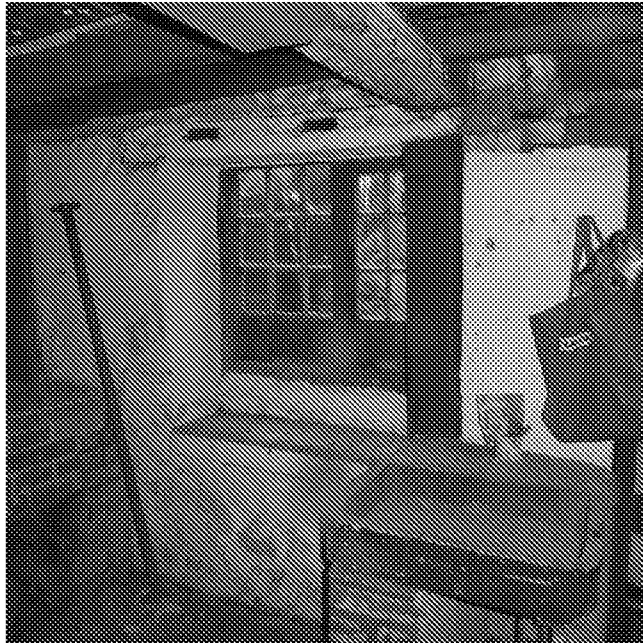
Exposed oak ceiling joists. Mostly good condition 3 no. beyond useable condition.

Spine beam split along entire length.

Temporary propping over C.I. basin and door.

Replacement of 3 no. 5x4" oak ceiling joists, to existing joint detail. Plasterboard on battens between oak joists, to be left exposed.

Repair to spine beam in accordance with SE info.

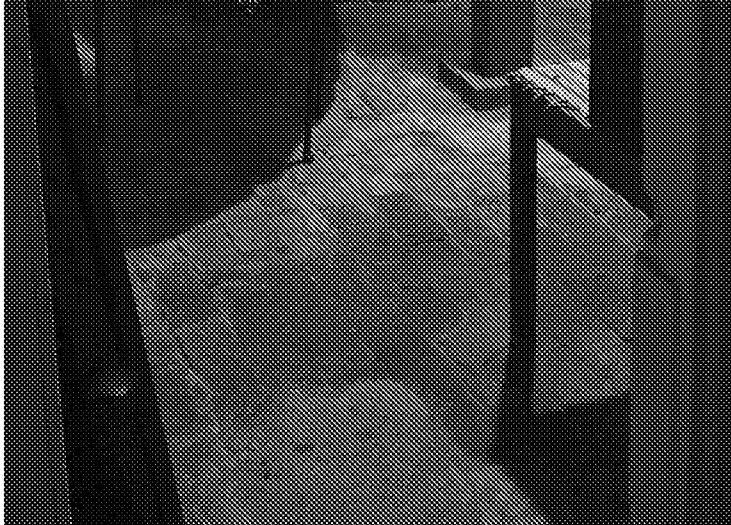
| <p>Floor</p> | <p style="text-align: center;">Existing</p> <p>Uneven historic brickwork, patched with concrete and in poor and damp condition.</p> | <p style="text-align: center;">Proposed</p> <p>To be removed and relaid using good surfaces, evenly laid, on dpm and 75mm insulation board if levels permit.</p> |

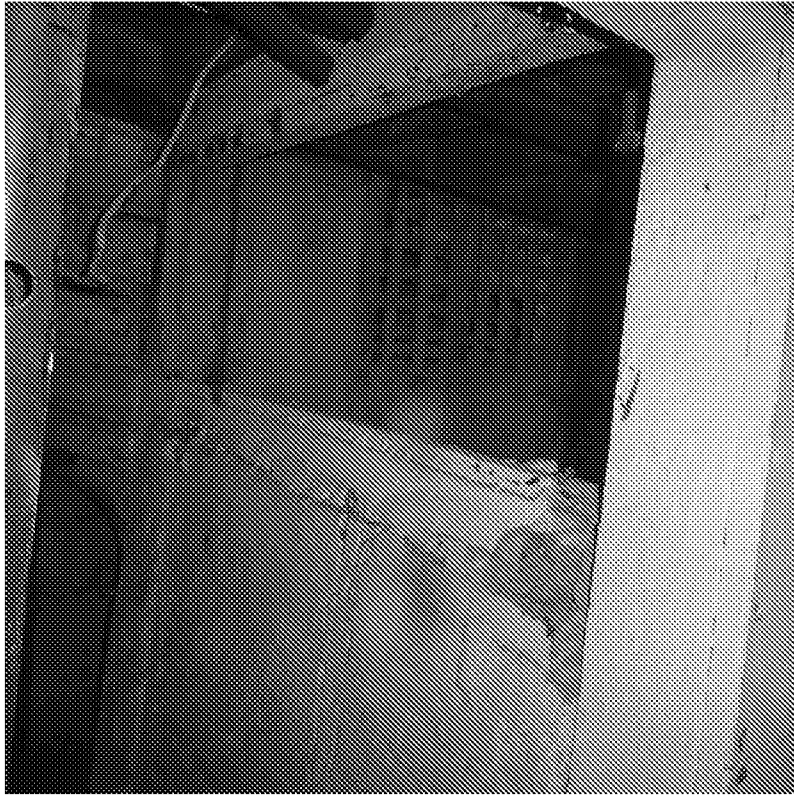
Stone cupboard with gated door and timber framing, brick infill.

Fake Cast Iron washbowl over unusable fire, set in insitu concrete slab.

Refurbish stone cupboard door and framing exactly as original.

Remove Cast Iron sink and modern brickwork. Reinststate corbelled hearth above.

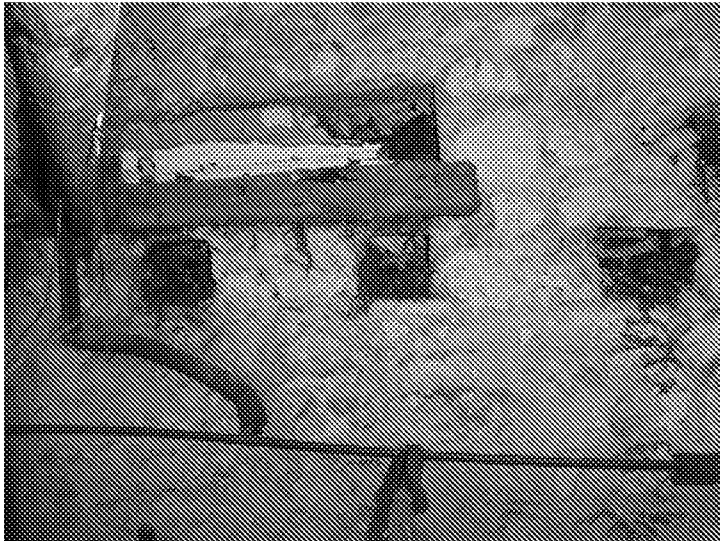
| | Existing | Proposed |
|---|---|---|
| Ceiling | <p>Rotten 6 x 4 " ceiling joists, pronounced unsafe to work under or over by SE</p> | 6 x 4" oak joists replace like-for-like and fit into exiting pockets in external walls on slate barers. |

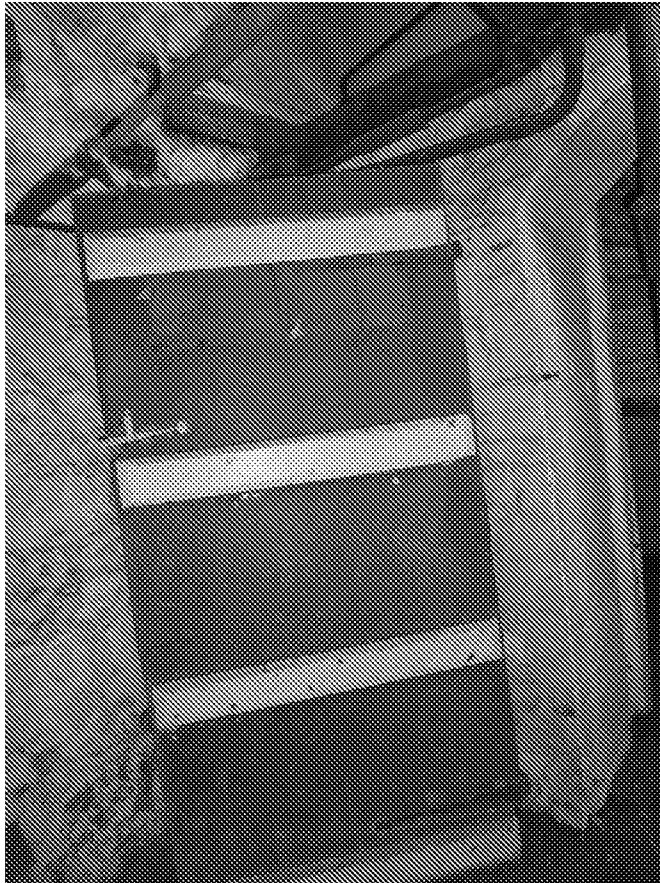
Stair support joists rotten in external wall.

Door found stored.

Refurbish existing stair and supports where built into wall.

Refurbish and rehang door on existing hinges.

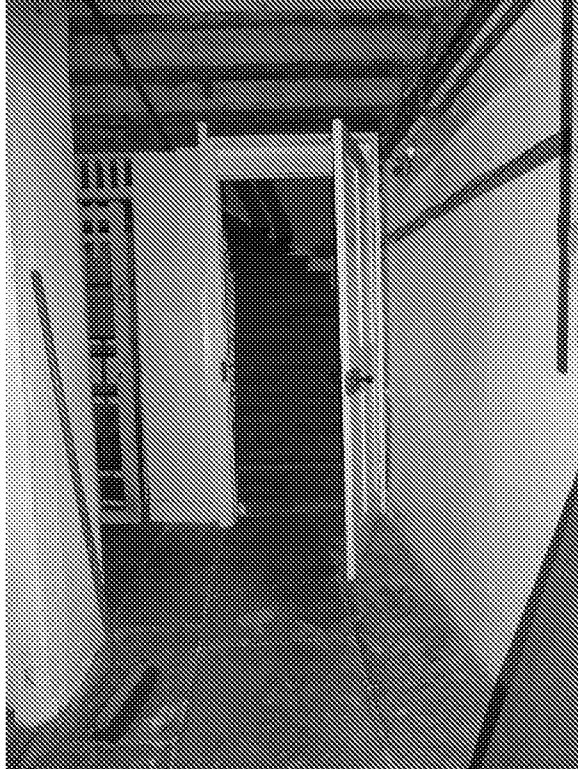
Decorated ancient plaster, soft and flaking.

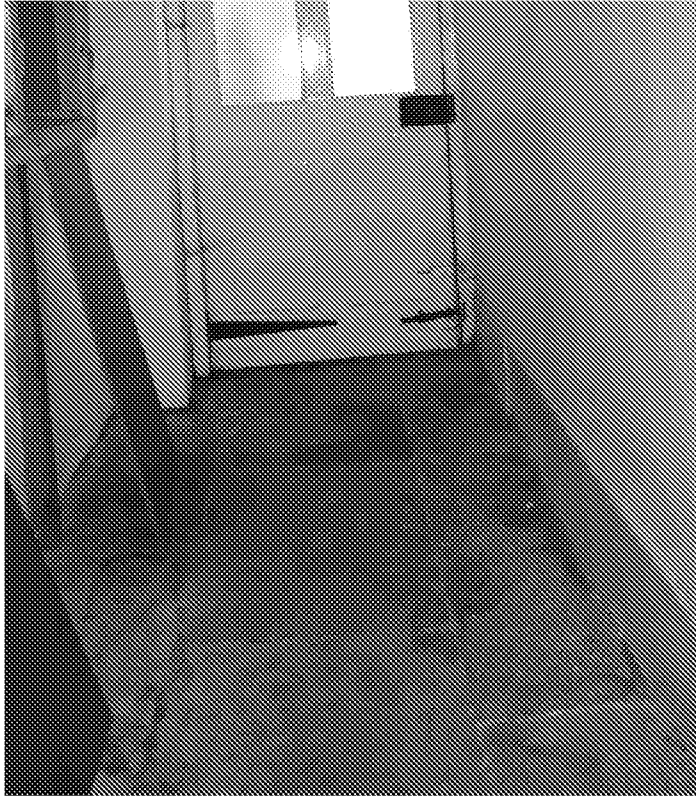
West wall, plaster method 2.

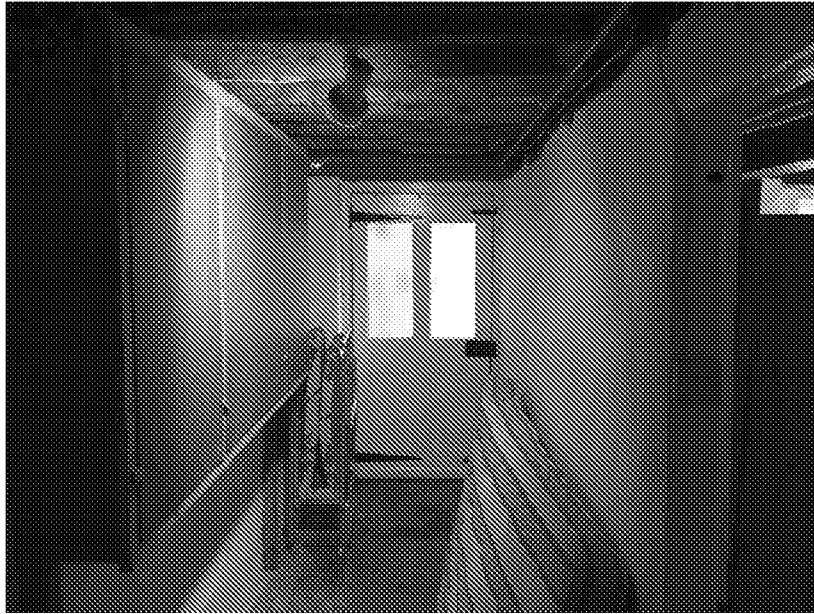
East wall redecorate once electric consumer unit and meters re-housed.

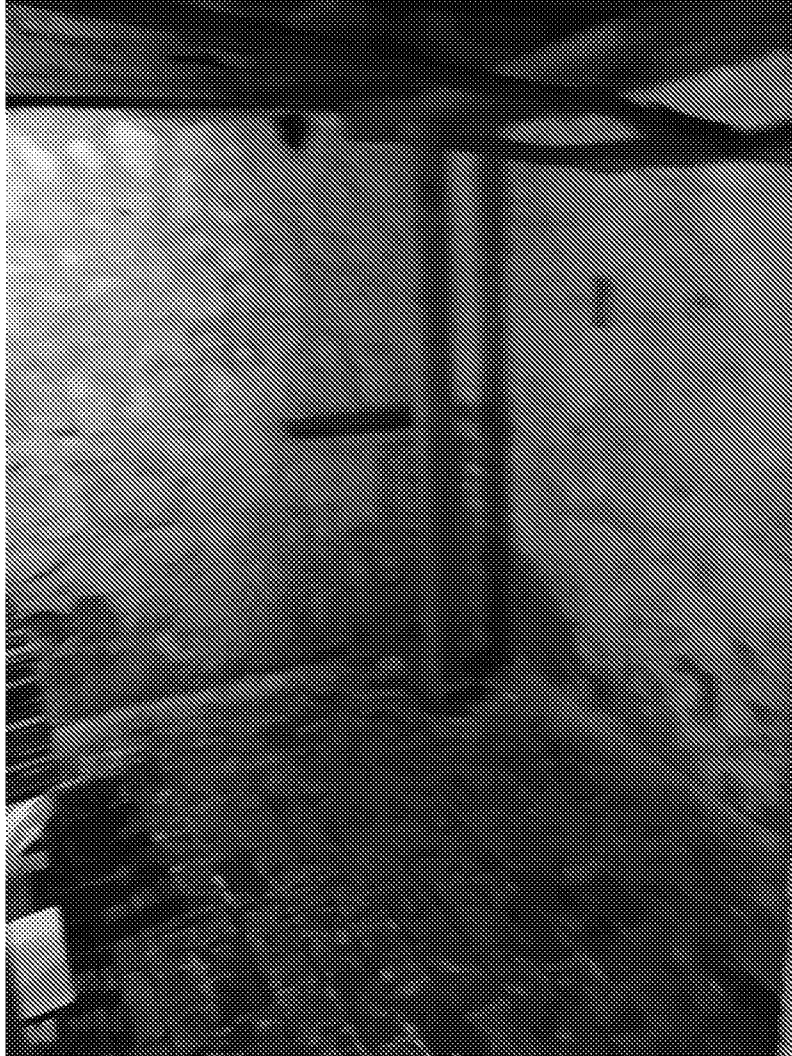
Exposed floor joists. All in adequate condition.

Plasterboard on battens between exposed joists

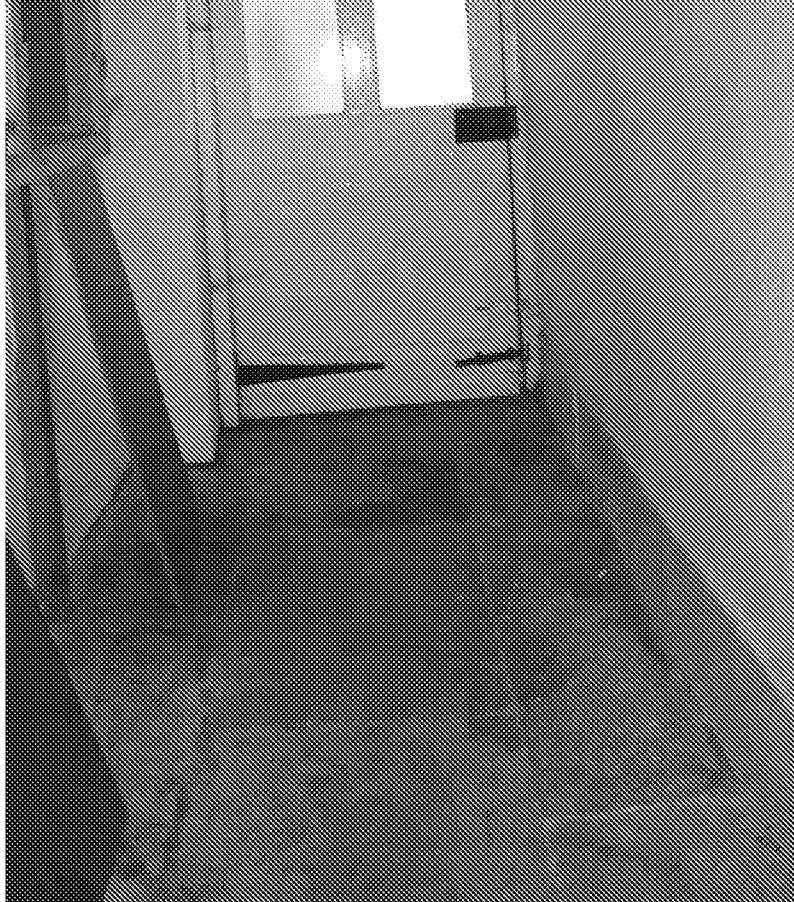
York stone slabs laid on bare earth. Damp ingress, rotten skirting's.

Lift, number, relay exactly as existing on dpm and insulation if levels permit.

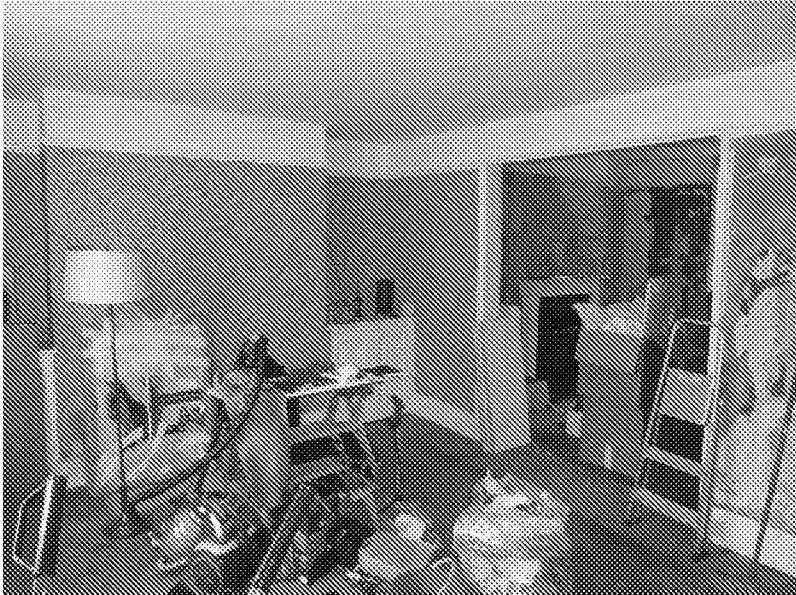
| Drawing Room | | |
|---|---|---|
| Walls | <p>External, flaky plaster on reed/lath.</p> <p>Partition walls, reed /lath on ancient studwork.</p> <p>Chimney stack, plaster no masonry.</p> | <p>Plaster schedule 1,2,3.</p> <p>Any architrave, picture rails, skirting's to be refitted when possible or replaced with same section.</p> |

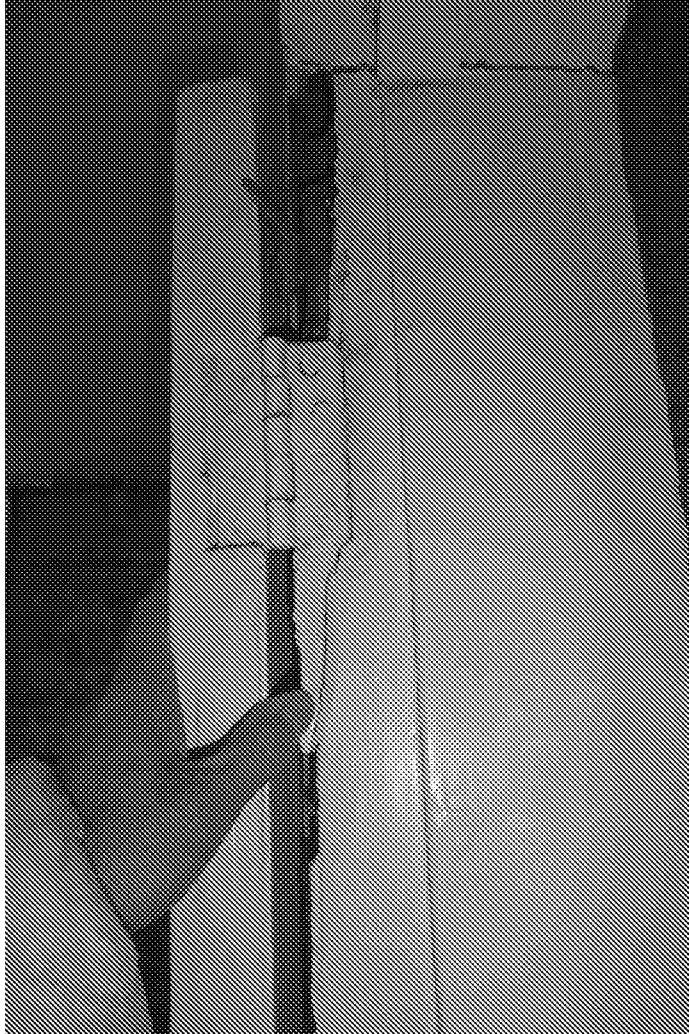
Door lining split at head and hinges.

Replace door lining as original section, with new stop but existing architraves.

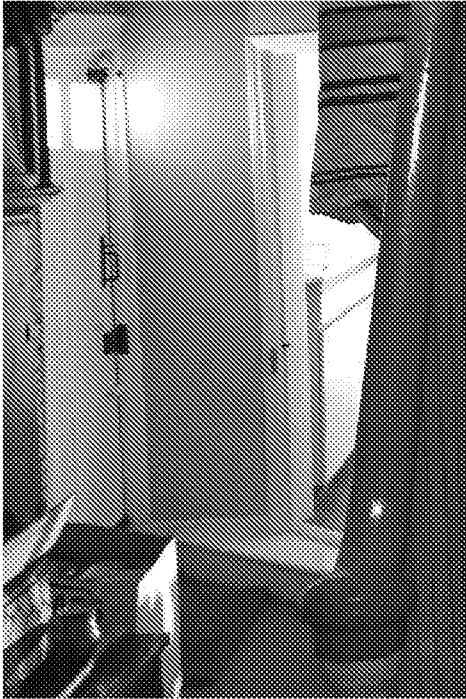
| Pantry | | |
|---|---|---|
| Floor | <p>Raised floor inserted to remove load from failed joists over utility room. (former cellar)</p> | Remove later floor to continue same level by boarding over new oak floor joists. |

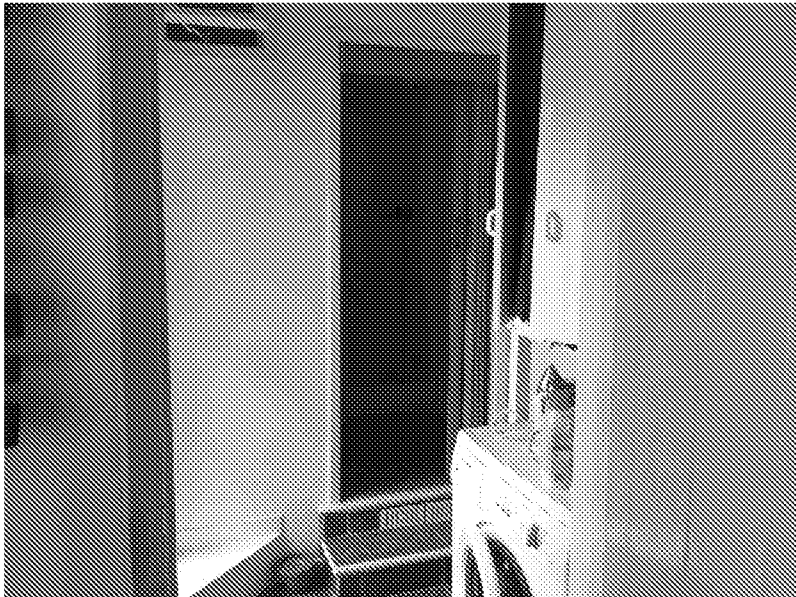
| WC | | |
|---|---|---|
| Floor | <p>Raised boarded timber floor, tiled, cracked tiles, leaks from shower.</p> | Remove floor structure, reduce to same level and cast oversite onto dpm. Screed and refit new WC and handbasin. |

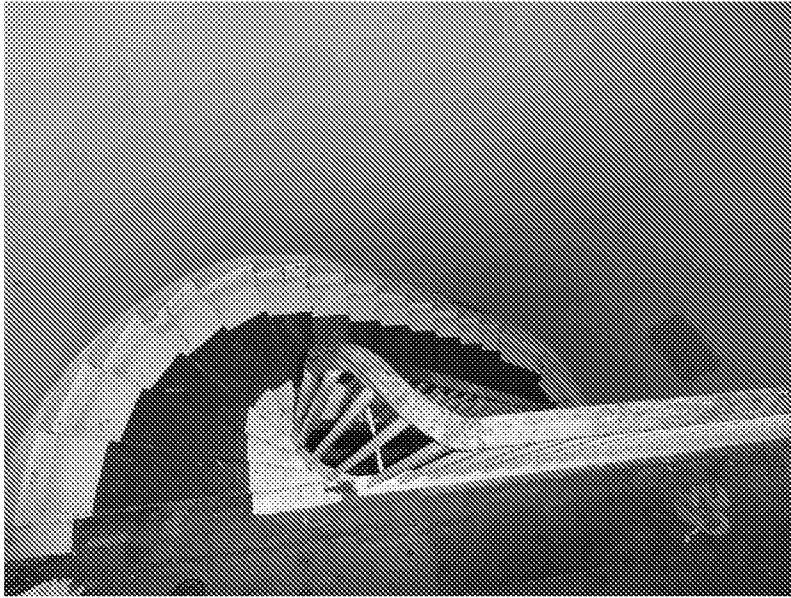
Lime plaster onto Party wall. (with No. 42)

Good condition generally.

Redecorate with minor local repairs to lime plaster necessary.

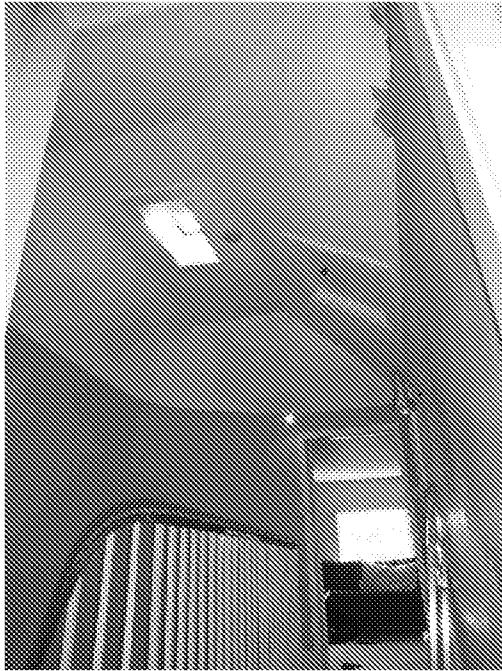
Above second floor, there is a dated skylight, which is in Georgian Wired Glass and believed to be reduced in size from the original frame evidence.

There is likely to be a separate LBC application to replace this to permit more light and stop leaks.

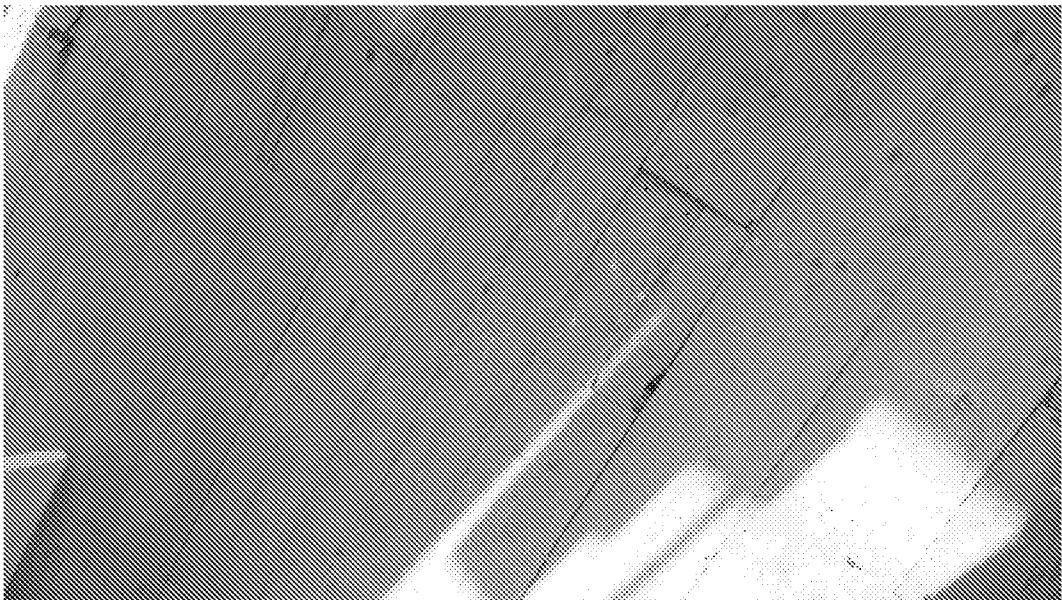
| Bedroom 1 | | |
|---|---|---|
| Floor | Timber boarding beneath carpet.<br> | Sand off, repair and retain, with replacement of like-with-like boards to match existing. |

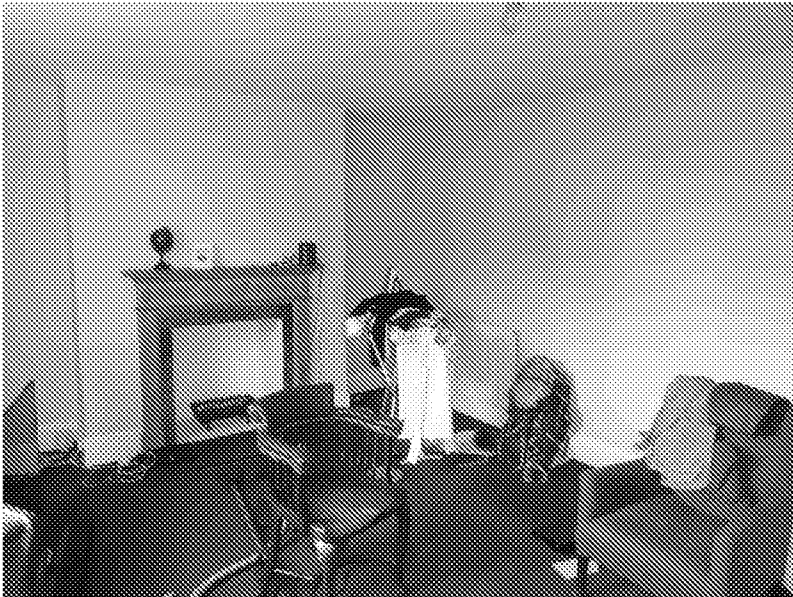
| | Existing | Proposed |
|---|---|---|
| Other | <p>Fireplace.</p> <p>Radiators.</p> <p>2 no. Radiators.</p> | <p>Remove modern fireplace and repair/reinststate plaster.<br/>Leave hearth as existing.</p> <p>New radiators in same position.</p> <p>Replace radiators with 2 no cast iron beneath windows. See drawing 106A.</p> |

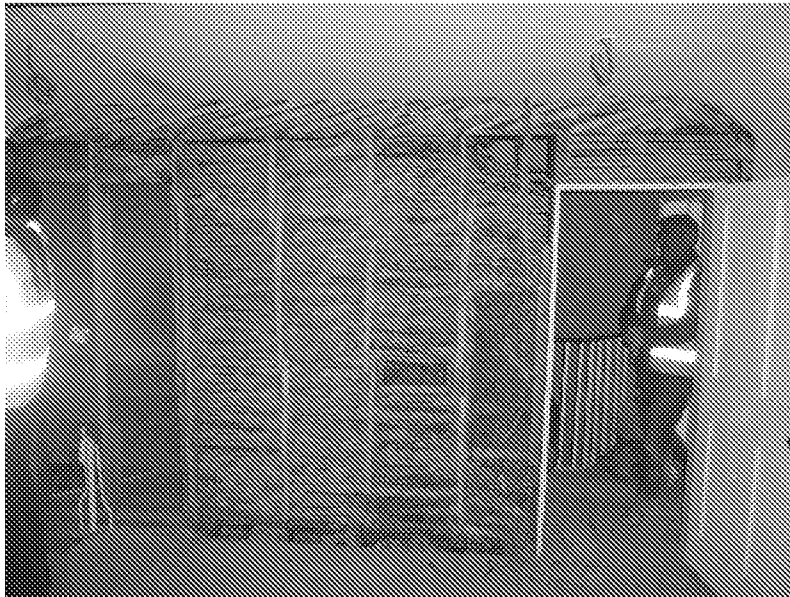
External wall brick and chalk.

Internal walls structural studwork, reed infill.

Chimneybreast, no fireplace opening.

As schedule.

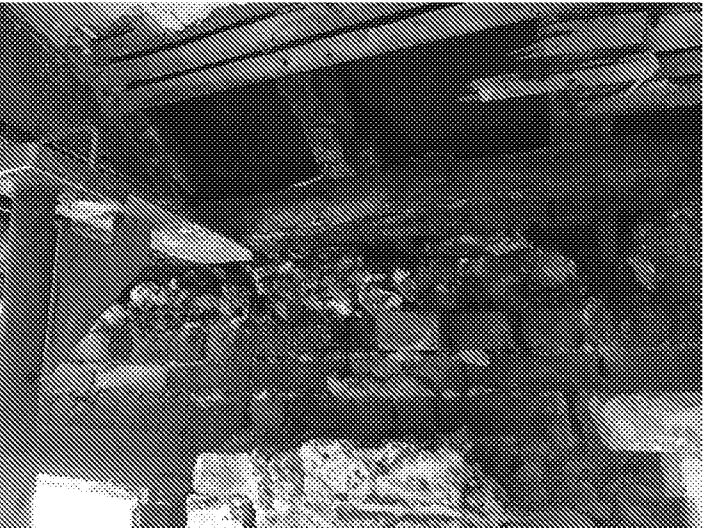
| <p>Ceiling</p> | <p>Mostly over boarded with plasterboard.</p> <p>Skeiling lath and plaster</p> | <p>Remove areas of skeiling to enable like-with-like 5"x5" oak wall plate.</p> |

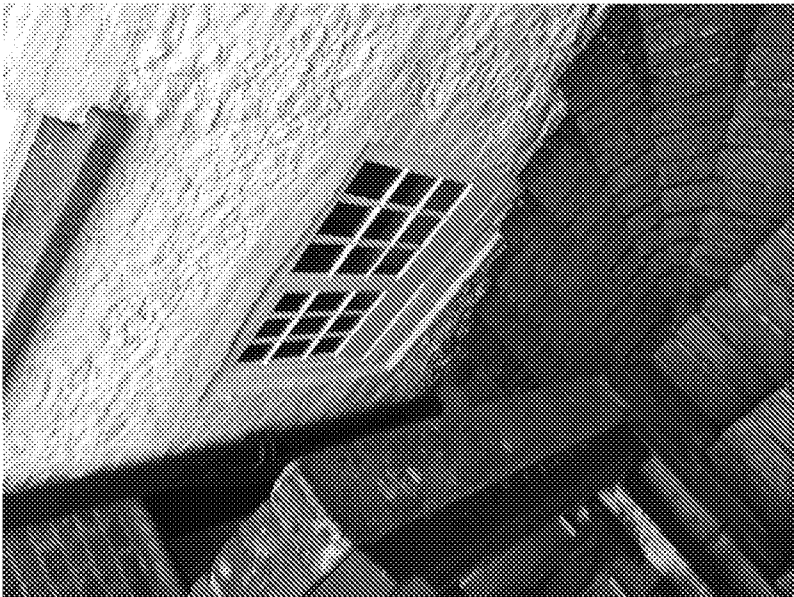
| External | | |
|---|---|---|
| Walls | Modern ½ brick wall to stair.<br><br> | Take down and replace with wrought iron handrail and balusters. |

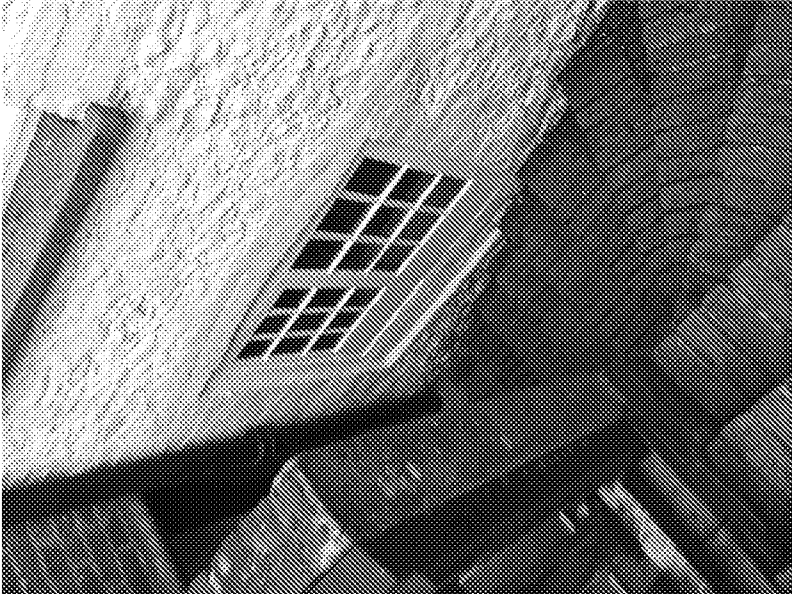
| External | | |
|---|---|---|
| Other | <p>Stair to upper (garden) level in engineering brick.</p> <p>Handrail and fittings steel.</p> <p>SVP down North elevation broken and leaking to terrace.</p> | <p>As existing.</p> <p>Fit new rest bend connecting to new manhole. Outlet to existing pipe into manhole outside back door: route beneath building to public sewer in Tarrant Street.</p> |
