# HERITAGE STATEMENT

44 Tarrant Street, Arundel, BN18 9DN

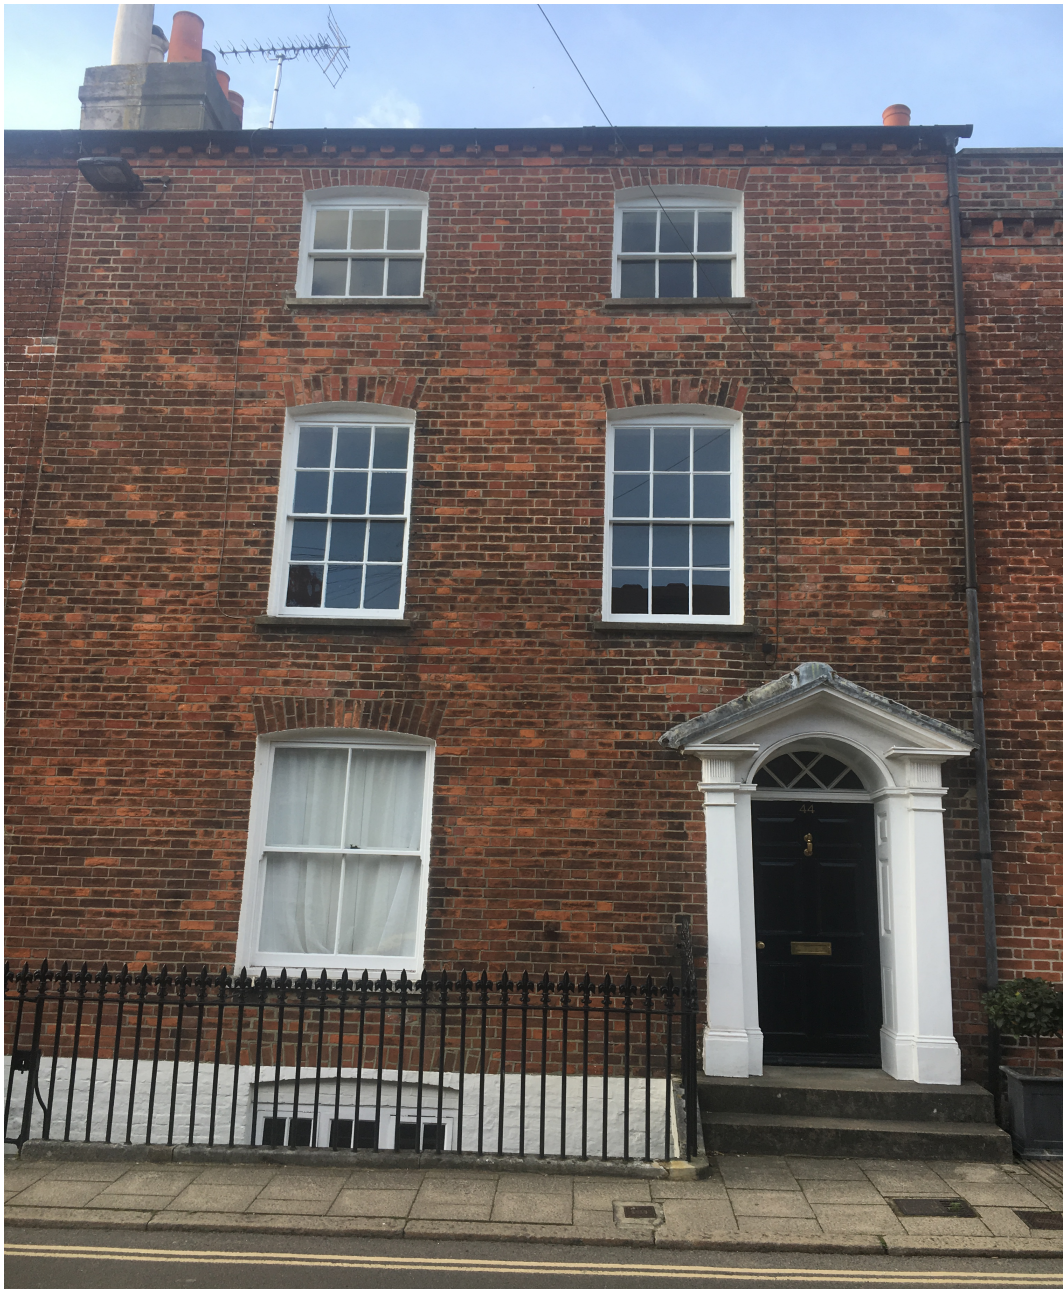
44 Tarrant Street is a Grade II Listed period property town house, of 4 bedrooms and 2 bathrooms on 4 floors, within a terrace of similar aged and style of buildings in a popular street in the centre of Arundel.
