Ref:- 21-132

Tuesday 23<sup>rd</sup> November 2021

**RE: 70A TARRANT STREET, ARUNDEL**

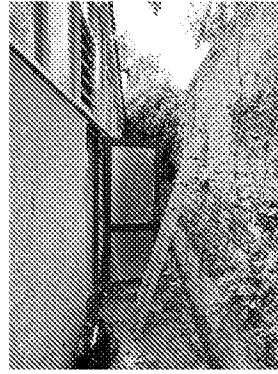
- 3.8 There was vegetation growing against the face of the retaining wall. There was also an ivy growing against the wall to the West side of the courtyard. A detailed inspection was not possible due to the vegetation covering this section of the wall. There was also vegetation, although to a lesser extent, growing against the wall to the East side of the courtyard.

**Photo No. 2 – Rear retaining boundary wall.  
Note vegetation growing against the wall**

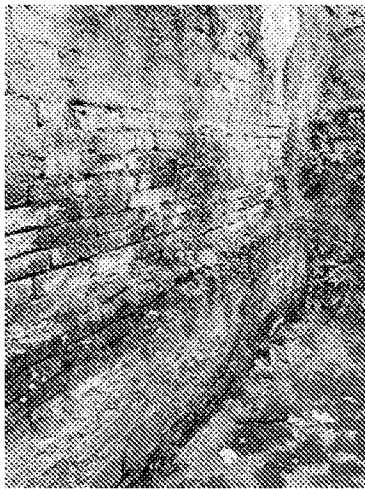
**Photo No. 3 – Rear retaining boundary wall.  
Note vegetation growing against the wall**

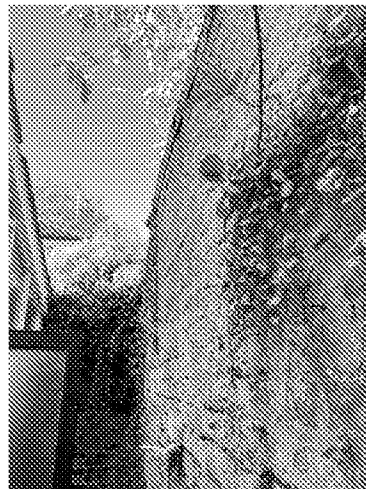
- 3.5 There was stepped cracking with distortions to the top of the retaining wall. The stepped cracking, which continued through bricks, was thought to be upto 15mm wide and was present from the top of the wall to 9 brick courses below. The boundary wall was bulging and leaning outwards at high level by upto 1:22 when checked with a spirit level and towards the garage to the South. The wall was thought to be leaning outwards at high level by upto 100mm over its full height from the top of the wall to the courtyard to the rear of the garage.

**Photo No. 4 – Bulging and leaning at high level to the rear retaining boundary wall**

- 5.3 In our opinion due to the extent of movement and deterioration which had already taken place to the retaining wall, presence of the tree behind which has caused physical damage to the wall and the potential of inadequate construction of the retaining structure we recommend that the boundary wall should be replaced. The retaining structure should be replaced in accordance with design and details prepared by a Chartered Structural Engineer / Civil Engineer with the works being carried out with relevant statutory consents including Building Regulations approval. It will be necessary to remove the trees and excavate the land from behind the retaining wall in order to undertake the works. Prior to undertaking any works it will be necessary to check whether any Listed Building or Planning approvals will be required for removal of trees and replacement of the wall. The new retaining structure should include barriers to prevent falls from the back garden on the upper ground level into the courtyard.

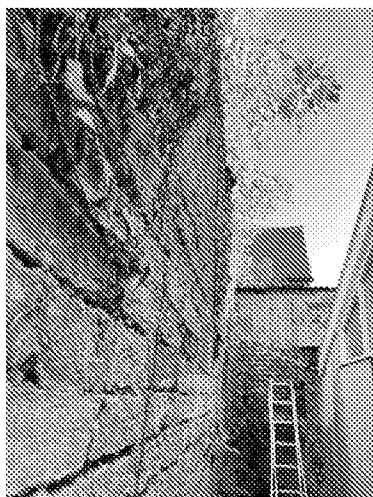
**Photo No. 5 – Bulging and leaning at high level to the rear retaining boundary wall**

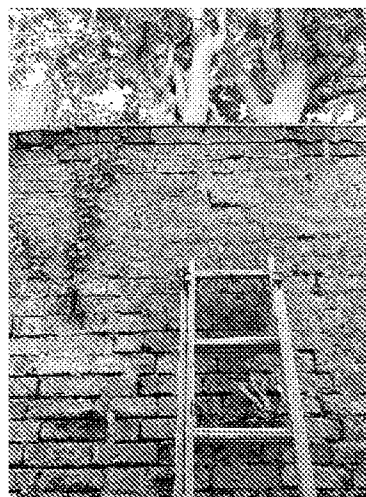
- 4.7 We consider that although the retaining structure may not have been of adequate design and construction that the wall may have performed satisfactorily and remained structurally stable for a number of years. However, the presence of the Fig tree growing directly against the rear face of the wall has applied physical lateral pressure causing the wall to move outwards at high level.

**Photo No. 6 – Cracking and movement with bulging at high level to the rear retaining boundary wall**

- 5.6 An attempt to carry out repairs to the retaining boundary wall could be made. We also suggest that the trees growing directly adjacent to the back of the retaining boundary wall should be carefully removed. The remedial works to the boundary wall could include to introduce Helibars at every third brick course to full length of the retaining wall which should return to the side walls. The remedial works, which will be superstructure repairs alone, will be subject to confirmation by a Helifix Approved Specialist Contractor. The works should also include to repoint the brickwork and to replace any cracked bricks. The fencing which is fixed to the top of the wall should be removed and fencing provided within the back garden to the upper ground level to prevent access to the rear of the wall. The Contractor appointed to undertake the works should provide temporary propping to the wall during the course of the works. The remedial works to the boundary wall could also be subject to the relevant statutory approvals. It will be necessary to monitor the boundary wall for any future cracking or ongoing movement.

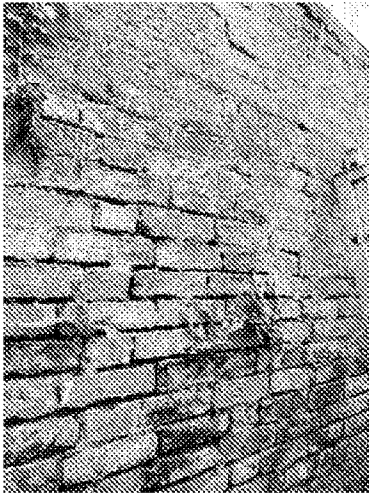
- 3.4 The brickwork to the retaining wall was weathered and had eroded with areas of loose and missing pointing to the structure with efflorescence and staining to the wall. There were large areas of loose and missing pointing to the wall below the upper ground level. There was also spalling to the brickwork on the upper section of the retaining wall.

- 4.4 The brickwork to the retaining wall was in a poor condition being weathered and had deteriorated with areas of eroded, loose and missing pointing to the structure with efflorescence and staining to the wall together with spalled bricks.

**Photo No. 7 - Deterioration of brickwork to the rear retaining boundary wall. Eroded, loose and missing pointing to the wall**

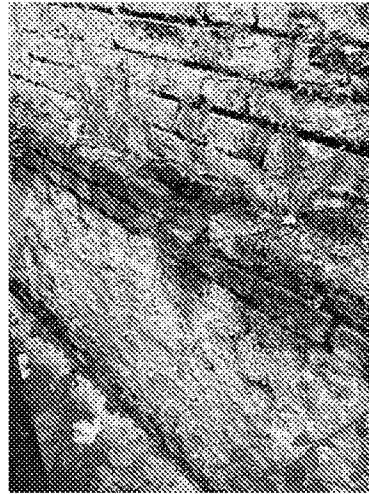
**Photo No. 8 - Low level mortar bound brickwork to the rear retaining boundary wall**

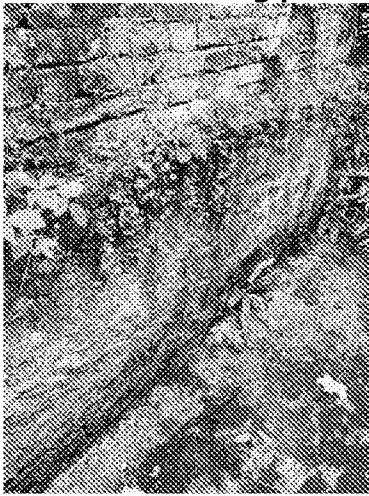
**Photo No. 9 - Low level mortar bound brickwork to the rear retaining boundary wall**

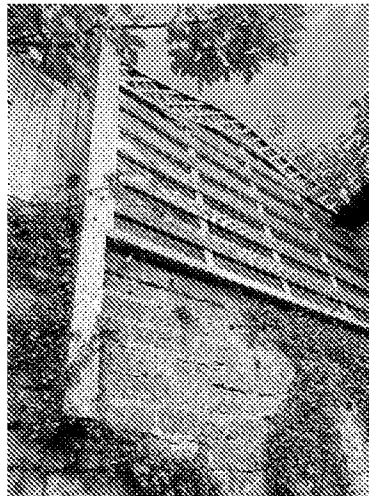
- 4.8 It was noted that the retaining wall extended by only 600mm above the upper ground level and therefore there were only limited barriers in place to prevent falls from the back garden into the courtyard below. Where fencing had been fixed to the top of the wall this will also place loadings from wind onto the retaining structure.

**Photo No. 10 - Trellis fencing fixed to the top of the rear retaining boundary wall with panels within the ground behind**

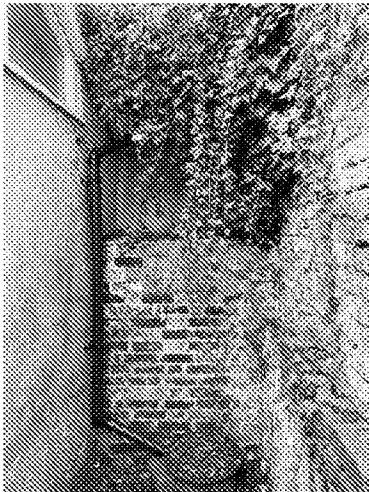
**Photo No. 11 - Return wall to the West side of the rear retaining boundary wall. Drainage to the roof over the building**

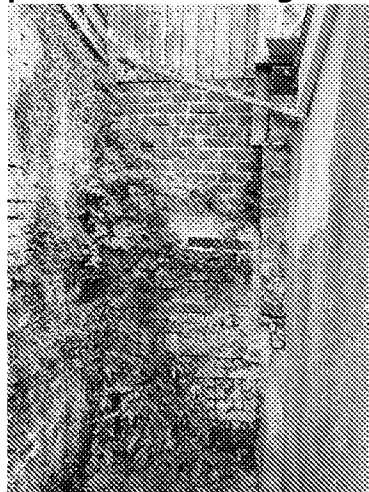
**Photo No. 12 - Return wall to the East side of the rear retaining boundary wall.**

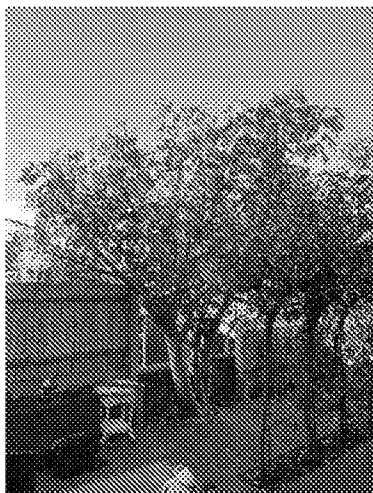
**Photo No. 13 – Tree within the back garden of Newburgh House growing directly against the rear retaining boundary wall**

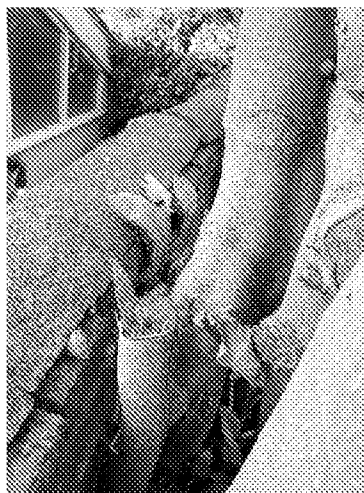
**Photo No. 14 – Tree within the back garden of Newburgh House growing directly against the rear retaining boundary wall**

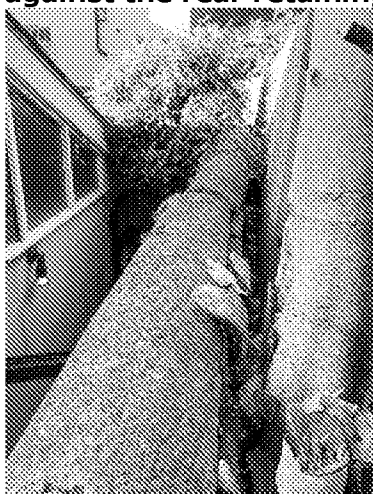
- 3.15 There was a concrete capping to the top of the retaining wall which was cracked and which had moved over the brickwork below at the location where the Fig tree was growing directly adjacent to the wall.

**Photo No. 15 – Cracked concrete capping and movement to the top of the rear retaining boundary wall at the location of the tree within the back garden of Newburgh House**

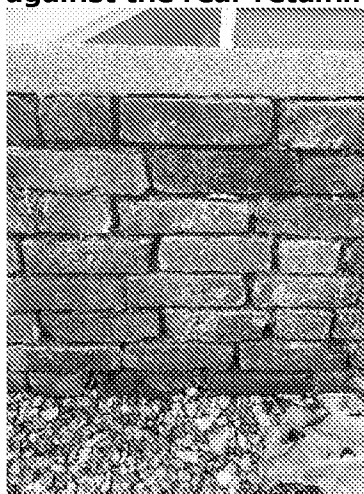
- 3.14 The wall which extended above the upper ground floor level was weathered with missing pointing to the brickwork and spalled bricks. This was at the location of the Fig tree.

**Photo No. 16 –Deterioration of brickwork to the rear retaining boundary wall. Eroded, loose and missing pointing to the wall within the back garden of Newburgh House**

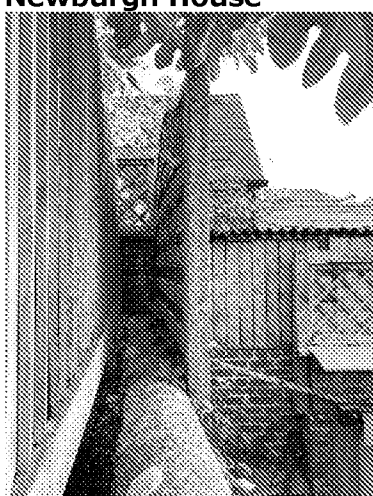
**Photo No. 17 – Trellis fencing and fence panels to the top of the retaining boundary wall within the back garden of Newburgh House**
