Arundel Cathedral House  
*Arundel, West Sussex*

Garden wall repairs and alteration

Design & access  
statement

## Arundel Cathedral House, West Sussex: Proposed repairs and alteration to garden wall

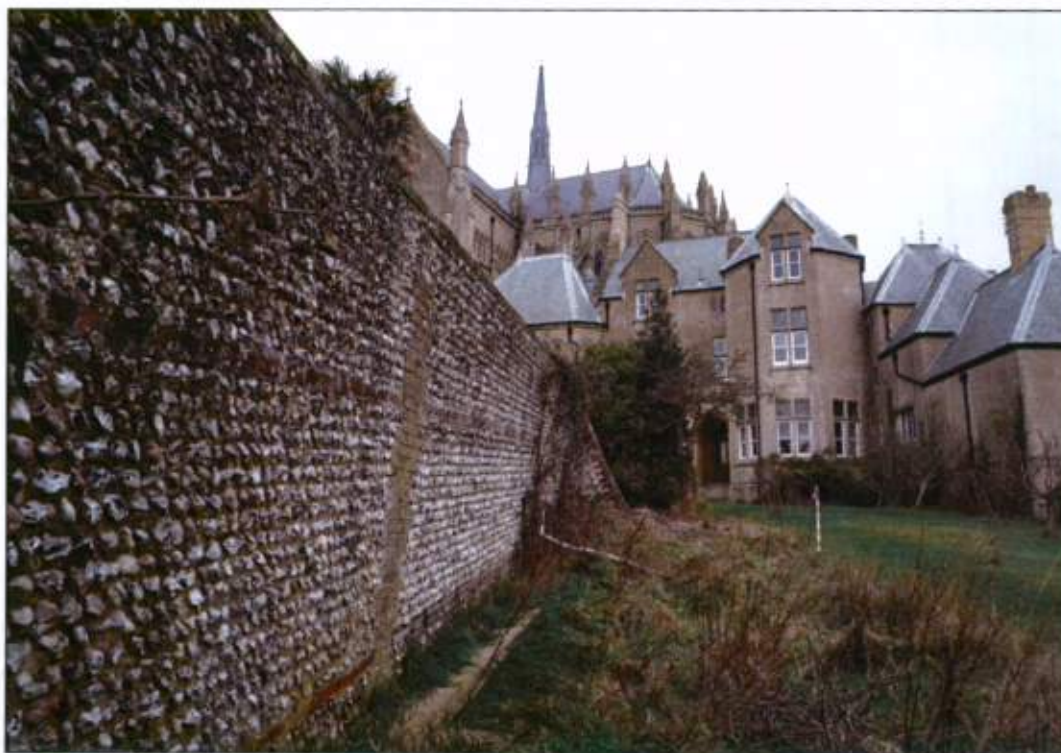
- 3.02 *The wall which is of greatest concern is the wall which runs north/south and divides the garden in two. This is a flint wall approximately 2.8m high and 330mm thick. It has a lean in it of approximately 320mm towards the east at its north end, see P04. Clearly this wall has been of concern for some time because a single large brick and flint buttress has been built on the east side at the point of greatest movement. Unfortunately the buttress has settled on its foundations slightly and a gap has opened between the face of the flint wall and the back of the buttress. The flint wall has integral brick piers built within it at regular centres approximately 5m apart. There is a stone coping on top of the wall and in at least on location, water running through the coping has caused localised failure of the flintwork.*

4.02 *below:* Photograph of garden wall, looking north towards Cathedral House. Note the lean on the wall and the presence of the existing buttress.

4.01 It is proposed to repair the wall and to construct a new brick and flint buttress adjacent to the wall, as shown on the structural engineer's drawing 09024/01. The effect of this on the appearance of the wall is illustrated in the sketches and photographs below.

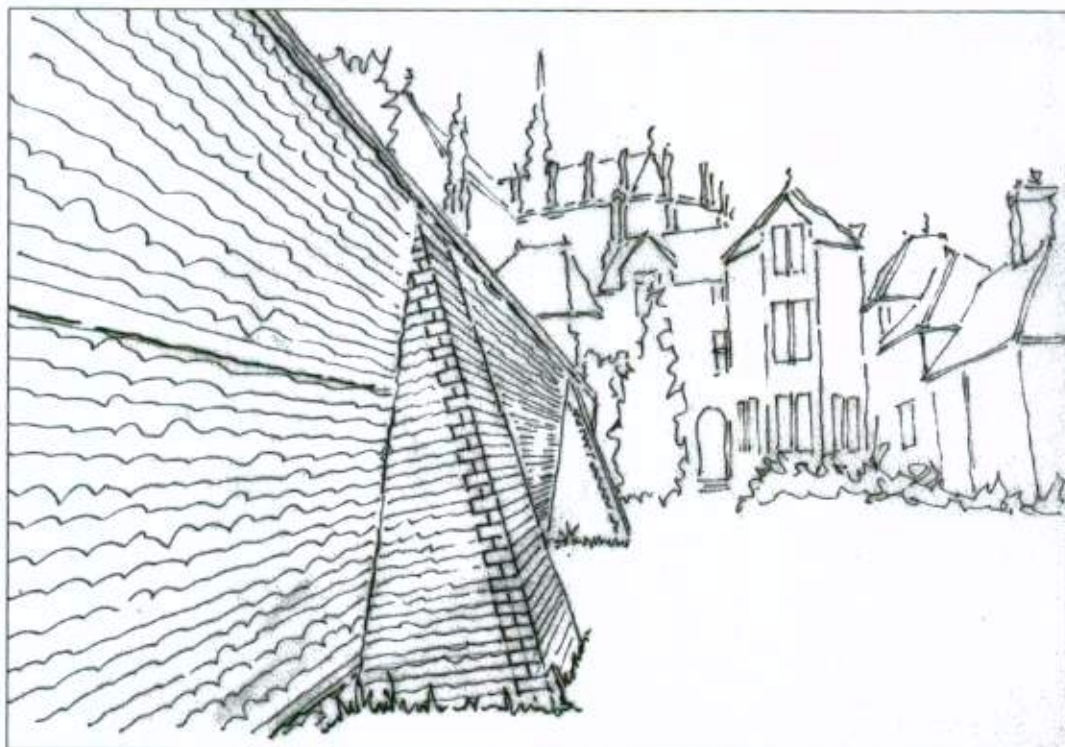
*above:* Sketch showing new buttress added to wall towards the southern end, constructed to match existing buttress.

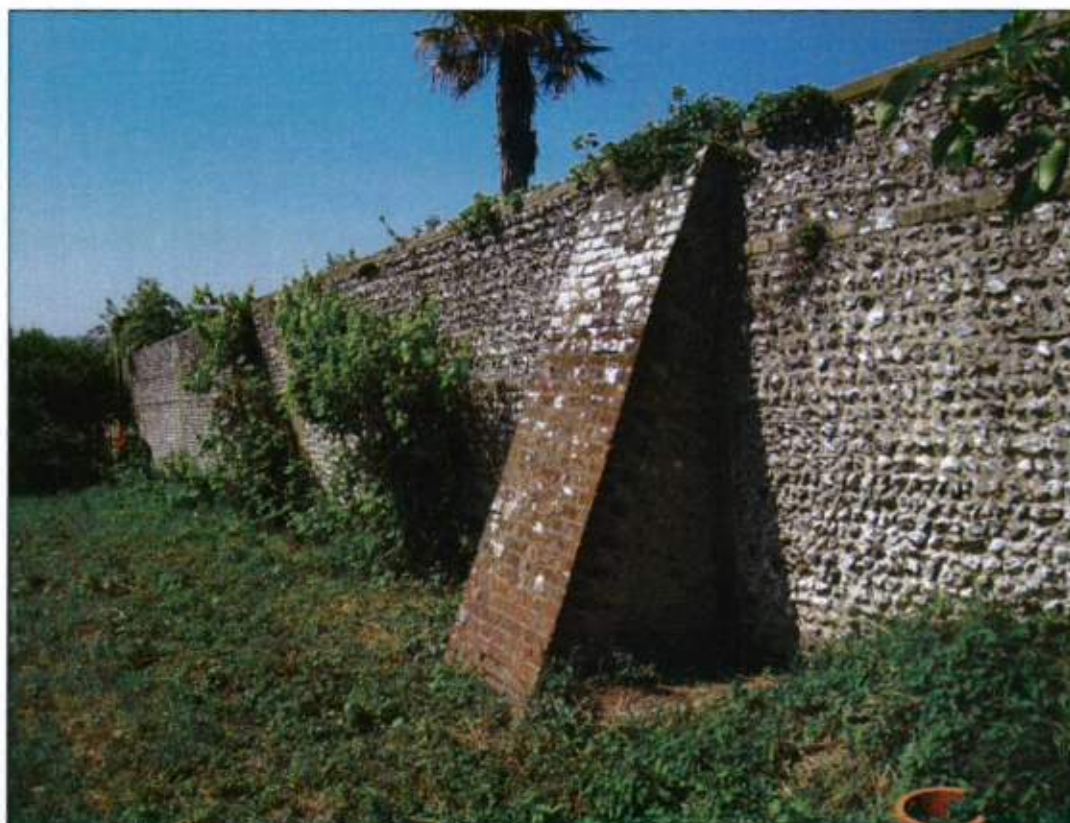
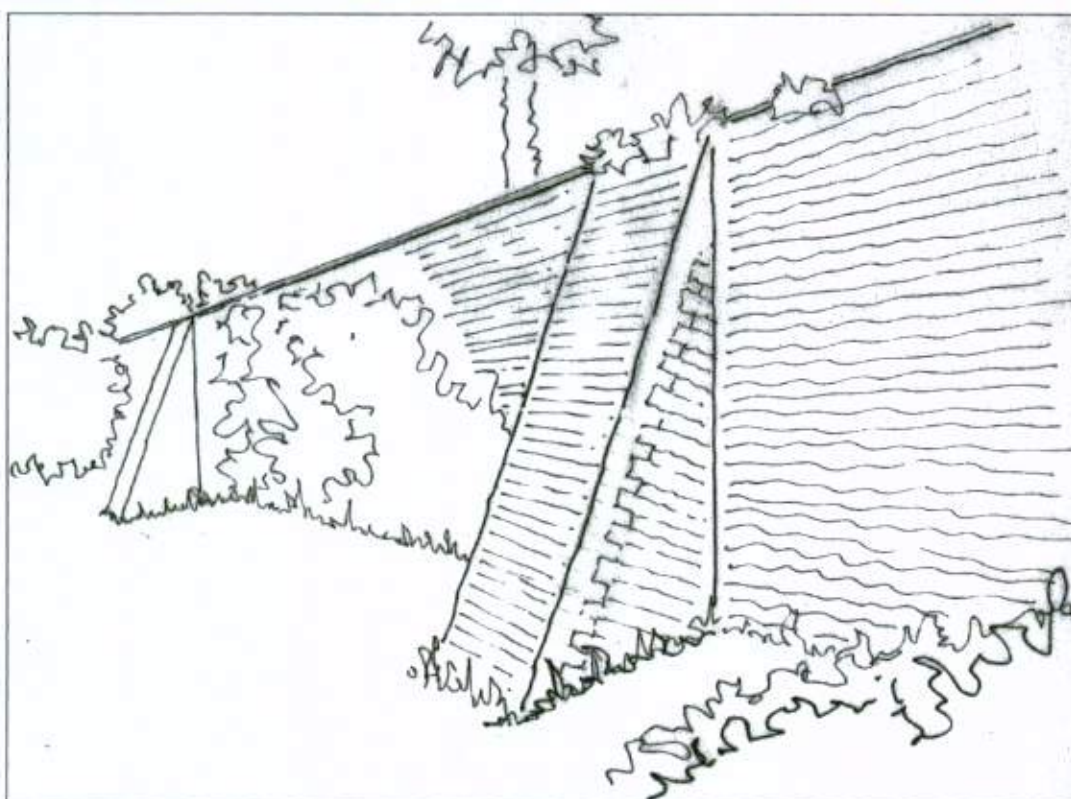
*above:* Sketch showing new buttress added to wall towards the southern end, constructed to match existing buttress. Indicative location shown.
