## **APPENDIX B      SITE BOUNDARY AND DILAPIDATION SURVEY**

## **APPENDIX C      PHOTOGRAPHS**

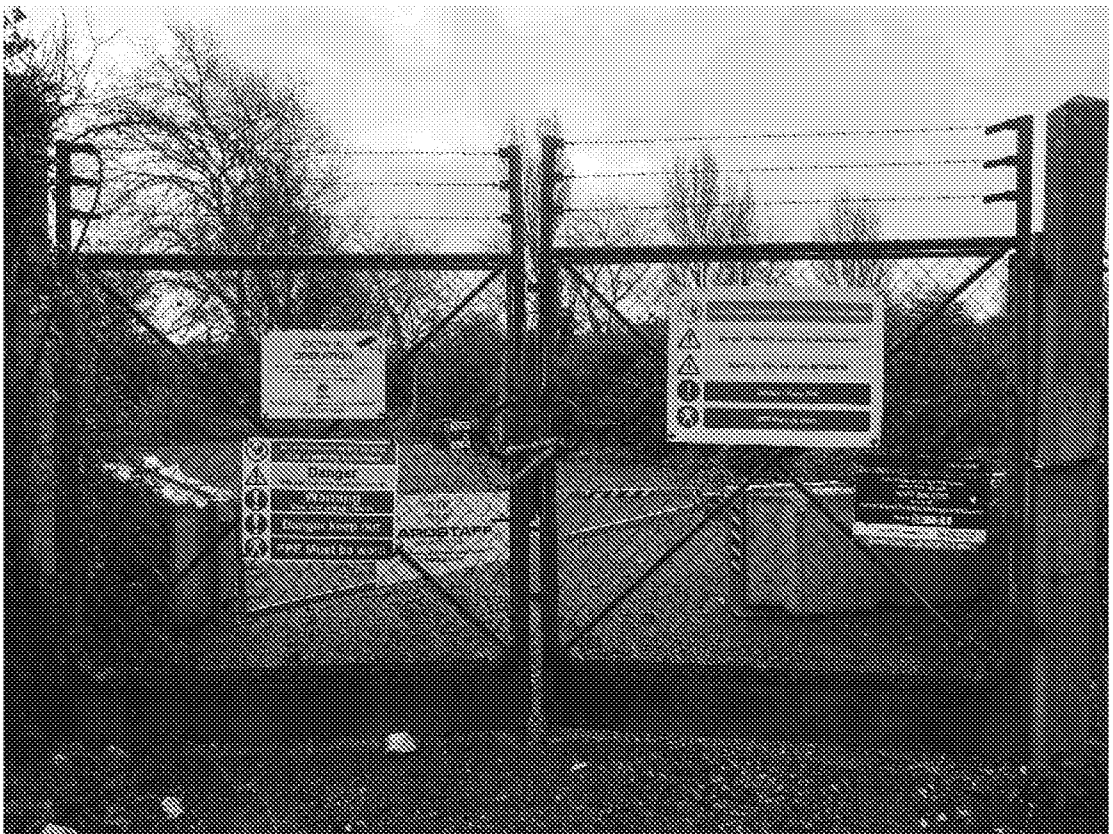
A pair of metal gates with chainlink fencing serves as the only current vehicular access point to site and is secured with an IDACS coded lock and chain. Three lines of barbed wire top the gate to approx. 2.5 m high and the gate functions adequately to secure the site. An internal swing gate secured with concrete blocks form a secondary security measure just inside of the main gate. A padlocked pedestrian gate forms a secondary route of access just to the north west of the main gate, although this gate has not been used or maintained for a long time.

Plate 2 View of Double Gate Vehicle Access Gate

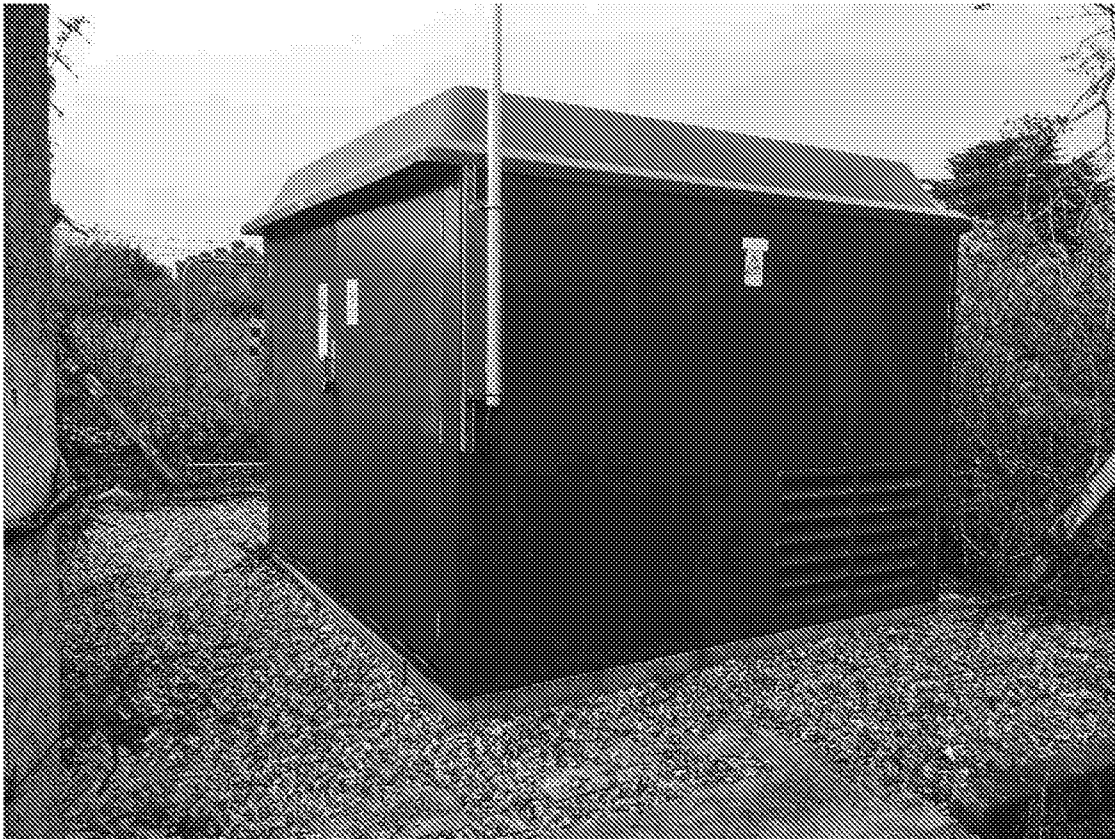
Plate 3 View of SSE Electrical Substation

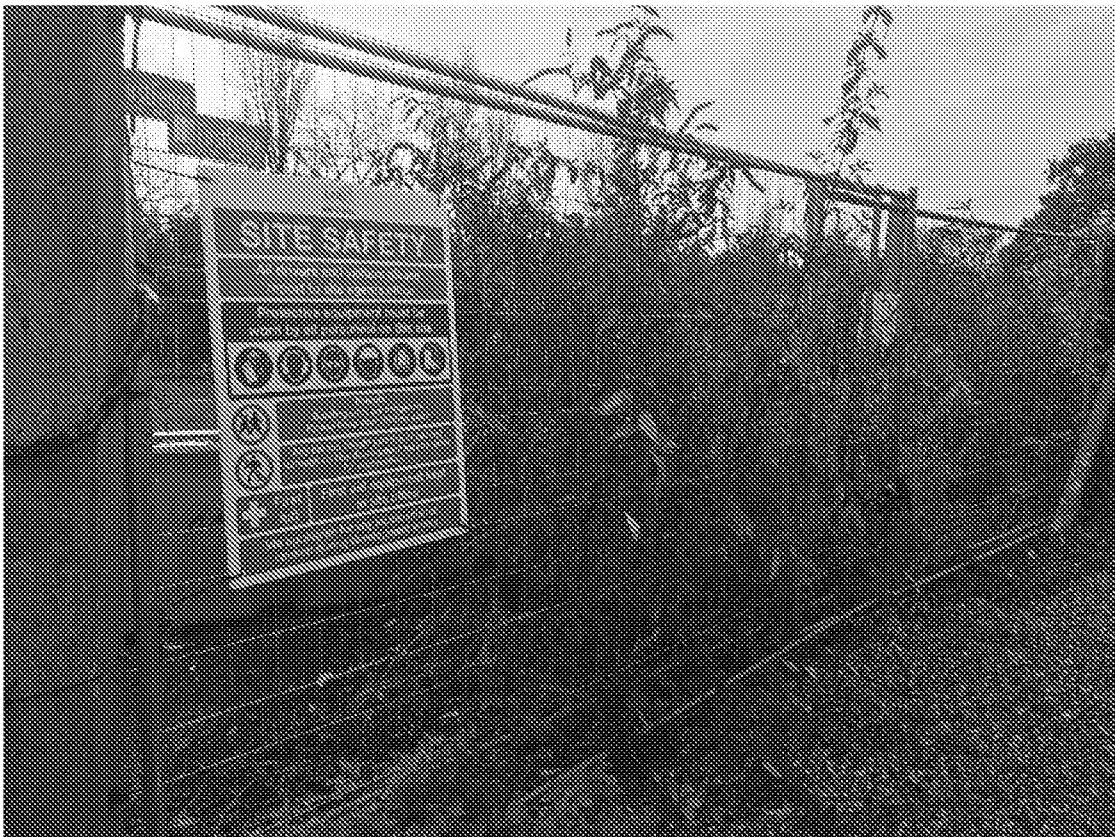
The fencing surrounding the electrical sub-station was found to have been damaged and subsequently repaired with heras fence panels tied into the existing chain link fencing.

Plate 4 View of Site Boundary Surrounding the Substation

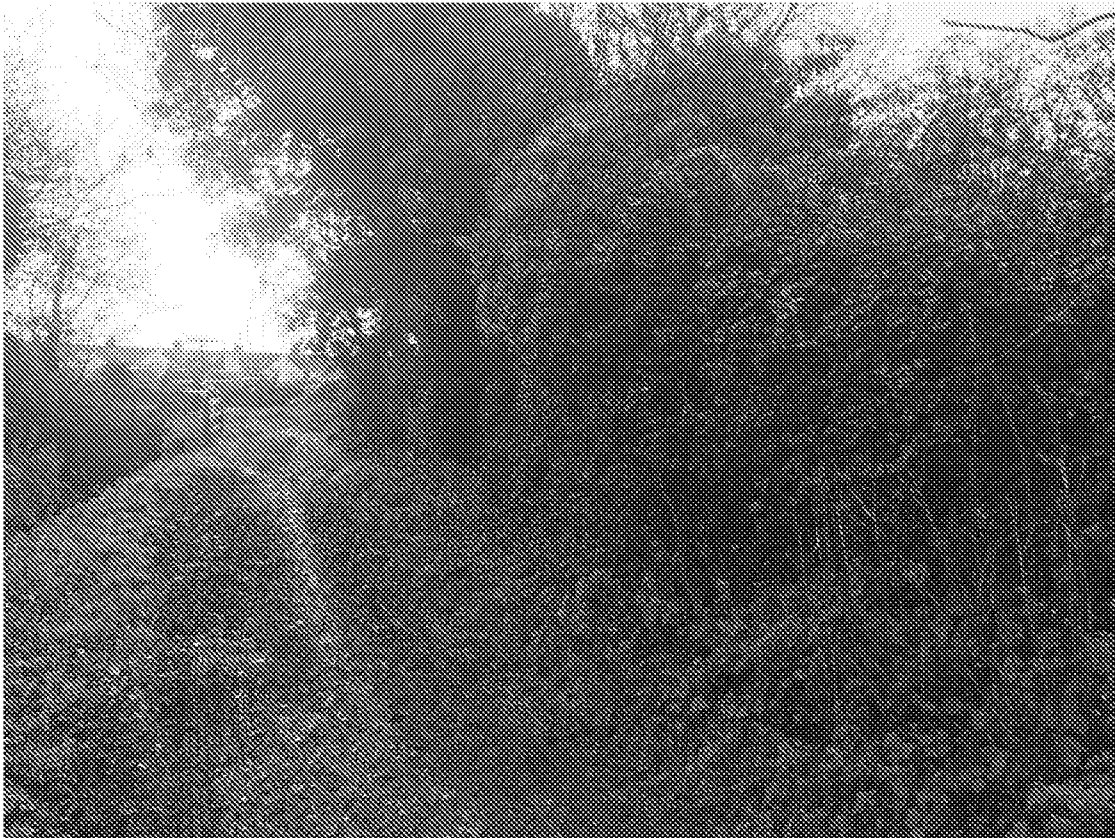
Plate 5 View of Access Track along Heavily Overgrown North Eastern Boundary leading to River Arun

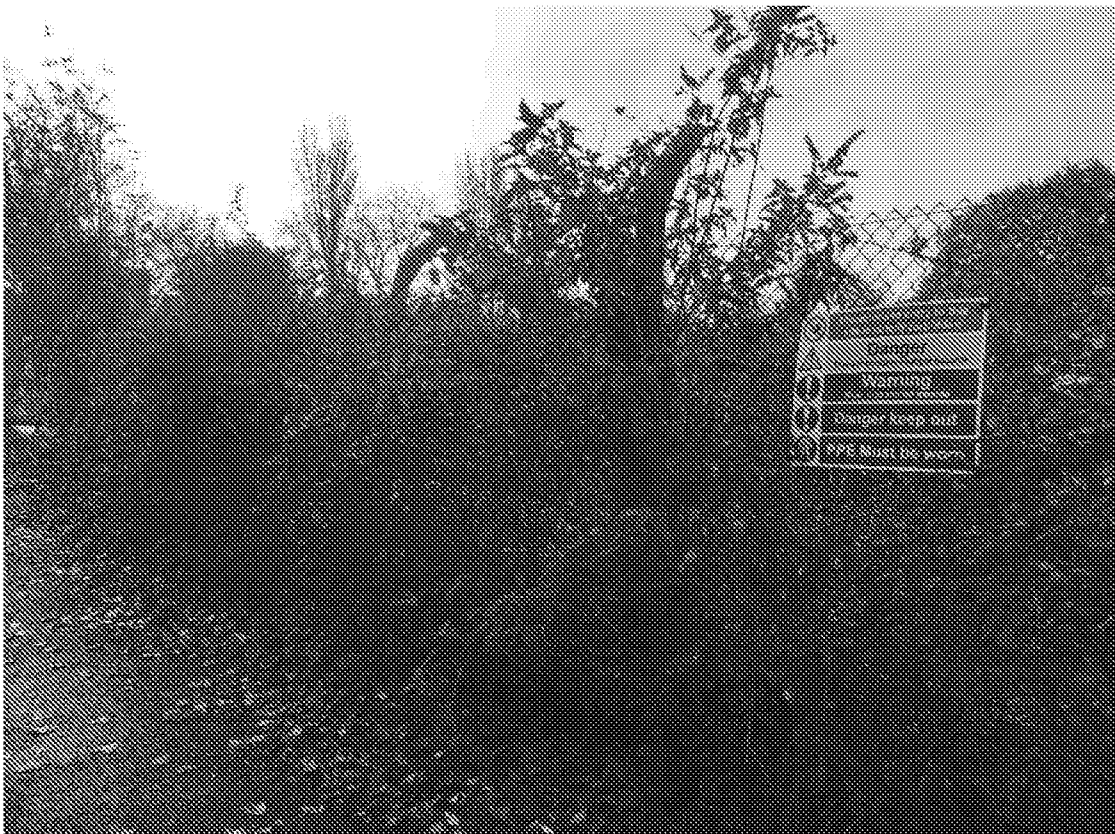
The north east boundary is heavily overgrown with a couple of leaning posts. A dwarf brick wall approximately 0.5m high is also present further north toward the junction with Ford Road. The dwarf brick wall continues along the north western boundary along the footpath of Ford Road. Directly behind the brick wall is a 1.5 m high (from the level of Ford Road) chainlink fence with concrete crank posts. Approximately 3.5 m into site is a further chainlink fence, 2.1 m high (from site level) and concrete crank posts. Trees and vegetation are present between these fencelines more so towards the northern site corner. This double fencing arrangement continues along the south western boundary, due to the differences in levels between site and adjacent property (the adjacent property being approx. 1 m higher than site level). The double fencing stops at the position of the surface water drain and turns 90 degrees to step back into the outer (site boundary) fenceline. This south western boundary and the area between the fencelines is considerably overgrown with brambles and scrub vegetation. The remaining single line of chainlink fence along the south west boundary and along the south east boundary is heavily overgrown and particularly at the concrete crankposts where ivy is completely smothering the posts. A couple of repairs are evident along these boundaries and the fence serves as an adequate boundary to the adjacent grazing land.

Plate 6 View of Site Boundary along North Eastern Boundary towards Ford Road

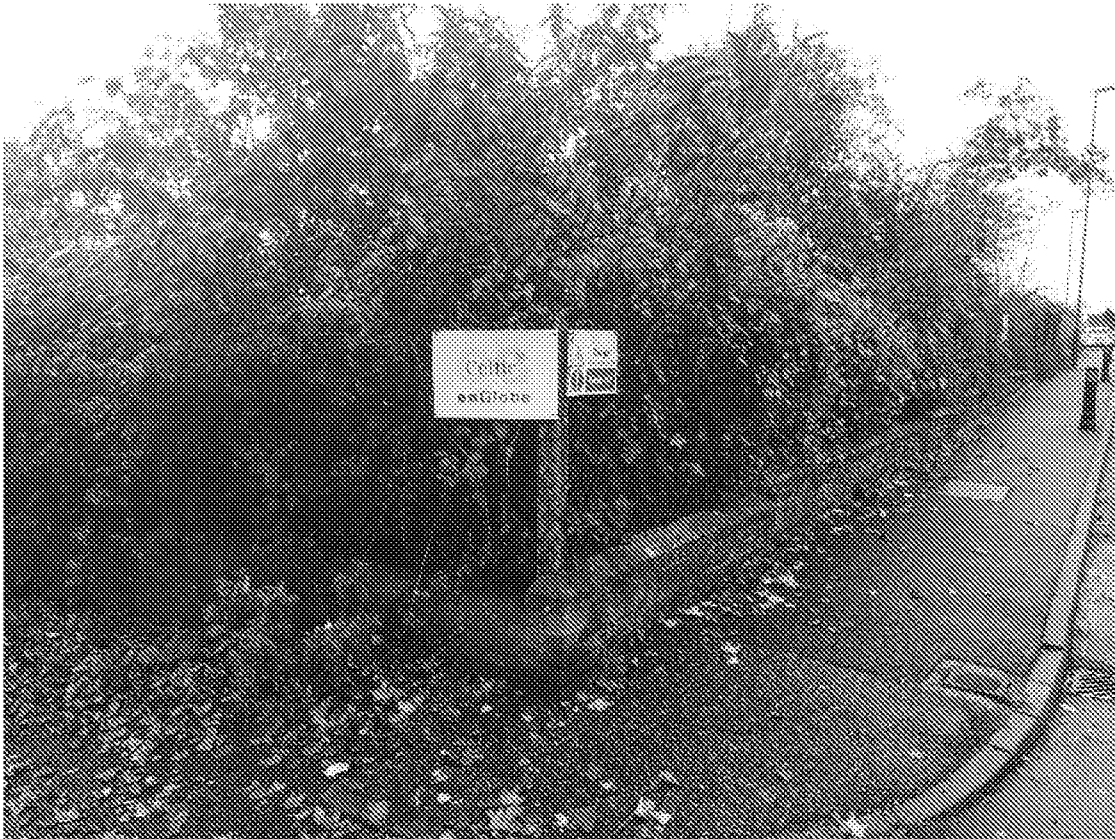
Plate 7 View of Site Boundary along North Western Boundary from Ford Road

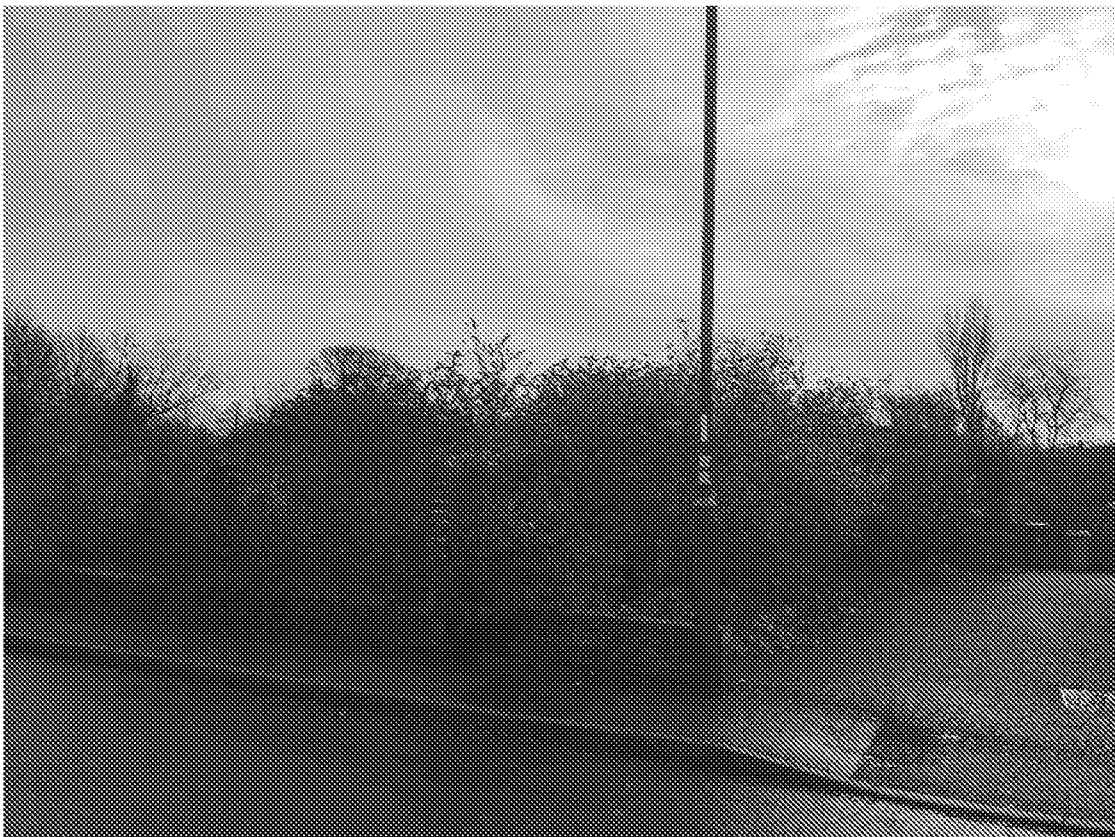
Plate 8 View of South Western Boundary (at Western Corner) Adjacent to Neighbouring Residential Property

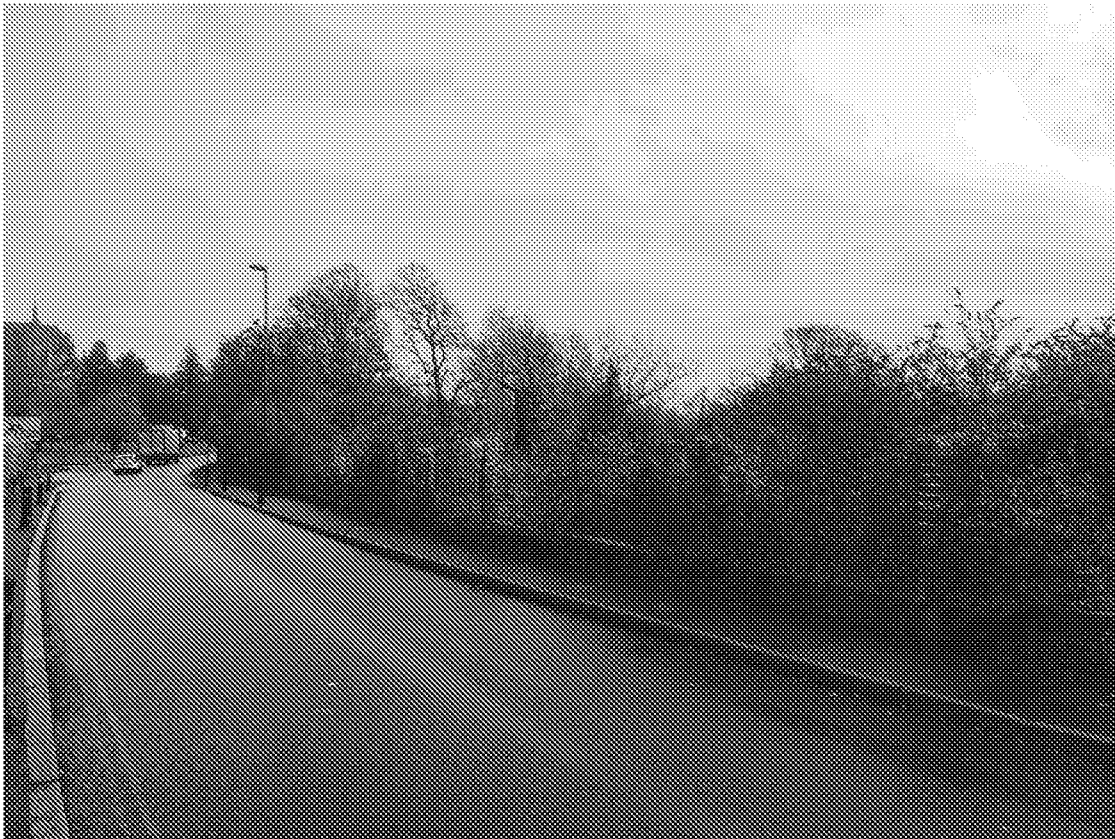
Plate 9 View of Ford Road and North Western Boundary Outer Fenceline

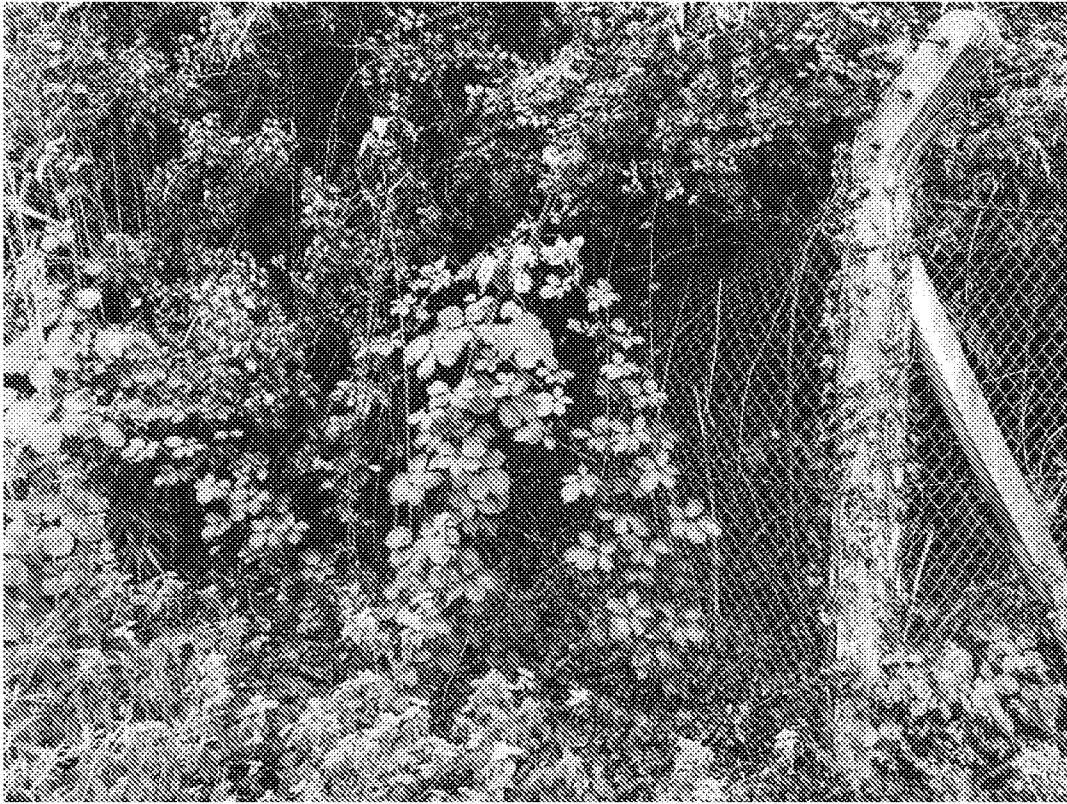
Plate 11 View of South Western Boundary on Line of Drain Looking West as Fence Returns to Single Line at Outer Boundary Fence

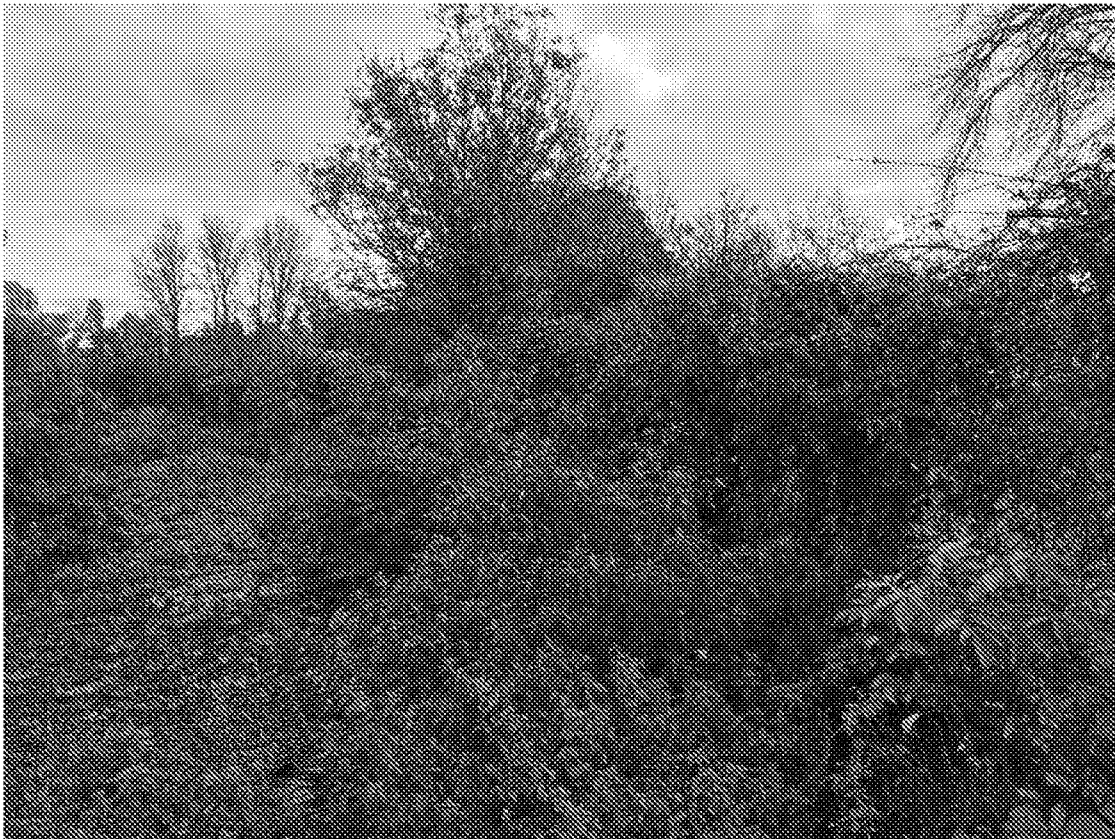
Plate 13 View of South Eastern Boundary Showing Heavily Overgrown Fenceline

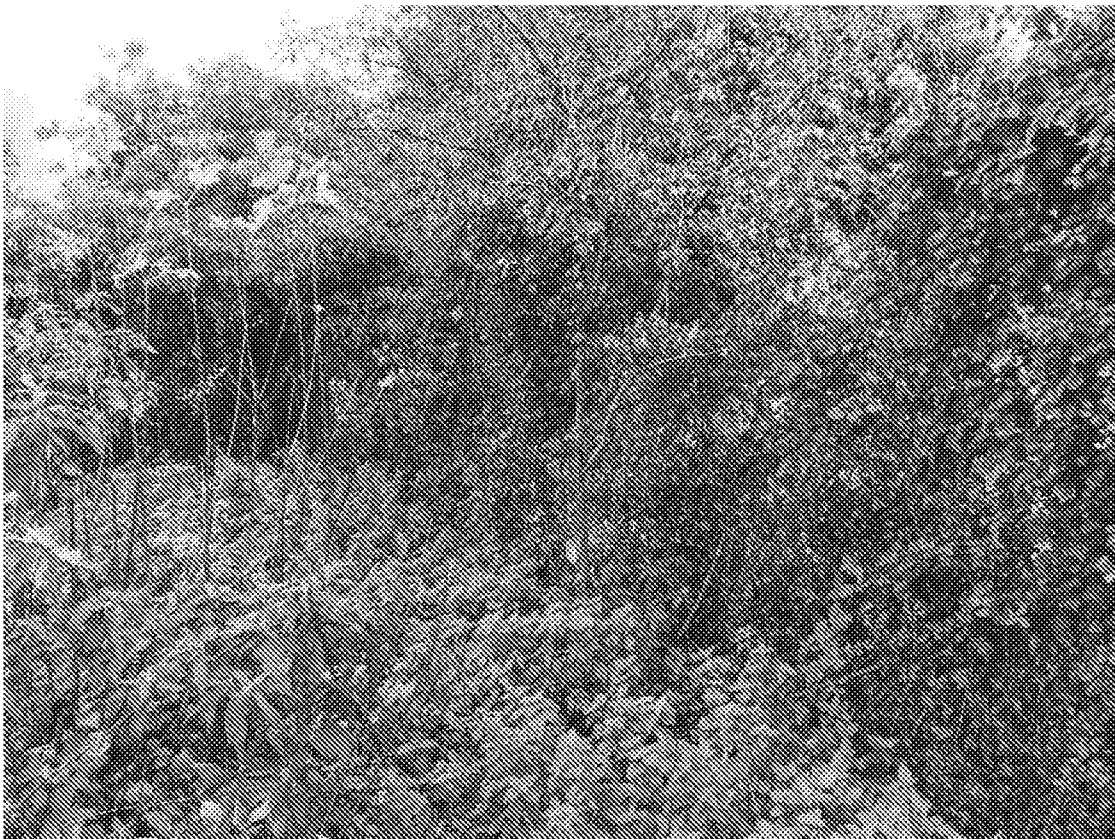
Plate 14 View of Eastern Corner of Site Showing Heavily Overgrown Fenceline
