## **Application for tree works: work to tree subject to a tree preservation order (TPO)**

**Species:** Holm Oak (*Quercus ilex*)

**Location:** 1 London Road, Arundel, West Sussex, BN18 9AZ

**TPO:** TPO/AB/3/20 (2020)

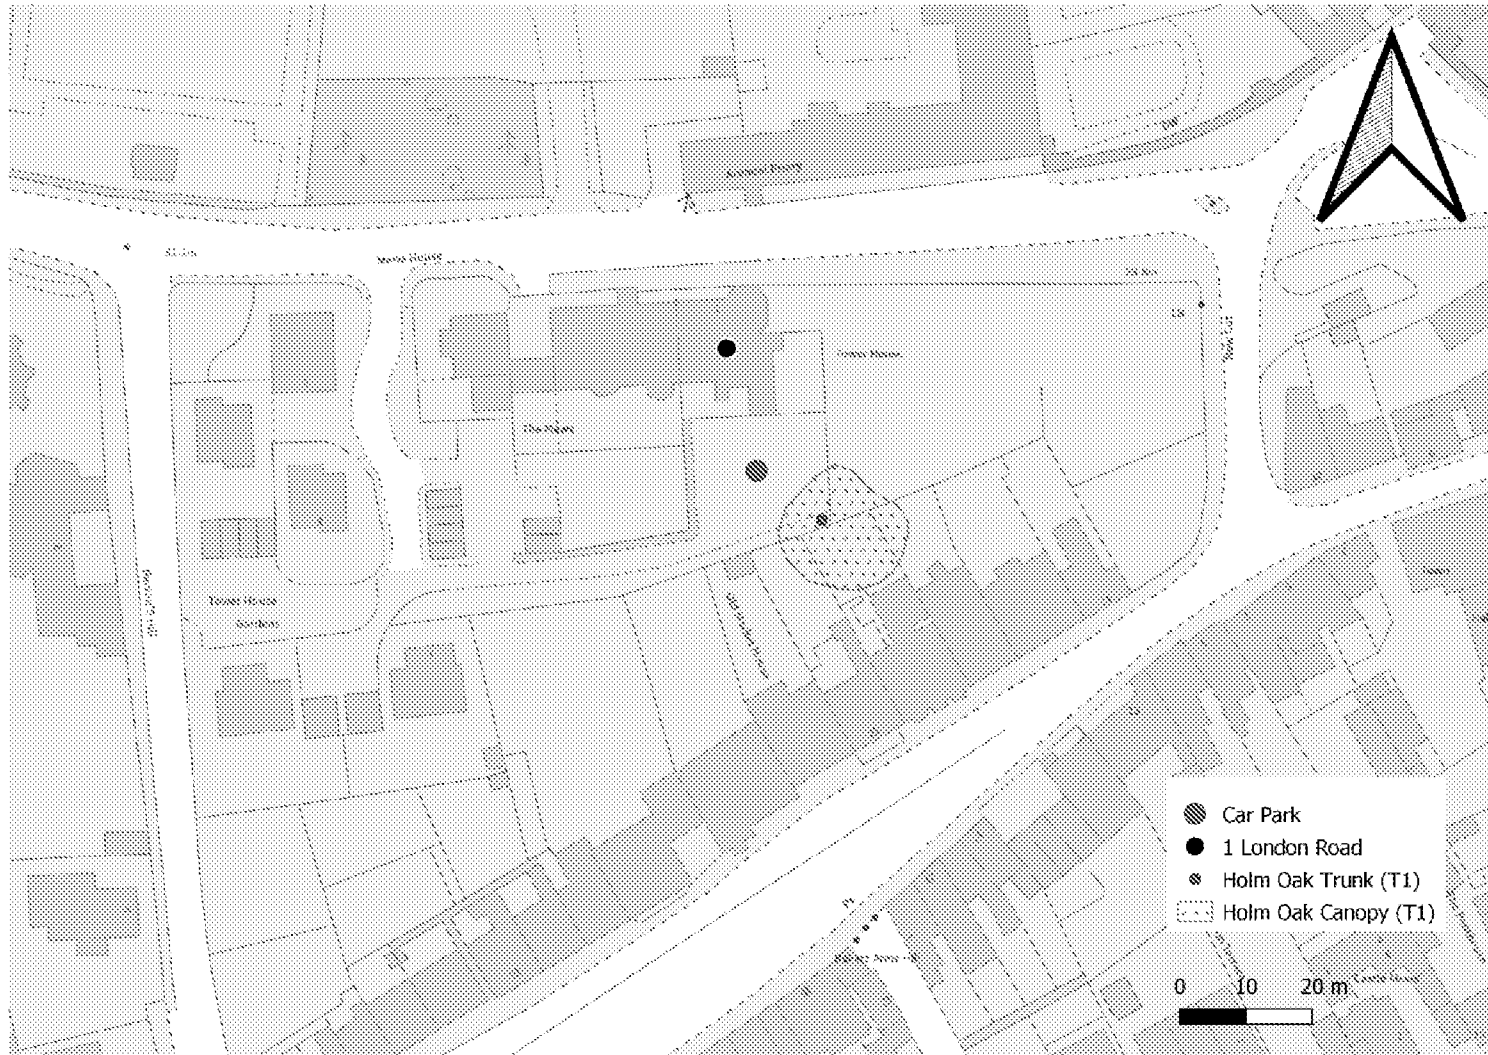
*Figure.1* Sketch plan illustrating *Quercus ilex* location (X 501675, Y 107149), canopy cover (263.62 m<sup>2</sup>), trunk (Ø 1.4 m), and location of retaining wall.

**2.4** A truck and chipper are to be situated in the car park to the north (*figure.1*) where, preparation and setting up would start (workforce to read and sign the risk assessment).

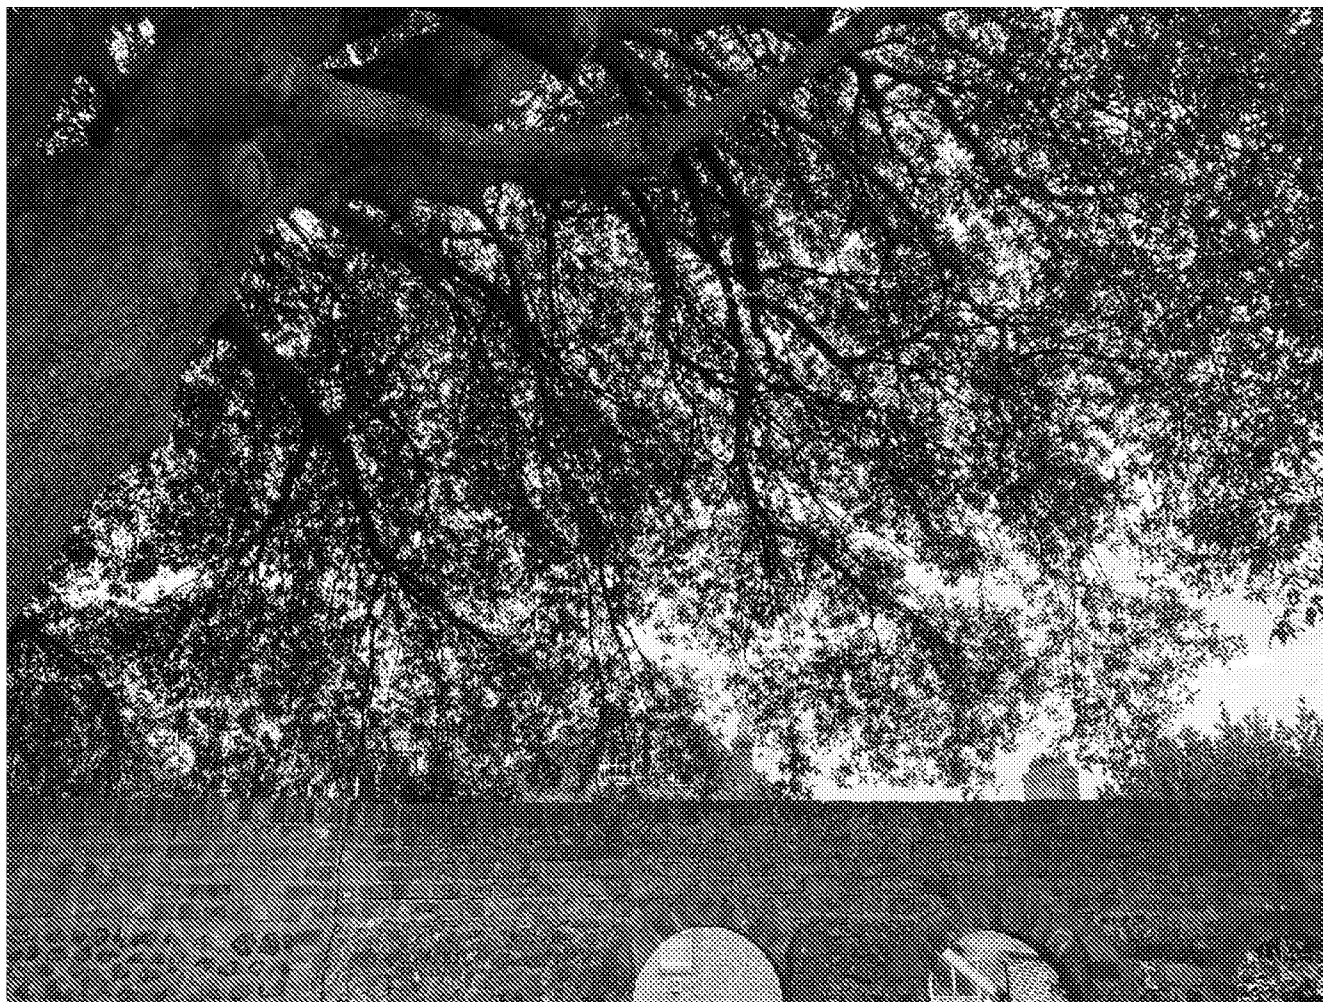
*Figure.2* Illustrates proposed limb cuts. From left to right, limbs of approx. Ø 5cm & 3cm to be cut.

**2.1** Remove the lower limbs on the south side of the tree (*figures. 2 & 5*). This will significantly reduce the overbearing weight; it will allow the tree to put more energy into growing on the north side which will gradually start to re-balance the tree.

**2.2** Two limbs of approx. Ø 10 cm, two limbs of approx. Ø 5 cm and one limb of approx. Ø 3 cm to be removed from tree (*figures. 2 & 5*).

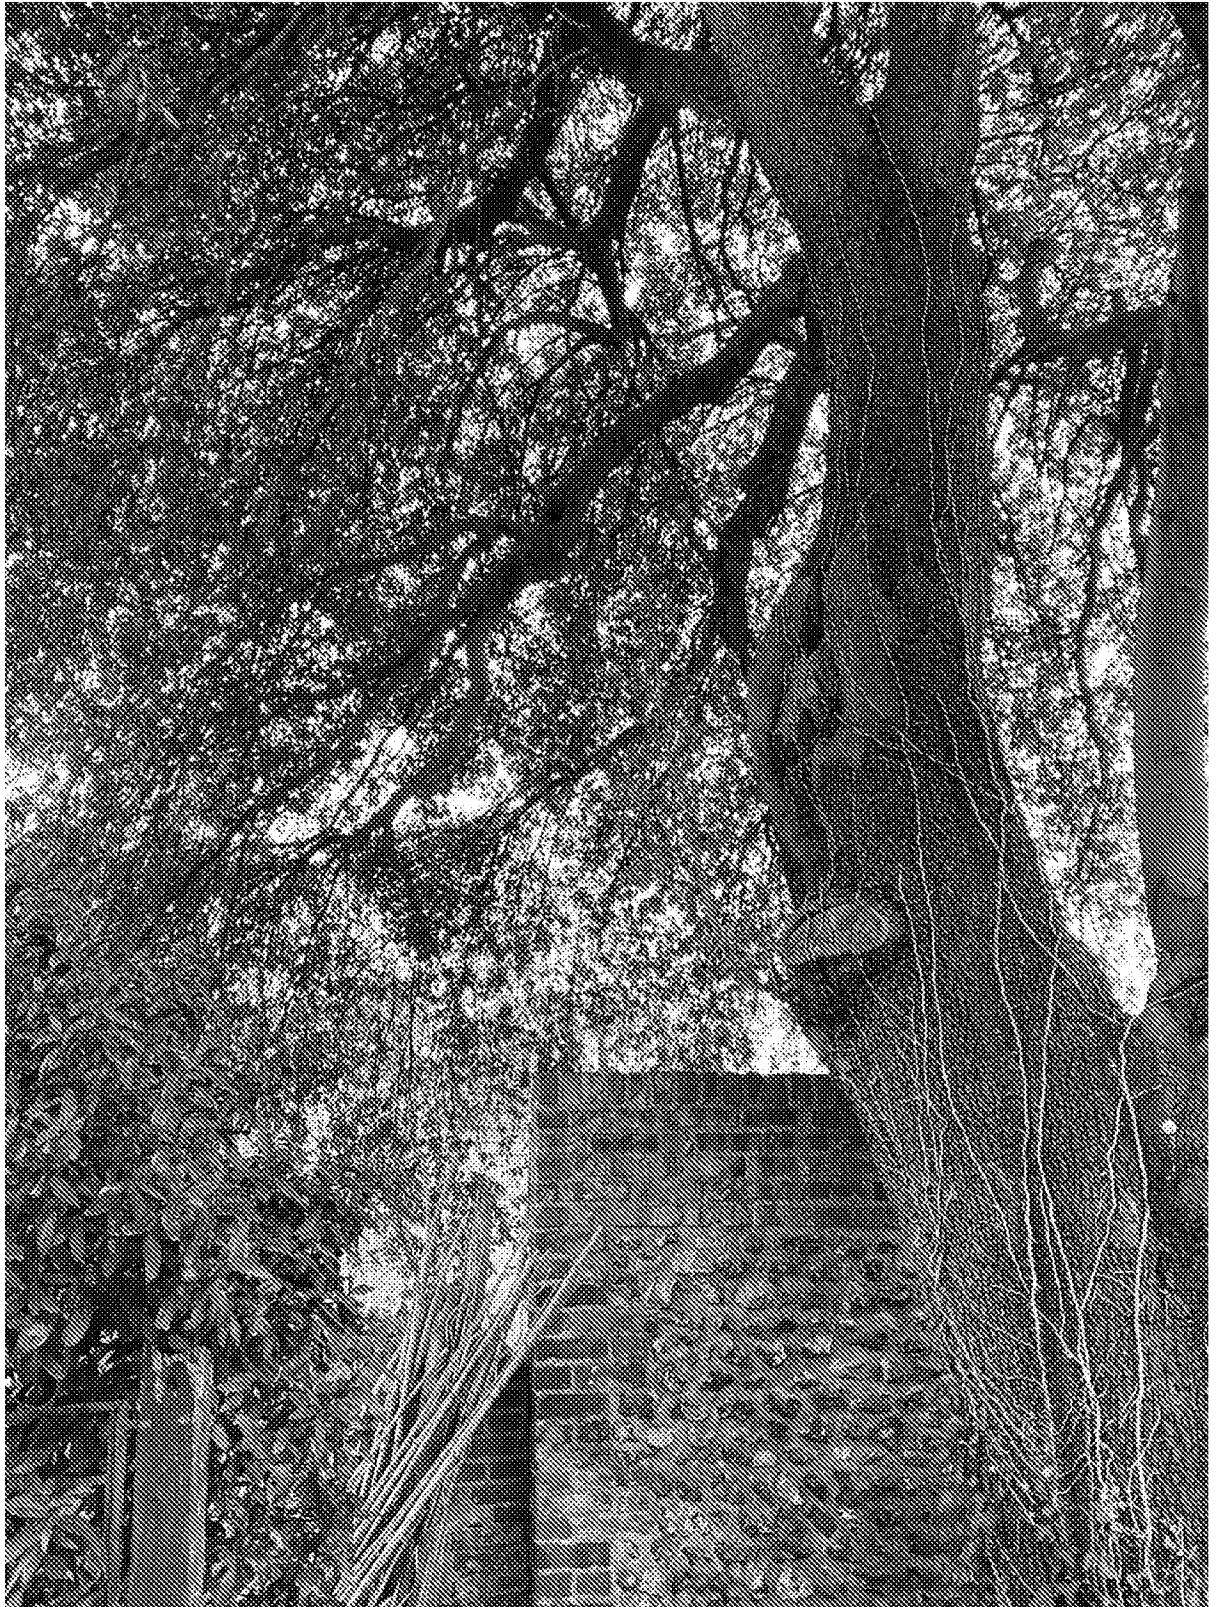
#### **1.2** Large wound on main stem (*figure.3*):

This wound is open and has not healed over fully, allowing water ingress and rot is now evident, this will decrease the strength and in-turn reduce the total weight carrying-capacity of the tree.

*Figure. 3* unhealed wound in the main stem, showing signs of advanced rot.

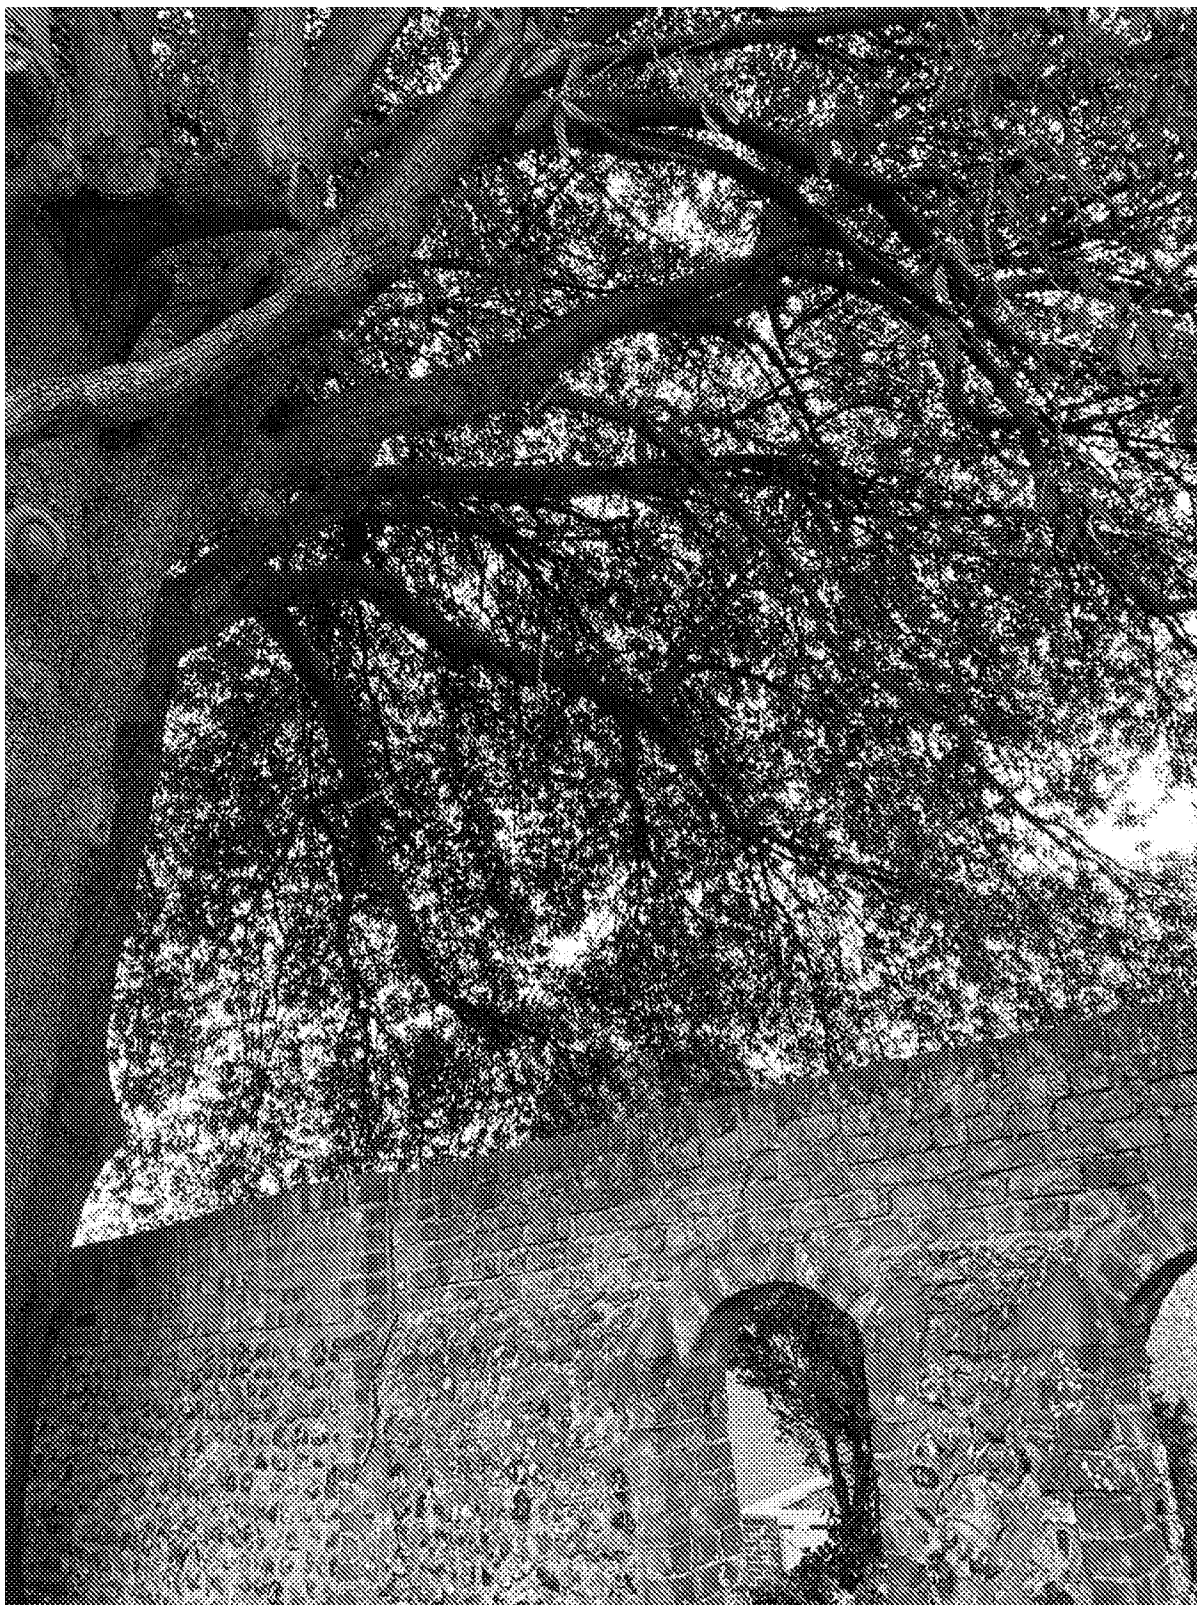
*Figure.5* Illustrates proposed limb cuts. From left to right, limbs of approx. Ø 5cm & 3cm to be cut.

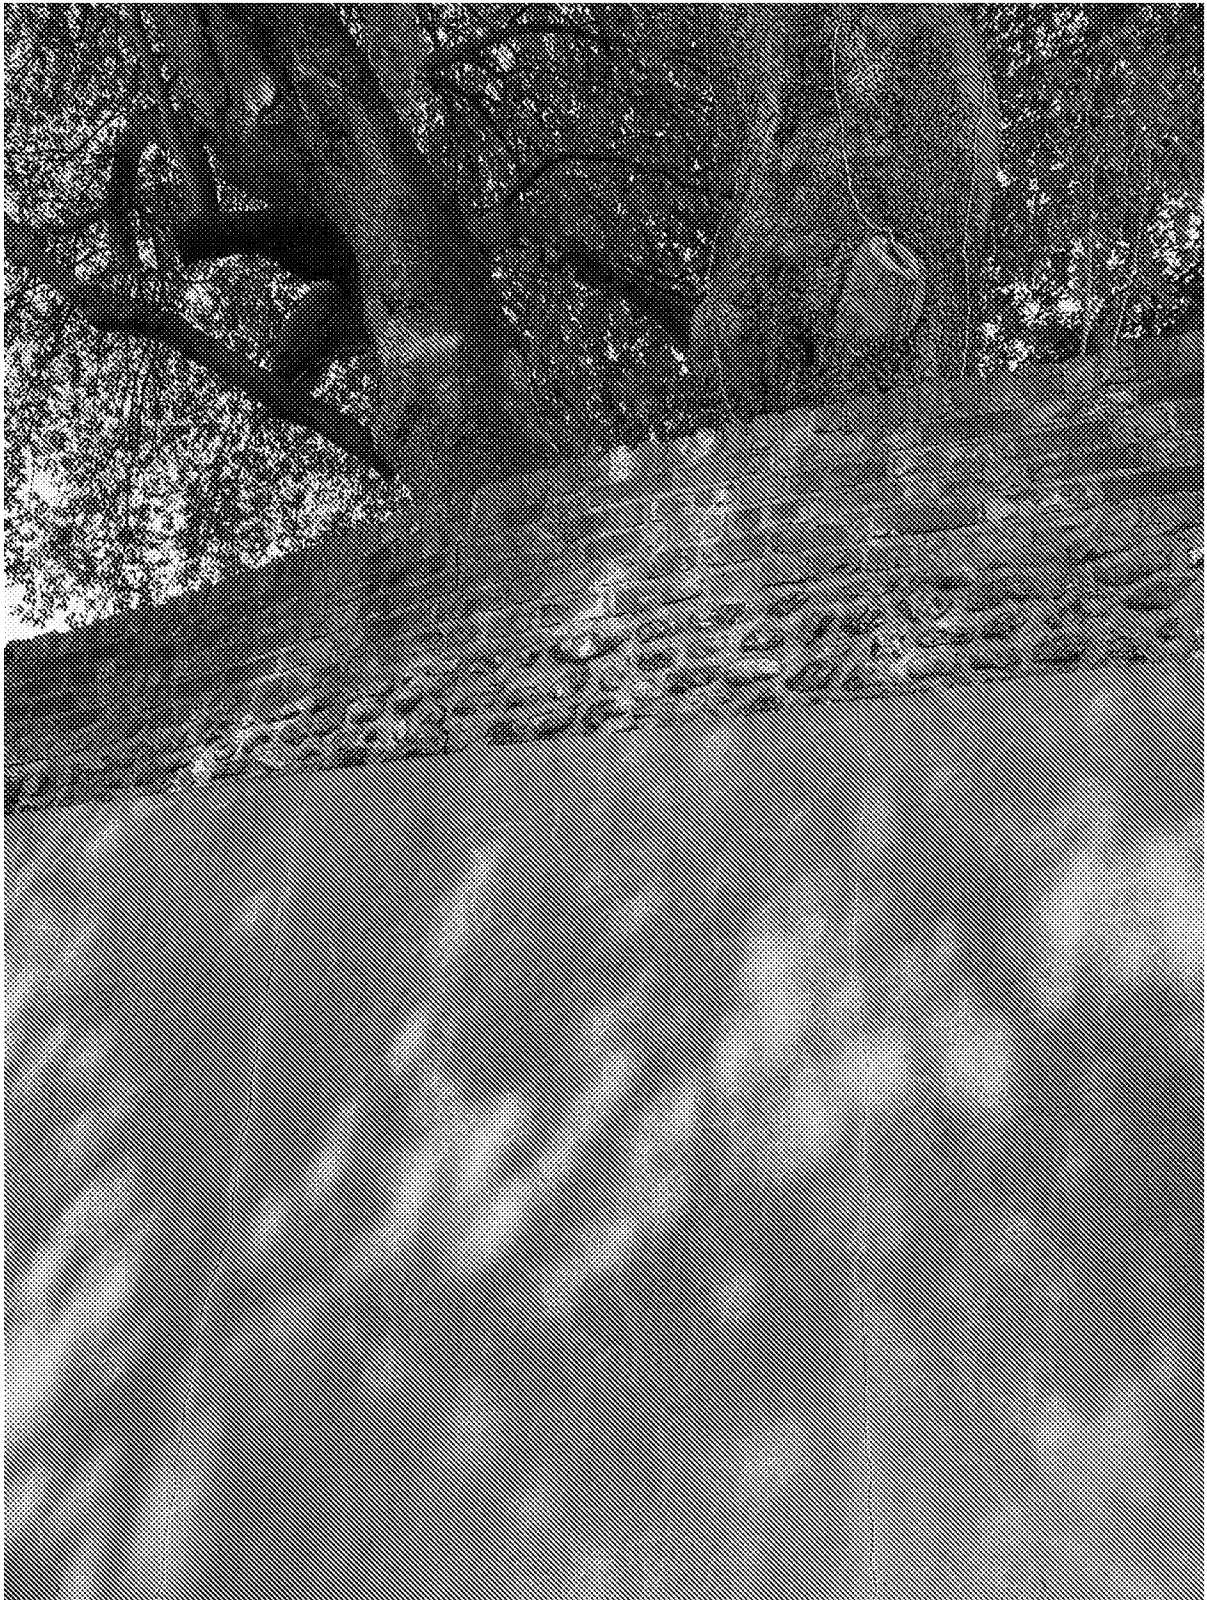
#### **1.4** Damage to retaining wall (*figure.6*):

Running directly under the centre of the canopy, an increase in the number and severity of cracks has been noted over the past year. The wall was repaired and partially rebuilt in 2016. If the tree continues to lean south-east with no maintenance, the wall will continue to deteriorate as the tree grows leaving no support directly under the lean, increasing the chances of a collapse, and damage to property and life if mitigating action is not taken.

*Figure. 6* Illustrating multipule cracks in the wall.
