## Aerial Tree Inspection Report

**Client:** Natasha Peskin

**Location:** 37 Torton Hill Road, Arundel, BN18 9HF

**Our reference:** ATIR/NP/10/25

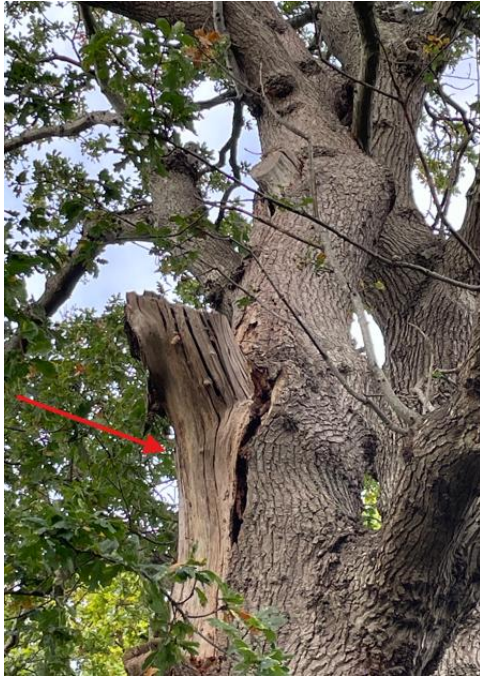
Old pruning wound on central stem at 6m above ground level. approx. 30cm depth with an opening of approx. 7cm at the widest part. The limb diameter at the position of the cavity is approx. 80cm. Acoustic test proved hollow sounding around the cavity and loose bark as expected.

Photo 1. Old pruning wound where branch has been removed

Reduce crown height by 3 meters and reduce south, east and west aspects by 1 meter. This will reduce weight and sail of the crown to lessen stress on the stem.

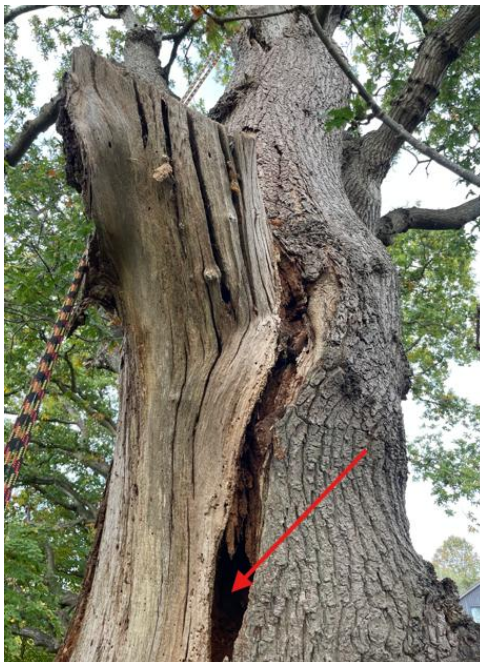
Cavity dimensions - 7cm diameter with opening of 4cm at it's widest

Photo 2. Decay cavity

$t/R = 0.25 \rightarrow$  moderate risk

The limb has been structurally reduced but retains a reasonable safety margin. This is due to the cavity being relatively small in proportion to the limb and the stem being centrally located and upright within the crown. It is partially protected by two neighbouring stems, helping reduce wind loading.

It is recommended that the tree be subject to monitoring and load management, such as pruning to reduce weight and leverage on the central stem and around the cavity. These measures will minimise the risk of failure while maintaining the structural integrity of the limb.

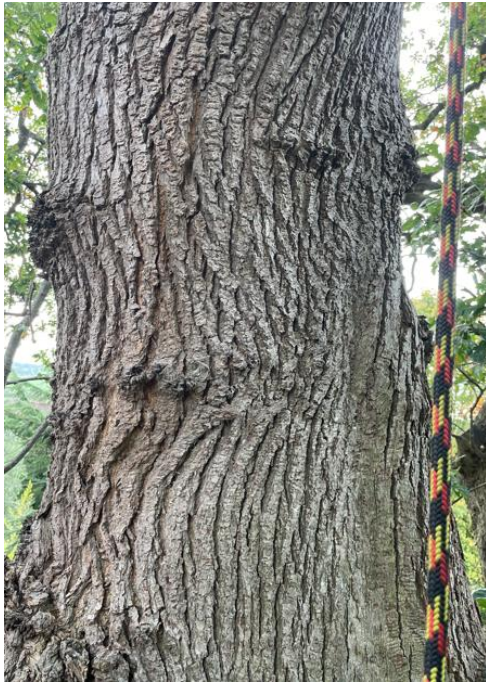
Photo 3. The opposite side of the stem, relative to the branch wound and decay. Shown from the north and exhibits no signs of decay.
