28<sup>th</sup> April 2021

**MALTRAVERS STREET, ARUNDEL, WEST SUSSEX, BN18 9QB - CHIMNEY INSPECTION**

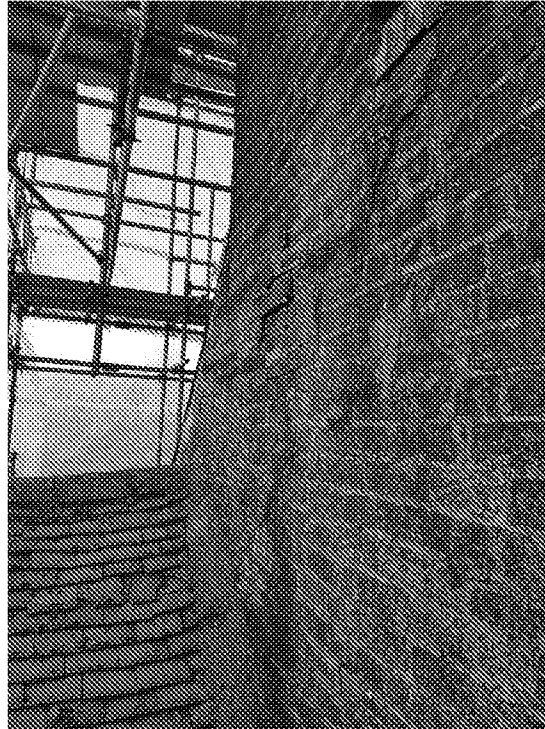
The chimney is constructed in standard format clay bricks laid in stretcher bond and bedded in what appears to be lime mortar. It extends to around 3.6m above parapet level and measures approximately 560mm x 1240mm in plan. There are no structural stays present and therefore the chimney acts as a vertical cantilever under lateral loading. The chimney itself is supported directly off the south-western gable wall of 61 Maltravers Street which abuts the adjacent residential property. As such it is not possible to carry out a full external inspection of the gable wall as the vast majority is concealed. Where exposed (above the level of the adjacent property's roof line), the brickwork within the gable generally appears to be in satisfactory condition with the exception of a localised area where significant movement has taken place. A number of bricks have moved outwards, resulting in cracking to the mortar jointing and the bricks themselves becoming unbonded (see Photograph 1). In one location the outer face of the brick units are projecting out approximately 30mm from the line of gable wall. The cause of the movement is not clear but the distress exhibited in the wall is of concern as it provides support to the large chimney stack above.

Photograph 1: Gable wall beneath chimney stack

It is not possible to carry out intrusive investigations to the defective brickwork in the gable wall due to the concerns over the short term stability of the chimney stack above. Therefore, we recommend that the stack is carefully dismantled down to parapet level and the brick units stored. The defective brickwork within the gable wall can then be investigated to establish the likely cause of movement in this area. Once the relevant investigations are completed, the necessary remedial works can be specified to reinstate the brickwork and restore the structural integrity of the wall in order that the chimney stack can be re-constructed using the salvaged bricks.

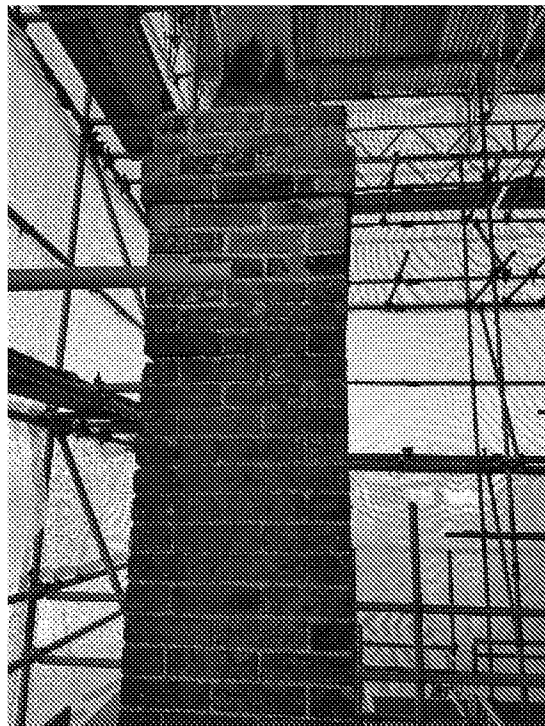
The chimney itself is leaning outwards towards the south-west and some of this could be attributed to weathering. However, there is evidence of historic remedial works including the introduction of steel rods within the jointing on the south-west side of the chimney and a metal packer, also within the jointing, at the southern most corner of the chimney (see Photograph 2). The latter has resulted in a slight reduction in the lean but has also compromised the structural integrity of the chimney as the upper brickwork is no longer bonded to the lower brickwork in this area. The chimney exhibits lateral movement when pressure is applied which is not unusual for a stack of this height but the deterioration of the horizontal jointing is also cause for concern. Telecommunication cables are attached to the brickwork and two different cables bands are located just above parapet level.

Photograph 2: Packer in chimney joint

We understand that the use of lime mortar is preferred and have based the structural design of the chimney stack based on half brick thick chimney walls constructed in designation (iii) sand cement mortar and hydraulic lime pointing. The calculations conclude that an optimum stack height of 1950mm above parapet level can be achieved without the need for additional horizontal restraint or the introduction of significant new structure within the chimney itself. This is on the basis that the plan size of the new chimney stack remains the same size as the existing.
