**Proposed restoration/modernization work by room/area**

(document given to architect together with comments from Martyn White in response to my request for information re consents required)

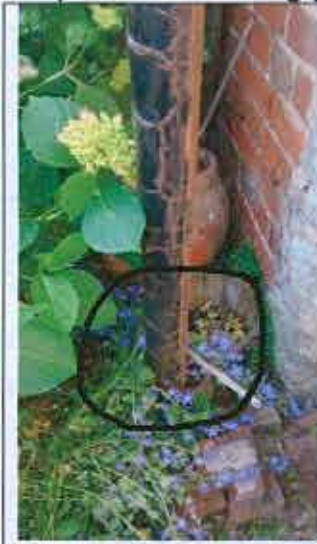
downpipe broken

Replace all existing gutters and downpipes with heritage guttering

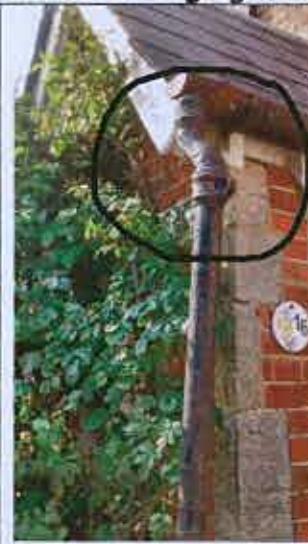
downpipe detached

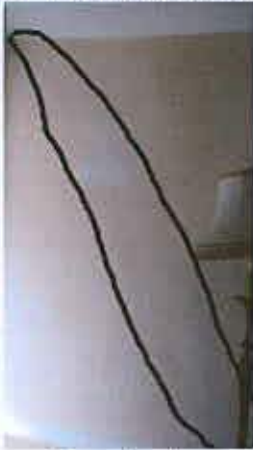
- Mend crack in wall

Diagonal crack, concealed by wallpaper, to be repaired by making good plaster\*<sup>1</sup> (if crack found to be worse than thought then metal ties between courses of bricks then replastered)

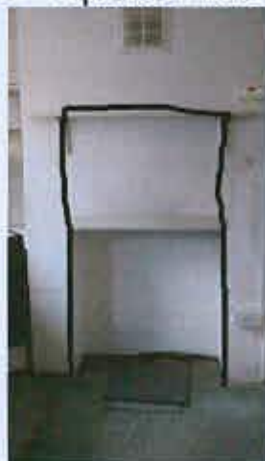
<- photo shows existing chimney breast marking approximate size of hole to be made. Supporting lintel at top, extractor to be fitted inside chimney, walls replastered\*<sup>1</sup>, new shelf to match kitchen units

- Open out hole in chimney breast to accommodate cooker

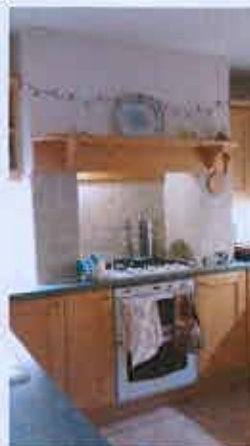
photo -> shows result of similar work in a neighbouring property

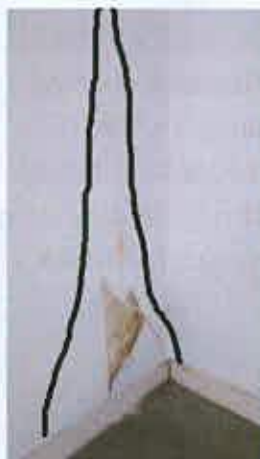
[damp caused by damage to old downpipe between 16/18, similar damage in adjacent wall in no.18, downpipe patched recently but would like to replace to prevent future problems, owners of 16/18 to share cost of new downpipe]

damaged plaster\*<sup>1</sup> to be removed back to point where there is something to key new plaster

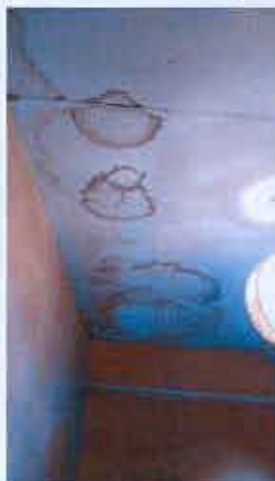
Currently the walls are plastered with damp damage along the walls, up to 1m above floor level where the garden adjoins the outhouse. Originally the outhouses were not plastered but were white-washed brick inside with clay tile or brick floors.

The builders recommend removing the damp-damaged plaster up to 1m from the floor level, injecting bricks with silicon (DPC), lining with a membrane and then attaching battens for foil-backed plaster board to line room walls, leaving air gap at the bottom. Also propose replacing damaged fibre board ceiling with foil-backed plasterboard, parallel to roof (roof leaks fixed about 2 years ago)
