# **APPENDIX G**

## **SOUTHERN WATER SEWER RECORDS**

**Land on East Side Ford Road  
Arundel  
West Sussex  
BN18**

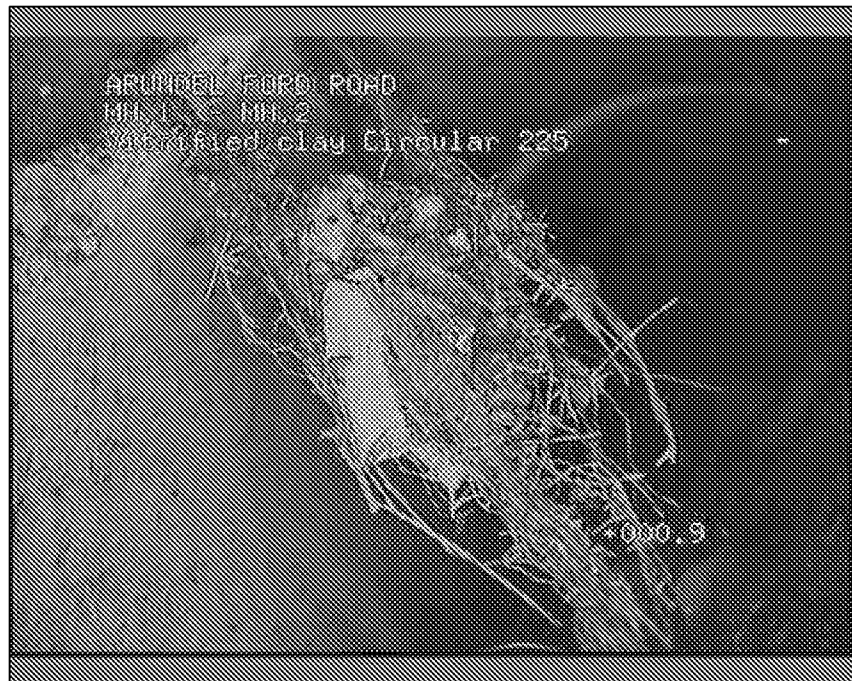
Photo: 1\_1\_6\_A.JPG  
 0.9m, Roots, mass, 10% cross-sectional area loss

Comment : **HIGH PRESSURE JETTING AND RE SURVEYING REQUIRED**

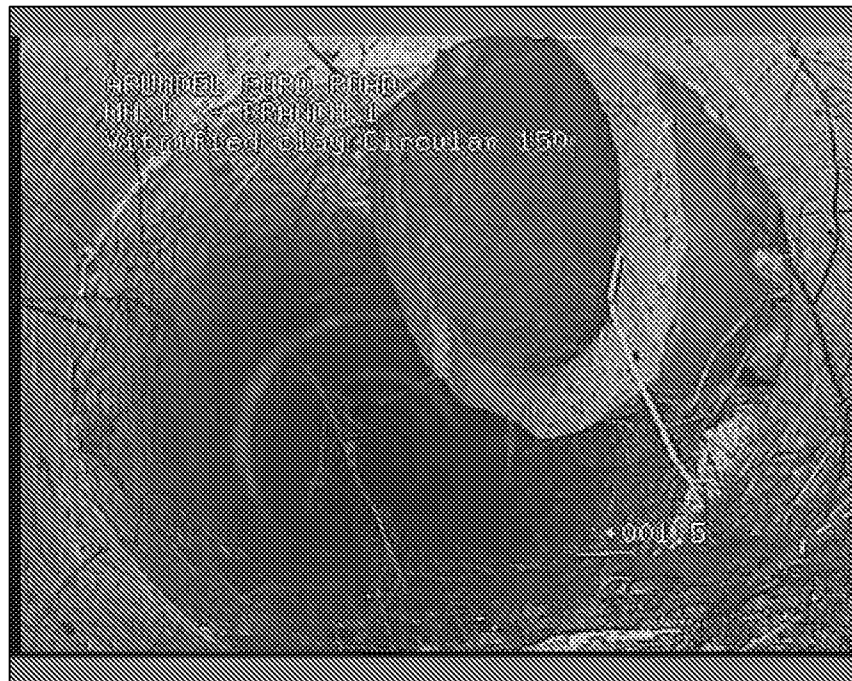
Photo: 4\_4\_17\_A.JPG  
1.5m, Connection intruding, at 2 o'clock, diameter 100mm, intrusion 40%

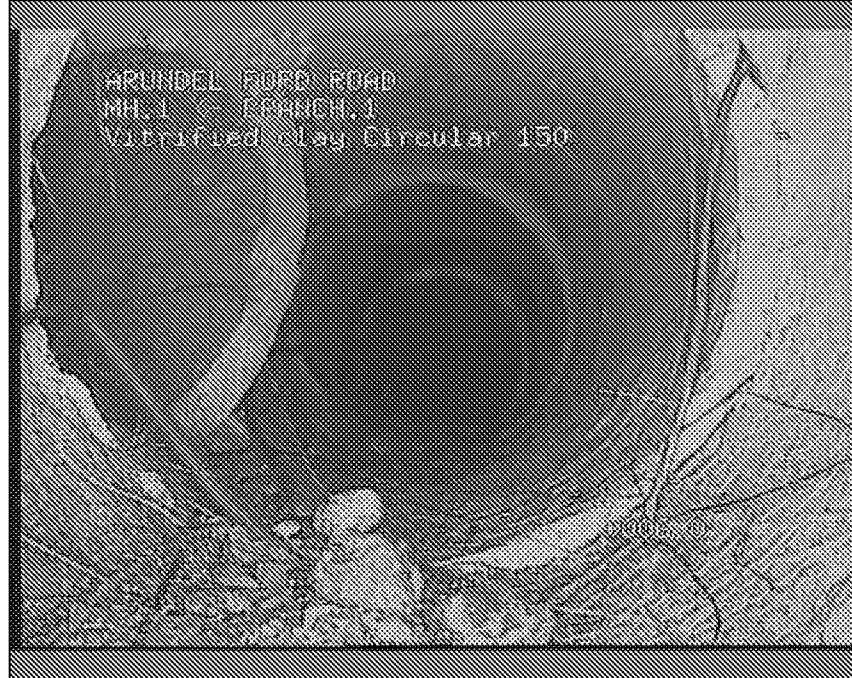
Photo: 4\_4\_18\_A.JPG  
6m, Connection intruding, at 9 o'clock, diameter 100mm, intrusion 25%

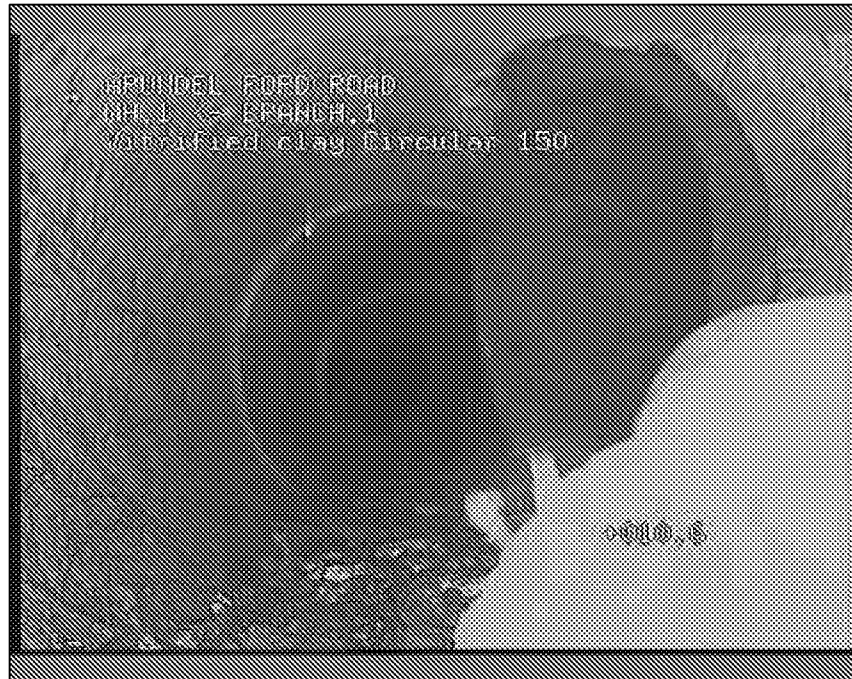
Photo: 4\_4\_21\_A.JPG  
10.6m, Connection intruding, at 3 o'clock, diameter 150mm, intrusion 30%

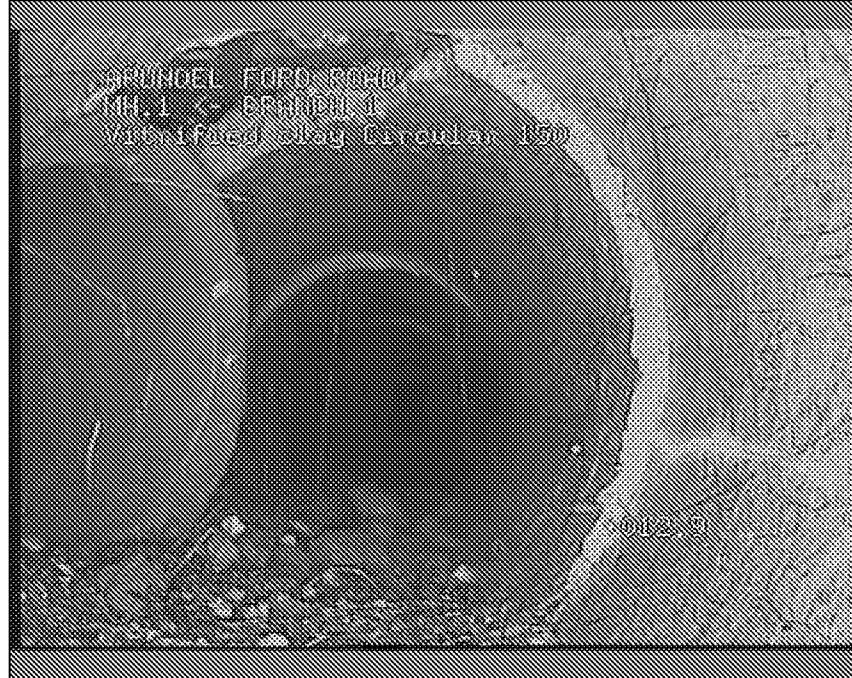
Photo: 4\_4\_24\_A.JPG

12.9m, Connection intruding, at 9 o'clock, diameter 150mm, intrusion 25%

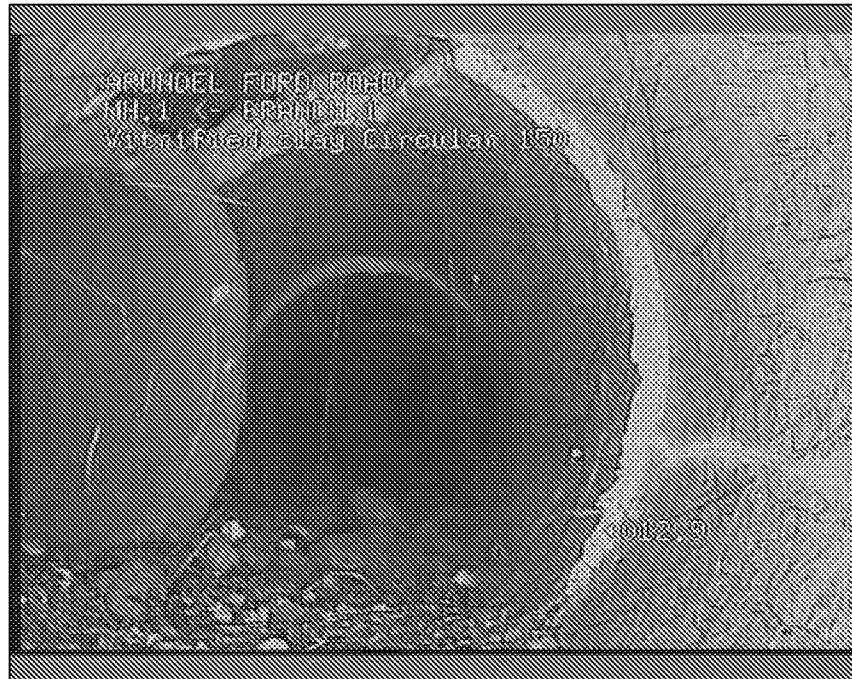
Photo: 4\_4\_25\_A.JPG

12.9m, Hole in drain/sewer, from 11 to 1 o'clock

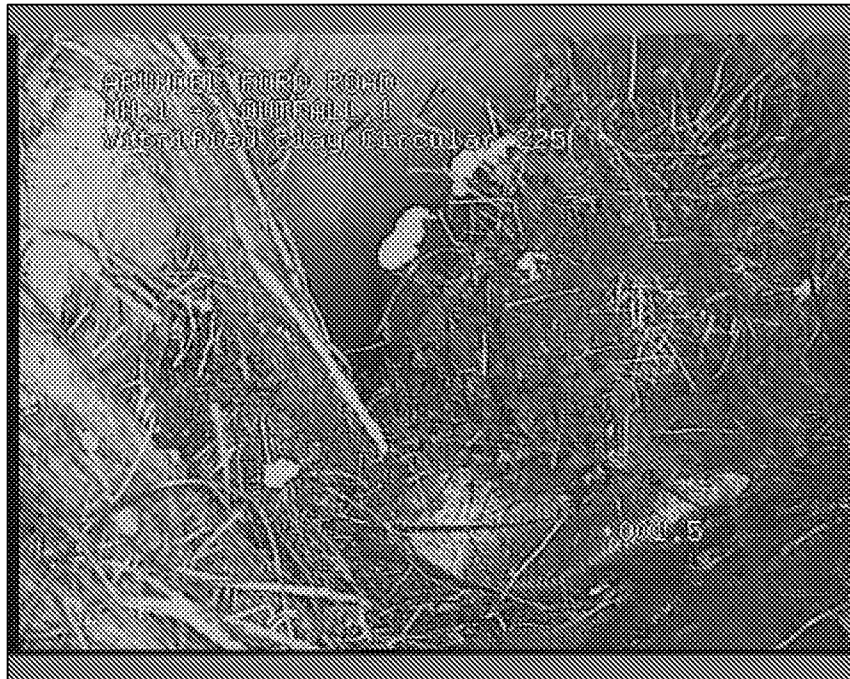
Photo: 6\_6\_54\_A.JPG  
1.5m, Roots, tap at joint

| Comment :<br><b>HIGH PRESSURE JETTING AND RE SURVEYING REQUIRED</b> |

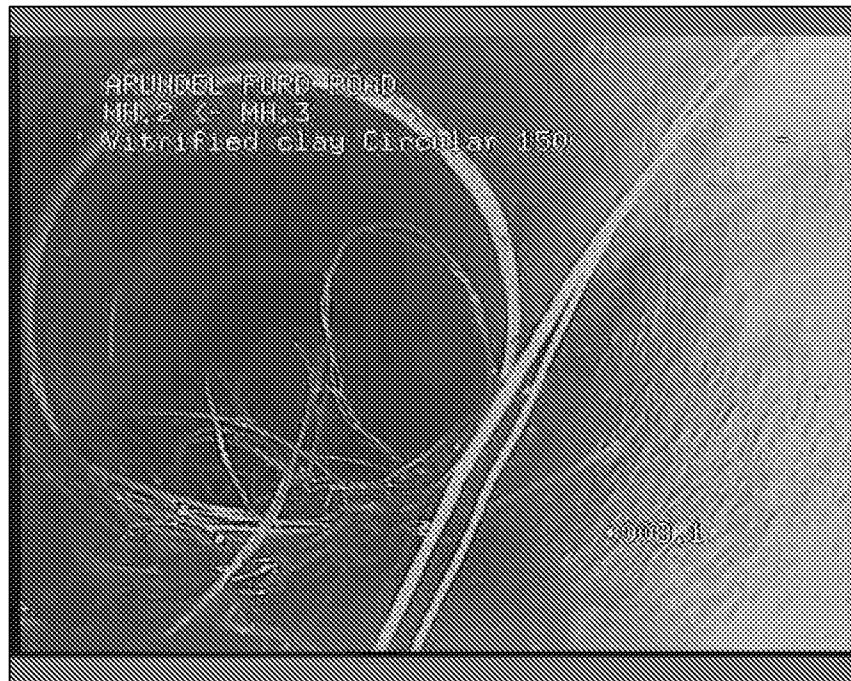
Photo: 8\_8\_70\_A.JPG  
8.1m, Roots, mass at joint, 10% cross-sectional area loss

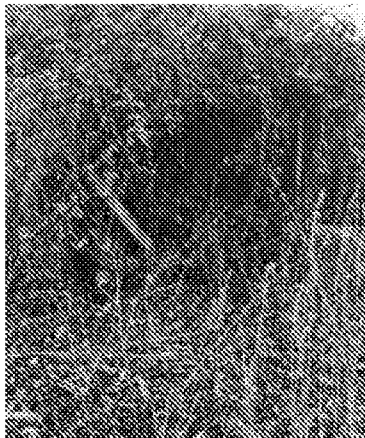
ROUGH LOCATION OF MH.3  
BEYOND FENCE LINE AND WITHIN VEGITATION

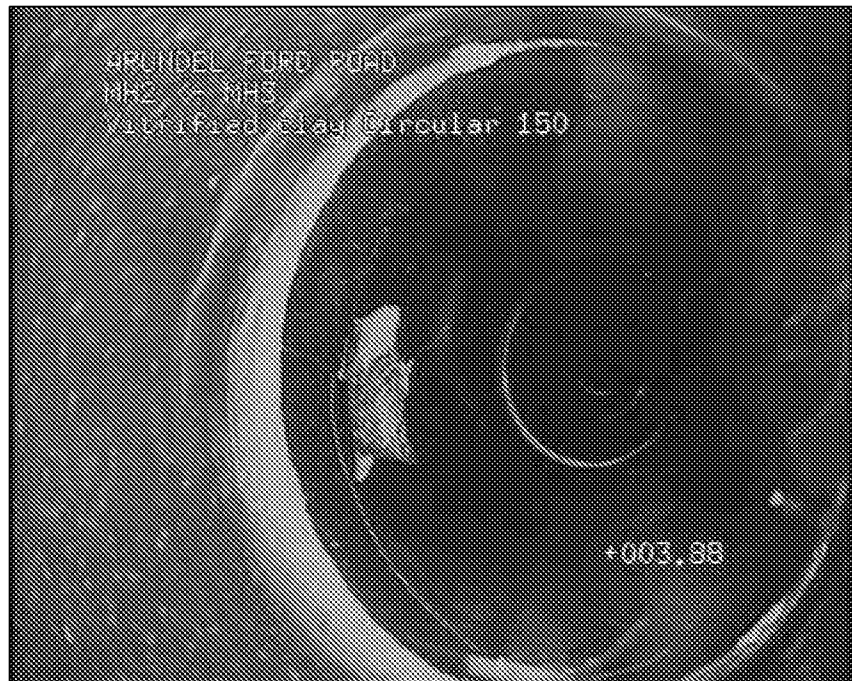
Photo: 1\_1\_13\_A.JPG  
 3.86m, Fracture, multiple at joint, from 7 to 5 o'clock

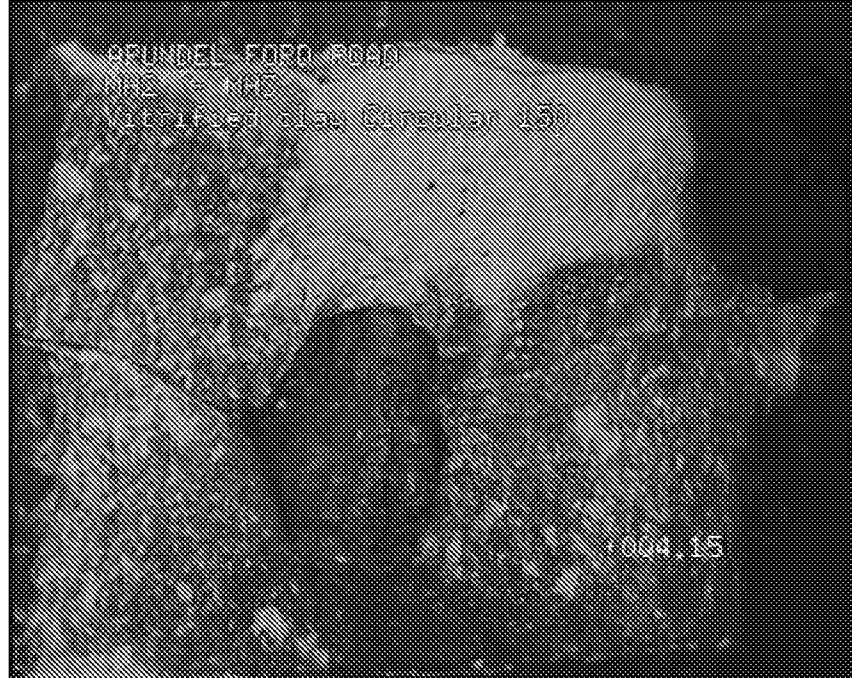
Photo: 1\_1\_14\_A.JPG  
 4.15m, Hole in drain/ sewer, at 12 o'clock

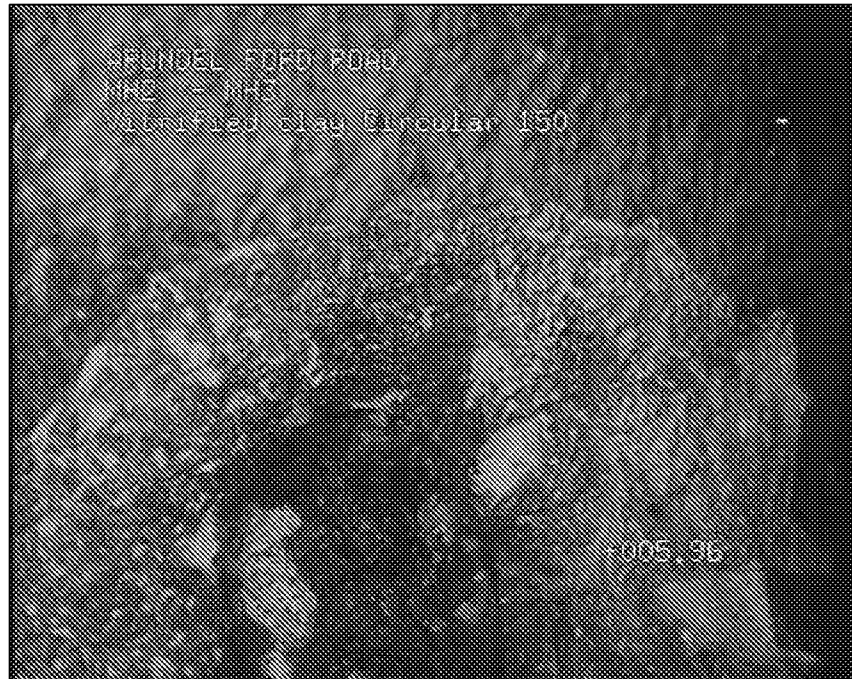
Photo: 1\_1\_19\_A.JPG  
 5.95m, Hole in drain/ sewer, at 9 o'clock

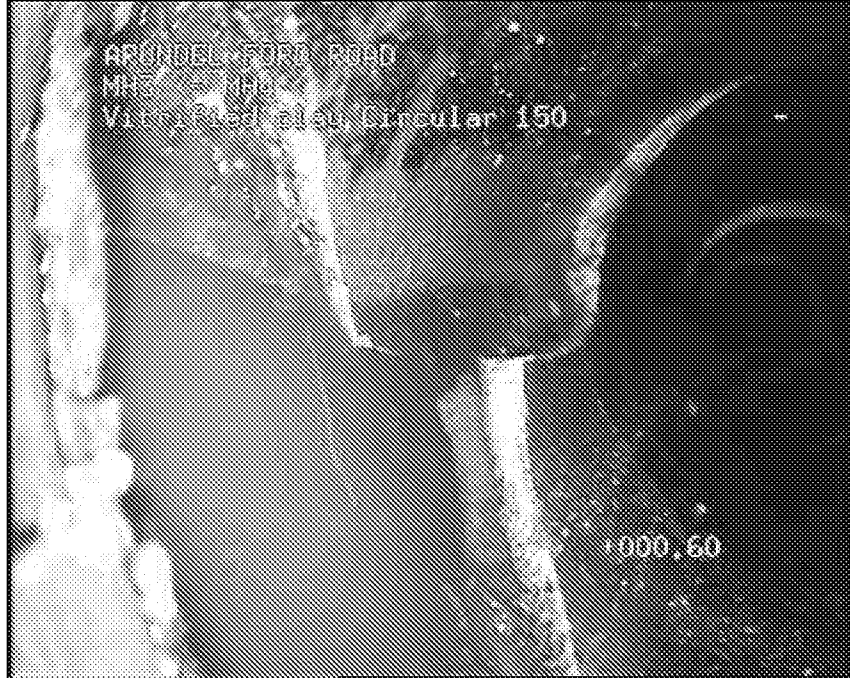
Photo: 3\_3\_26\_A.JPG  
 0.6m, Hole in drain/ sewer, from 5 to 7 o'clock

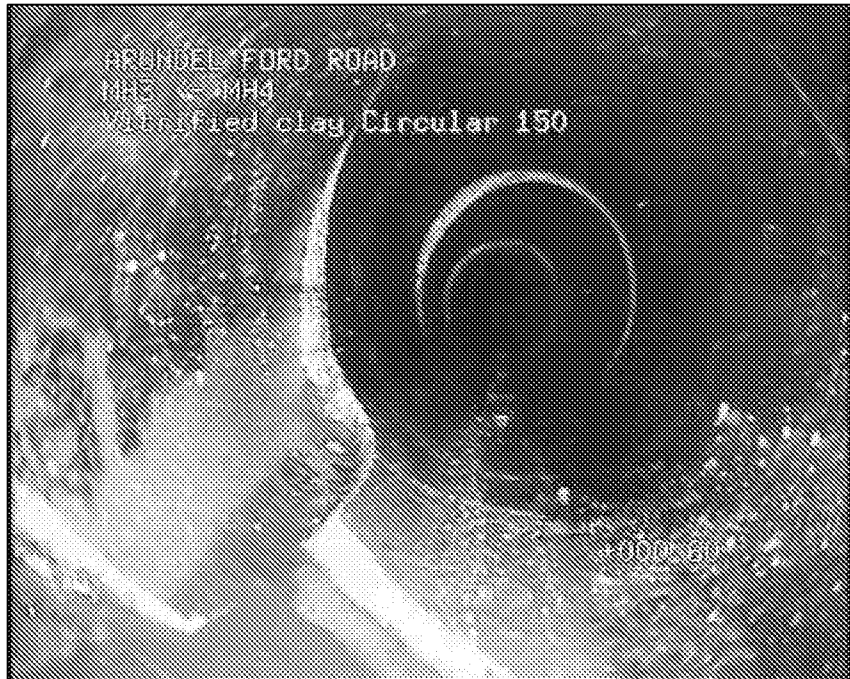
Photo: 3\_3\_27\_A.JPG  
 0.6m, Broken pipe, from 5 to 7 o'clock

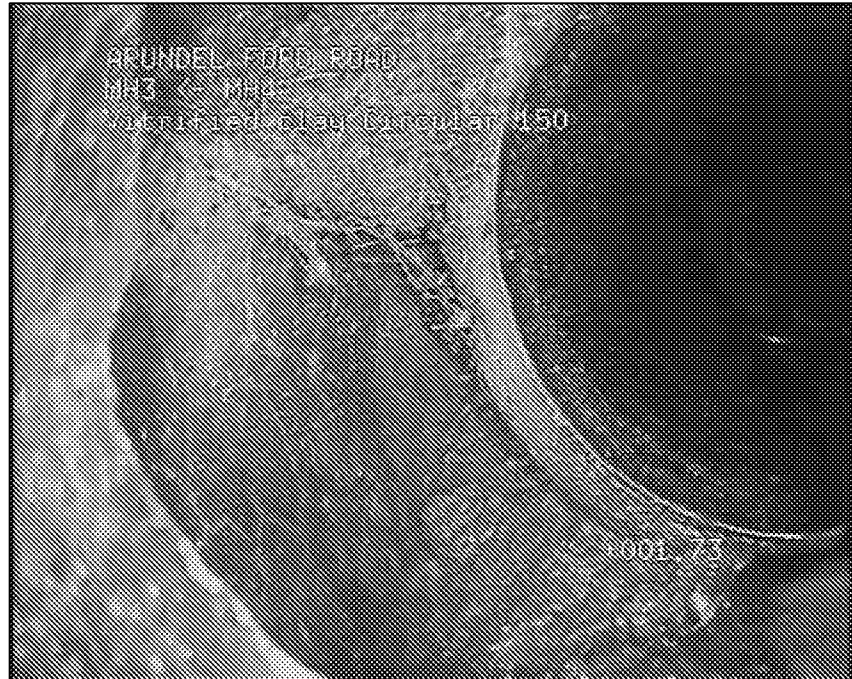
Photo: 3\_3\_30\_A.JPG  
 1.73m, Hole in drain/ sewer at joint, from 7 to 12 o'clock

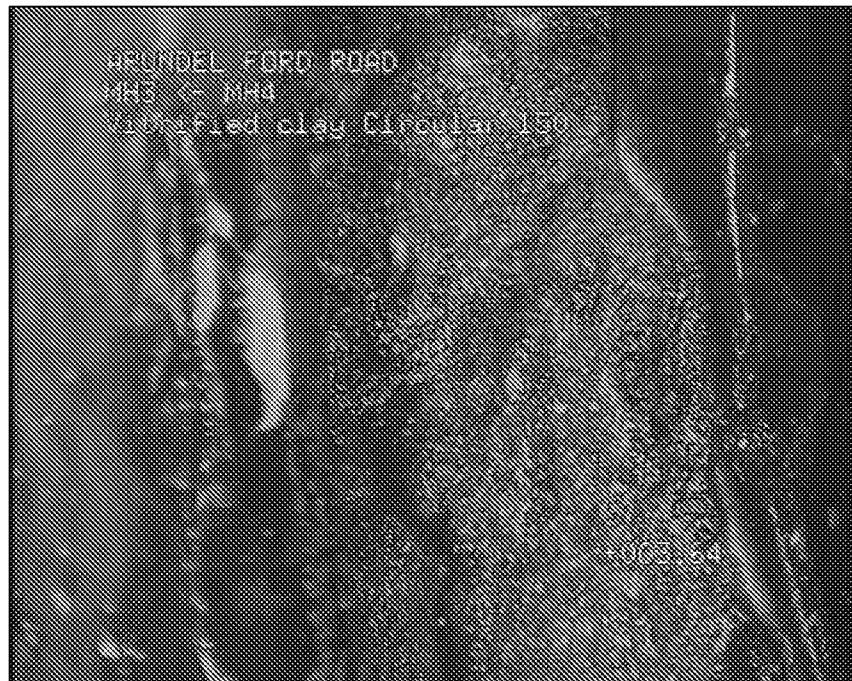
Photo: 3\_3\_35\_A.JPG  
 3.64m, Open joint, medium

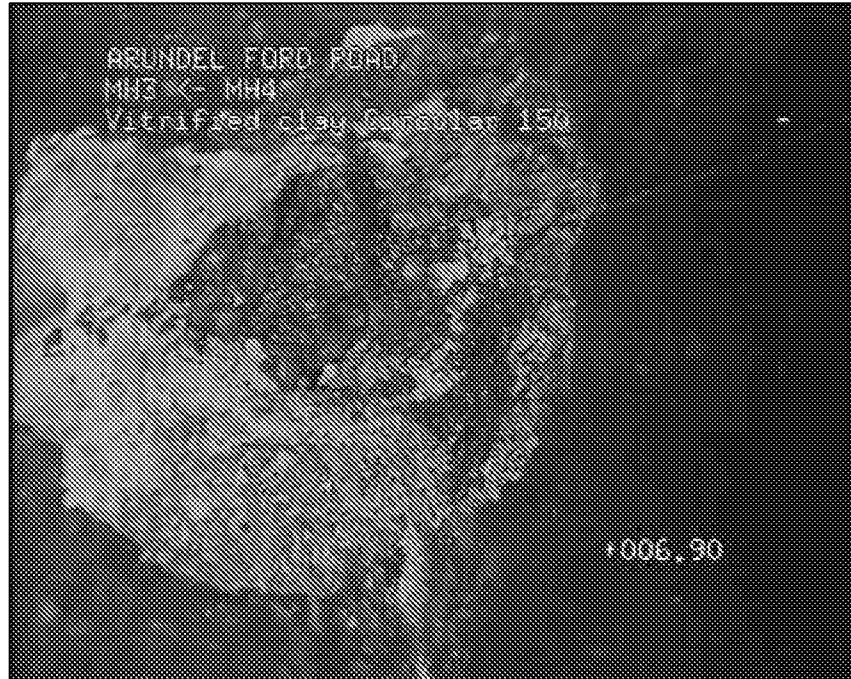
Photo: 3\_3\_40\_A.JPG  
 6.9m, Hole in drain/ sewer, at 12 o'clock

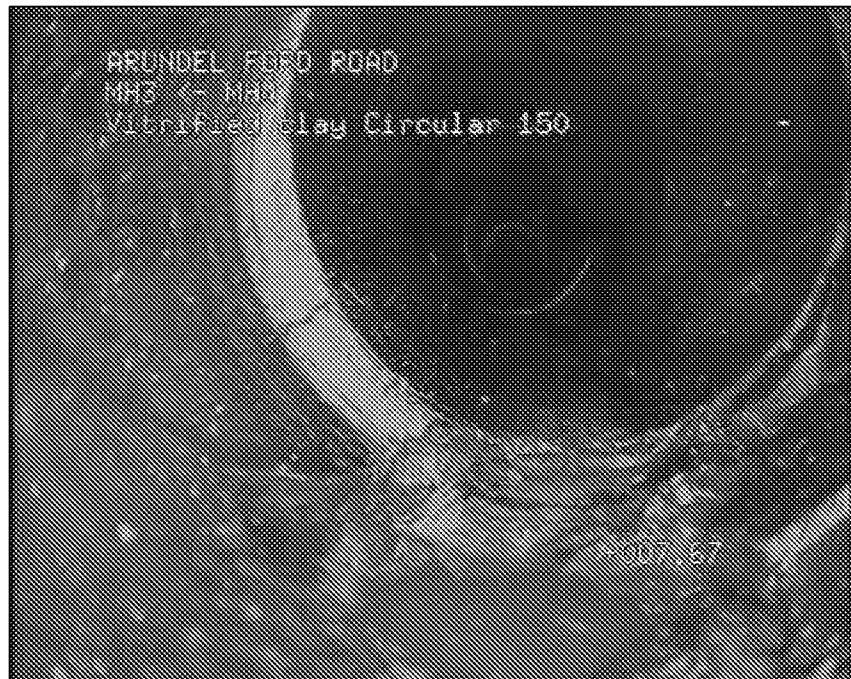
Photo: 3\_3\_42\_A.JPG  
 7.67m, Hole in drain/ sewer at joint, at 6 o'clock

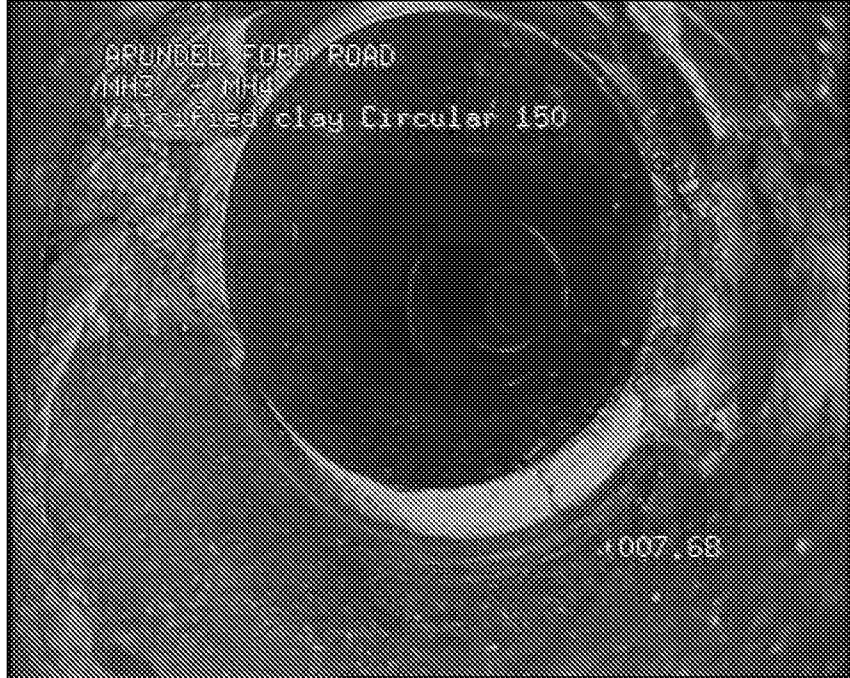
Photo: 3\_3\_43\_A.JPG  
 7.68m, Fracture, multiple at joint, from 6 to 6 o'clock

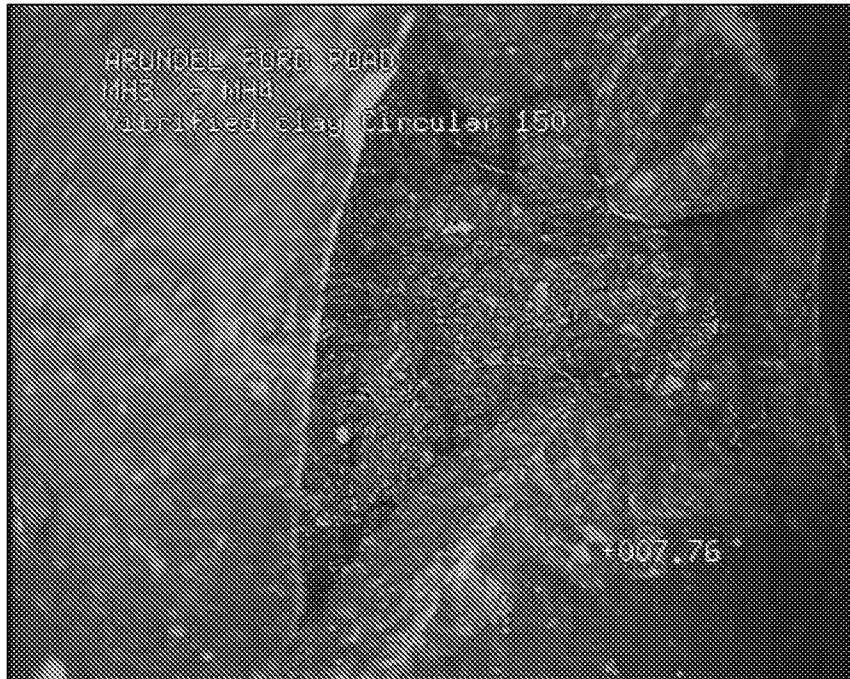
Photo: 3\_3\_44\_A.JPG  
 7.76m, Hole in drain/sewer at joint, at 12 o'clock

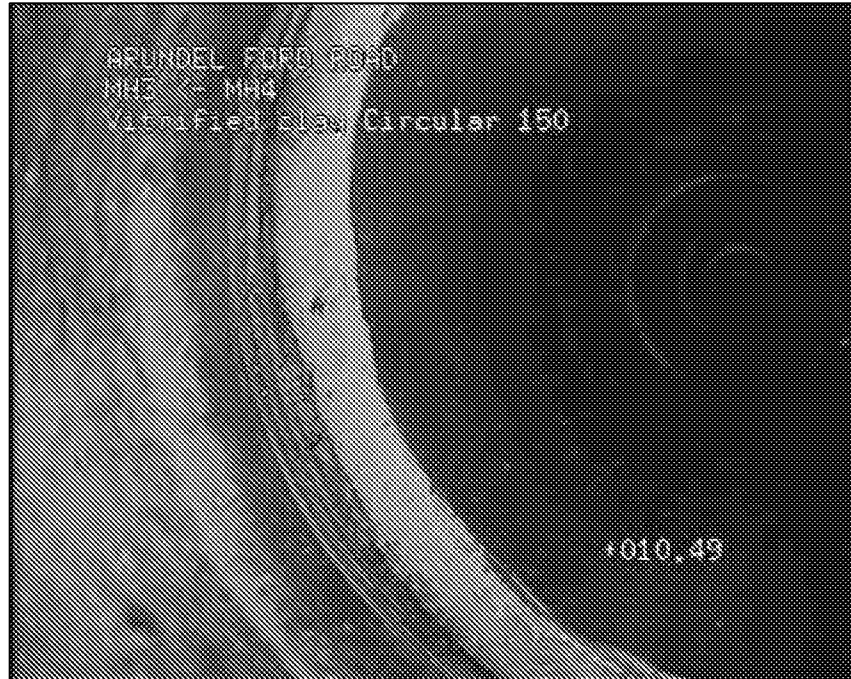
Photo: 3\_3\_46\_A.JPG  
10.49m, Joint displaced, medium

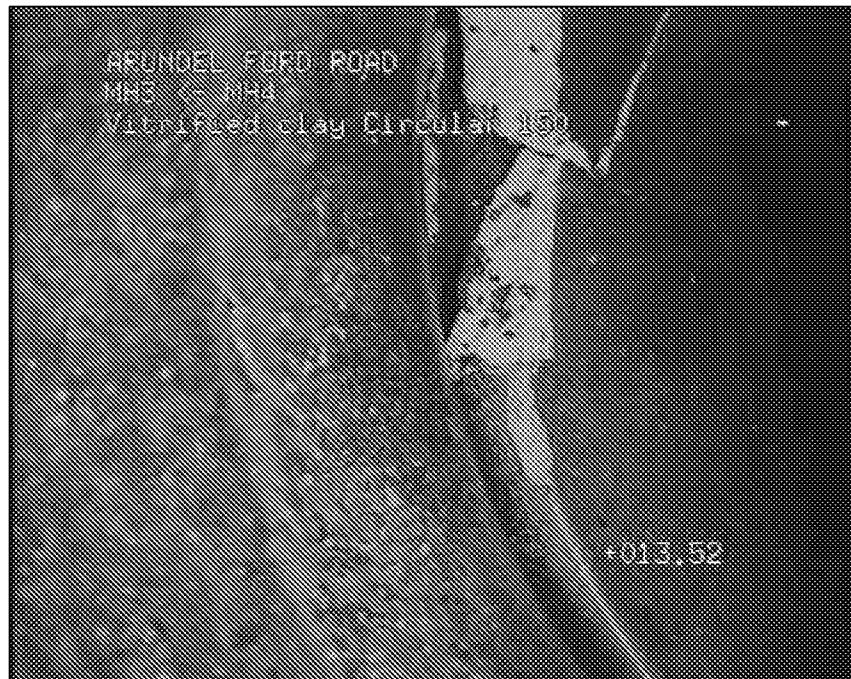
Photo: 3\_3\_49\_A.JPG  
13.52m, Hole in drain/sewer at joint, from 11 to 12 o'clock

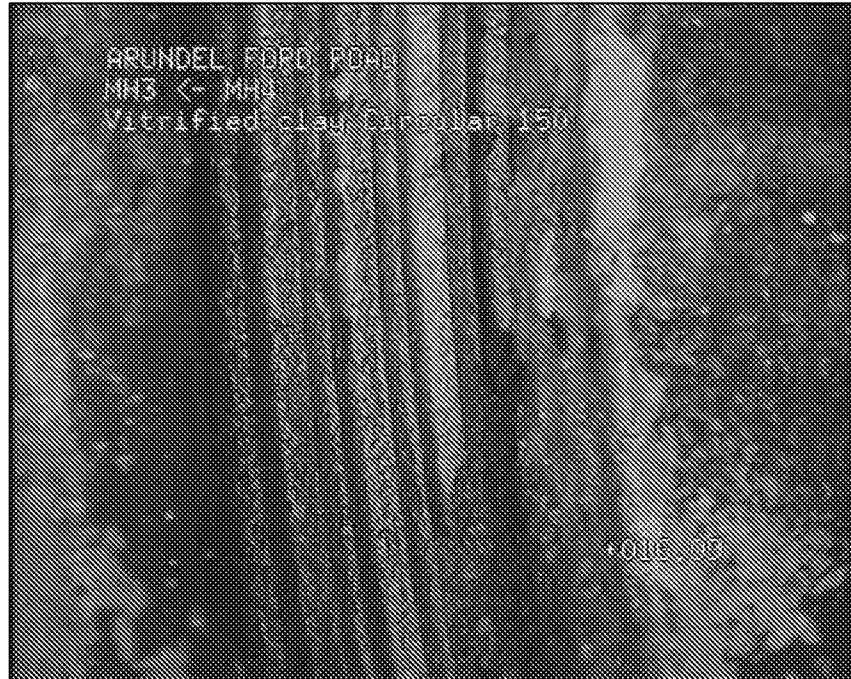
Photo: 3\_3\_57\_A.JPG  
16.09m, Open joint, medium

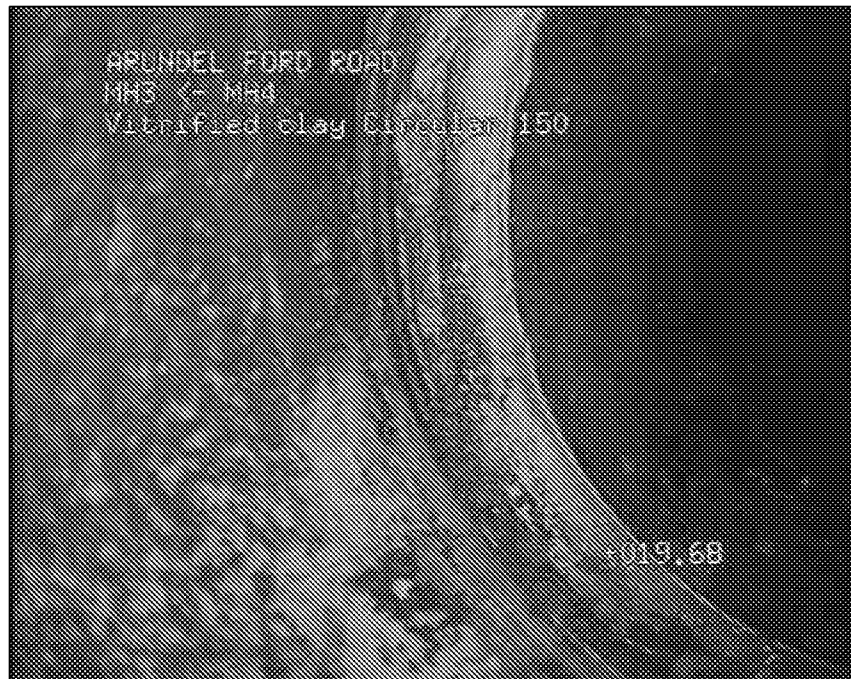
Photo: 3\_3\_59\_A.JPG  
19.67m, Joint displaced, medium

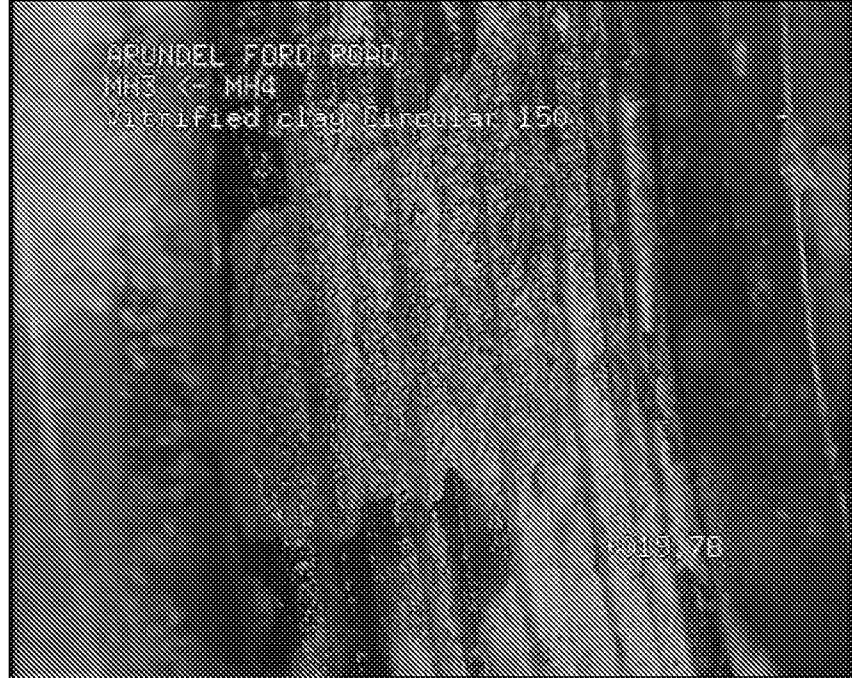
Photo: 3\_3\_60\_A.JPG  
 19.76m, Open joint, medium

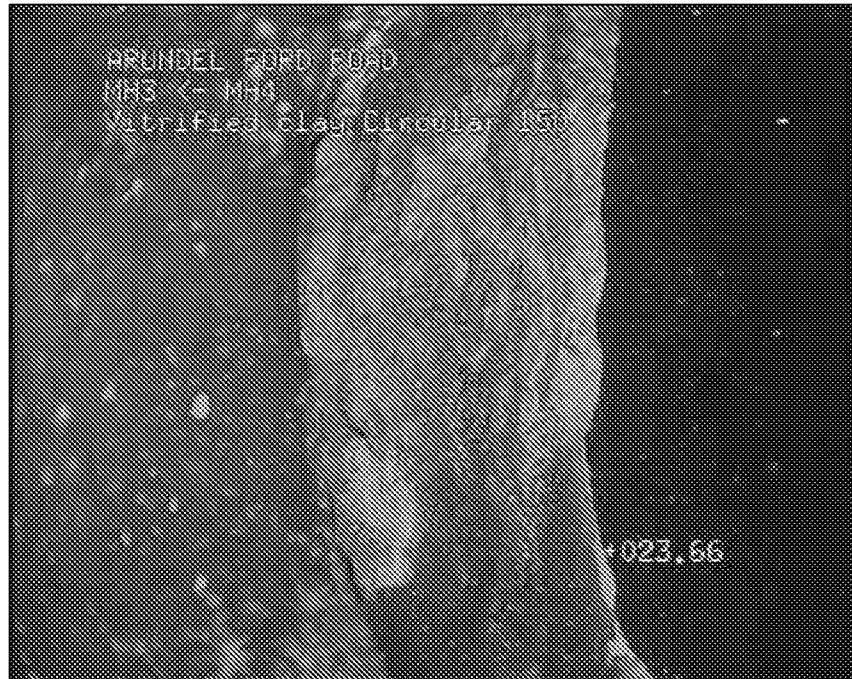
Photo: 3\_3\_66\_A.JPG  
 23.66m, Open joint, medium

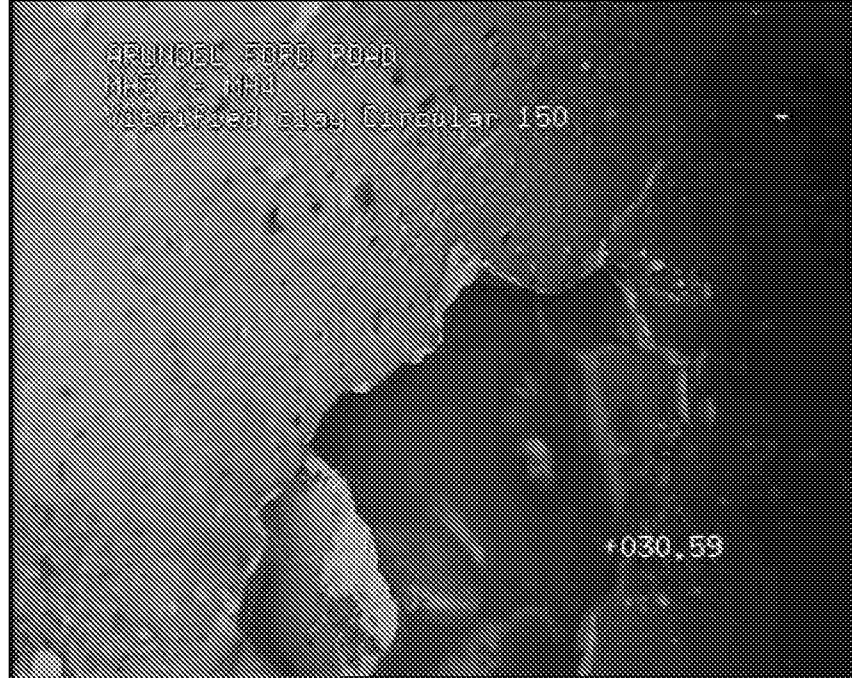
Photo: 3\_3\_72\_A.JPG  
 30.59m, Hole in drain/sewer, at 6 o'clock

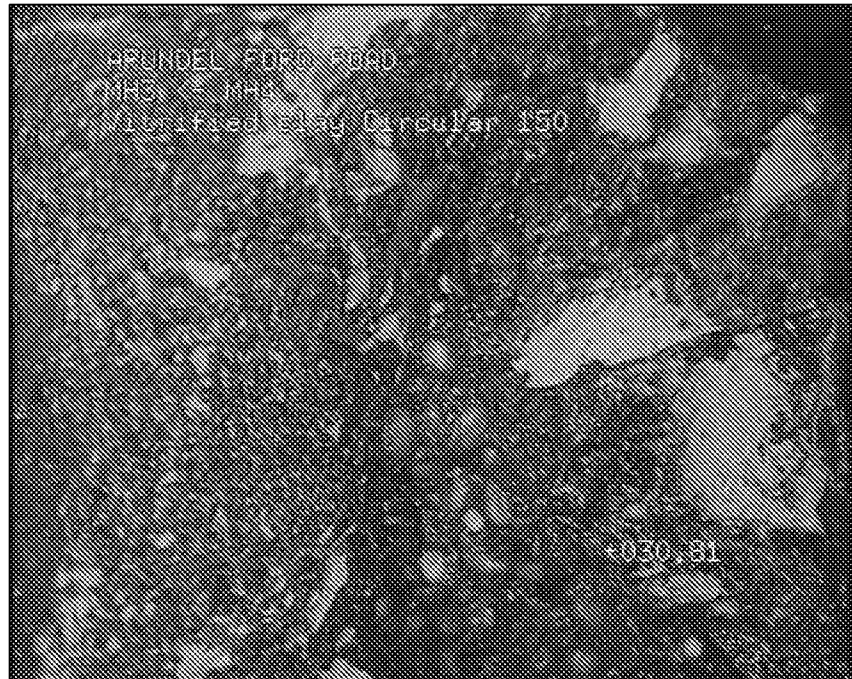
Photo: 3\_3\_73\_A.JPG  
 30.81m, Hole in drain/sewer, at 12 o'clock

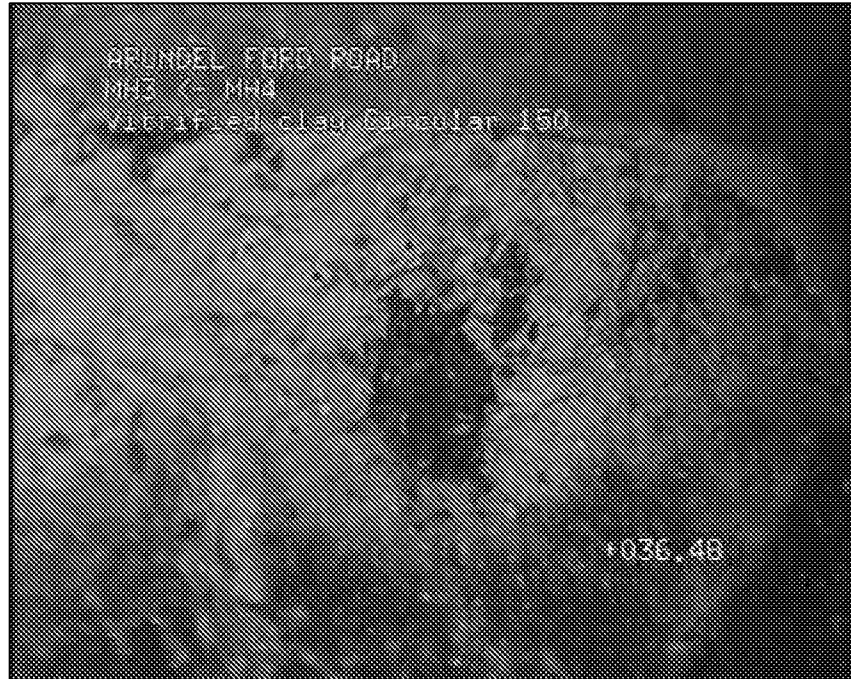
Photo: 3\_3\_80\_A.JPG  
 36.48m, Hole in drain/sewer, at 11 o'clock

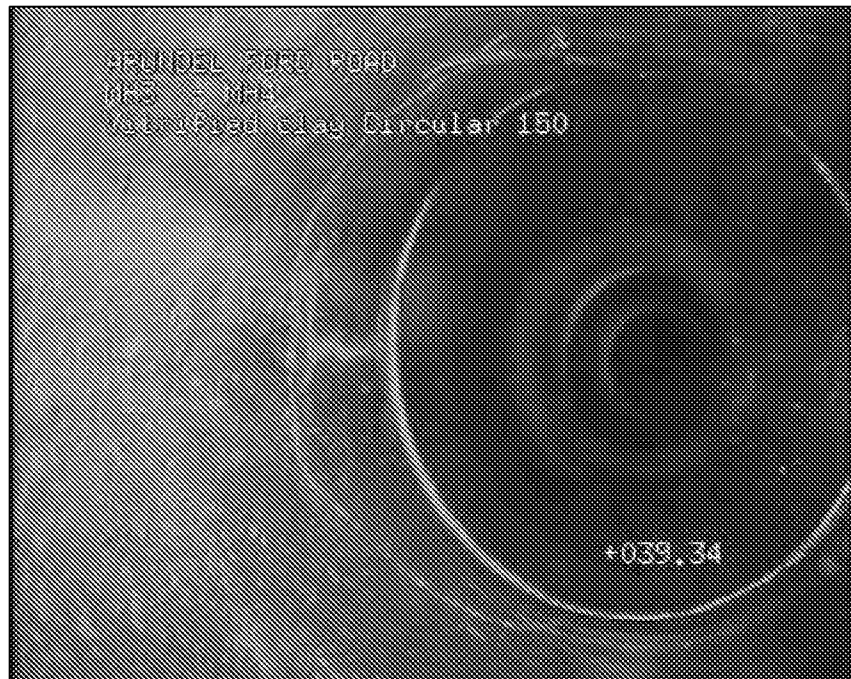
Photo: 3\_3\_85\_A.JPG  
 39.34m, Fracture, multiple at joint, from 7 to 5 o'clock

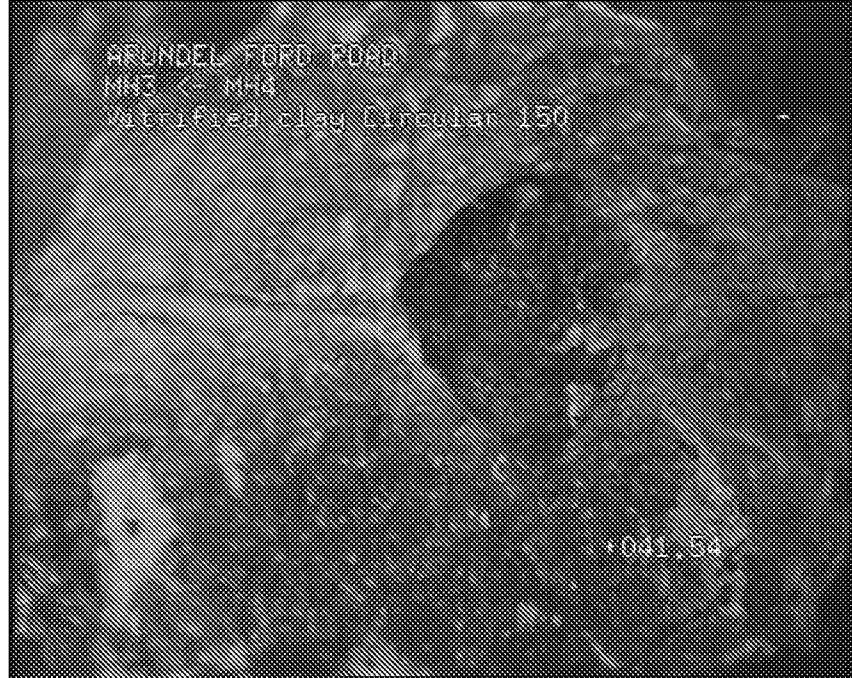
Photo: 3\_3\_90\_A.JPG  
 41.54m, Hole in drain/sewer, from 11 to 12 o'clock

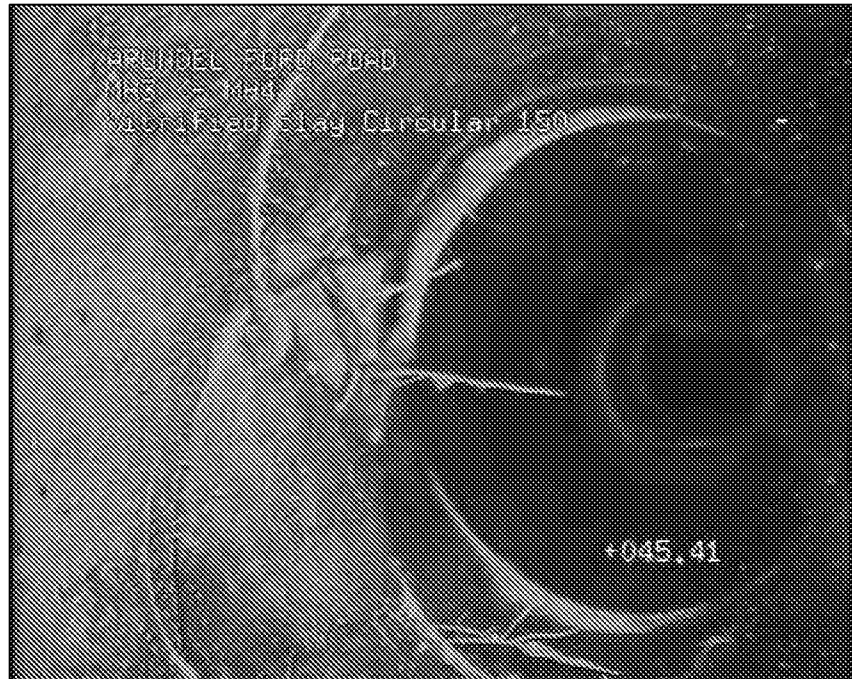
Photo: 3\_3\_93\_A.JPG  
 45.41m, Fracture, multiple at joint, from 7 to 5 o'clock

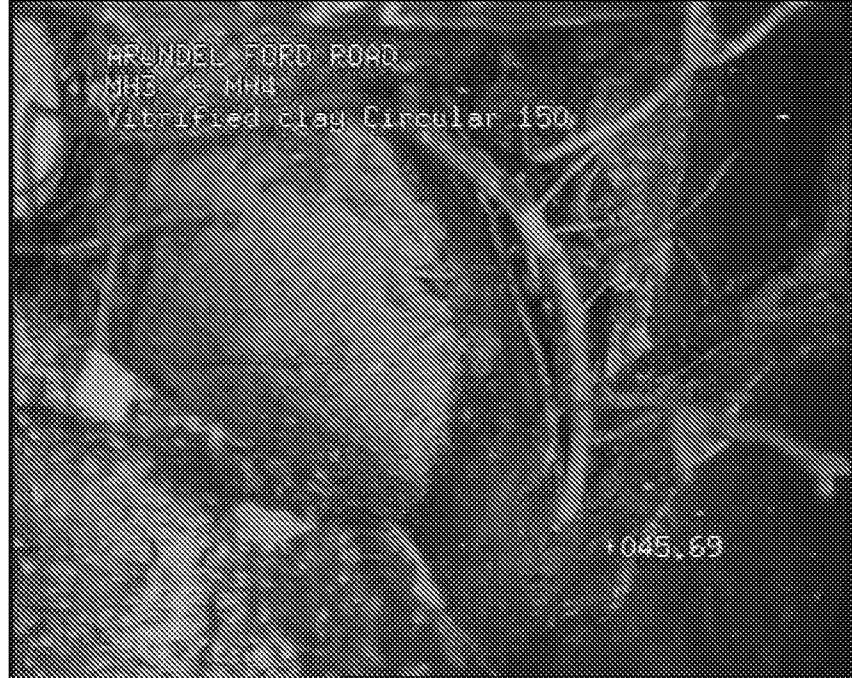
Photo: 3\_3\_94\_A.JPG  
45.69m, Hole in drain/sewer, from 11 to 12 o'clock

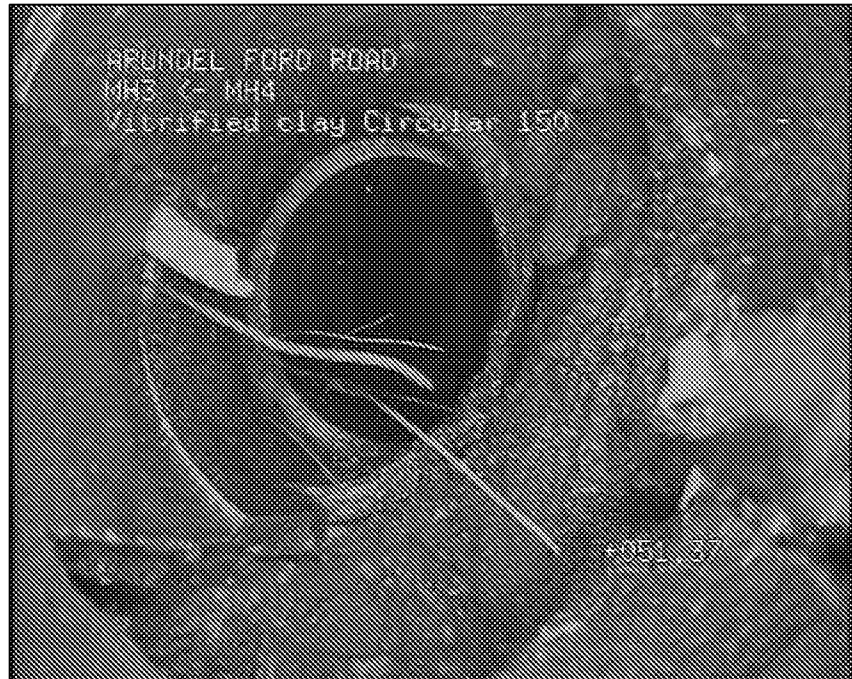
Photo: 3\_3\_107\_A.JPG  
51.37m, Hole in drain/sewer, from 3 to 9 o'clock

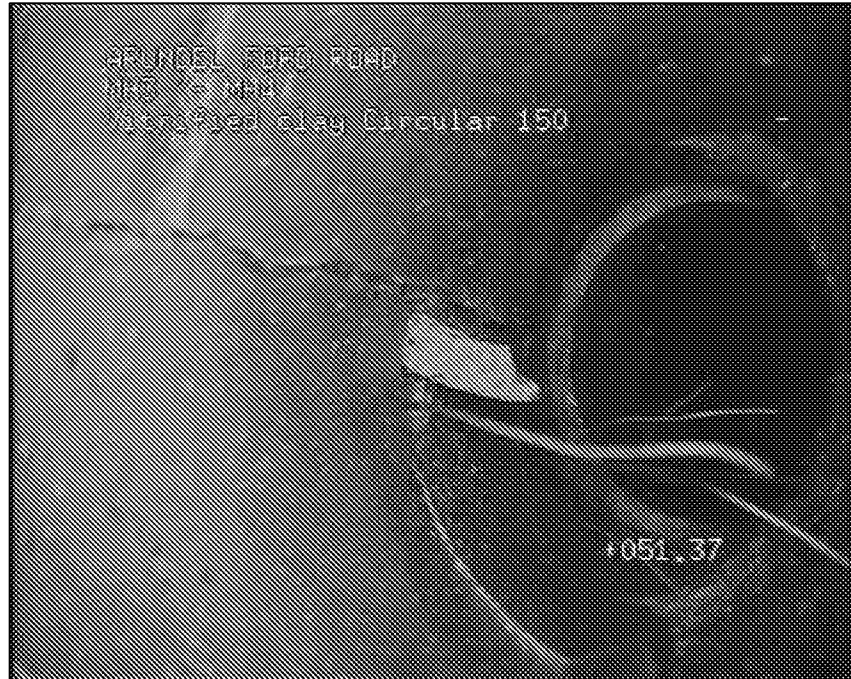
Photo: 3\_3\_108\_A.JPG  
51.37m, Fracture, multiple, from 6 to 6 o'clock
