## Bryceson Shaw Associates

**44 Tarrant Street, Arundel**

### Notes on structural defects found in the property.

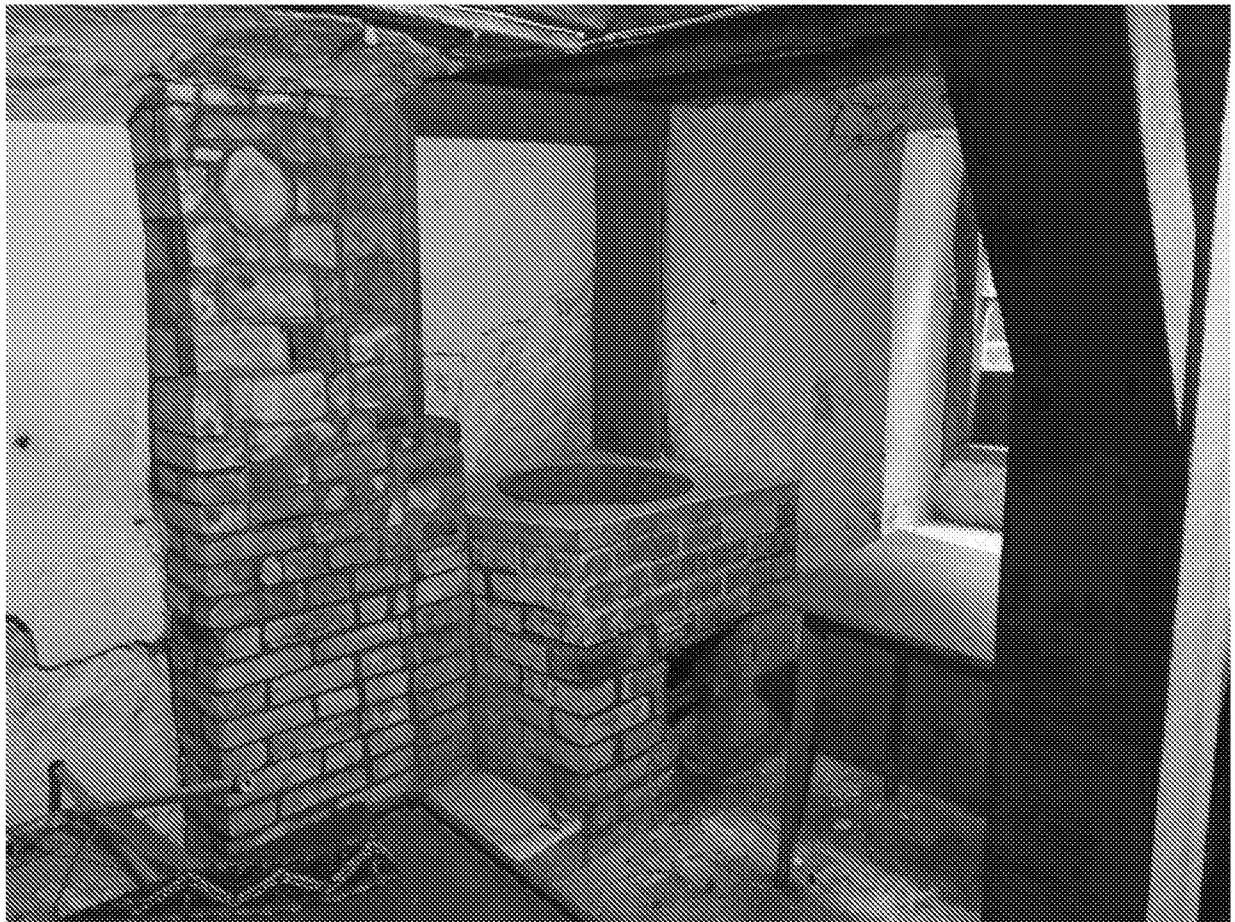
Photo 1

The joists in the Northwest corner had rotted away at the ends in the party wall and were being supported by an inappropriate structure that obscured original structure, see photo 1. Upon removal of the joists to consider repair to the ends it was found that the timber had decayed/rotted to the point where repair was not going to result in structurally sound timber. The 3 joists had to be replaced with new oak of the same section.

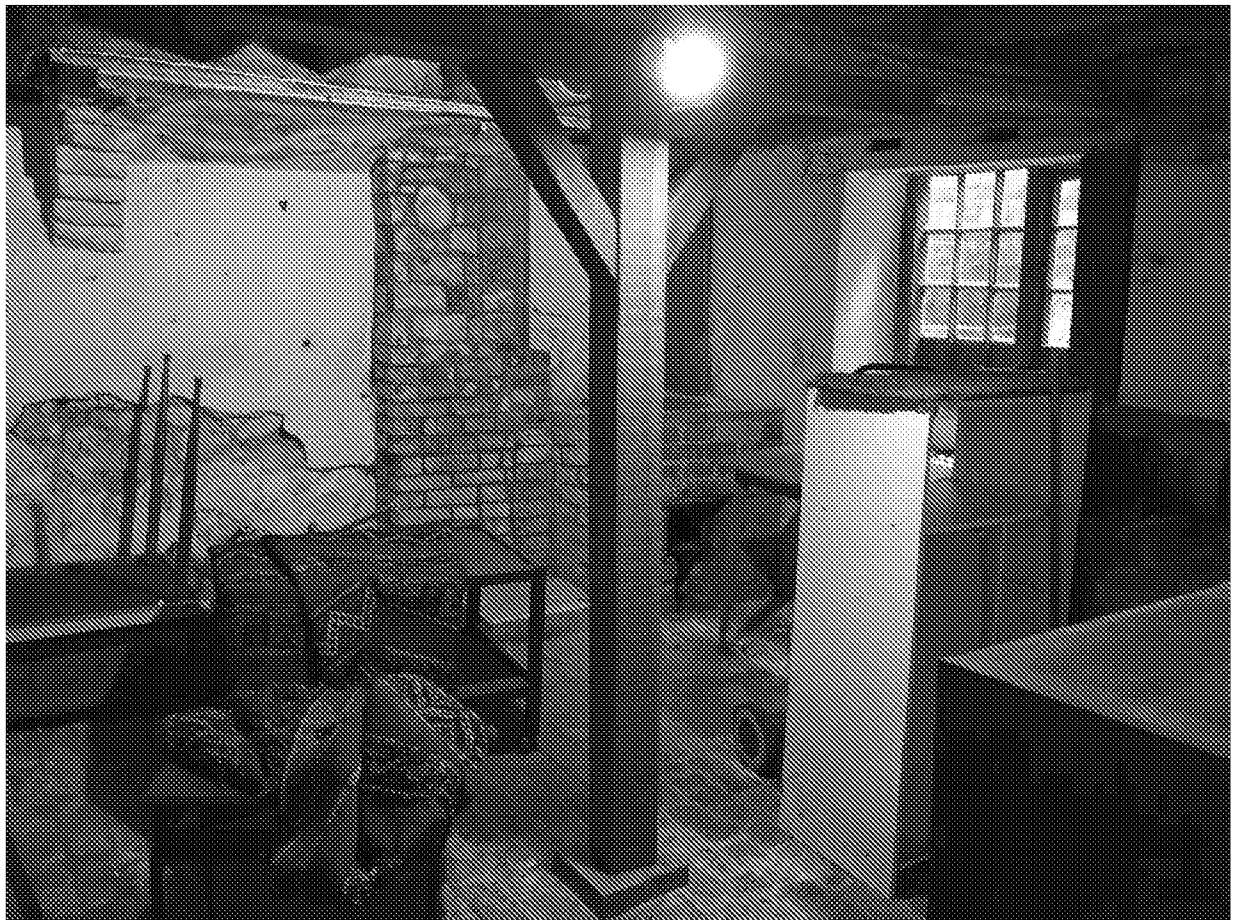
Photo 2

The summer beam supporting the joists is propped with a central post and it was desired to remove this. The beam had a major split along its length and that explained the post, see photo 2. A drawing was prepared detailing in-situ reinforcing repairs to the beam. The outer end of the beam was supported with a section of timber post that obscured the window, see photo 3. This was installed because the lintel had decayed. As the wall was to be re-plastered a discrete section of steel box section was inserted as the new lintel.

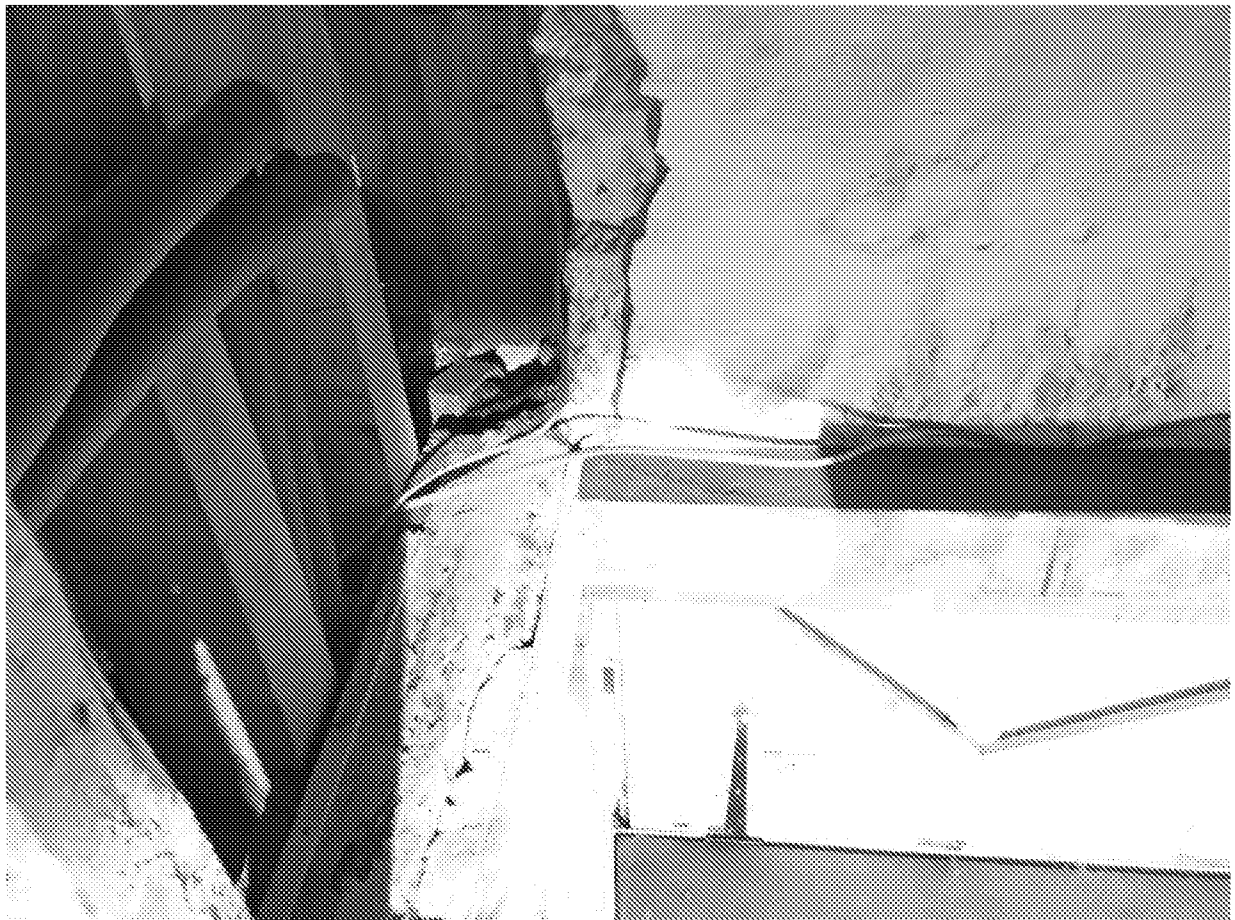
Photo 4 (this is rotated)

The beam over the doorway to the utility room had rotted away where it was built into the rear wall and was supported with a post, see photo 4. I did not believe the beam could be removed so an in-situ repair to the end would have to be done. The end of the beam would have to be cut back and some other structure removed to allow access, a section of species and moisture content matched timber could then be attached to the end using the Rotafix system as detailed on a drawing.

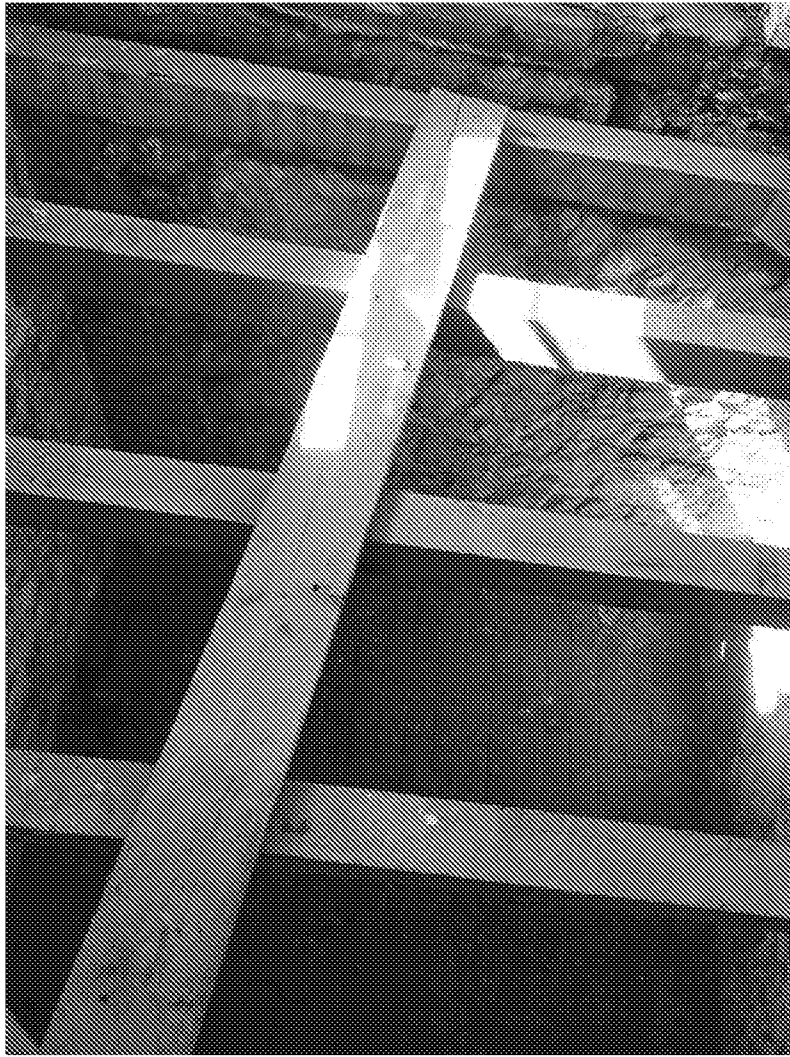
Photo 5

There was a rotting false floor over this room, under the pantry, and the original joists under were also badly rotted and decayed to the point where it was not considered safe for operatives to work on the floor. Upon stripping the structure it was apparent that the joists could not be rendered structurally sound with any means of repair so for safety they had to be replaced with oak of the same section, see photo 5.

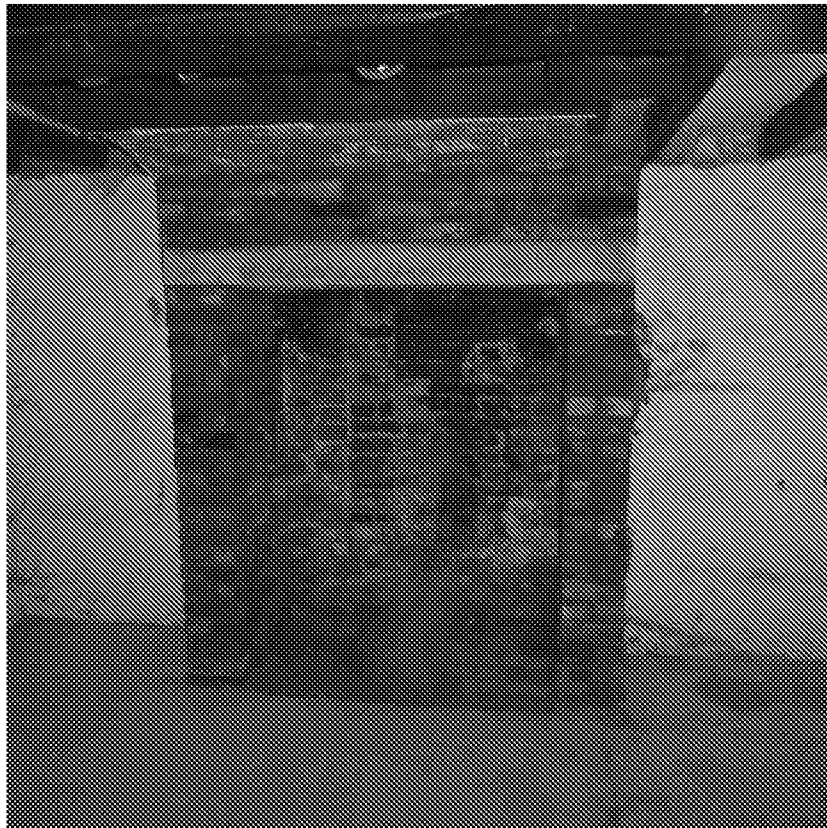
Photo 6

The fire place was found in a bad state of repair and as it was to be plastered a concrete lintel was used over the re-built brickwork, see photo 6.

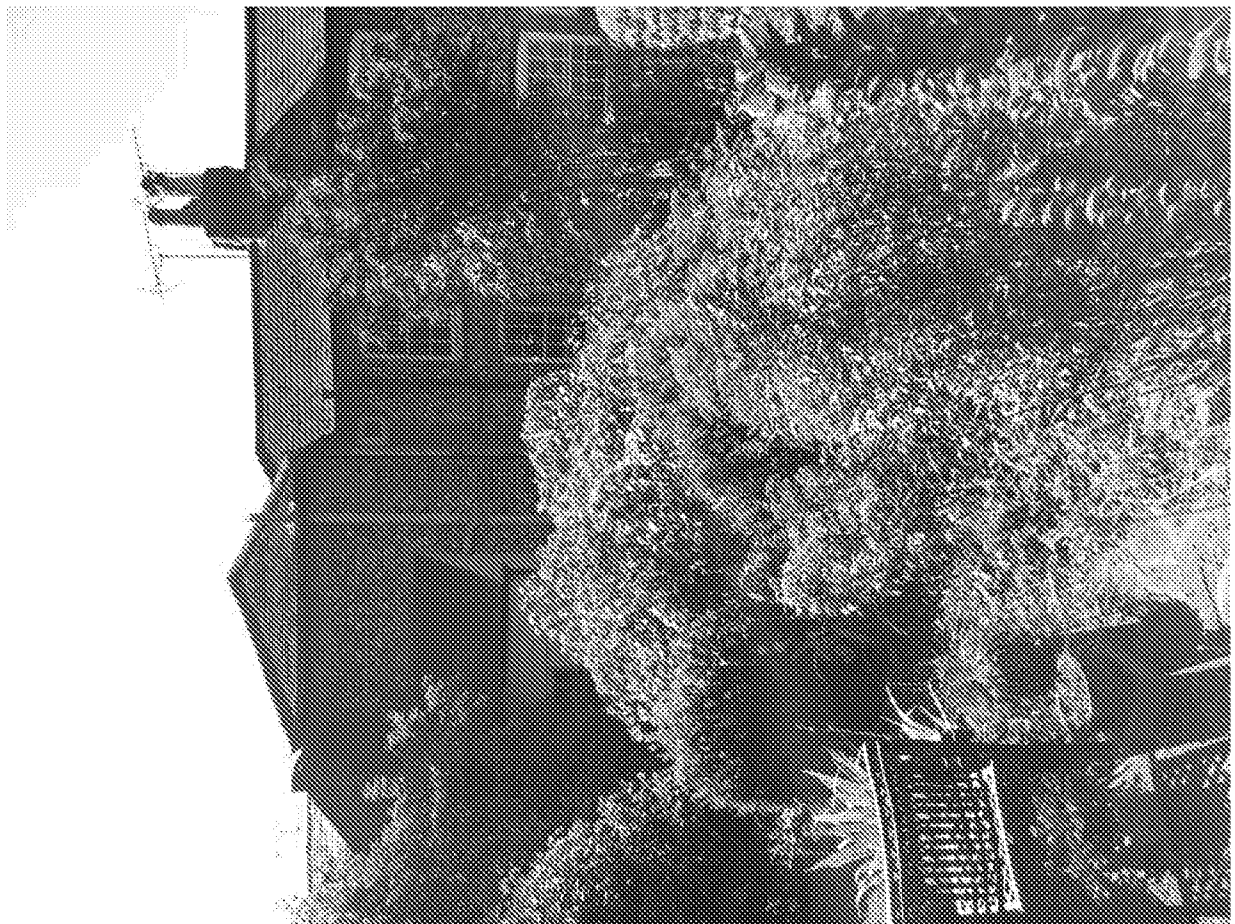
Photo 7 (this is rotated)

The rear external wall had a section of badly cracked brickwork to the right hand side of the window and this was specified to be repaired by crack stitching with the Helifix system to avoid having to remove bricks. Photos 7 & 8 shows the distortion to the left side of the window heads and this was considered to instrumental in the damage to the brickwork. This would appear to have been an historic repair as there is additional brickwork in the flint to the left hand side of the dining room window, behind the soil pipe.

The main defects found when the rear wall was stripped were the lintel over the window was badly decayed and causing movement in the brickwork. The wall plate was found to so badly decayed that it was causing movement in the roof, see photo 7 for the dip in the roof to the left of the window. This could have allowed water ingress which exacerbated the decay. Both timbers could not be safely repaired so had to be replaced and the loose brickwork re-built to support them.

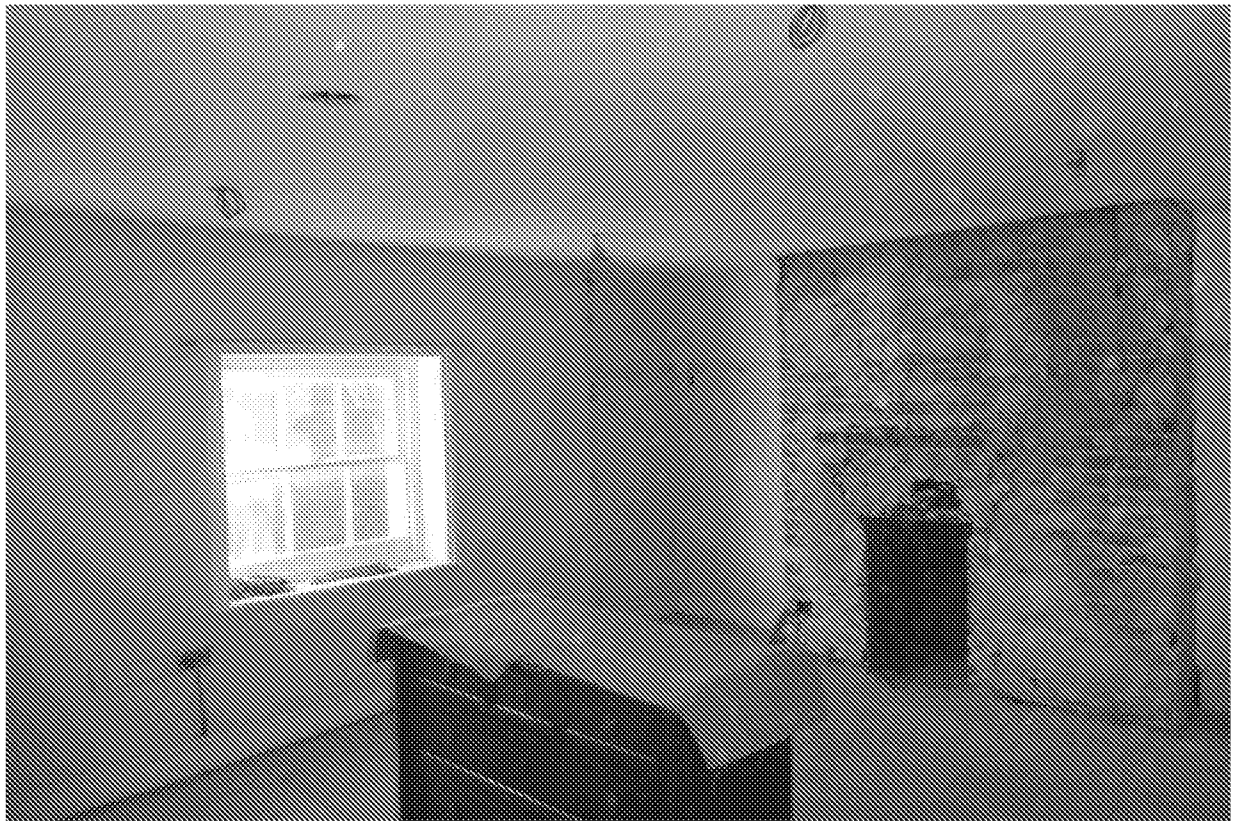
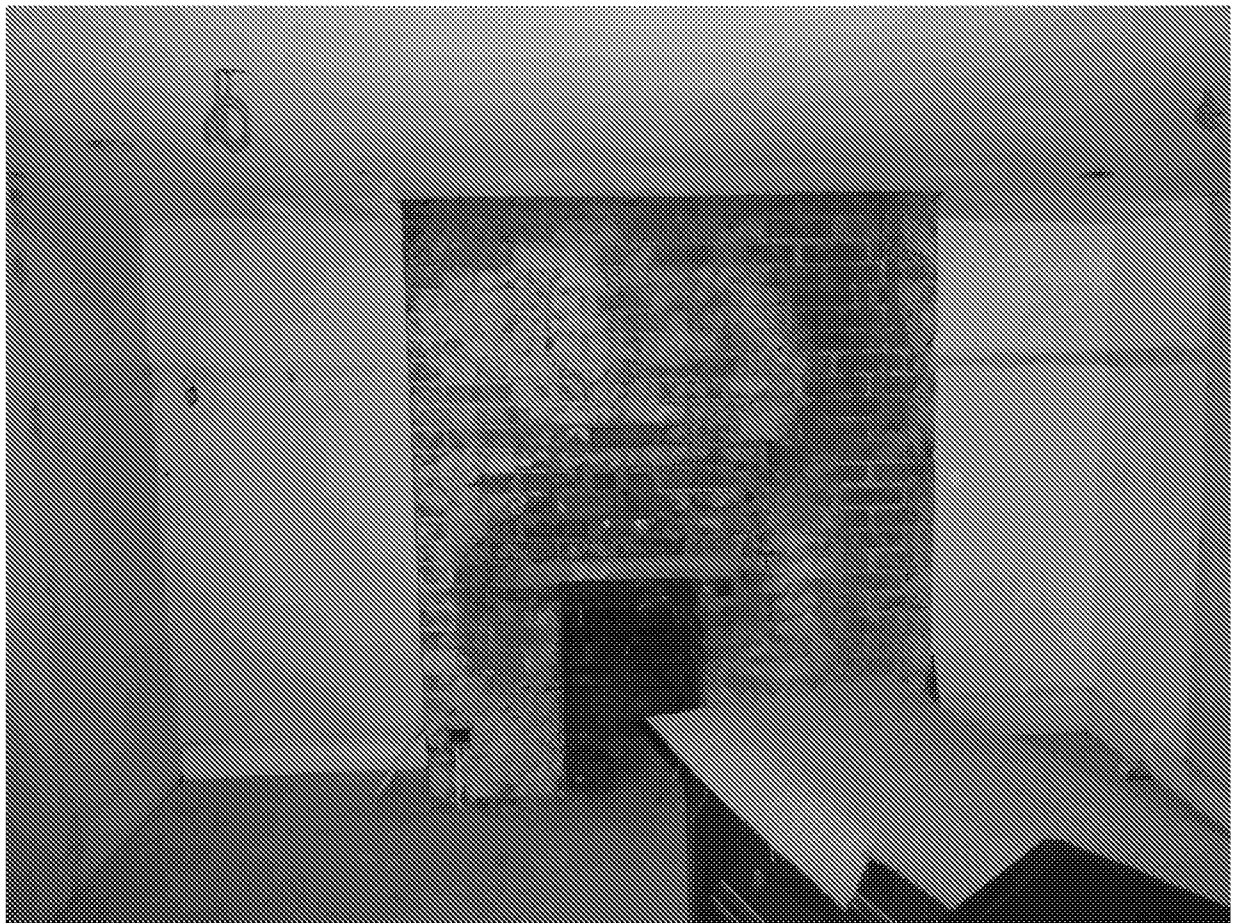
Upon opening up the fire place it was found in a defective state and as it was to be re-plastered a concrete lintel was installed in the original structure, see photos 9 & 10.

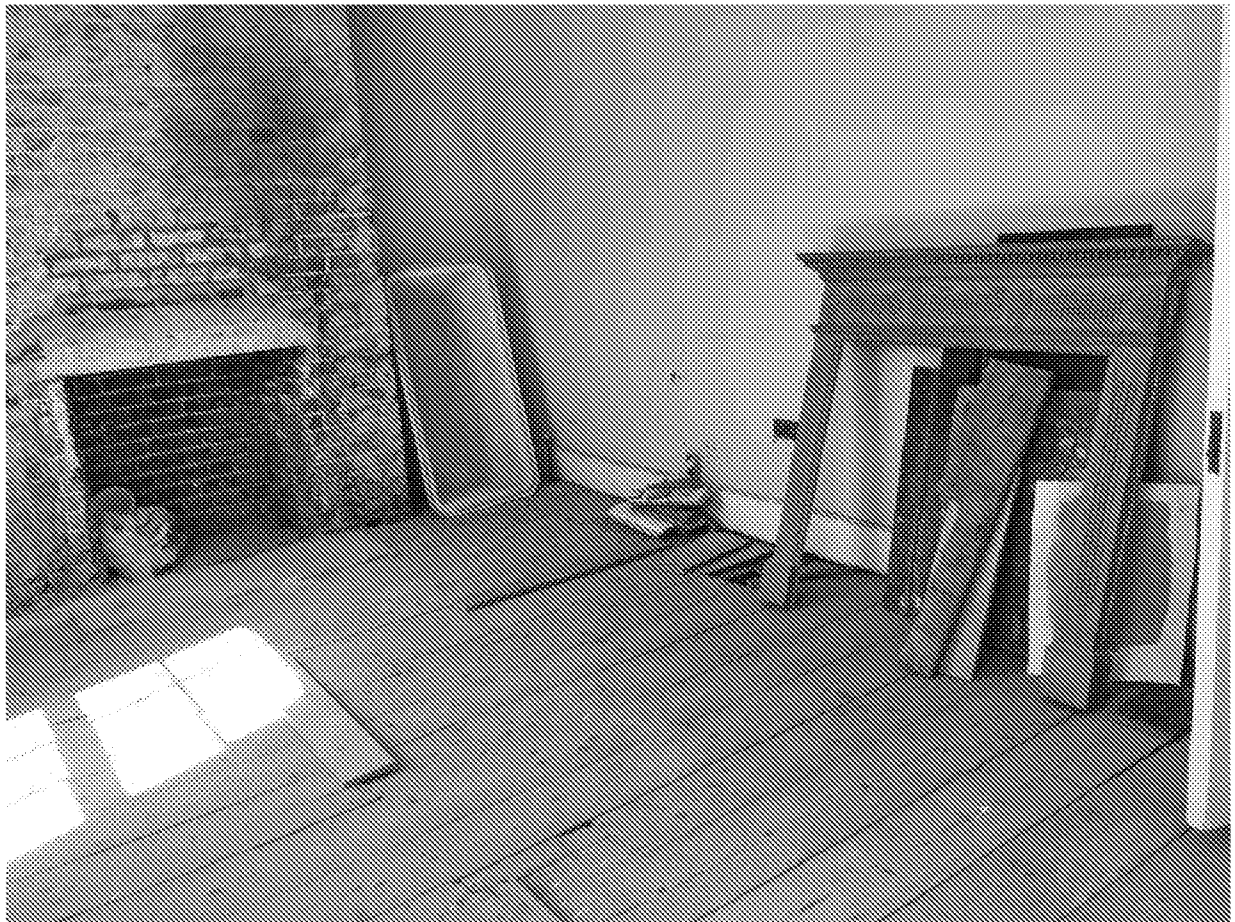
Photo 11

Upon opening up the fire place it was found in a defective state and as it was to be re-plastered a concrete lintel was installed in the original structure, see photo 11.
