**Land off Nyton Nurseries**  
**Westergate**  
**Tree Survey Report**

20<sup>th</sup> July 2017

**Our Ref: JSL2869\_770**

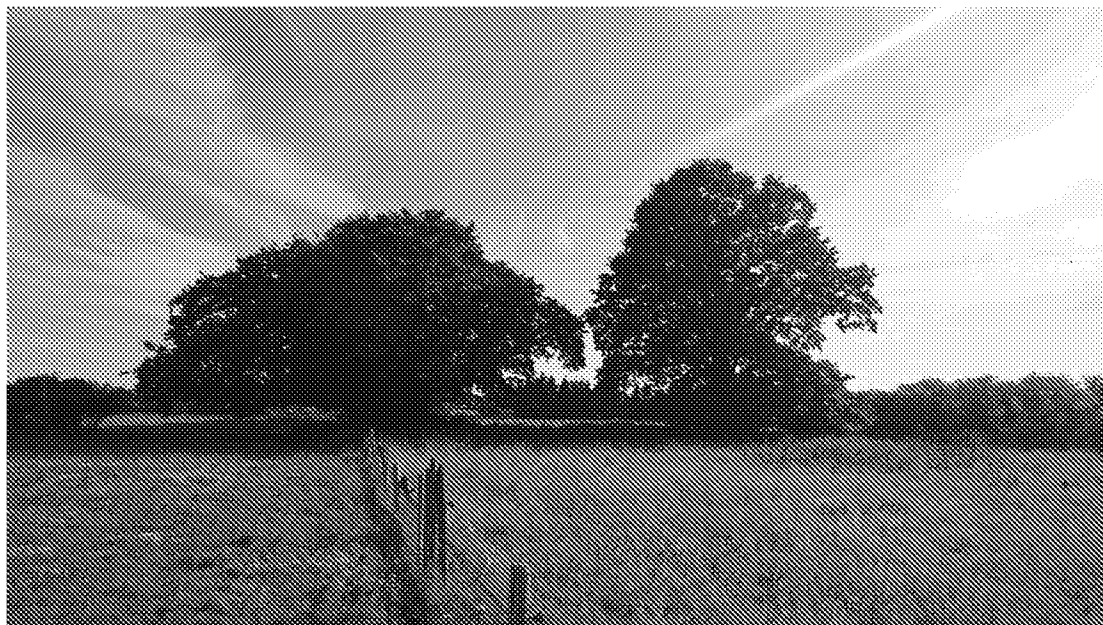
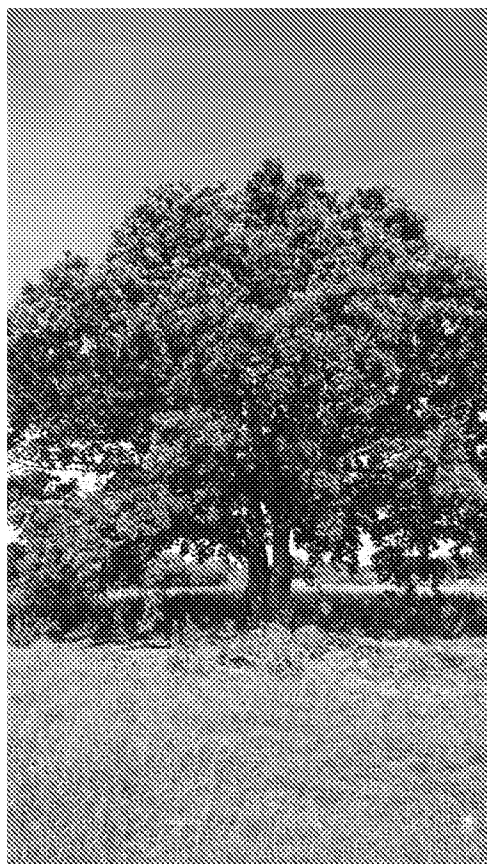
- 4.4 There were 3 BS5837 category A trees identified in the survey. T49, T50 and T51 were all pedunculate oaks with high amenity value and a significant estimated remaining contribution of over 40 years (figs. 1a & 1b, appendix 3). T50 in particular exhibited veteran characteristics of high cultural value (fig 1c, appendix 3). Such trees would offer instant maturity and high landscape value to any built environment and it is recommended the physical constraints of these trees is considered in the design phase of any potential re-development and efforts are made to retain them in such a scheme. See paragraph 4.14 and 4.15 for planning considerations associated with mature trees.

Figures 1a (top, T49 and T50), 1b (bottom left, T51) T49, T50 and T51 were high quality BS5837 category A oak trees with high amenity value.

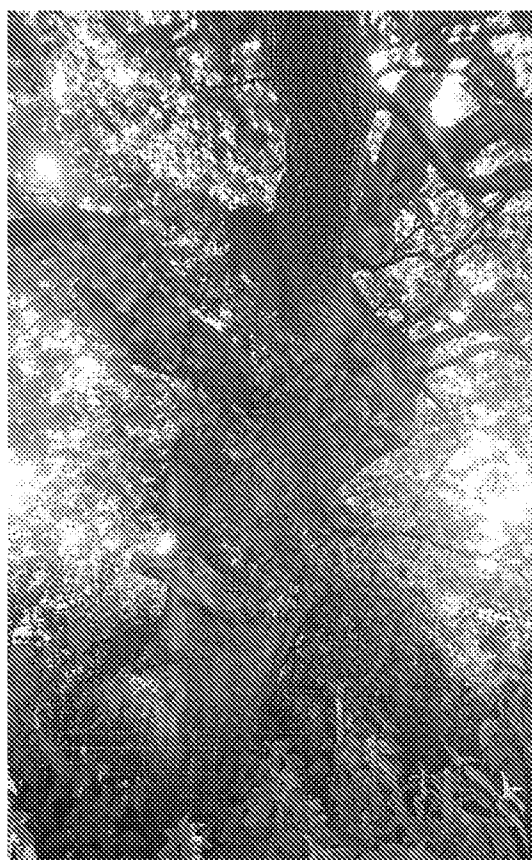
Figure 1c (bottom right). T50 was the highest amenity tree on site and exhibited veteran characteristics.

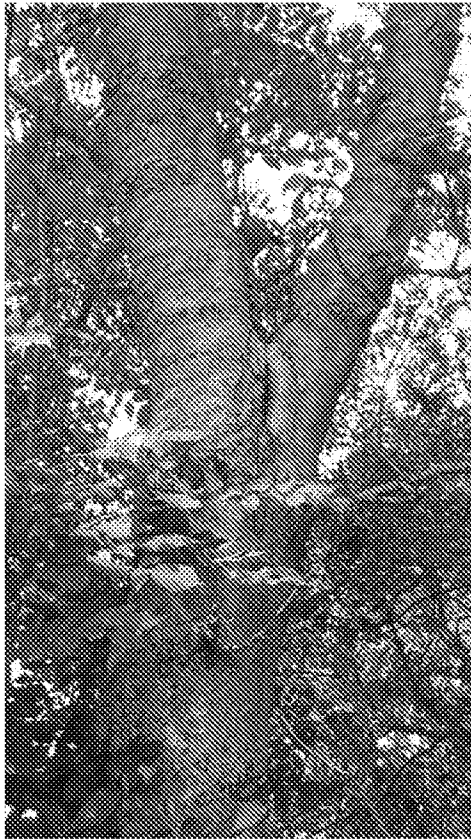
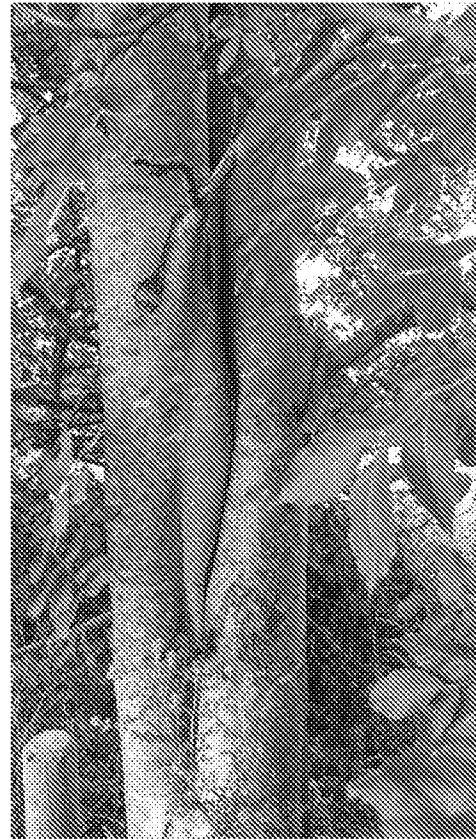
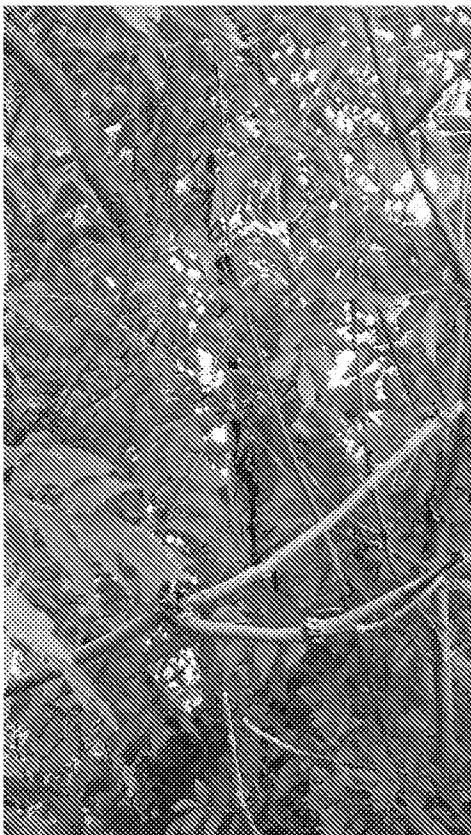
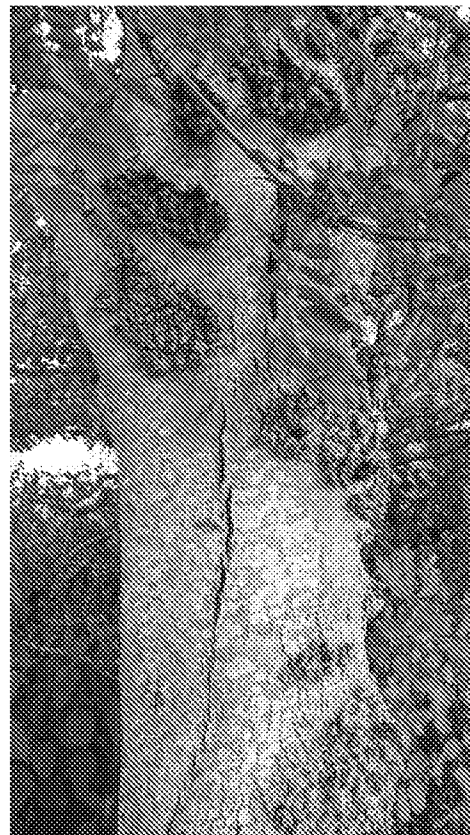
- 4.5 It was apparent during the survey that T12 x45, the line of early- mature ash trees dividing the former nursery site from the rest of the survey site, have not been actively managed since they were planted. Consequently several possess structural defects such as included bark unions (fig. 2a and 2b) and hazard beams (fig 2c), as well as some pathogenic conditions such as bacterial canker (*Pseudomonas savastanoi* pv. *fraxini*, fig. 2d). A full hazard evaluation survey is beyond

Figures 2a (top left) and 2b (top right). Included growth unions were present on several trees within T12 x45.  
 Figure 2c (bottom left). A hazard beam was also noted on a major limb on one of the trees within T12 x45.  
 Figure 2d (bottom right). Bacterial canker (*P. savastanoi pv. fraxini*) was present on some trees within T12 x45, causing cankers and vertical splits.

the scope of this survey but in the event of increased pedestrian traffic within the context of potential site development, it is recommended such a survey is undertaken and risk abatement is carried out as necessary.

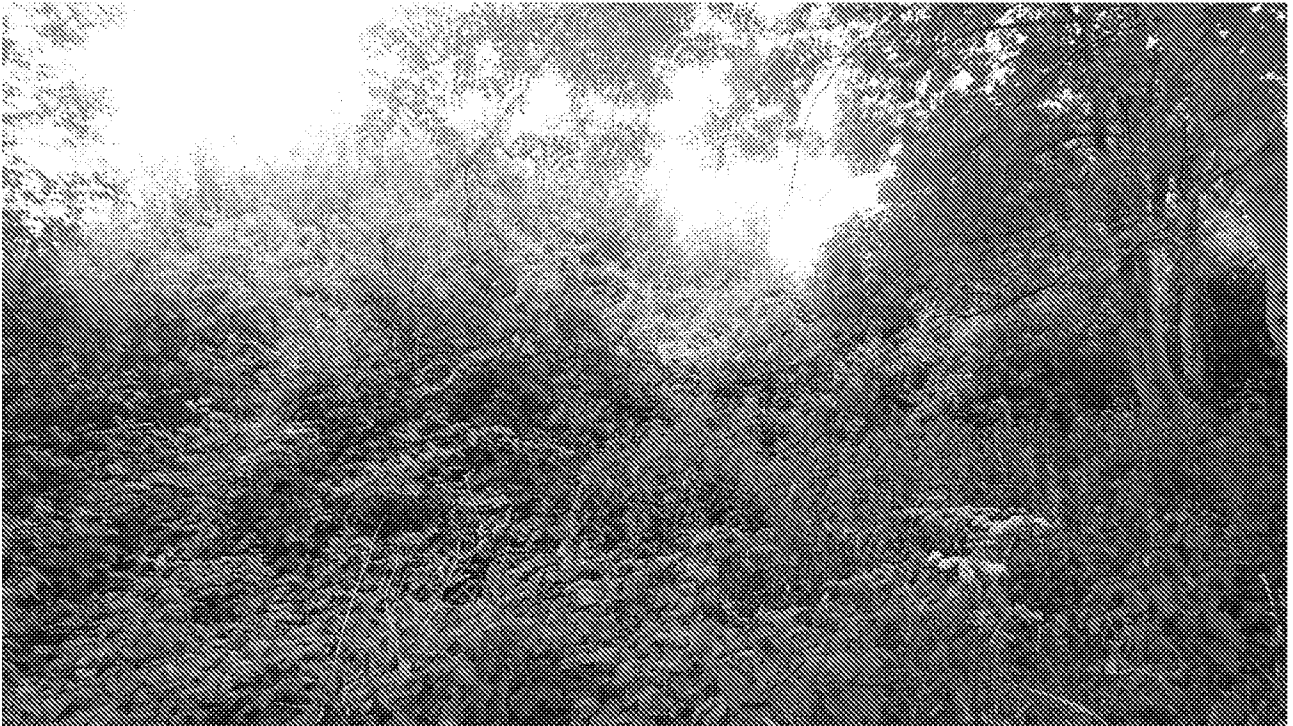
Figure 3 (top). G3- G5 comprised an area of dense pioneer vegetation. Access was limited and therefore it was not possible to undertake a detailed survey of the area, however the trees within were of low quality pertaining to a category C2 of the BS5837 tree grading criteria.

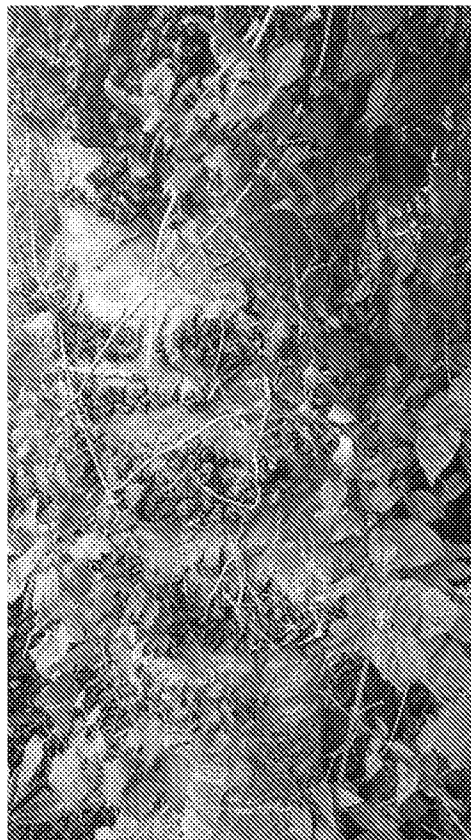
| Ref. no. | Species | Height (m) | Crown spread (m) | | | | Stem dia. (m) | Stem no. at 1.5m | Height of crown clearance (m) | Dir/height | Age class | Structural Physiological condition | General observations Management recommendations | Estimated remaining contribution (years) | Tree Quality Category (BS5837) |
|---|---|---|---|---|---|---|---|---|---|---|---|---|---|---|---|
| 20 | Fraxinus excelsior<br>Common Ash | 13.0 | 6.5 | 5.5 | 3.5 | 5.5 | 0.32<br>0.18<br>0.16<br>0.26 | 4.00 | 2.00 | N | EM | Fair | Multiple stems at ground level, lacks central leader. Signs of bacterial canker. Root girdling noted. Ivy on stem. | 15+ | C2 |

Figure 4 (bottom). T20 showed symptoms of bacterial canker (*P. savastanoi pv. fraxini*) and its structural condition should be further monitored.

- 4.8 Three ash trees at the southern border of the site overhung the car park of the neighbouring veterinary practice. T20 showed symptoms of bacterial canker (fig. 4 appendix 3); it is recommended the tree is further monitored for signs of structural decline, should such decline be noted then remedial tree surgery is recommended as a matter of urgency. T21 is protected by TPO/AL/1/13 and was in apparent good condition. T22 was a multi-stemmed tree and had a large stem cavity in the plane of lean of one the stems, towards the veterinary practice (fig. 5a and 5b, appendix 3). The stem has a large end weight and it is recommended this stem is reduced to reduce the risk of failure.

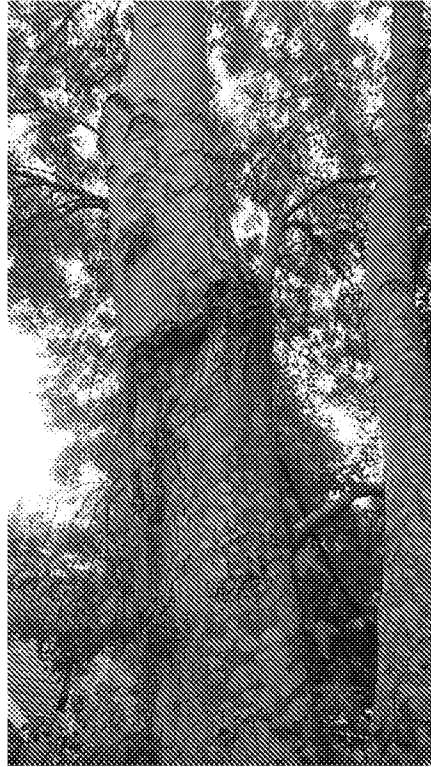
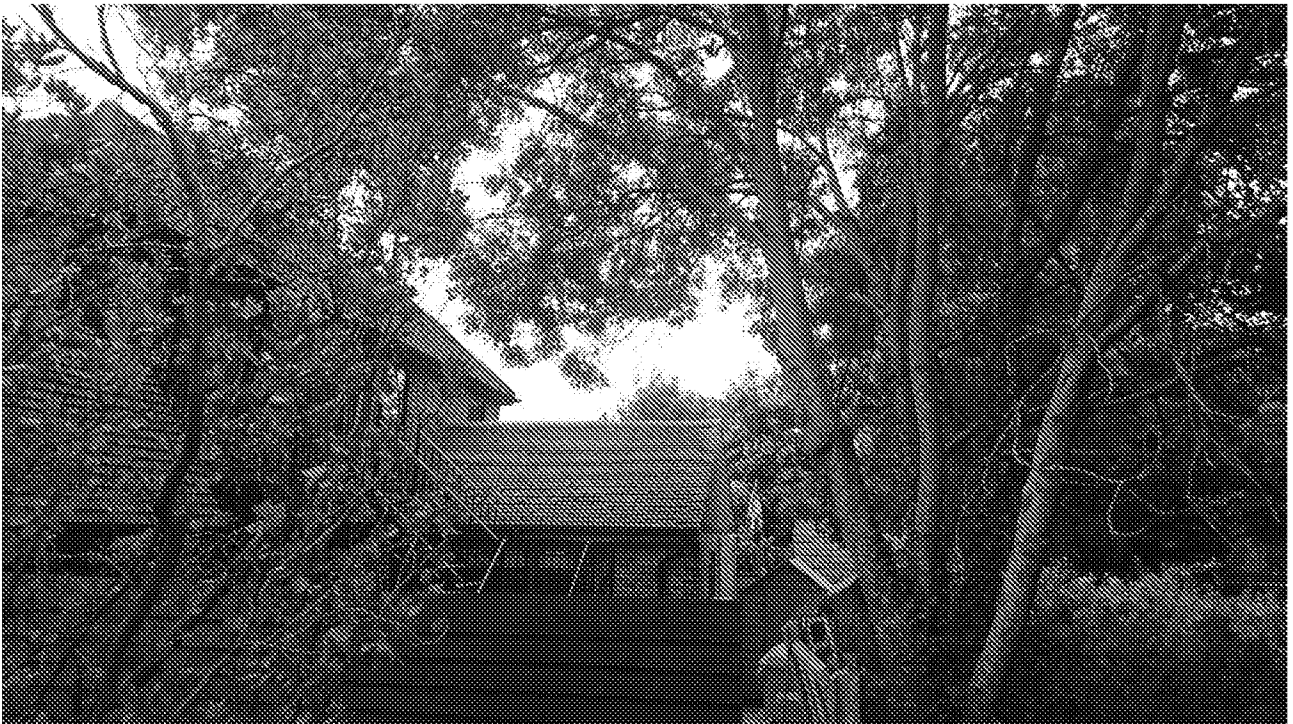
Figures 5a (top) and 5b (bottom). T22 had multiple stems and one had a stem cavity in the plane of its lean, a potential structural weakness. The stem was also leaning towards the veterinary practice, pictured in 5b. The stem also had a heavy crown weight which was biased towards the veterinary practice. It is recommended the stem is reduced.
