# ARBORICULTURAL REPORT

Land at Wings Nursery, Lidsey  
Road, Woodgate

Beechdown ref: B/0300/21

Wings Nursery – BS 5837 tree survey/report – January 2021

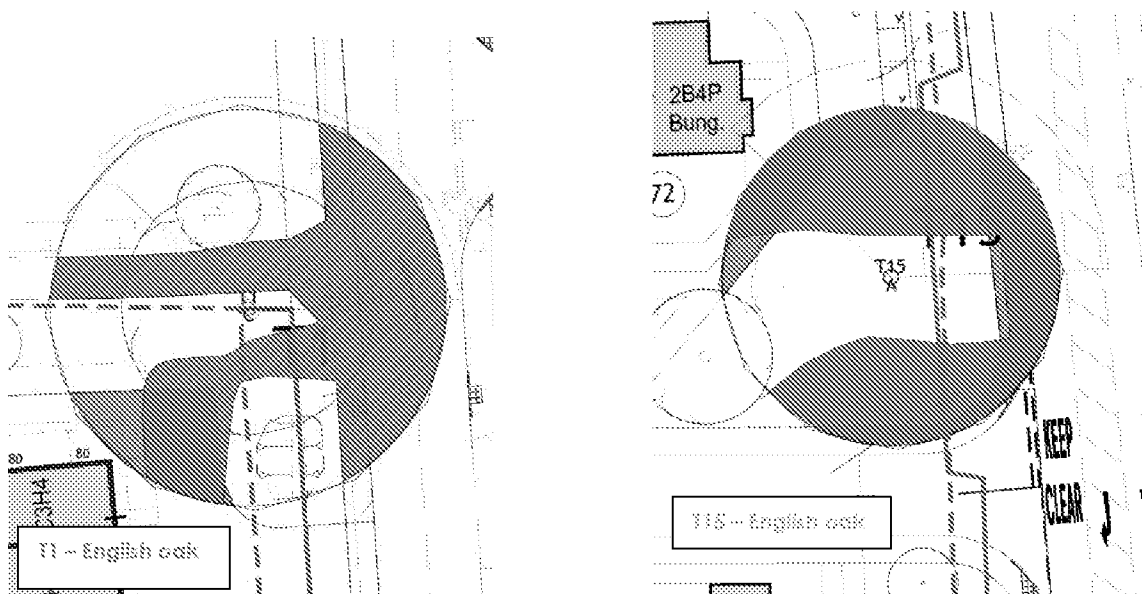
**Fig.2 – Existing hard-surfacing within RPA shown in purple**

- 12.4 Construction of the private driveway and parking spaces to plot 71 impacts on around 3% of the unsurfaced RPA of the English oak (T1), shown in orange at **Fig. 2**, while proposed pedestrian access, also shown in orange at **Fig.2** extends over just 2% of T15's RPA. The southern end of the proposed access drive also extends into the RPA of T15 but only into existing hard-surfaces.

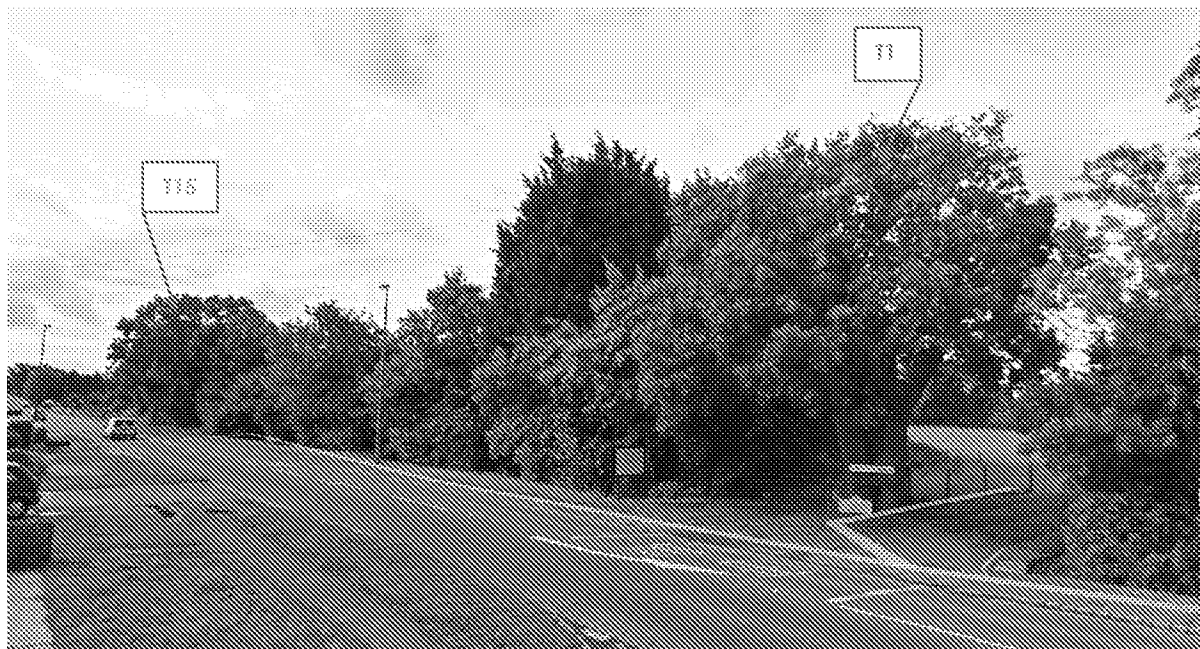
Fig. 3 – Image courtesy of Google Maps (map data © 2020 Google)

12.3 The majority of the recorded roadside trees, and dense understorey of bramble-covered hazel, hawthorn and elder, between the English oaks (T1&T15), shown at **Fig. 3** below, are not directly affected by the development proposal; however, management of this group has lapsed and while it currently provides good habitat and screening,

work to clear and improve the ditches/culverts and accessibility to pavements and verges will result in the loss of the majority of the low-level cover and retention of just individual trees of relatively poor form with increased exposure and greater potential for failure.
