| <b>Project Name:</b> | Land at Bayards, Eastergate (Miller Homes) |
| <b>Document Reference:</b> | 091.5016/SVR/2.2 |
| <b>Document Name:</b> | SuDS Verification Report – Area 2 |

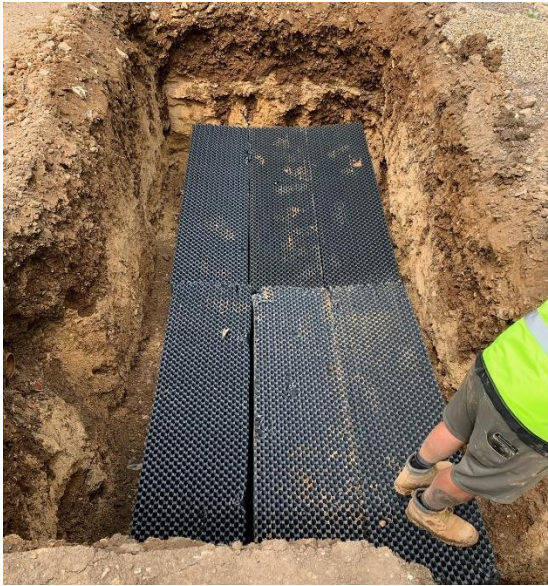
Plots 64-65

- 4.4 The image for plots 64-65 shows a different arrangement to what was proposed, this would suggest the wrong image has been supplied or the incorrect number of crates have been installed, the proposed design was for 2.5m wide by 4.5m long and 0.4 deep which with a total storage volume of  $4.28\text{m}^3$ . The image appears to show 6 SDS GEOLight crates with a total storage capacity of  $4.28\text{m}^3$ , the storage requirement is therefore met. However, the surface area from the sides and base of the crates have reduced from  $16.85\text{m}^2$  to  $14.25\text{m}^2$  this will have a minor effect on the rate of infiltration. The image also shows signs of poor workmanship - Damaged crates, crates not clipped together, crates moving away from each other likely due to an uneven surface and sediment appears to already be in the crates reducing the overall capacity of the system.

- 6.6 Given the number of crates used is not clear from the images, the Contractor will need to confirm the amount of crates for each soakaway to ensure compliance was achieved.

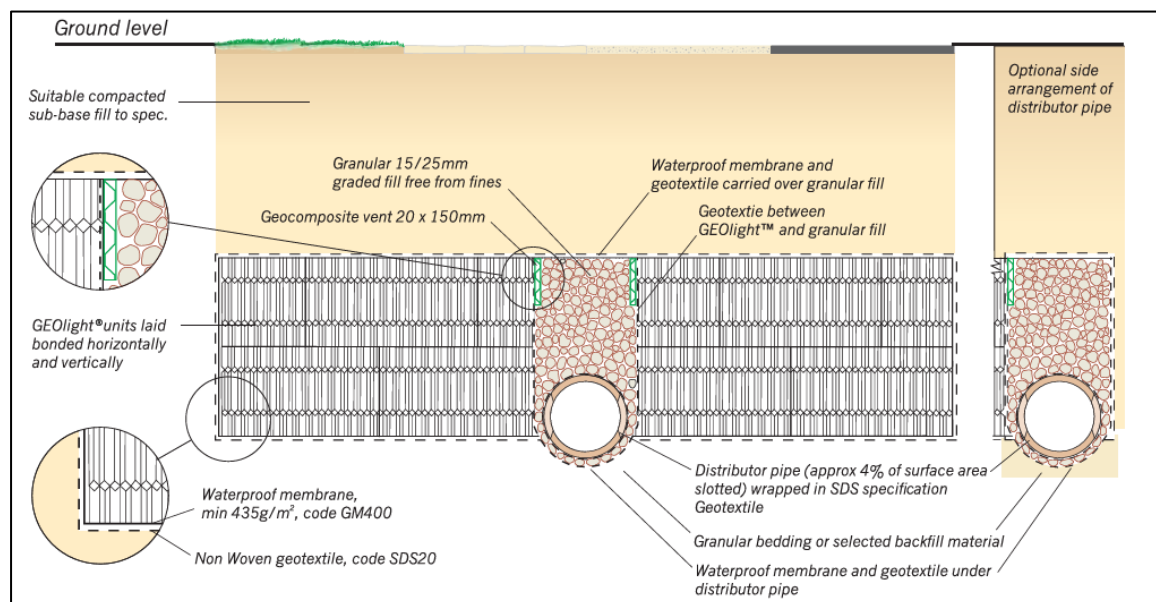
Figure 3: SDS GEOLight Cross Section

However, the contractor has instead installed an in-situ pipe that has been hand-cut with spiral slits to function as a perforated pipe, intended to feed water into the crates. This pipe appears to have been installed without appropriate bedding.

Furthermore, the structural integrity of the pipe has likely been compromised due to the hand-cut slits, which is also evident from the CCTV footage. There also appears to be no restraint preventing the pipe from shifting or rotating. As a result, there is no assurance that the slits will remain correctly oriented (i.e. facing downward towards the crates).

This may lead to ineffective interaction between the pipe and the attenuation system, potentially causing the drainage to perform in an unintended and unpredictable manner. will face down towards the crates therefore resulting in a non-compatible interaction that may cause the drainage to act in away that is unexpected.

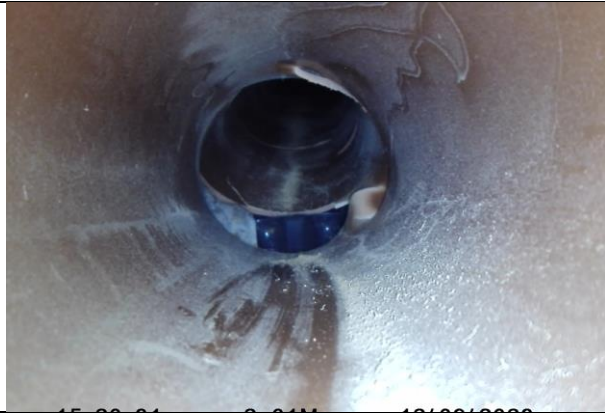
| Ref | Defect Images | Comments |
|---|---|---|
| PSCP217-SA50 | | Pipe has snapped at the point where pipe rests on crates. |

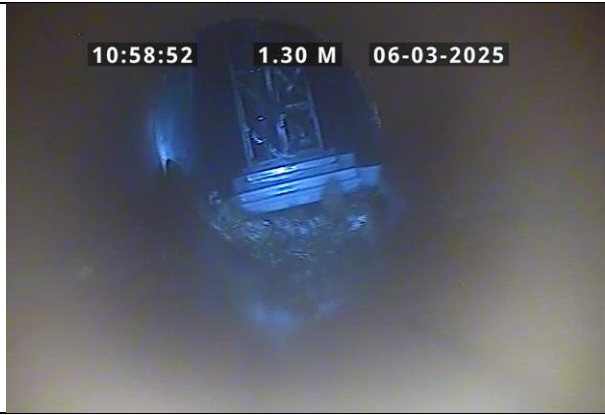
| Ref | Defect Images | Comments |
|---|---|---|
| PS210-SA66-67 | | Connection into side of infiltration crate, appears to be PolyStorm crate unit. Membrane is slightly protruding into pipe. No other visible defects. |

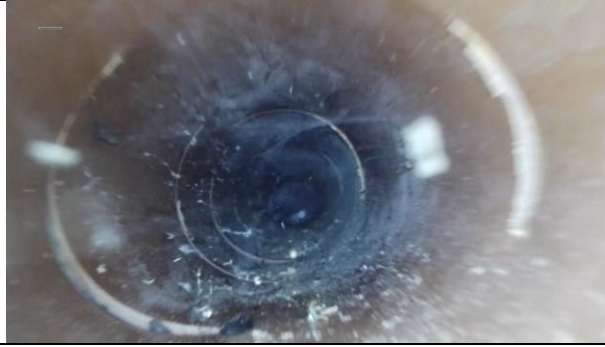
| Ref | Defect Images | Comments |
|---|---|---|
| PS213-SA66-67 | | Pipe with spiral splits shown, pipe has deformed and no longer circular. Pipe also appears to be bent and changes direction without a junction. Drainage approach differs between plots 66 & 67, contractor to confirm if this is correct. |

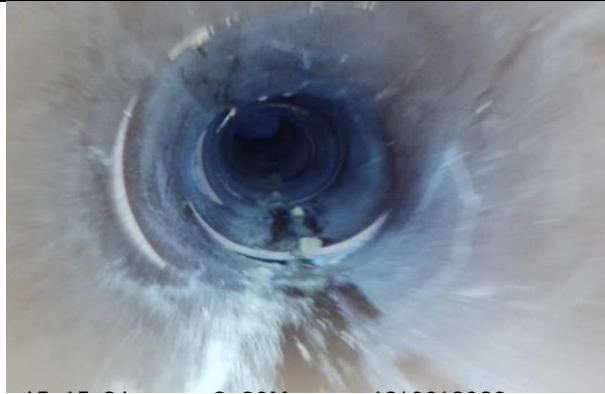
| S206-SA64-SA65 | | Pipe with spiral splits shown, pipe has deformed and no longer circular. Pipe also appears to be bent and changes direction without a junction. |

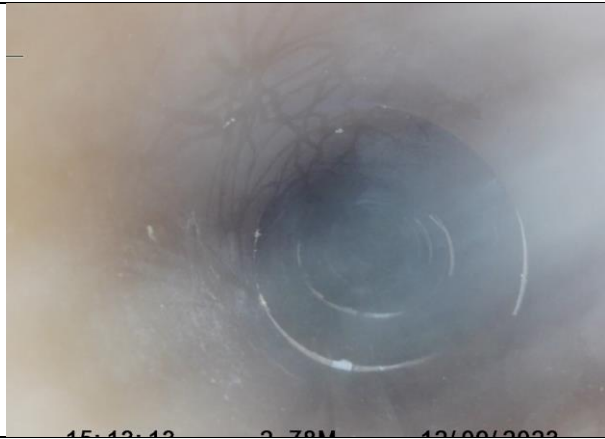
| PS203-SA64-65 | | Pipe with spiral splits shown, pipe has deformed and no longer circular. Pipe also appears to be bent and changes direction without a junction. |

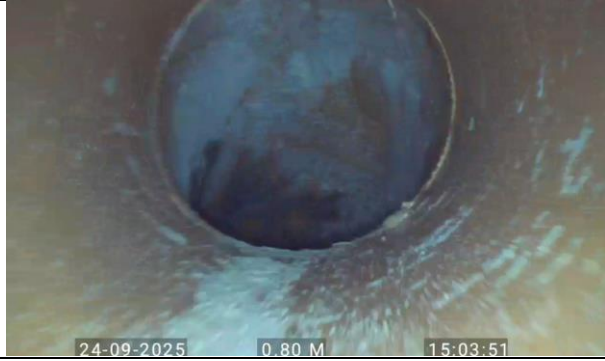
| PSCP220-SA53 | | No visible major defects, pipe run appears to end in a bend into the top of crate system |

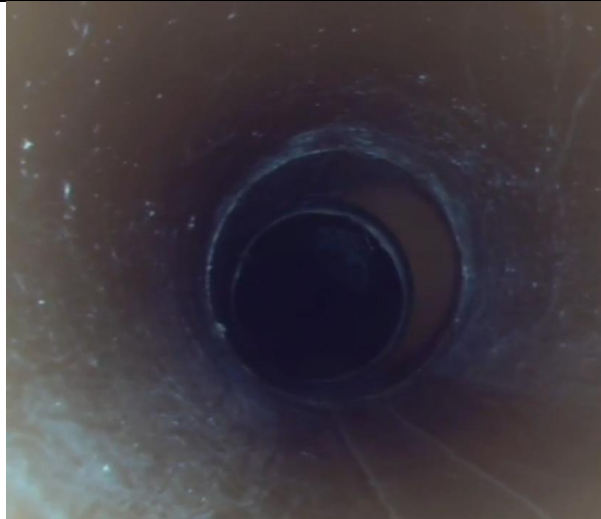
| PS5281-PS61 | | Footage shows a pipe junction, design shows no junction into this pipe. |

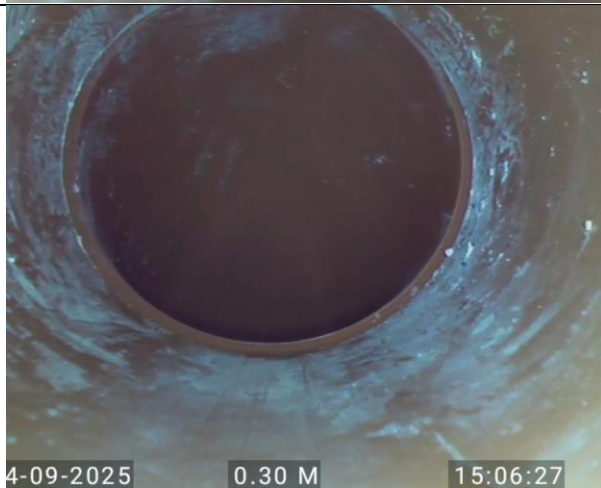
| PS61-SA57-63 | | Pipe appears to run into the top of the crates with a bend at the end of the pipe. |
