| <b>Project Name:</b> | Land at Bayards, Eastergate (Miller Homes) |
| <b>Document Reference:</b> | 091.5016/SVR/3.2 |
| <b>Document Name:</b> | SuDS Verification Report – Area 3 |

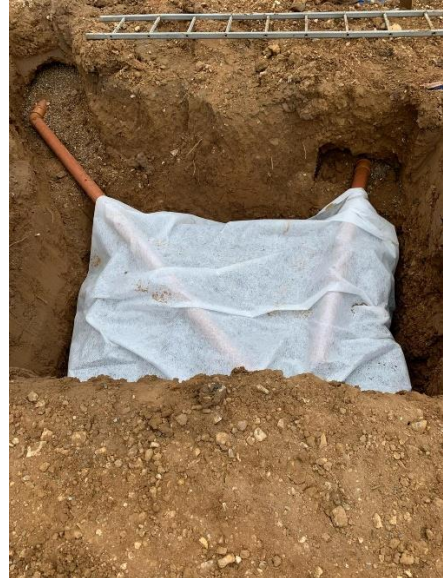
Plot 48

- 4.8 Plots 48, 49 & 51 have shown an arrangement that differs from the design outlined within the construction detail on sheet 091.5061.551 C01, this is likely due to the use of the SDS GEOLight. This product typically requires a specific arrangement, including a perforated pipe running centrally through the attenuation crates, as illustrated in **Figure 3** below. However, the contractor has instead installed an in-situ pipe that has been hand-cut with spiral slits to function as a perforated pipe, intended to feed water into the crates. This pipe appears to have been installed without appropriate bedding. Furthermore, the structural integrity of the pipe has likely been compromised due to the hand-cut slits, which is also evident from the CCTV footage. There also appears to be no restraint preventing the pipe from shifting or rotating. As a result, there is no assurance that the slits will remain correctly oriented (i.e. facing downward towards the crates).

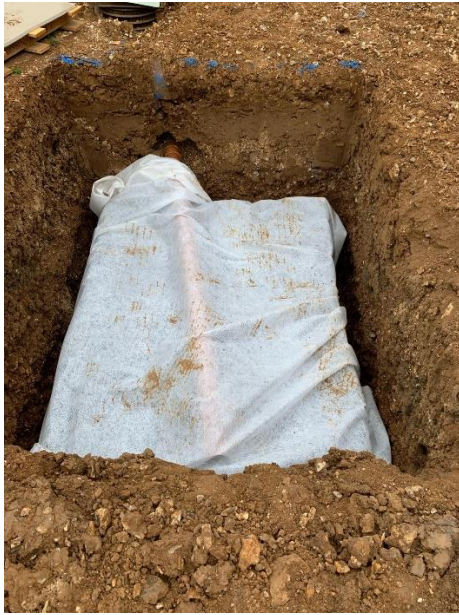
- 4.6 For the other plots it is unclear how many crates were installed but from the images Plot 49 shape differs from the intended shape, this could be due to other factors on site.

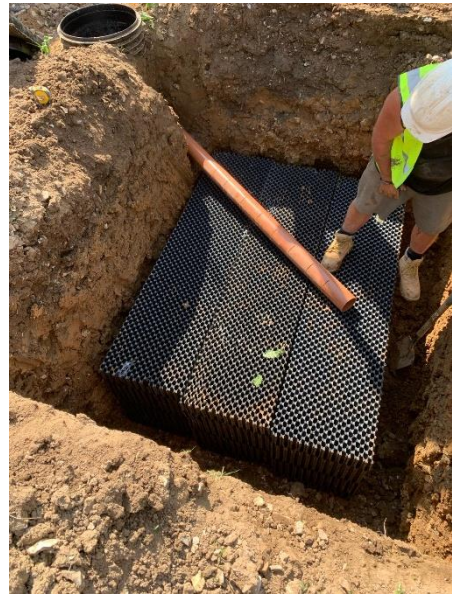
Plot 51

- 4.5 In the image for plot 51 it appears three SDS GEOLight blocks have been installed at the total dimensions of 2m long x 1.5m wide x 0.75m deep, this has a total storage volume of 2.14m<sup>3</sup>. Whereas the design was 4m long x 2.5 wide x 0.4m deep, this has a total storage volume of 3.8m<sup>3</sup>

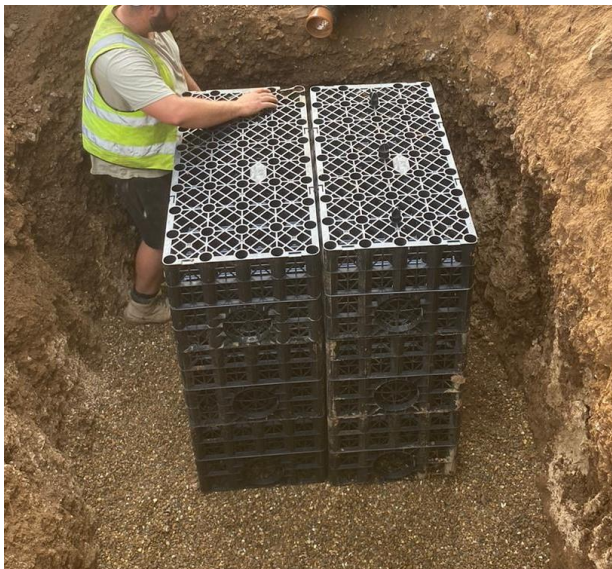
Plot 52

- 4.4 The image for plot 52 shows a different arrangement to what was proposed, this would suggest the wrong image has been supplied or the incorrect number of crates have been installed, the proposal was for 1m wide by 7m long and 0.4 deep which would total to 14 crates being used. The image shows 6 crates used, this is significantly less storage, and this may cause this property to be at risk of flooding. The crates also appear to be Polystorm Modular Cell, which were not approved

by Paul Basham Associates. The design storage volume is 2.66m<sup>3</sup> and the as-built storage volume is 1.14m<sup>3</sup> this is significantly less and will mean the crates are more likely to flood.

- Install additional infiltration crates where the storage volume is less than what was specified in the approved design or provide supporting hydraulic modelling to support the as-built storage.

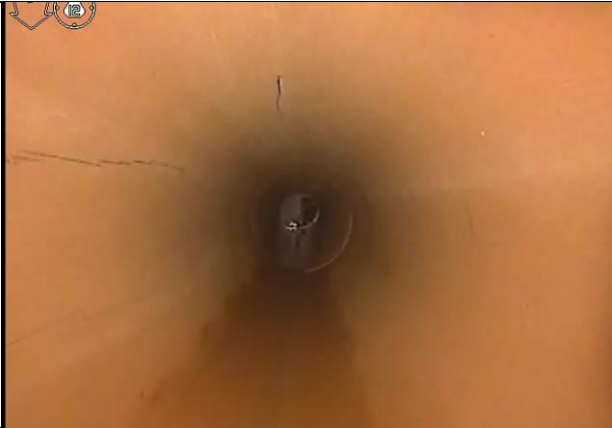
| Ref | Defect Images | Comments |
|---|---|---|
| S5-S6 | | Depth 1.5m As Built depth<br>1.38m<br>Longitudinal cracking present<br>at 7.95m<br>Video terminates at 12.48m<br>Design length 16.809m<br>Downstream defender does<br>not appear to have been<br>installed in S6 |

- 7.1 Provide images of SA Road 2 during construction and CCTV S6 to Soakaway.
- 7.2 Chamber S6 the Downstream Defender Vortex Plus has yet to be installed, this will need to be installed.

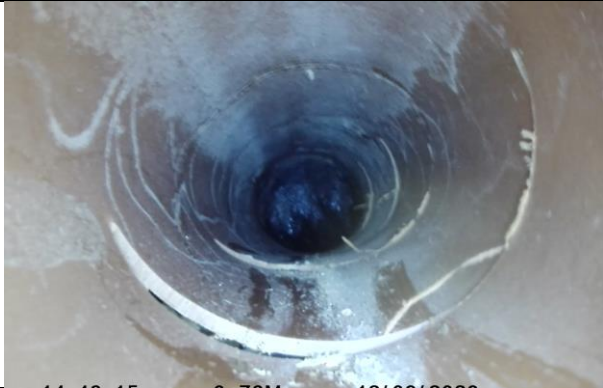
| PSCP240-SA38/39 | | Semi spiral cuts present on the video, causing the pipe to bend. Pipe also not cleaned after being cut and signs of debris from cuts present. CCTV survey shows the pipe is back falling. |

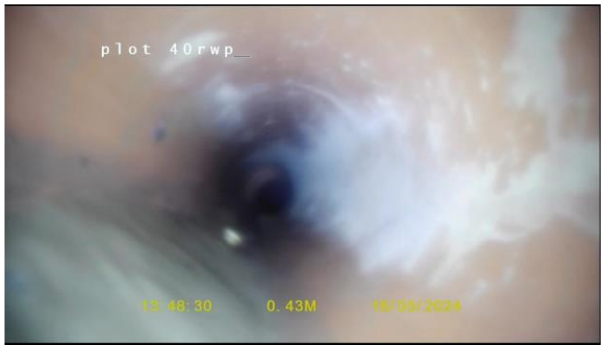
| PS243-PSCP249 | | Video labelled as Plot 40 RWP, suggesting that the RWP is connected directly into PSCP249 and that PS243 chamber was not constructed. Standing water present in pipe downstream, unclear if this was due to poor drainage or recent weather, no recent weather was provided. |

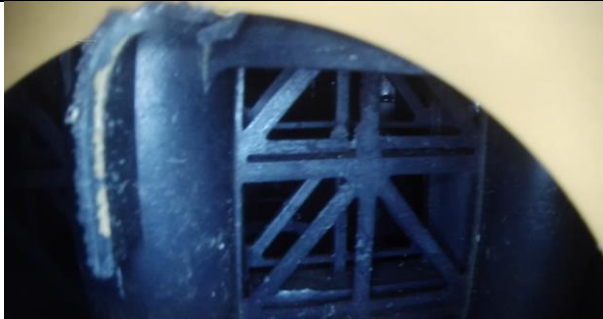
| PS3301-SA43-45 | | damage to infiltration crates has been caused due to inadequate connection.<br>No defects within pipe |

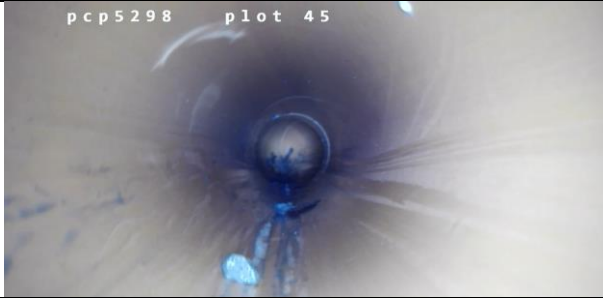
| PS5285-<br>PSCP298 | | Bend encountered, Chamber PS5285 does not appear to have been constructed. |

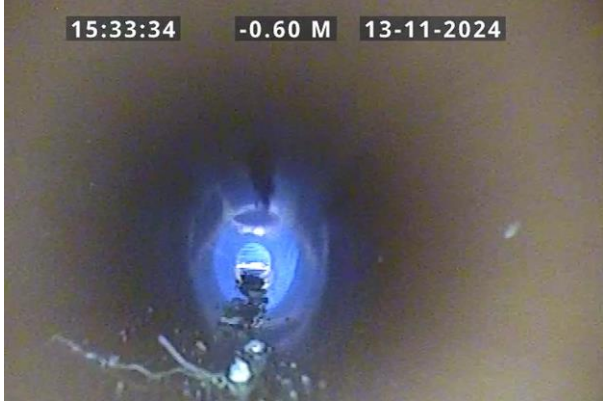
| PSCP298-<br>PS5299 | | Large amounts of sediment build up, PS5299 looks to have been built as a catchpit manhole unclear if there are two catchpit manholes or PS5299 is the sole catchpit on the network. |

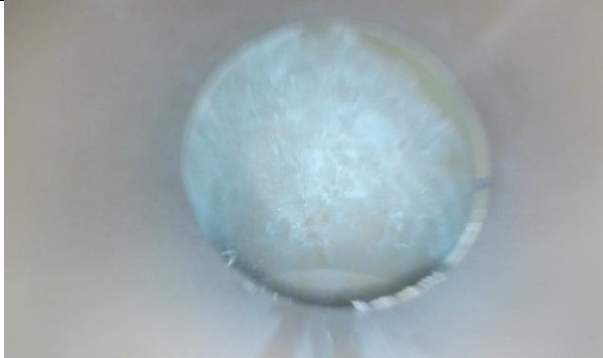
| PS5299-SA43-<br>SA45 | | Pipe appears to change direction of slope, at ~1.5m into survey. The pipe appears to terminate above infiltration crates. |

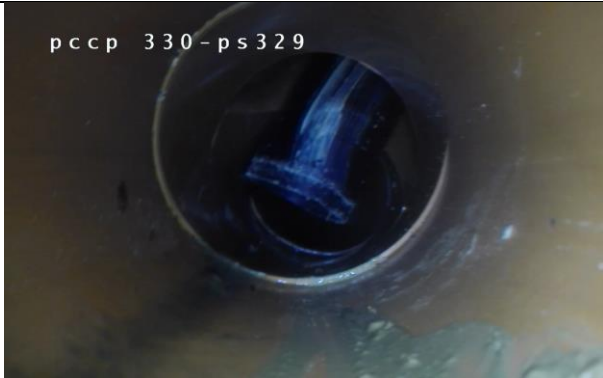
| RWP (Plot 48) –<br>PSCP330 | | RWP looks to have not been properly connected.<br>No defects within pipe sediment build up could suggest pipe has been laid at a shallow gradient. |

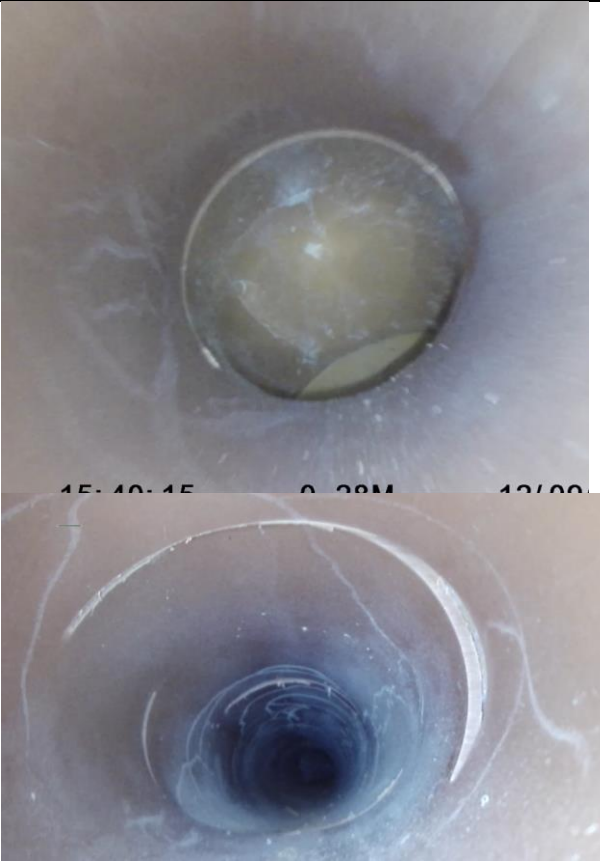
| PSCP330-SA48 | | <p>Pipe appears to change direction twice and spiral slits have been cut into pipe. From the images in section 4.4 there is two pipes coming into the crate system, the other pipe will need to be surveyed and a catchpit manhole must be installed upstream of this pipe.</p> |

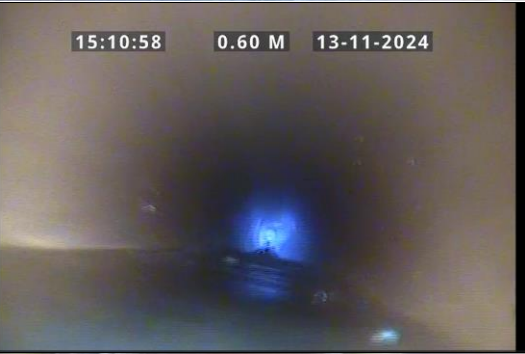
| PS334-PSCP335 | | <p>Standing water and large amounts of sediment build up in PS334. Water does not appear to be flowing downstream suggesting that the pipe is back falling</p> |

- 7.3 The air vent to the Soakaways requires investigation and resolution.
- 7.4 Investigate the cases where the pipes may be back falling and remediate if necessary.

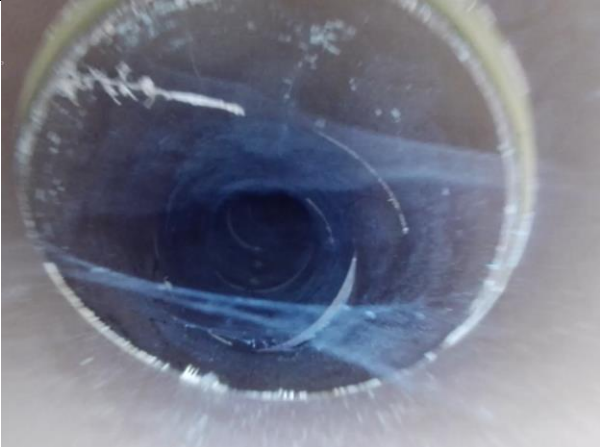
| PSCP335-SA49 | | <p>Pipe displacements, deformed pipe due to spiral section cut through the pipe. Pipe appears to have moved away from joint in image.</p> |

- 7.5 The remedial works required within Area 3 is as listed below:
- The Contractor shall obtain written approval from crate supplier that the constructed soakaways comply with their specification. Notwithstanding this requirement, it is recommended that all damaged or deformed pipes be removed and replaced.

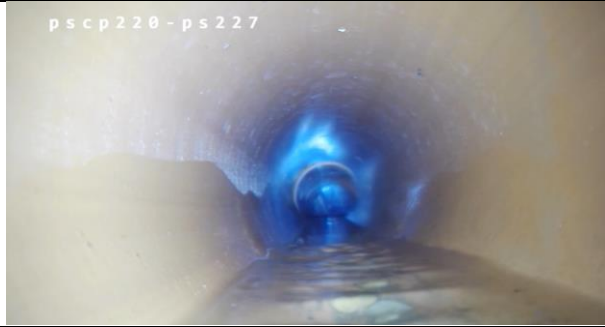
| PS5270-PS227 | | Small amount of water present in PS227 |

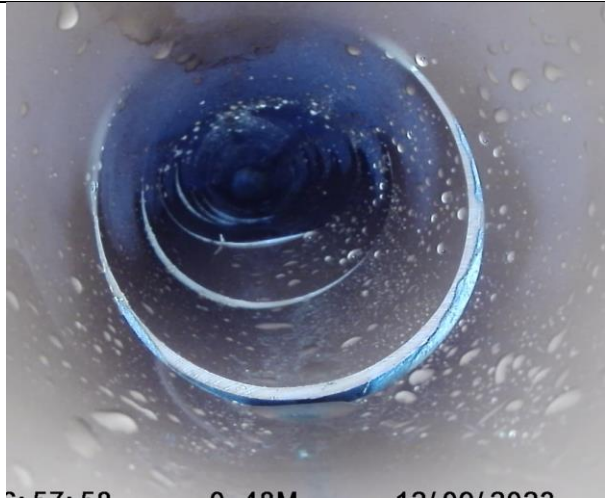
| PSCP228-SA51 | | Pipe displacements due to spiral cuts in pipe, pipe has changed direction due to settlement. |

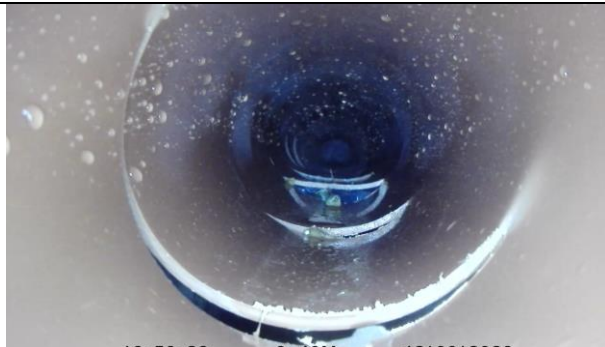
| PSCP231-SA52 | | Pipe displacements due to spiral cuts in pipe. |
