| <b>Project Name:</b> | Land at Bayards, Eastergate (Miller Homes) |
| <b>Document Reference:</b> | 091.5016/SVR/5 |
| <b>Document Name:</b> | SuDS Verification Report – Area 5 |

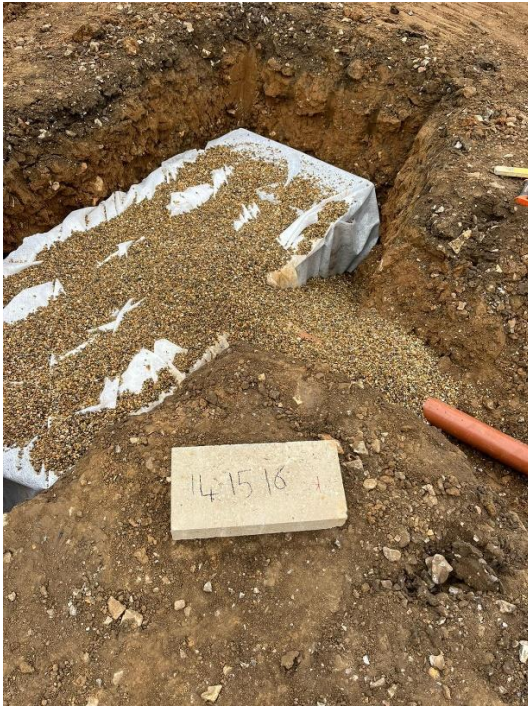
Plots 14-15-16 (1)

- 4.4 The image for plots 14-15-16 (1) indicates that the drainage pipe has been incorrectly connected. The pipework should be installed in full accordance with the approved design drawings and the manufacturer's installation data sheet. The current arrangement does not reflect the approved specification and will require correction to ensure compliance with design intent and manufacturer requirements.

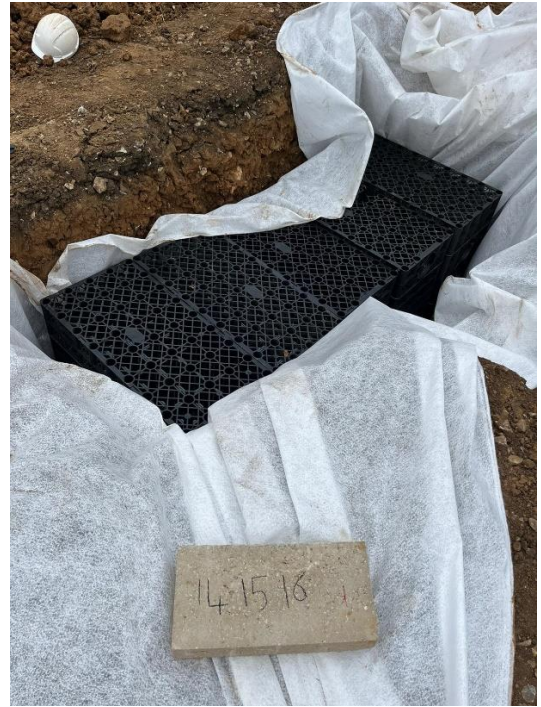
Plots 14-15-16 (2)

- 4.5 Image 14-15-16 (2) appears to show rows of five SDS GEOLight crates; however, they do not appear to be clipped together and are shown to be moving apart. As the image does not clearly confirm the installation depth or the total number of crates provided, it is not possible to verify whether the required storage capacity has been achieved in accordance with the approved design and specification.

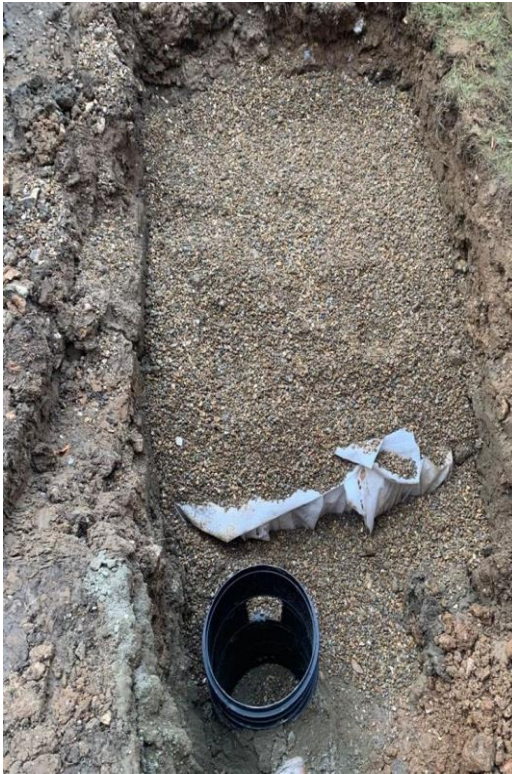
Plot 23

- 4.6 For plot 23, the image does not show the connection between the drainage pipe and the infiltration crate. As the crate appears to have already been covered, it is not possible to confirm whether the connection has been installed correctly or in compliance with the approved design.

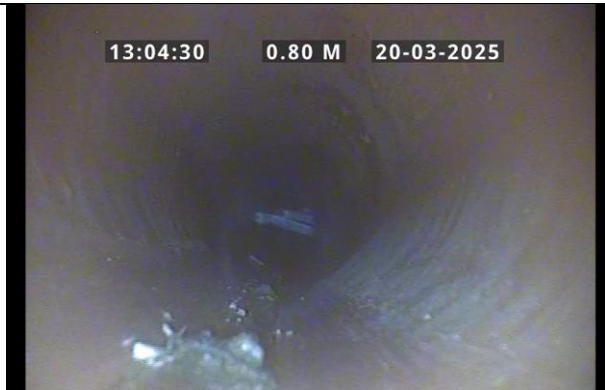
| Ref | Defect Images | Comments |
|---|---|---|
| PS304-SA12 | | Sediment in manhole after catchpit, would suggest that either the catchpit isn't being maintained or has been constructed incorrectly. |

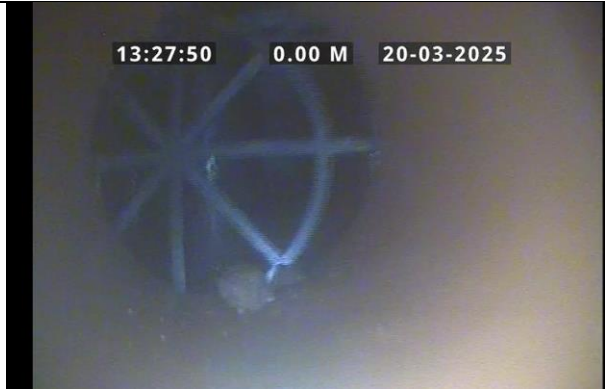
| Ref | Defect Images | Comments |
|---|---|---|
| PSCP13-SA13 | | <p>Sediment in manhole after catchpit, would suggest that either the catchpit isn't being maintained or has been constructed incorrectly.</p> <p>Preformed knockout panel has not been removed, this could restrict flow into the crate.</p> |

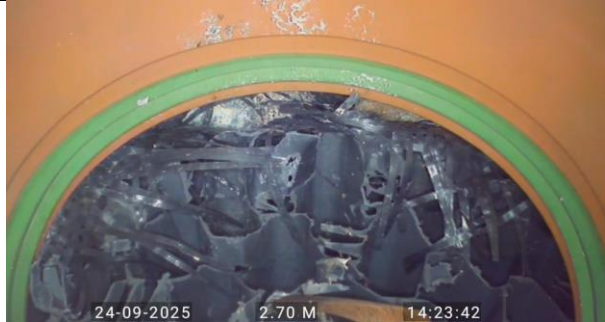
| Ref | Defect Images | Comments |
|---|---|---|
| PSCP324-SA14-15 | | Geotextile membrane fibres frayed, visible damage to crates and non-standard connection into crates. |

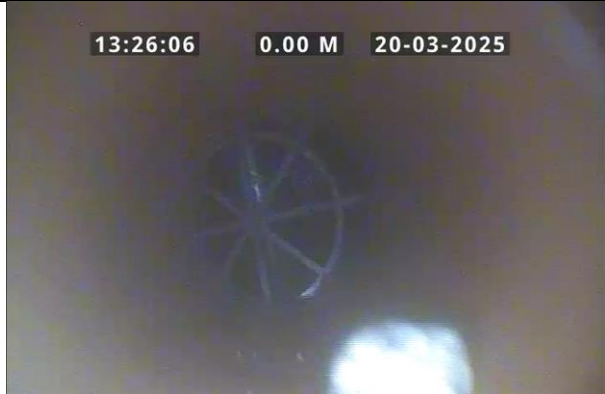
| PSCP113-SA19 | | <p>Sediment in manhole after catchpit, would suggest that either the catchpit isn't being maintained or has been constructed incorrectly.</p> <p>Preformed knockout panel has not been removed, this could restrict flow into the crate.</p> |

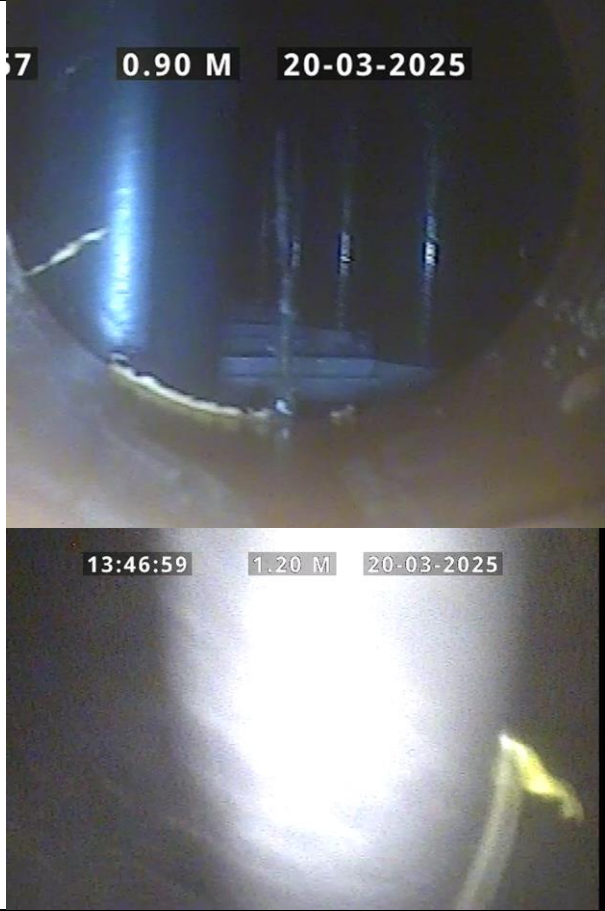
| PSCP118-SA20 | | <p>Possible root ingress into attenuation crates</p> |

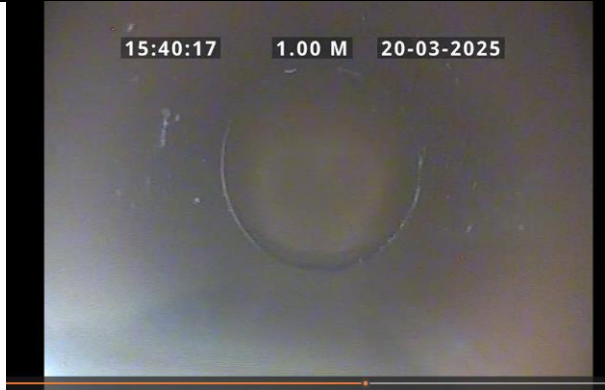
| PS5291-SA23 | | Pipe appears to end with a bend that goes into the top of the crate, top appears to be the preformed knock out section. Suggesting crates have been laid incorrectly. Potential for structural stability to be undermined if this is the case. |

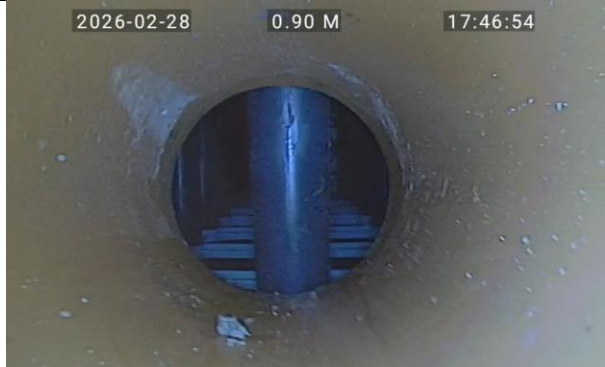
| PSCP141-SA24-25 | | No visible major defects, however, this does not seem to reflect the photos provided of this soakaway. The CCTV indicates a side connection into the crate whilst the photos indicate the pipe is placed on top of the crate. |

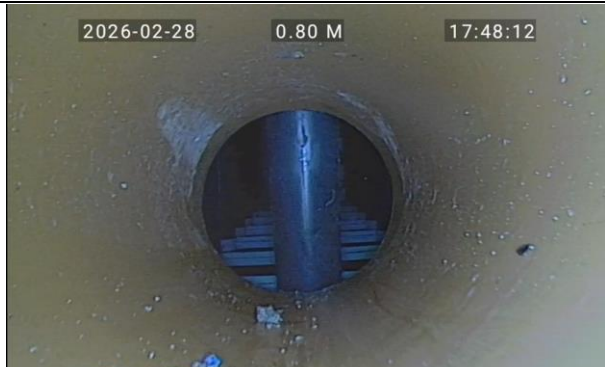
| PSCP138-SA24-25 | | Same pipe as PSCP141-SA24-25 was recorded in survey.<br><br>Along with this, this does not seem to reflect the photos provided of this soakaway. The CCTV indicates a side connection into the crate whilst the photos indicate the pipe is placed on top of the crate. |
