Our Ref: 211379 - Let 1 - Aldingbourne

16 June 2021

**Re: Tree issues at land at Springfield Hook Lane, Aldingbourne, PO20 3TE**

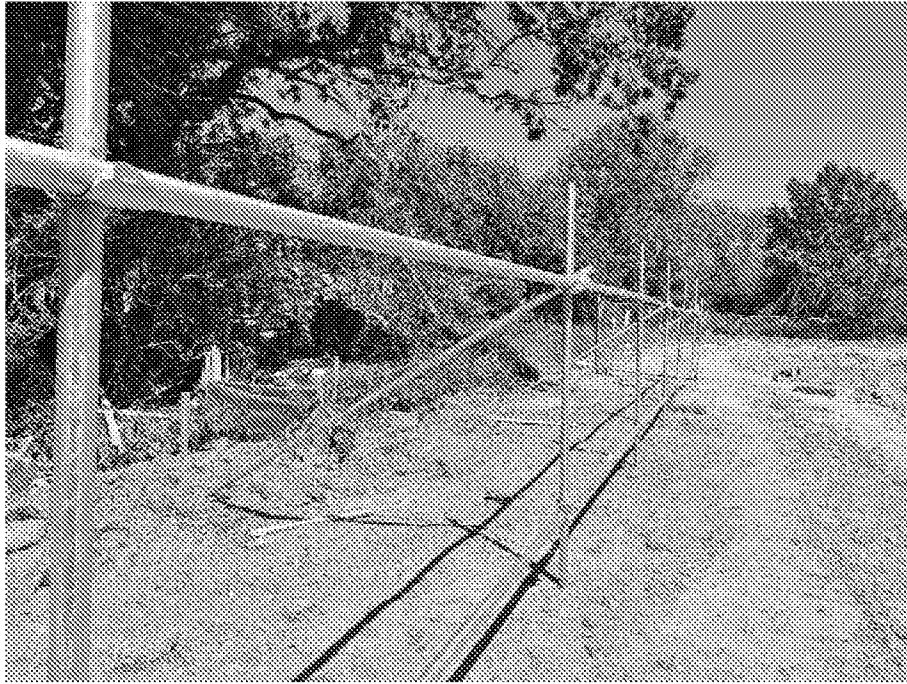
The erection of the tree protection barriers was ongoing when I visited, but was nearing completion (photograph 1). I observed and sample checked the barrier positions on site using a laser measuring device against the dimensioned drawing that I had prepared previously. I noted that the barriers appeared to be generally in the positions shown on the tree protection plan. Where significant trees were growing along the northern site boundary, the weld mesh panels were appropriately braced with a vertical and horizontal scaffold framework and rear facing stabiliser struts (photograph 2).

**Photograph 1** – Tree protection being erected during my visit

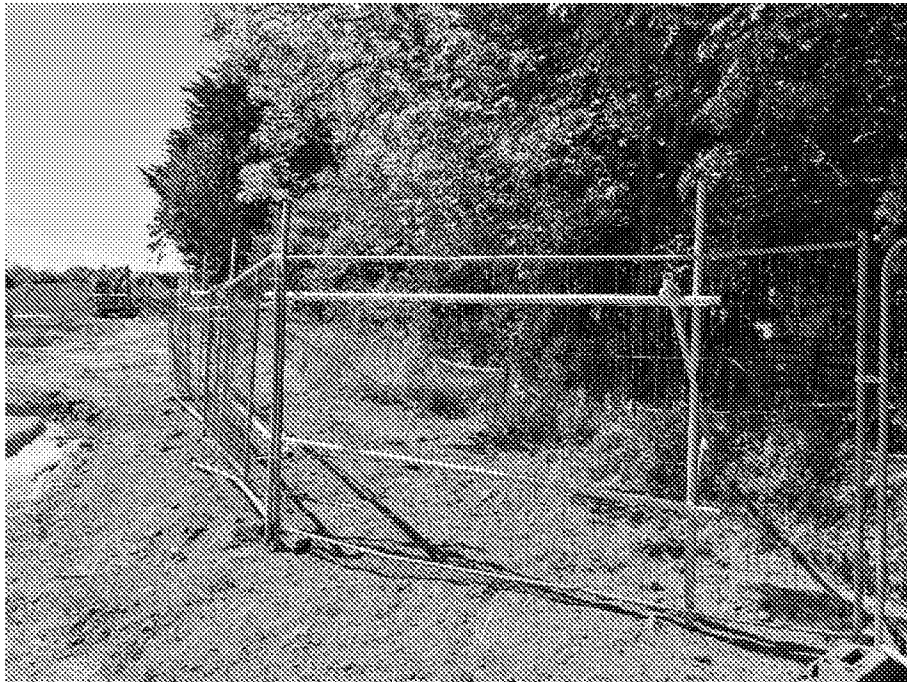
**Photograph 2** – Tree protection scaffold braced adjacent to areas of significant tree activity

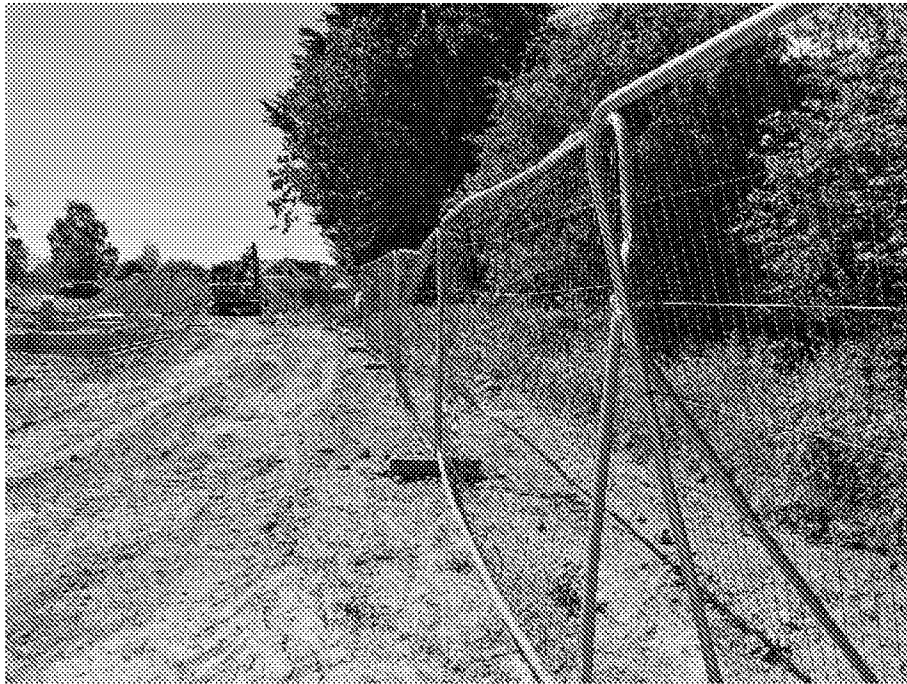
Where there were less significant trees (or areas of scrub), then a lesser specification was being utilised, which incorporated mesh panels on rubber block trays, with rear facing stabiliser struts pinned in position (photograph 3). Tree protection notices were being attached to the panels during my visit (photograph 4). The tree protection barriers on the eastern site boundary (and where trees have been removed previously) appeared to be in roughly the correct positions, but the protection consisted of weld mesh panels placed on their rubber block trays.

**Photograph 3** – Tree protection on rubber bock trays (with struts) adjacent to areas of lesser tree activity

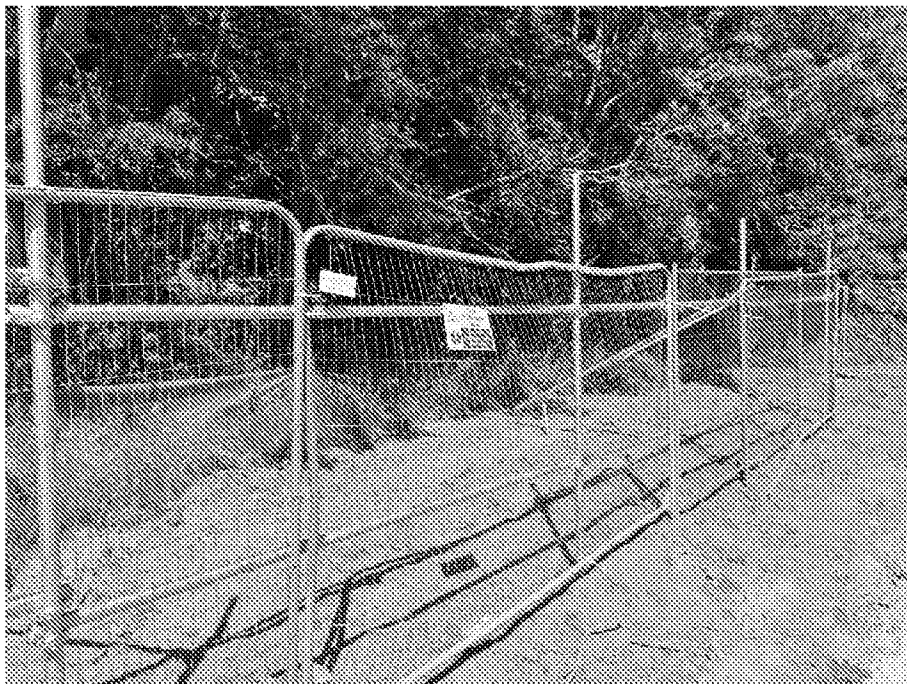
**Photograph 4** – Tree protection signage
