# Preliminary Geo-Environmental Risk Assessment

**Bognor Regis, Oldlands Farm PO22 6NN**

**Presented to Lysander Associates**

Issued: June 2021

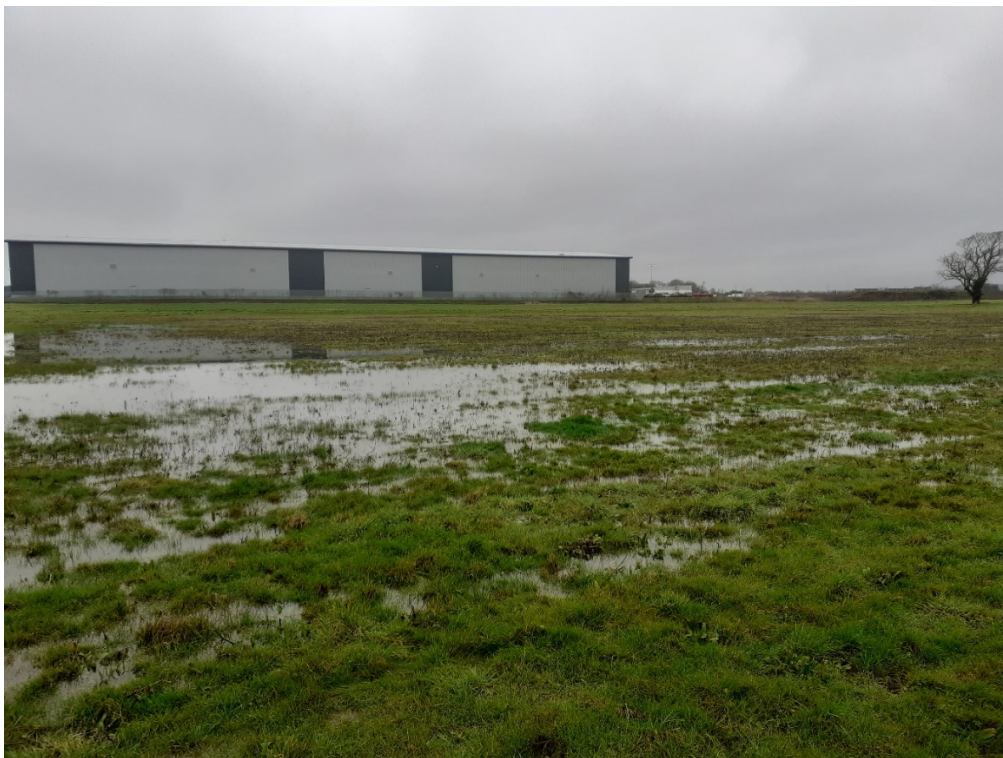
| <b>Shallow Groundwater</b> | <p>Can generate difficulties when excavating, further discussion in the Groundworks section below. The Site was noted to be flooded during the winter period which may preclude construction activities during this period.</p> |

**Photograph 2 –View from north of the site looking towards Rolls Royce facility with Site noted to be flooded.**

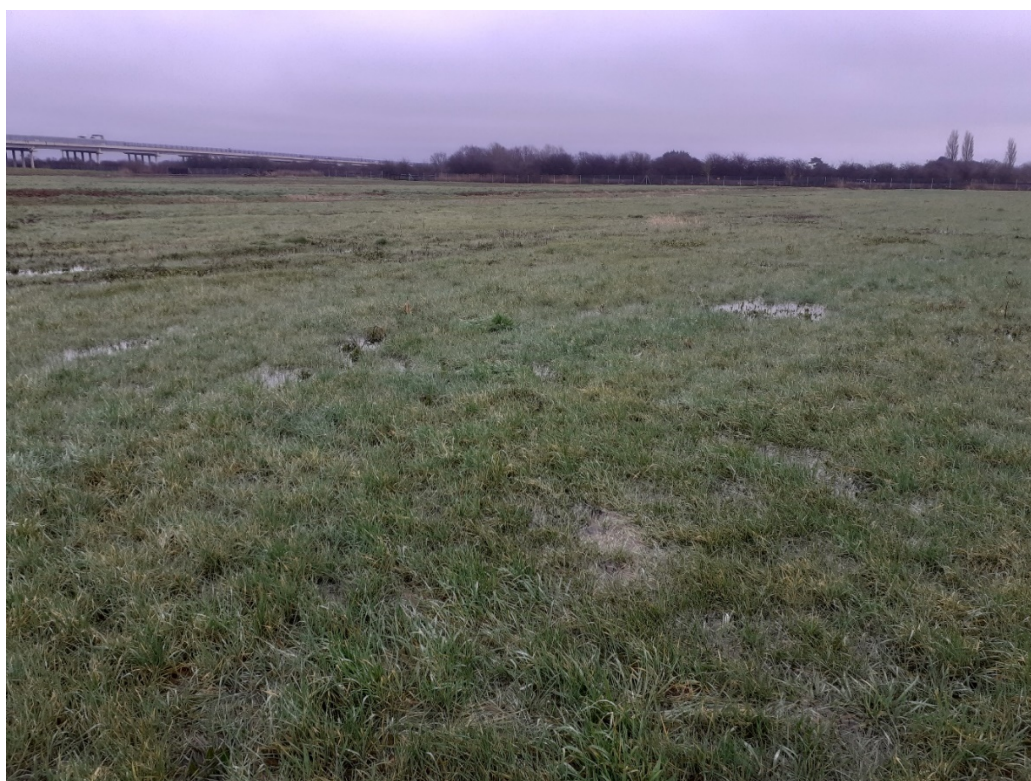
**Photograph 4 –View East across saturated ground**

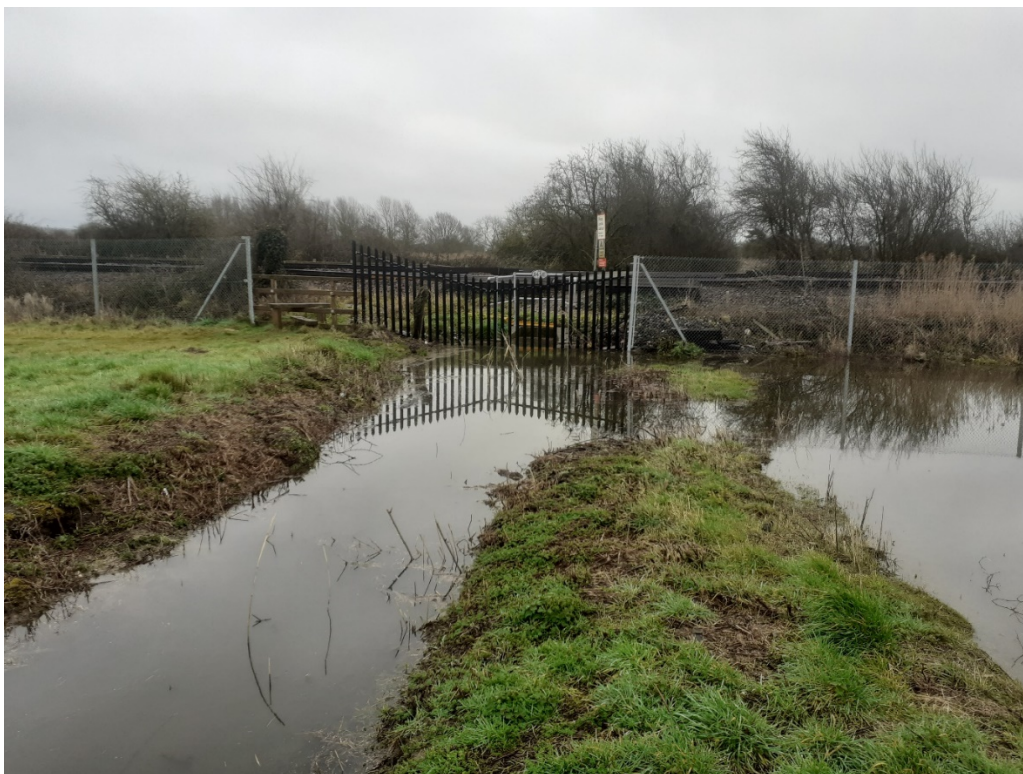
**Photograph 6 – Flooded access onto railway line along southern boundary of the Site**

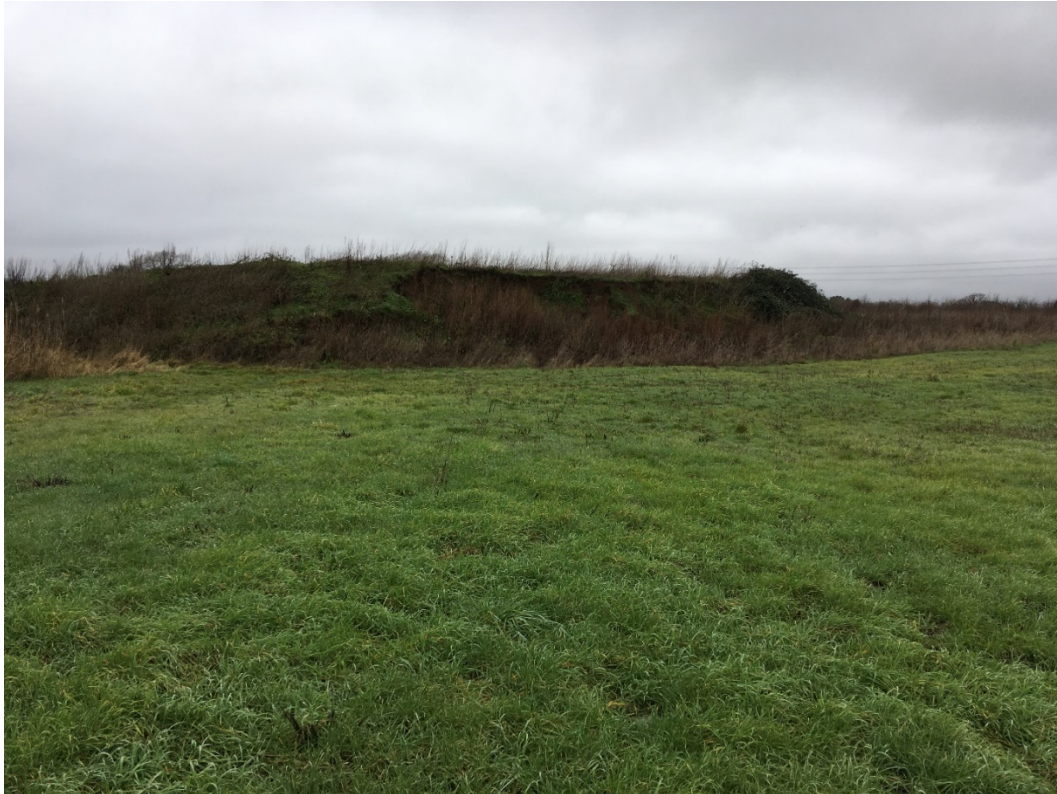
| <b>Soils</b> | <p>The risk of the Site requiring widespread remediation to protect end users is considered to be low.</p> <p>Spoil left from previous excavations within Made Ground may be suitable for re-use as general fill. The underlying River Marine Deposits and River Terrace Deposits similarly should be suitable for re-use as general fill, all of which is subject to further testing and specification. It should be noted that soils extracted below the groundwater level are likely to be saturated and may require drying or extensive modification to enable the material to be suitable for reuse. Chalk deposits are likely to degrade during periods of poor weather and may become unsuitable for use.</p> |

**Photograph 7 –Stockpile of soil in south west of the Site.**
