**Land At Woodgate Nurseries  
Lidsey Road  
Woodgate  
West Sussex**

**Preliminary Ground Contamination  
Risk Assessment Report**

**Project Reference: P16445**

**Report Reference: R16071**

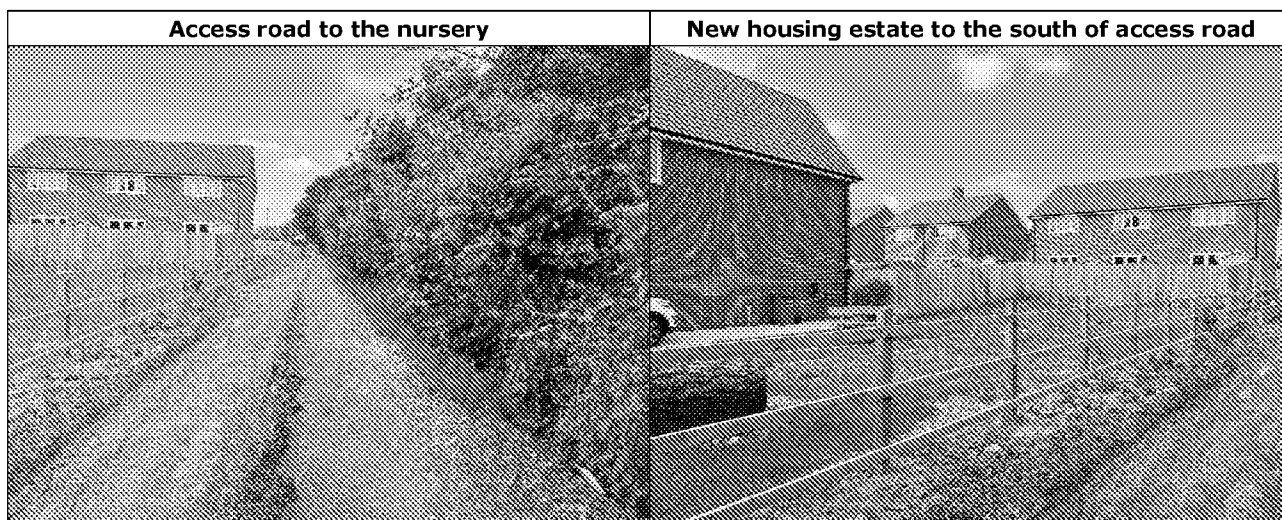
Access to the former nursery area was via a driveway leading off Lidsey Road. An open grass covered plot of land was present to the north of the driveway, with a house at the western end. A new housing estate was located off-site to the south of the driveway. Off-site to the south of the nursery area are more derelict glass houses, associated with a further historical nursery. A railway line runs along the northern boundary of the site.

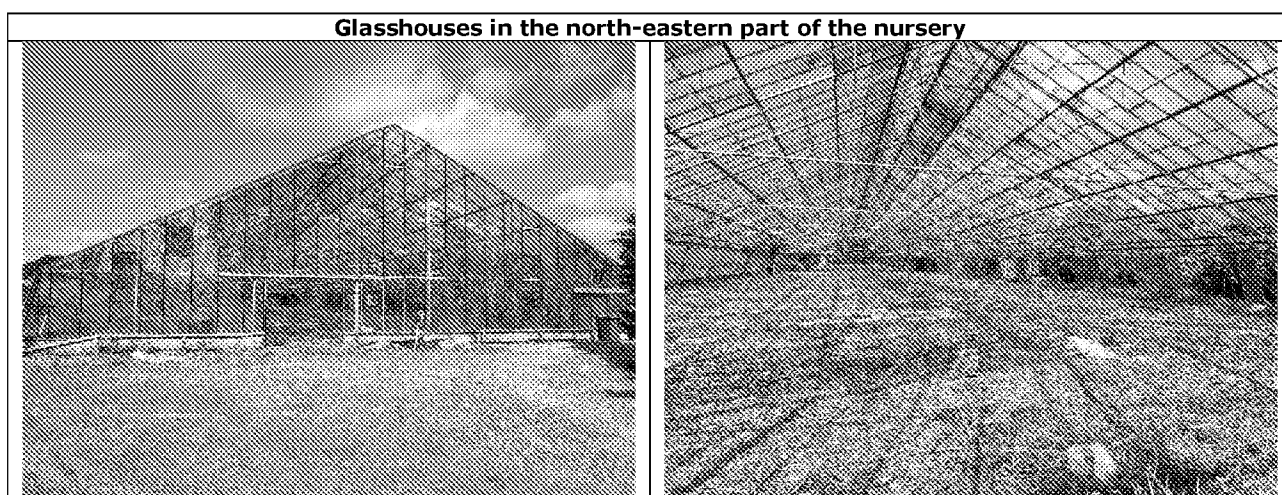
Three glass houses of varying sizes, all of which were in poor states of repair, are located in the north-eastern part of this area. Within the glass houses, the remains of heating systems were visible, and several rusted above ground fuel storage tanks were present around the outside.

Given the dilapidated condition of the glasshouses, works within the footprint of these structures should be carried out following their demolition and clearance.

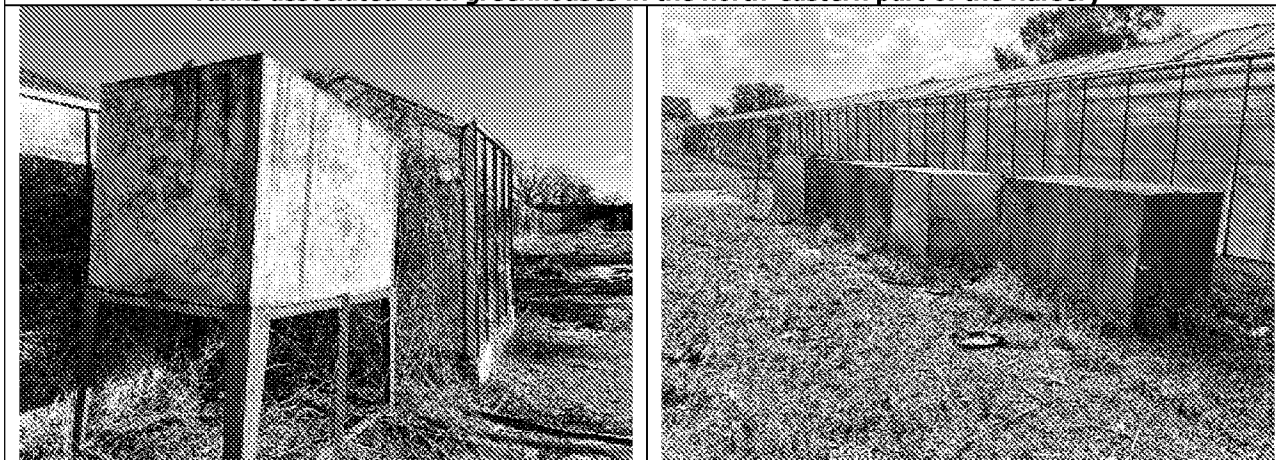
**Tanks associated with greenhouses in the north-eastern part of the nursery**

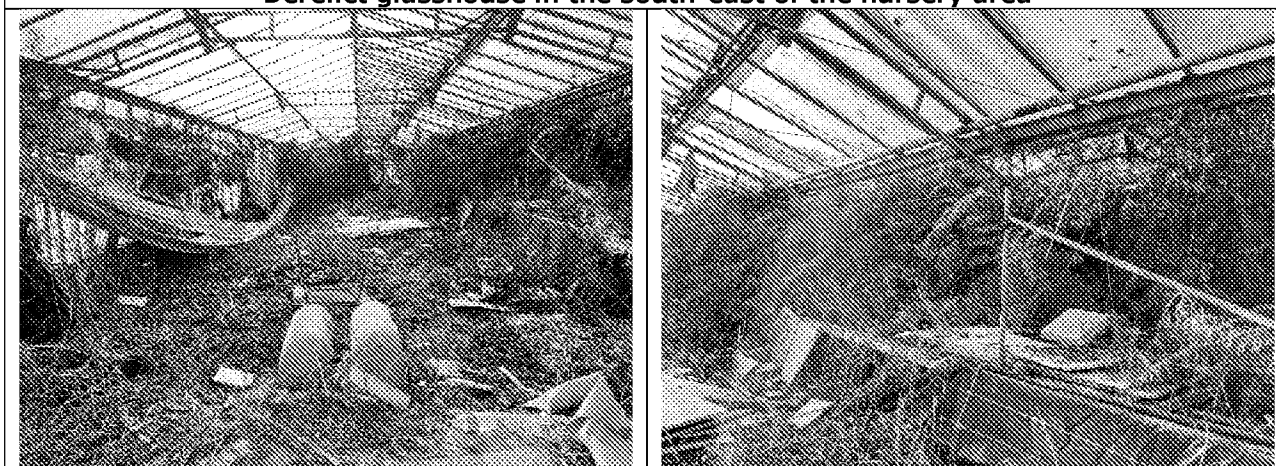
The derelict glass house was overgrown with vegetation, with only around half the structure accessible. As with the other glasshouses, the remains of heating systems were visible, with two ducts noted rising from the ground.

**Derelict glasshouse in the south-east of the nursery area**

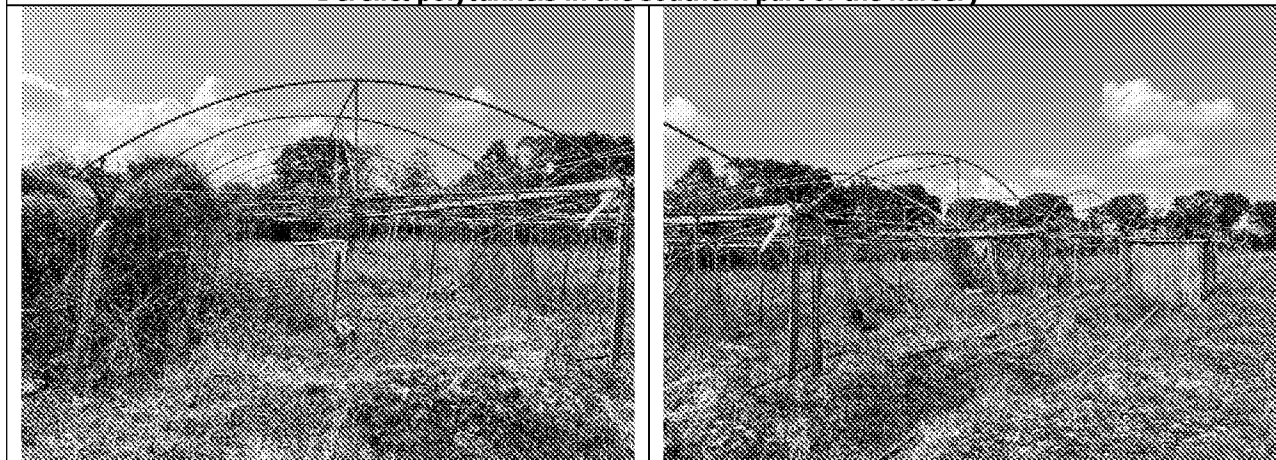
**Derelict polytunnels in the southern part of the nursery**

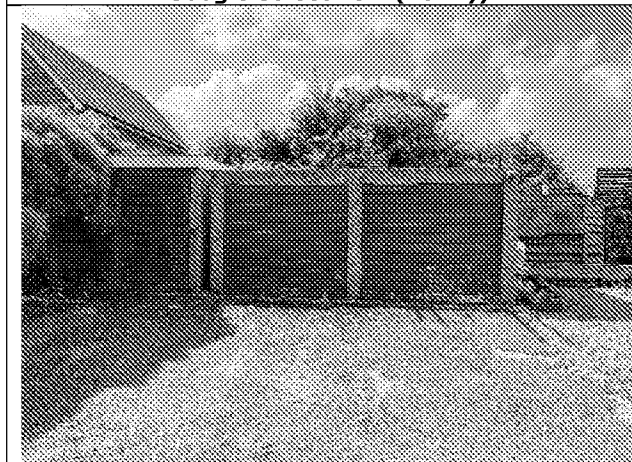
A review of Google Streetview imagery for September 2011 shows a larger above ground tank present located immediately to the south of the garages, in the location of the wooden toilet block.

**Garage block and wooden toilet block  
(location of former above ground tank shown on  
Google Streetview (2011))**

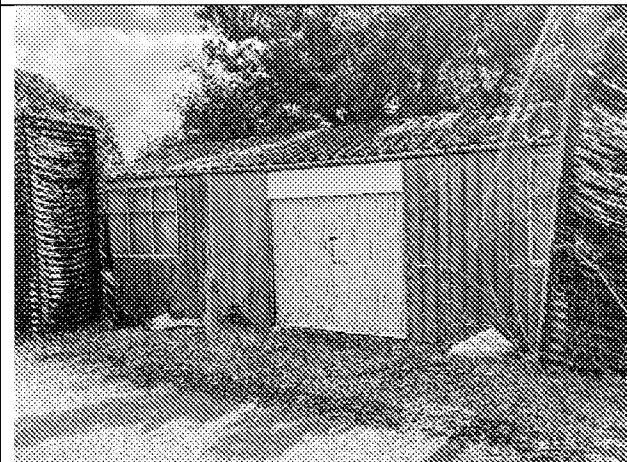
**Asbestos clad storage shed to the south of  
garages**

It is noted that an asbestos survey of existing structures and infrastructure<sup>3</sup> was beyond the brief of this report. The risk assessment assumes that, should asbestos be identified within buildings or infrastructure, any such materials will be managed in accordance with current legislation and guidance, to ensure this does not represent an ongoing risk to end users and, specifically, to ensure that asbestos materials are not introduced into the underlying soils.

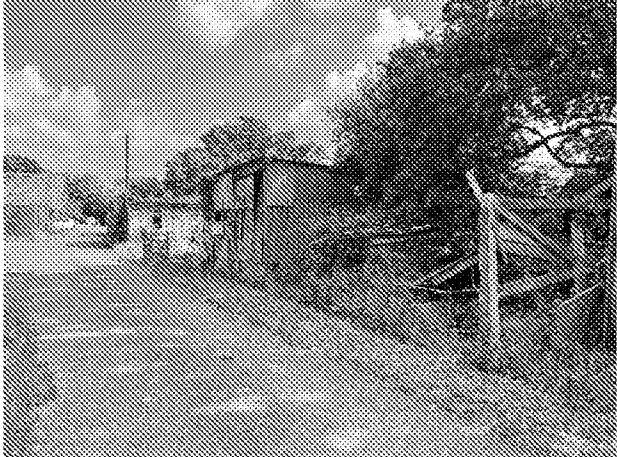
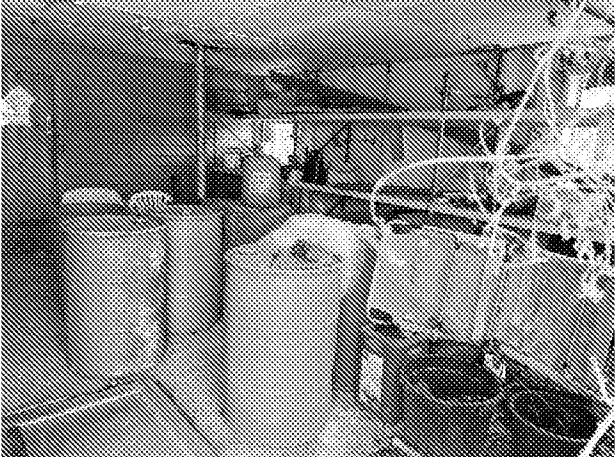
| Asbestos clad storage shed to the south of garages | Storage in asbestos clad storage sheds |

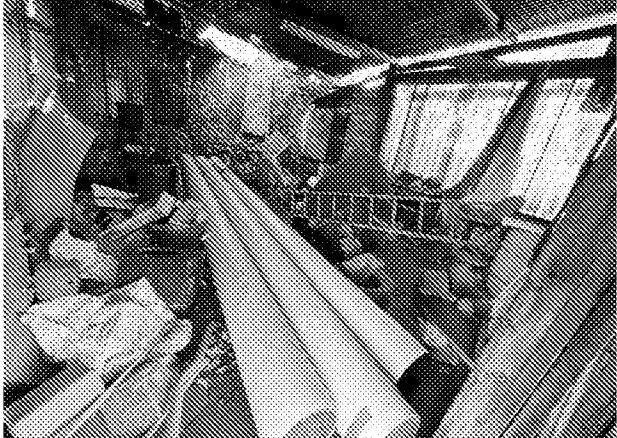
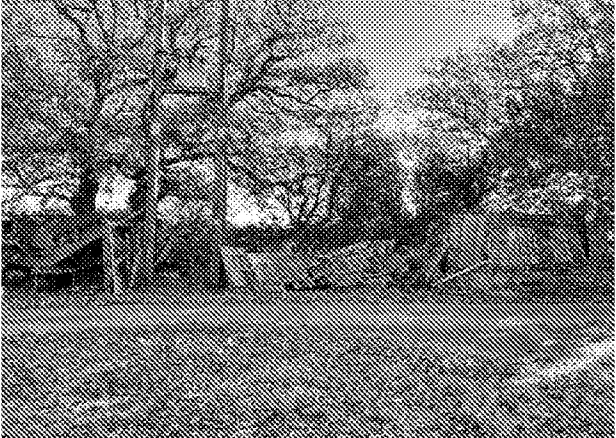
South of these buildings was a clearing which contained a trailer, building materials and a pile of timber and rubble. South of the clearing was a building being used to store large diameter tubes, metal and domestic waste. An above ground tank was located to the rear of this building. Further south again were a series of dilapidated and partially demolished sheds.

| Building containing pipework and tank | Dilapidated sheds to the south |

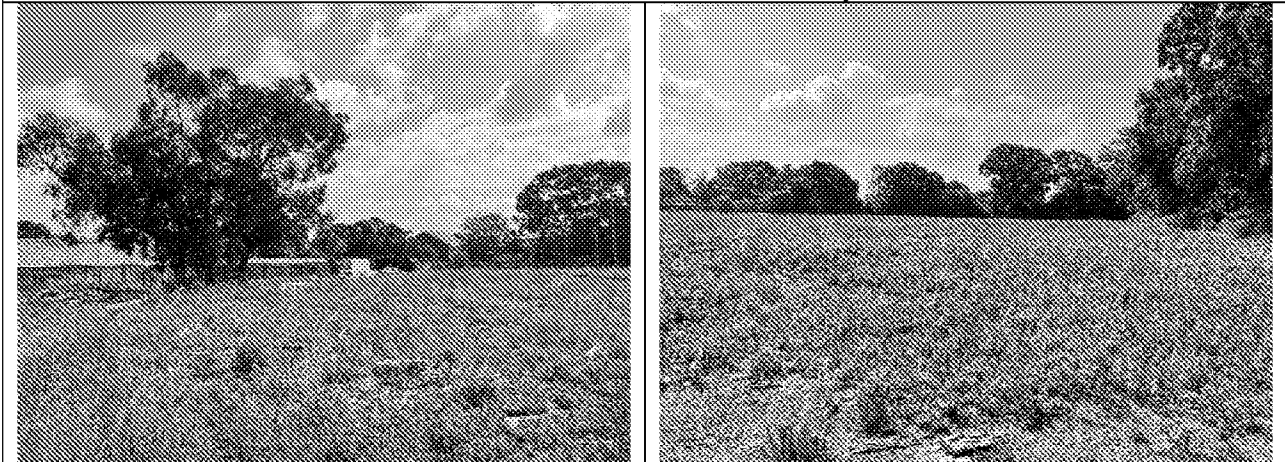
The western half of the former nursery area comprised an area of open land, the surface soils of which could be seen to contain concrete, metal, wood and vegetation, particularly near the glasshouses in the north-east of the site.

**Western half of the former nursery**

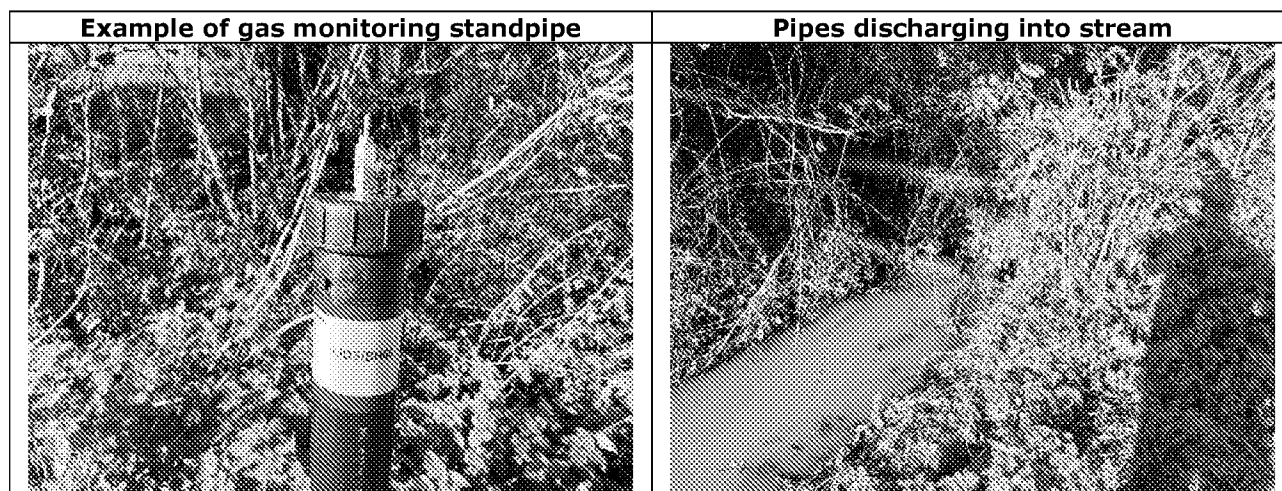
The fields extend further to the west of the site, until a drainage ditch and a hedging is reached, beyond which is the Lidsey Landfill site. Along the western edge of the field, where it bounds the landfill, were numerous gas monitoring standpipes, at approximately 50m intervals. Two pipes leading from the landfill site appeared to discharge into a stream in a field to the south-west of the site.

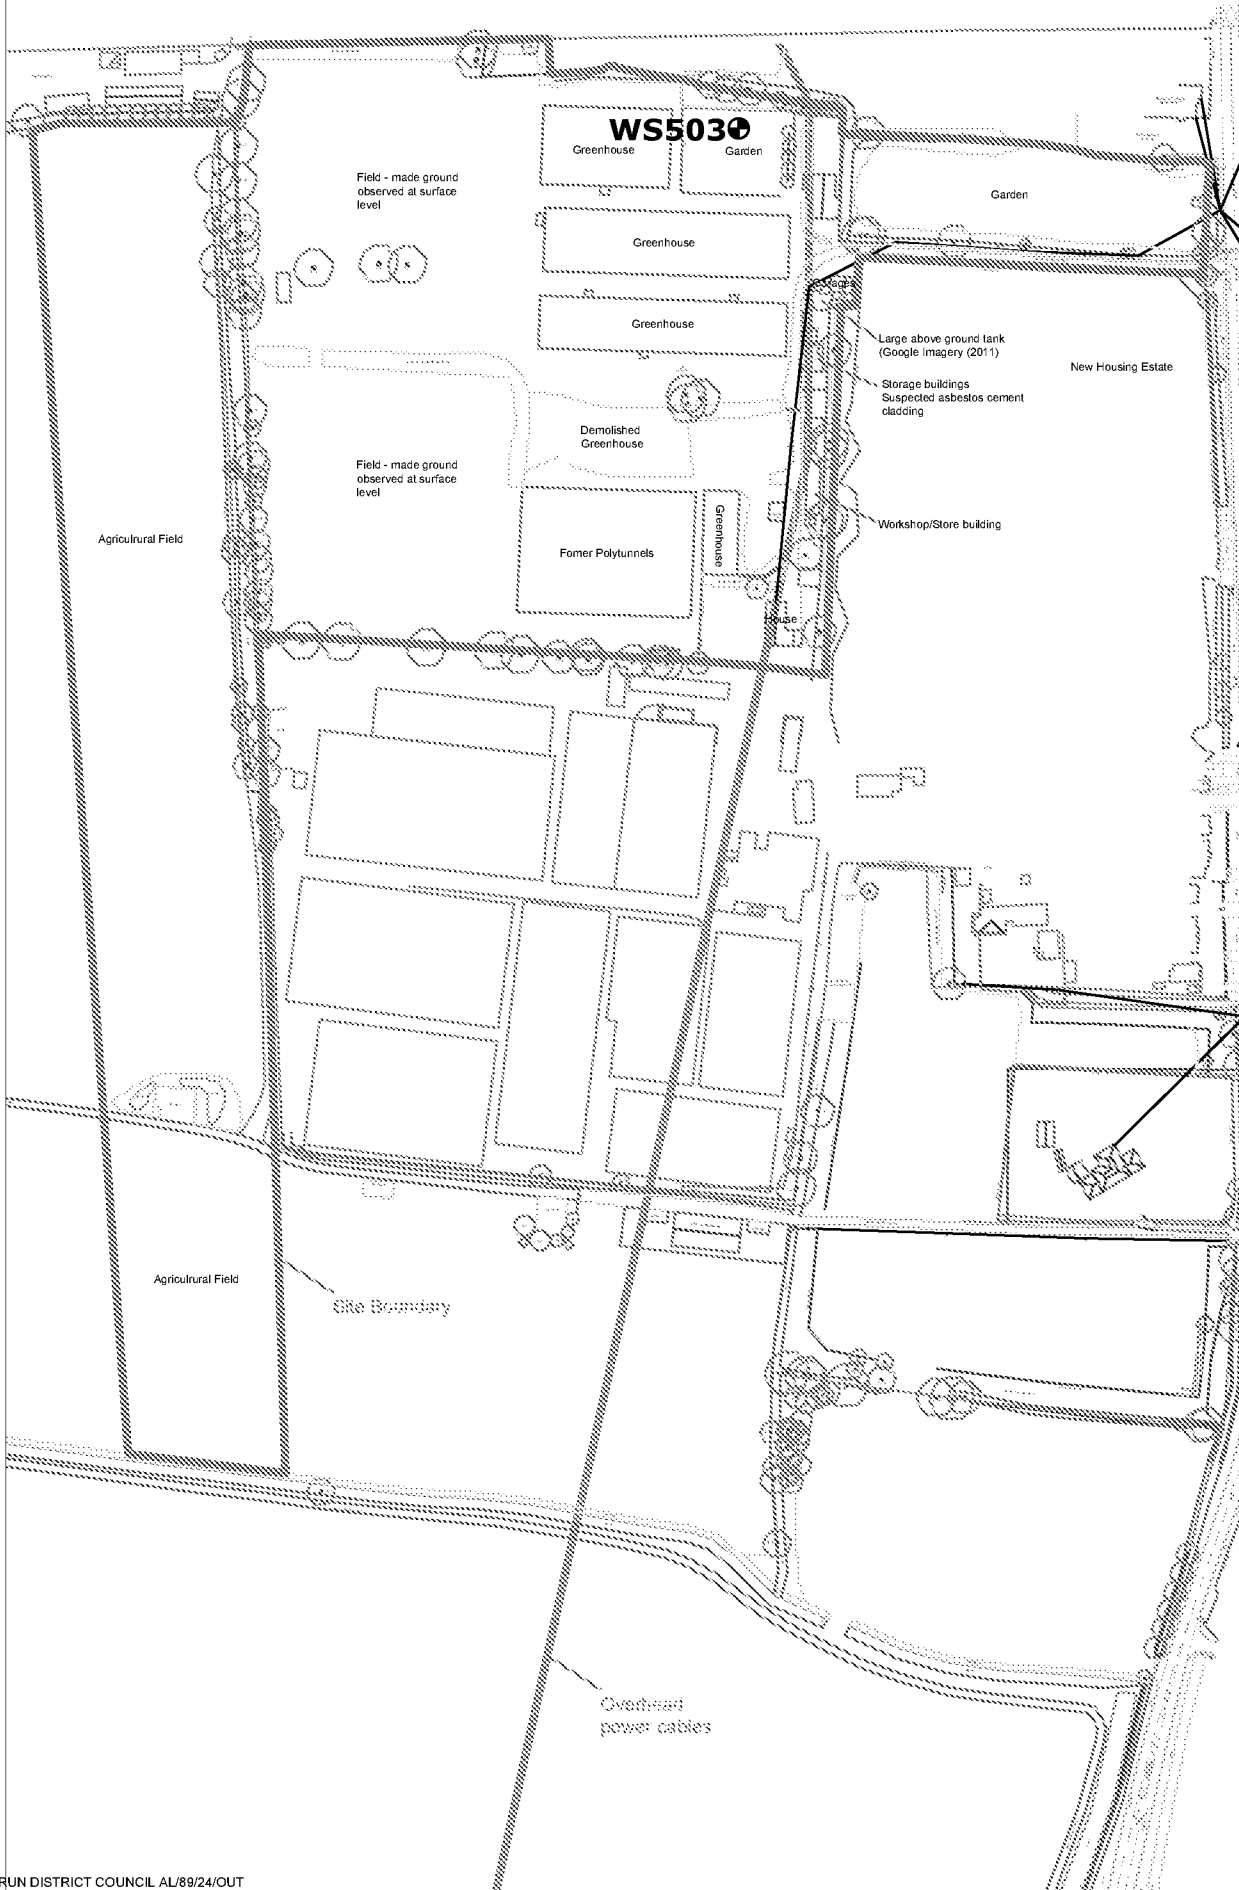
Figure 1 Site Walkover Plan

The site is located to the west of Lidsey Road, Woodgate, West Sussex and is centred on the approximate Ordnance Survey national grid reference 493506, 104145. A site walkover plan is presented as Figure 1.
