# **ARBORICULTURAL REPORT**

## **31 Chalk Lane**

**Reference Number: 745.V1**

**Site Address:**  
**63 Barrack Lane**  
**Bognor Regis**  
**West Sussex**  
**PO21 4DE**

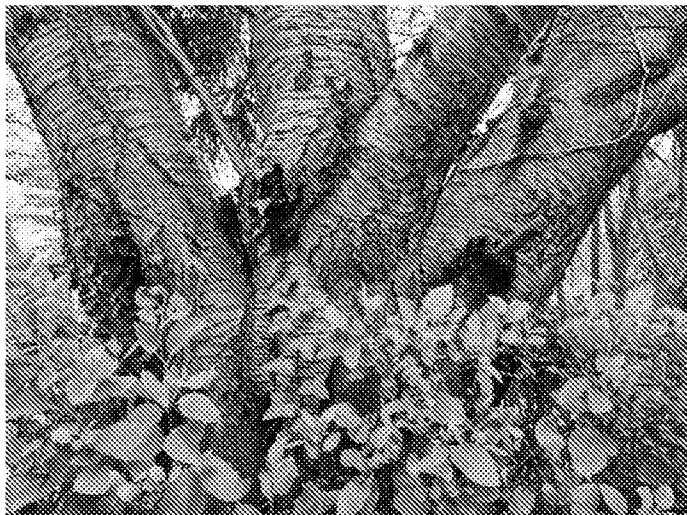
| <b>Comments:</b><br>Large tree located from within hedging to front boundary of property. Multi stem at 2m with 3 stems moderate included bark union between stems with northern union having a cavity. Northern stem had damage to bark with decaying heartwood crating cavity, major deadwood throughout crown. Ivy and vegetation around stem at tree base impeding full investigation. Shallow rooting to south east with large roots visible across lawn area of garden, roots in proximity to underground pipeline and inspection chamber. | | | | | | | | | |
| Overview | | | | | Picture 1. T1 showing tight included unions between stems | | | | |

| <b>Recommended remedial action:</b><br>Prune tree crown back to relevant clearance envelopes.<br>Address potential issues with root damage to pipeline.<br>Routine inspection of tree defects to address safety concerns. | | | | | | | | | |

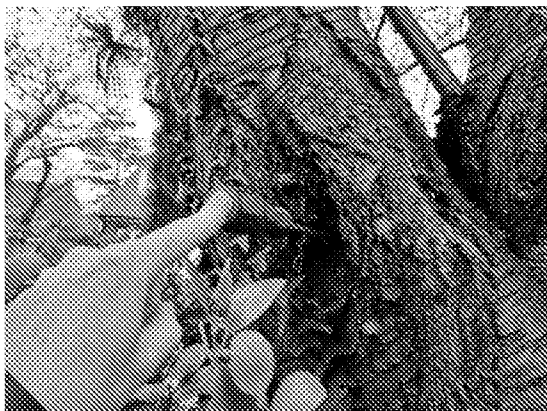
The single Wild Cherry tree is located growing from the boundary hedge to the front of the property, the tree has a large spread with branching overhanging the pavement and carriage way. The tree has three stems from c.2m with tight unions, early inclusions as well as pockets of decayed. The north-eastern stem has damage and decay pocket, the crown has major deadwood

**Picture 3. T1 northern stem with damage and decay pocket at c.2 m**

The tree T1 Wild Cherry is located in a prominent position to the front of the property, the tree is in need of and will require ongoing management to prune branching that is overhanging the pavement and road; this should be done to back to the required clearance envelopes. The tree should be routinely monitored for the development of compromised parts such as included bark unions and decay at areas of damage.

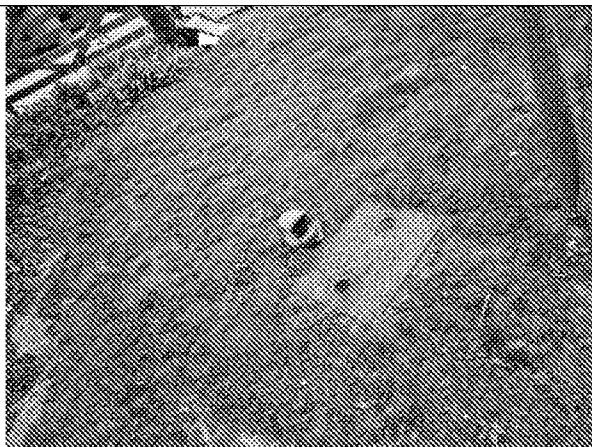
The tree roots will continue to cause disturbance to the lawn as is typical for the species. Deeper roots are likely to be developing towards the moisture associated with the pipeline, this has a potential to cause major damage to the pipeline.

**Picture 4. T1 large surface roots in proximity to drainage pipeline**

- Removal of the tree to stop any damage to garden and pipeline and plant a replacement tree in a suitable location, Or;
- Prune branching to north west back to pavement edge and crown lift over pavement to 3m, routine inspection as to tree condition should be undertaken.
