# Gale Tree Consultancy

Tree Condition Report

35 Colts Bay, Aldwick

Ref: TCR/322/22

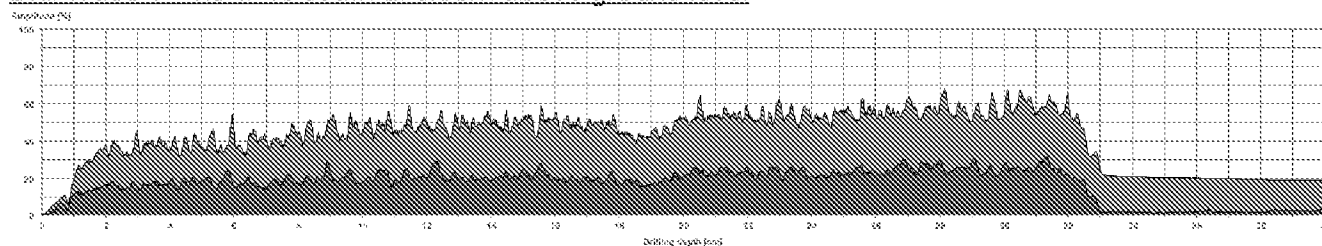
#### Drill Trace 1 – north to south at c.5cm above ground level

- The drill trace indicates a steady resistance to the drill through to c.33cm where it exits the stem

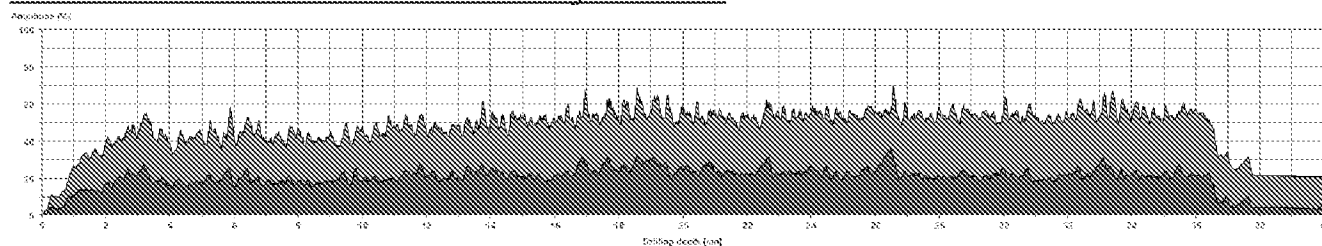
#### Drill Trace 2 – east to west at c.5cm above ground level

- The drill trace indicates a steady resistance to the drill through to c.38cm where it exits the stem

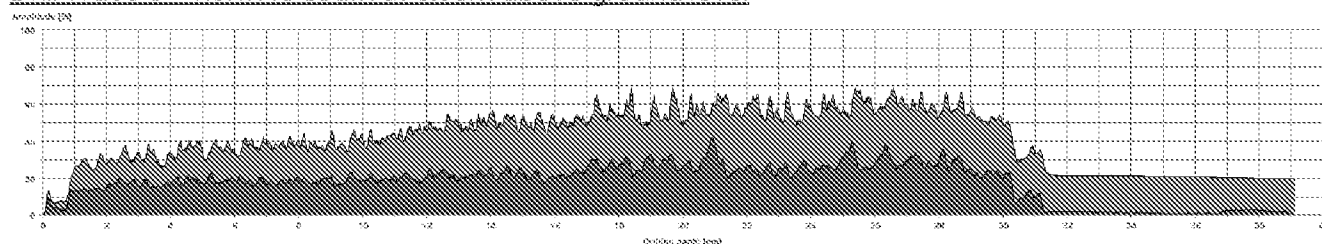
### Drill Trace 3 – north to south at c.5cm above ground level

- The drill trace indicates a steady resistance to the drill through to c.31 cm where it exits the stem

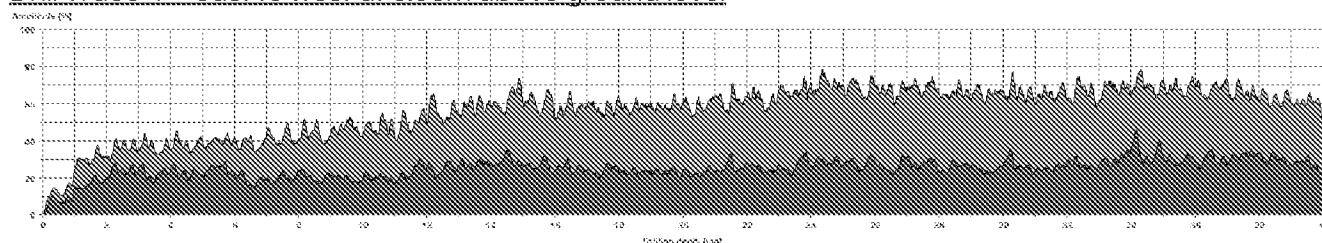
### Drill Trace 4 – east to west at c.5cm above ground level

- The drill trace indicates a steady resistance to the drill through to the end of the assessment; the drill did not exit the stem

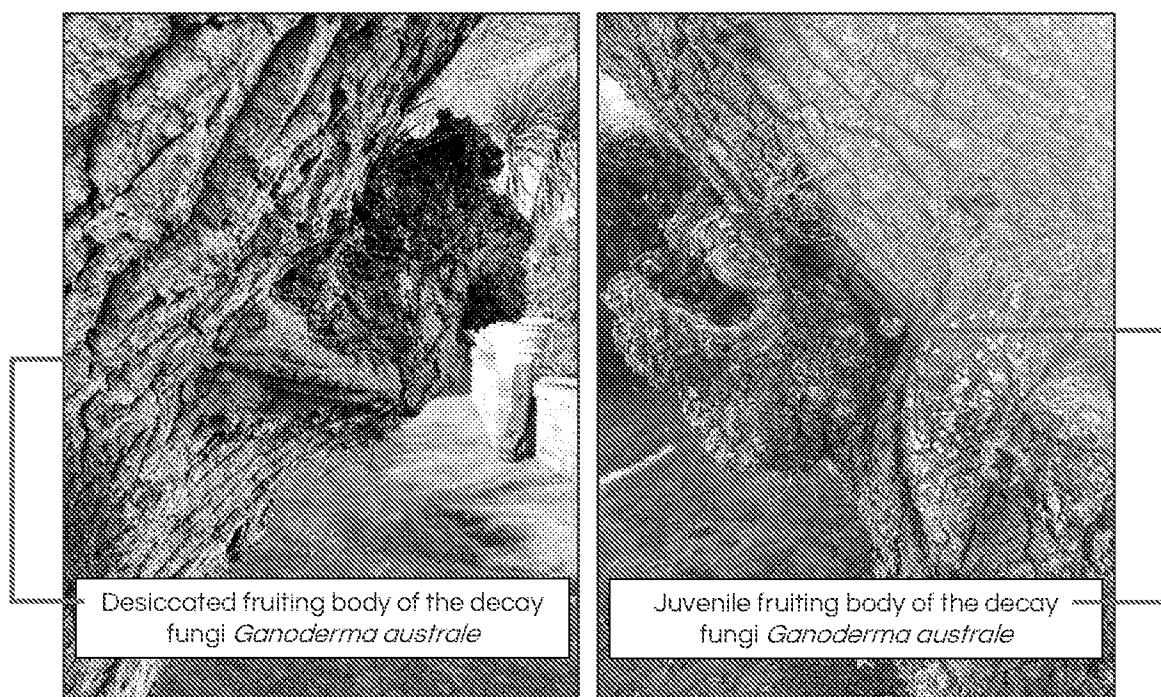
- The main stem bifurcates at c.1.7m into 1 x PSS on the north (N) side of the tree and 1 x SSS on the south (S) side; the N PSS has a bias to the east
- On the east side of the main stem is a large wound c.35cm off the ground. The wound measures 60x35cm (HxW) and wound wood is being formed<sup>1</sup>
- The N PSS has a wound at c.2.5m, the result of a SSS being removed; the wound is occluding with the formation of wound wood
- At c.1.5m on the east side of the N PSS is a desiccated fruiting body of the decay fungi *Ganoderma australe* with a further, juvenile fructification within a burr on the north side of the stem – see below:

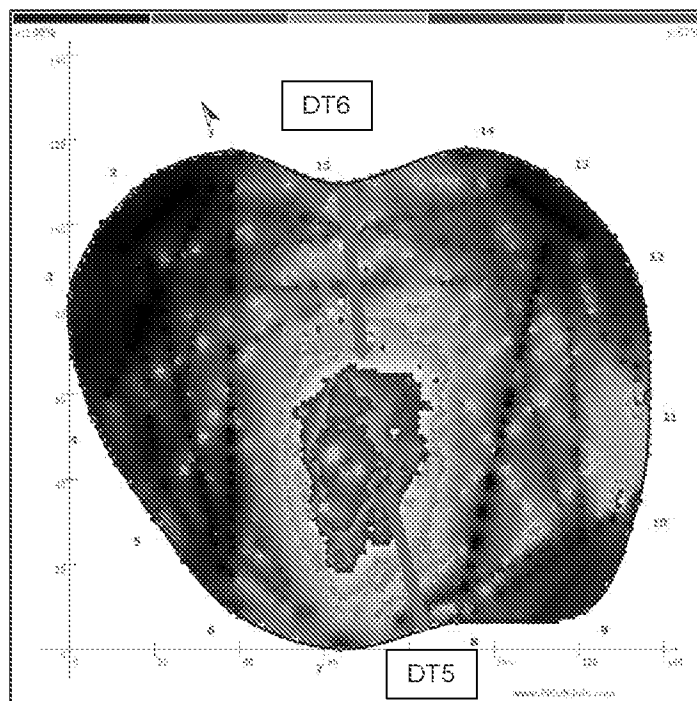
- The tomogram below indicates an area of low sonic velocity within the central area of the stem at level of assessment as indicated by the colour shift from brown to blue – see below:

- The tomogram indicates a small area of low sonic velocity is forming within the central area of the stem, as indicated by the colour shift from brown to blue
- The two drill assessments undertaken at the level of assessment both confirm the tomogram and suggest that the current extent of decay in the base is not likely to be structurally significant
- The drill traces undertaken on the N PSS between c.1.2m and c.1.7m indicate extensive decay/hollowing is occurring

- With the data collected, I am of the opinion that a column of decay is forming on the west side of the stem that extends up and into the north primary stem section. However, the tomogram does not suggest this extends down to the level of the assessment

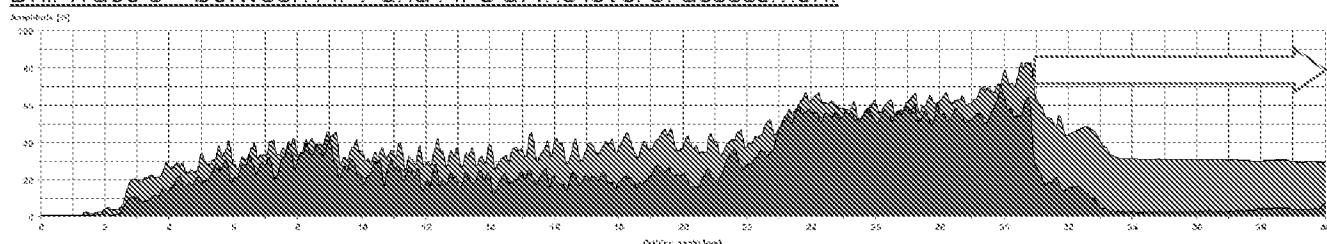
## Drill Trace 5 – between MP7 and MP8 at the level of assessment

- The drill trace indicates a gradual resistance to the drill to a depth of c.22cm after which it increases significantly through to c.31 cm
- From c.31cm, the drill enters an area of extensive low drilling resistance through to the end of the assessment

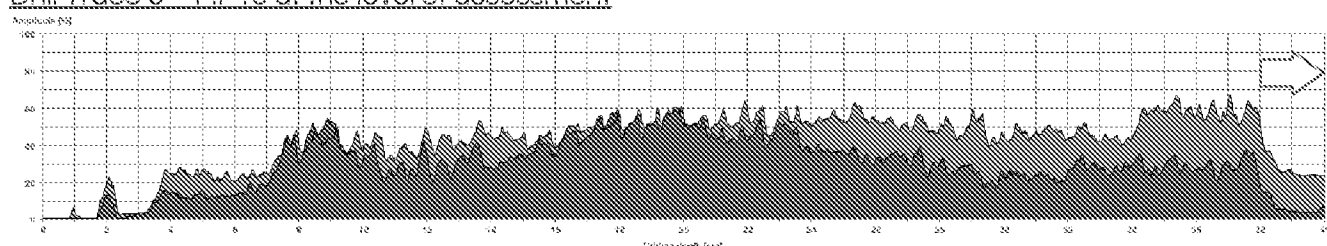
## Drill Trace 6 – MP15 at the level of assessment

- The drill trace indicates a steady increase in resistance through to c.23cm after which it begins to drop slightly
- From c.38cm, the drill enters an area of low drilling resistance through to the end of the assessment
- To assess the condition of the N PSS between c.1.2m and c.1.7m, the Resi was used a further seven times – please see the annotated photo below and the drill traces on the following page:

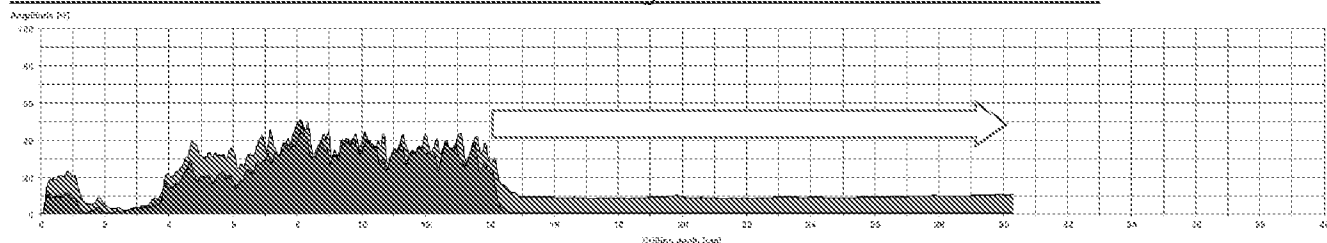
## Drill Trace 7 – west side of stem at c.1.0m above ground level – stem diameter 63cm

- The drill trace indicates an initial area of resistance to the drill to a depth of c.14cm
- At c.14cm, the drill breaches the trees reaction zone<sup>2</sup>, as indicated by the sudden and sharp drop, and enters an area of extensive decay/hollowing
- The automatic needle retraction feature was triggered at c.30.4cm to remove the risk of damage/breakage of the drill bit

- Drill Traces 7-10 undertaken on the west side of the stem indicate that the average thickness of sound wood is c.11.5cm before the drill enters the area of decay/hollowing

- The tree has been topped previously with the new growth forming the upper crown structure. It is my recommendation that, to mitigate against the risk of the north primary stem section failing, that the tree is reduced back to the previous topping points

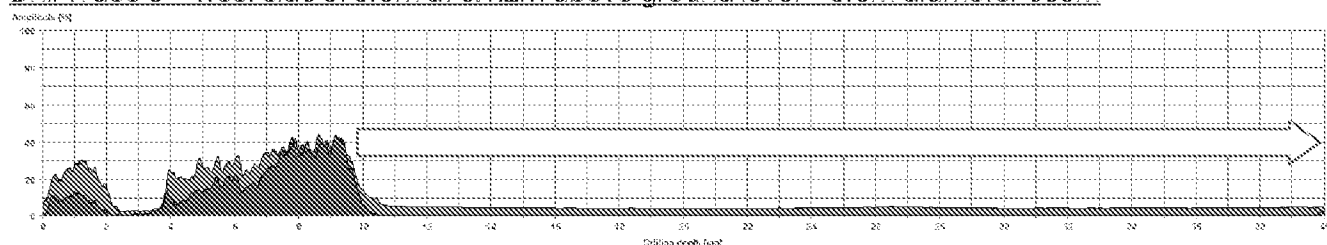
## Drill Trace 8 – west side of stem at c.1.2m above ground level – stem diameter 58cm

- The drill trace indicates an initial area of resistance to the drill to a depth of c.9.5cm after which it drops away suggesting incipient decay is beginning to form to a depth of c.10.4cm
- From c.10.4cm, the drill enters an area of extensive decay/hollowing through to the end of the assessment

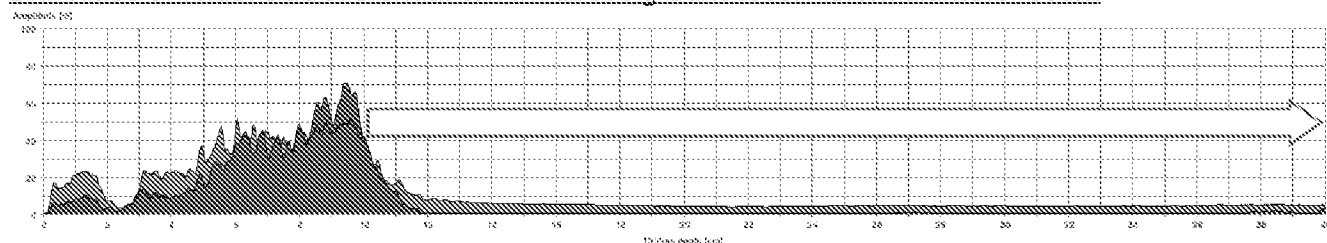
## Drill Trace 9 – west side of stem at c.1.4m above ground level – stem diameter 56cm

- The drill trace indicates an initial area of resistance to the drill to a depth of c.9.8cm after which it drops away suggesting incipient decay is beginning to form to a depth of c.11.8cm
- From c.11.8cm, the drill enters an area of extensive decay/hollowing through to the end of the assessment

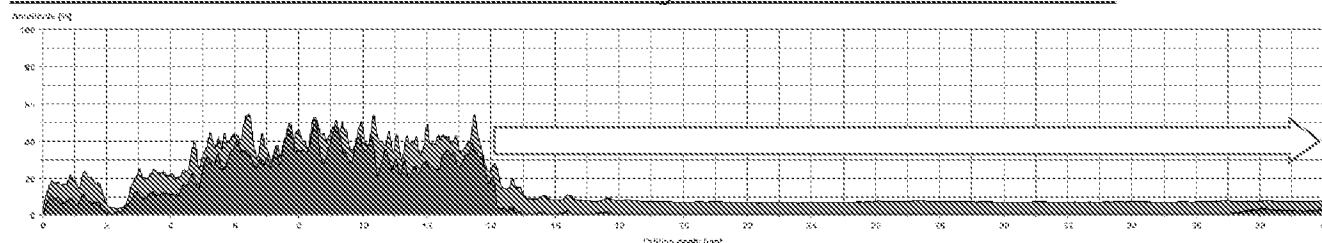
## Drill Trace 10 – west side of stem at c.1.6m above ground level – stem diameter 58cm

- The drill trace indicates an initial area of resistance to the drill to a depth of c.13.8cm after which it drops away suggesting incipient decay is beginning to form to a depth of c.14.2cm
- From c.14.2cm, the drill enters an area of extensive decay/hollowing through to the end of the assessment

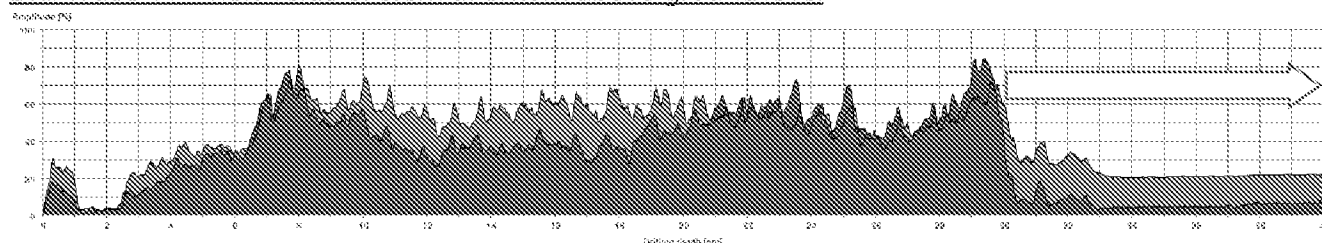
## Drill Trace 11 – north side of stem at c.1.0m above ground level

- The drill trace indicates a steady increase in resistance to the drill to a depth of c.29.8cm after which it drops away suggesting incipient decay is beginning to form to a depth of c.30.3cm
- From c.30.3cm, the drill enters an area of extensive decay/hollowing through to the end of the assessment

- Drill Trace 11-13 indicate the thickness of the sound wood on the north side of the stem is c.29cm before the drill enters the area of decay/hollowing

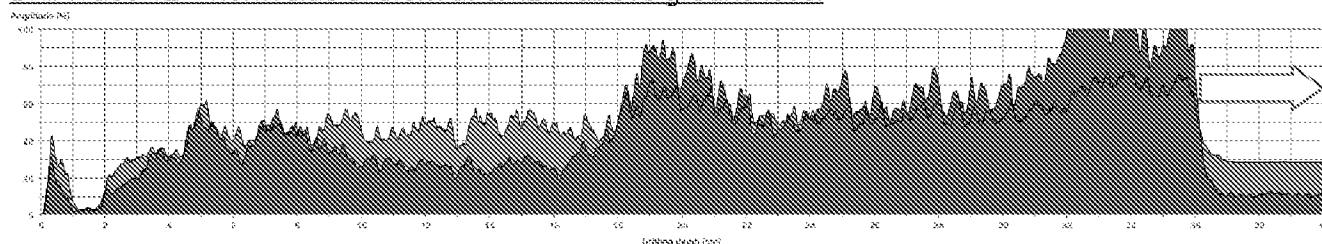
## Drill Trace 12 – north side of stem at c.1.2m above ground level

- The drill trace indicates an area of resistance to a depth of c.16cm consistent with sound wood
- From c.16cm the resistance increases markedly through to c.36cm where it drops sharply, the nature of which would suggest the drill breached a reaction zone

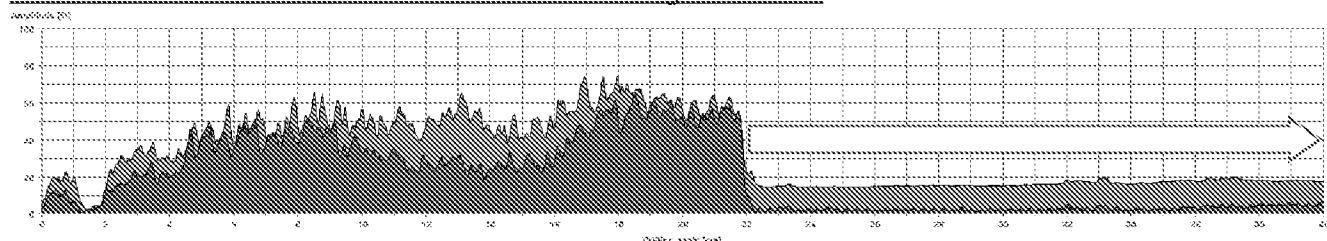
## Drill Trace 13 – north side of stem at c.1.4m above ground level

- The drill trace indicates a steady increase in resistance to the drill to a depth of c.22cm after which it drops sharply suggesting the drill breached a reaction zone
- From c.22cm, the drill enters an area of extensive decay/hollowing through to the end of the assessment

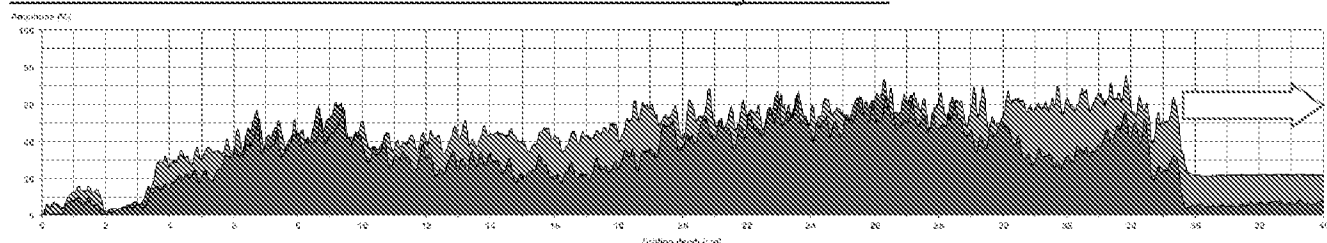
## Drill Trace 14 – southwest side of stem at c.1.0m above ground level

- The drill trace indicates a steady increase in resistance to the drill to a depth of c.34.5cm after which it drops sharply suggesting incipient decay is beginning to form to a depth of c.35.8cm
- From c.35.8cm, the drill enters an area of extensive decay/hollowing through to the end of the assessment

- Drill Trace 14 indicates sound wood to a depth of c.34.5cm before an area of decay/hollowing is reached; Drill Trace 15 indicates sound wood is present throughout the drill depth

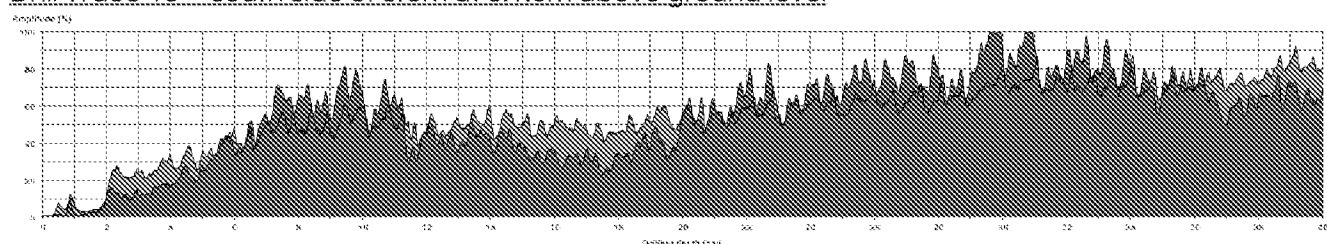
## Drill Trace 15 – south side of stem at c.1.0m above ground level

- The drill indicates a steady increase in resistance through to the end of the assessment suggesting sound wood is present
