## Tree report

- Land adjacent to 7 Countisbury Road Aldwick Bognor Regis West Sussex -

Planning Application: AW/141/16/PL

David Meagher – Landscape Architect

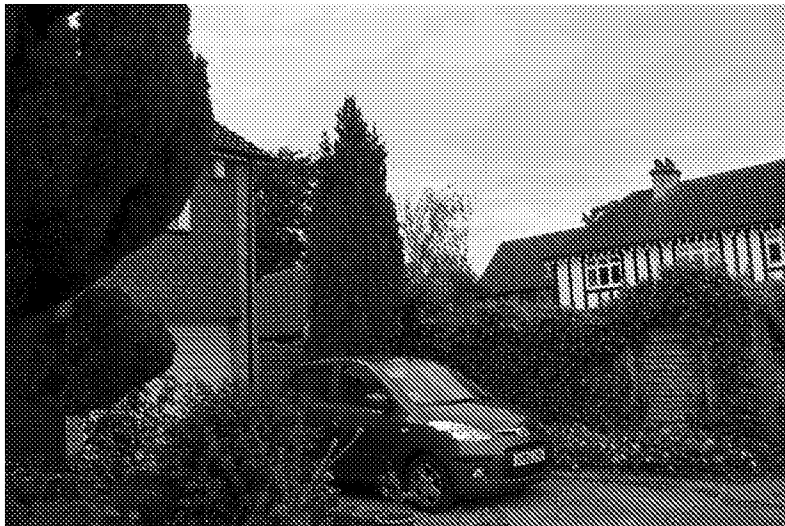
The individual T1 appears to be of good vigour, unaffected by foundations which have been dug prior to the lapse of outline planning permission. On closer inspection the foundation trench is devoid of roots structure, apart from a shallow root which appears to be severed, which may have been historically associated with a tree which had been removed prior to the planting of the Lawson's cypress.

A Healthy specimen of Lawson's cypress (*Chamaecyparis lawsoniana*) located in the neighbouring property, the only tree potentially affected by the construction.

5.2 Trees T1-T4: It is not envisaged that there will be a need for further excavations which will impact on T1. Services such as telecommunication fibre optics, water gas or electric services should be installed away from the RPA of T1 which should be afforded temporary protection with Arris fencing (See appendix 4). If there is a need for further excavation, it is recommended that excavation is by hand only (see appendix 3 Tree constraints plan).

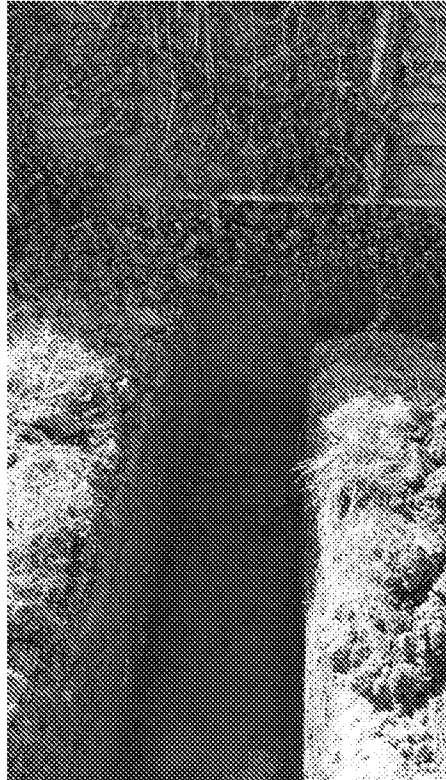
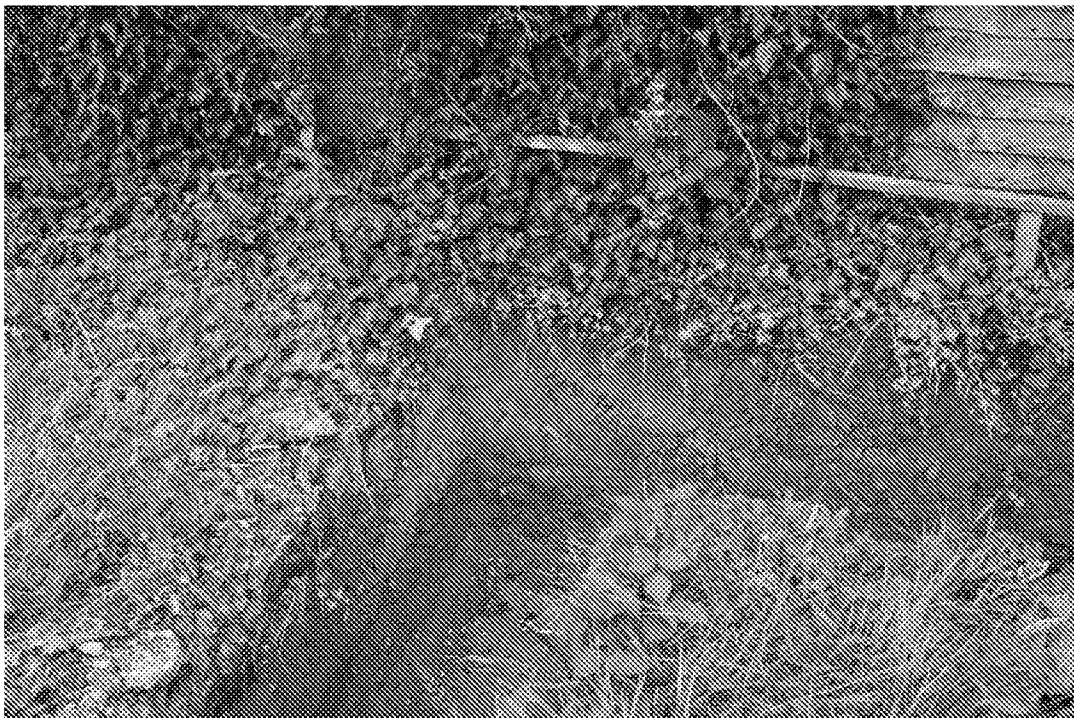
#### **Appendix 1:**

The foundation trench photographed recently (left and bottom)

The foundation trench when it was first excavated (below)

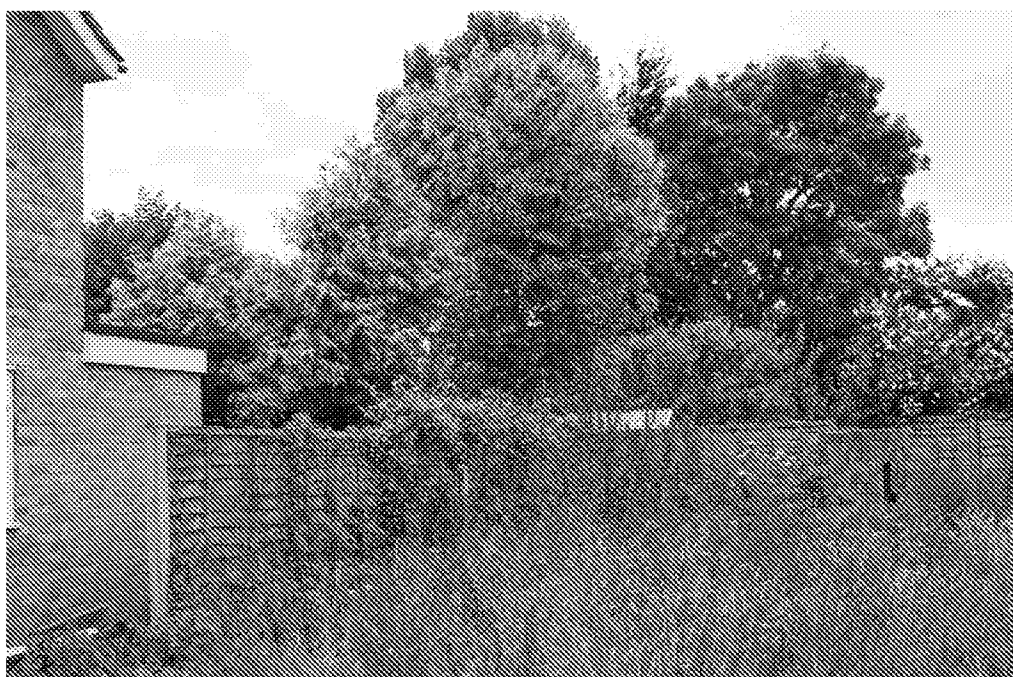
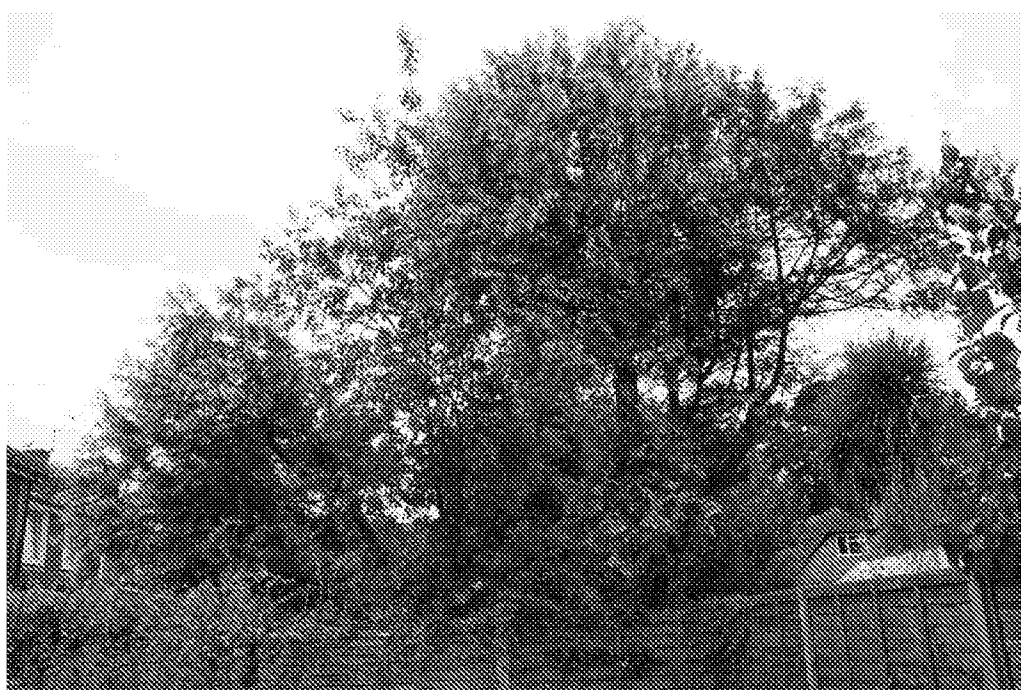
Trees T2 -T4 located in the rear garden are unaffected as no structure or storage are within the vicinity of the root protection area (RPA). T3 a self-set *Malus domestica* (apple) is situated close to T4 and nearer the dividing fence. This tree is immature and has suffered stress due to heavy shade which has led to the formation of a narrow stem with a poorly shaped crown. The proposals for the area where roots may intrude is for the garden use with the planting of fruit trees. T2 & T4 trees have been poorly pruned with lower laterals reduced to form clear stems resulting in poor bushy growth.

Neighbouring trees in relation to the development site

T2 - T4 are situated away from the main excavation area. If tree roots intrude, they will be in an area which is designated as garden space. Within this area it is recommended that there is no storage of site construction materials. It is recommended that the standard RPA is protected by Arris fencing (see appendix 4). Fruit trees are to be planted in the area where these may occur. Care is to be taken when excavating the tree pits which should be done by hand. (see appendix 3 Tree constraints plan)
