**THE FORMER MONTROSE HOTEL  
2 SELSEA AVENUE, BOGNOR REGIS  
WEST SUSSEX PO21 2QZ**

**DISMANTLING & DEMOLITION**  
(Including the removal & disposal of all non-licensed ACM's)

**SCOPE OF WORKS**

April 2023

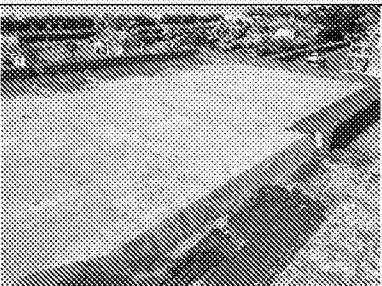
Ref	Sample No	Floor	Location	Description	Accessibility	(A) Product Type	(B) Condition	(C) Surface Treatment	(D) Asbestos Type	Material Assessment Score (A + B + C + D)	Priority	Photo
1	001	Top Roof	External - Roof	Silumen roofing felt	Low	1	0	0	0	0	NA

Quantity		ID		Recommendations		Comments						
60m2		NAD		NA		No asbestos detected in sample.						
Ref	Sample No	Floor	Location	Description	Accessibility	(A) Product Type	(B) Condition	(C) Surface Treatment	(D) Asbestos Type	Material Assessment Score (A + B + C + D)	Priority	Photo
2	-	Top Roof	External - Roof	General observation

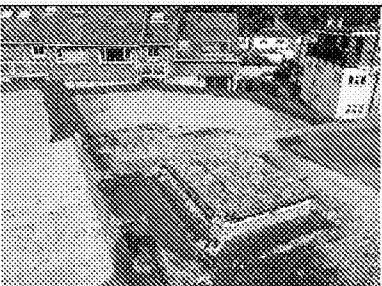
Quantity		ID		Recommendations		Comments						
				Modern felt layers to timber roof deck, modern silicone seal to skylight, timber soffits and fascias,

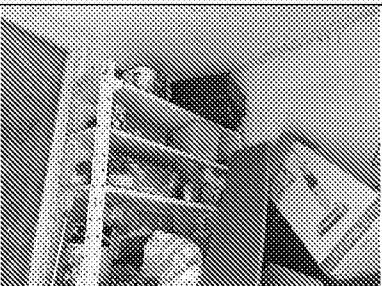
Ref	Sample No	Floor	Location	Description	Accessibility	(A) Product Type	(B) Condition	(C) Surface Treatment	(D) Asbestos Type	Material Assessment Score (A + B + C + D)	Priority	Photo	
3	-	Lower Roof	Store	No suspect ACMs observed

Quantity		ID	Recommendations		Comments								
					No suspected asbestos containing materials observed. Plasterboard ceiling to timber deck, plasterboard walls with plastic external cladding, modern felt roof, timber soffits and fascias.								
Ref	Sample No	Floor	Location	Description	Accessibility	(A) Product Type	(B) Condition	(C) Surface Treatment	(D) Asbestos Type	Material Assessment Score (A + B + C + D)	Priority	Photo	
4	002	Lower Roof	External Roof	Bitumen roofing felt	Low	1	0	0	0	0	NA

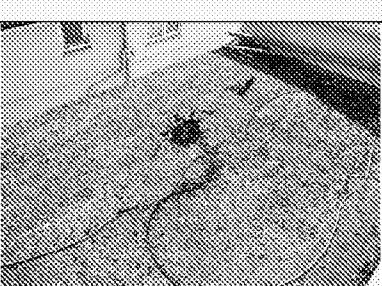
Quantity		ID	Recommendations		Comments								
20m <sup>2</sup>		NAD	NA		No asbestos detected in sample. Modern felt layers to timber deck, timber soffits & fascias.

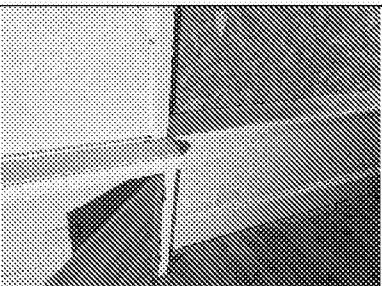
Quantity		ID	Recommendations	Comments								
6m2		NAD	NA	No asbestos detected in sample. Solid wall.

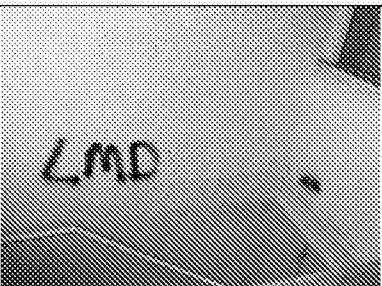
Quantity		ID	Recommendations	Comments								
15m2		NAD	NA	No asbestos detected in sample. Solid and plasterboard walls.

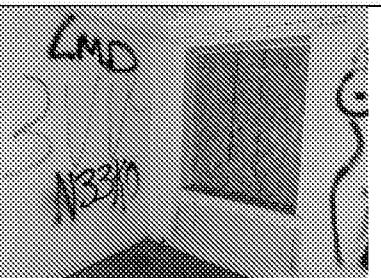
Quantity		ID	Recommendations	Comments								
				No suspected asbestos containing materials observed. Plasterboard ceiling, solid and plasterboard walls, timber floor under carpet.

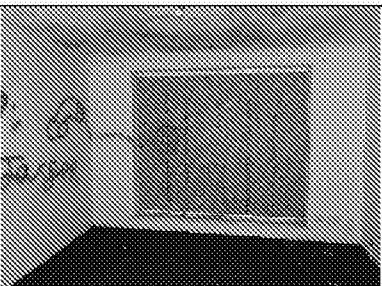
Quantity		ID		Recommendations		Comments						
				No suspected asbestos containing materials observed. Plasterboard ceiling, solid and plasterboard walls, timber floor under carpet.

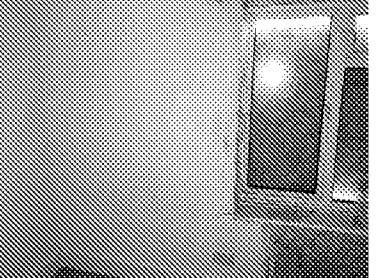
Quantity		ID	Recommendations	Comments								
12m2		NAD	NA	No asbestos detected in sample. Solid and plasterboard walls.								
Ref	Sample No	Floor	Location	Description	Accessibility	(A) Product Type	(B) Condition	(C) Surface Treatment	(D) Asbestos Type	Material Assessment Score (A + B + C + D)	Priority	Photo
28	As sample 009	First	Bathroom	Textured coating to ceiling	Low	1	1	0	1	3	Low

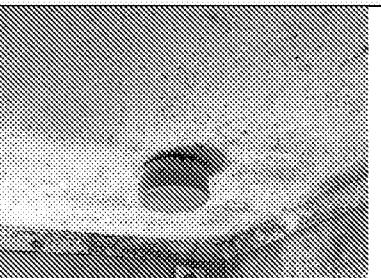
Quantity		ID	Recommendations	Comments								
3m2		AD	Remove	Plasterboard ceiling, solid and plasterboard walls, timber floor.

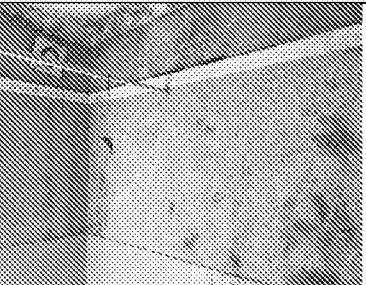
Quantity		ID		Recommendations		Comments						
3m <sup>2</sup>		AD		Remove		Solid and plasterboard walls.						
Ref	Sample No	Floor	Location	Description	Accessibility	(A) Product Type	(B) Condition	(C) Surface Treatment	(D) Asbestos Type	Material Assessment Score (A + B + C + D)	Priority	Photo
30	As sample 009	First	Lobby 1	Textured coating to ceiling	Low	1	1	0	1	3	Low

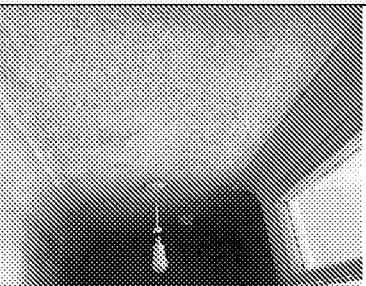
Quantity		ID		Recommendations		Comments						
6m <sup>2</sup>		AD		Remove		Plasterboard ceiling, solid and plasterboard walls, timber floor under carpet.

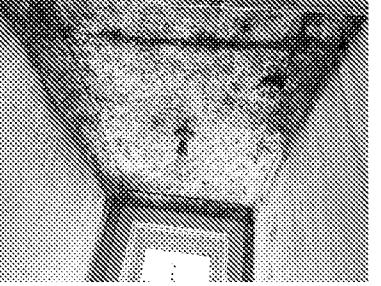
Quantity		ID	Recommendations	Comments								
2m2		AD	Remove	Plasterboard ceiling, solid and plasterboard walls, timber floor.								
Ref	Sample No	Floor	Location	Description	Accessibility	(A) Product Type	(B) Condition	(C) Surface Treatment	(D) Asbestos Type	Material Assessment Score (A + B + C + D)	Priority	Photo
32	012	First	Landing	Textured coating to ceiling	Low	1	1	0	1	3	Low

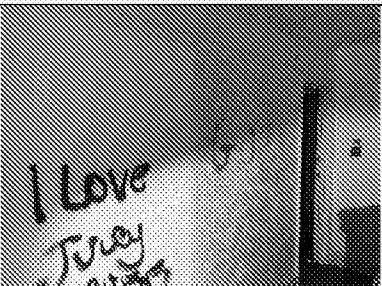
Quantity		ID	Recommendations	Comments								
15m <sup>2</sup>		NAD	NA	No asbestos detected in sample. Solid and plasterboard walls.								
Ref	Sample No	Floor	Location	Description	Accessibility	(A) Product Type	(B) Condition	(C) Surface Treatment	(D) Asbestos Type	Material Assessment Score (A + B + C + D)	Priority	Photo
34	As sample 012	First	Shower	Textured coating to ceiling	Low	1	1	0	1	3	Low

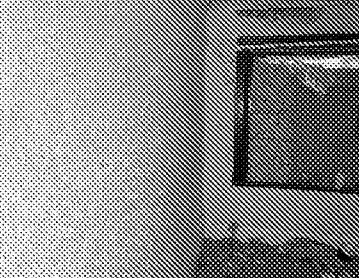
Quantity		ID	Recommendations	Comments								
12m <sup>2</sup>		NAD	NA	No asbestos detected in sample. Solid and plasterboard walls.

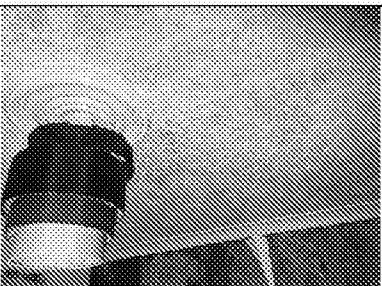
Quantity		ID		Recommendations		Comments						
14m <sup>2</sup>		AD		Remove		Plasterboard ceiling, solid walls, timber floor.

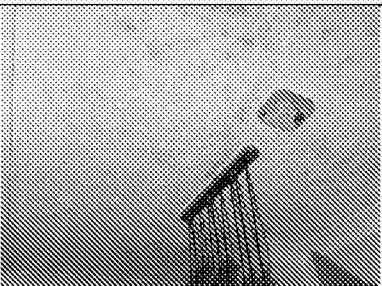
Quantity		ID		Recommendations		Comments						
8m <sup>2</sup>		AD		Remove		Plasterboard ceiling, solid walls, timber floor.						
Ref	Sample No	Floor	Location	Description	Accessibility	(A) Product Type	(B) Condition	(C) Surface Treatment	(D) Asbestos Type	Material Assessment Score (A + B + C + D)	Priority	Photo
48	As sample 016	Ground	Lobby	Textured coating to ceiling	Low	1	1	0	1	3	Low

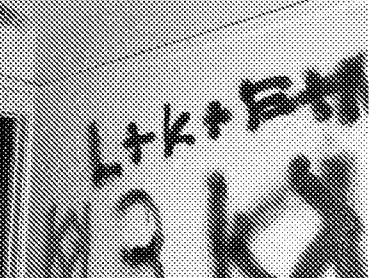
Quantity		ID	Recommendations	Comments								
15m <sup>2</sup>		NAD	NA	No asbestos detected in sample. Solid and plasterboard walls.

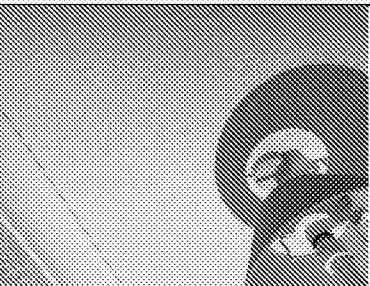
Quantity		ID		Recommendations		Comments						
1m2		AD		Remove		Plasterboard ceiling, solid walls, timber floor under carpet.						
Ref	Sample No	Floor	Location	Description	Accessibility	(A) Product Type	(B) Condition	(C) Surface Treatment	(D) Asbestos Type	Material Assessment Score (A + B + C + D)	Priority	Photo
58	019	Ground	Lobby to 004	Textured coating to wall	Low	1	1	0	0	0	NA

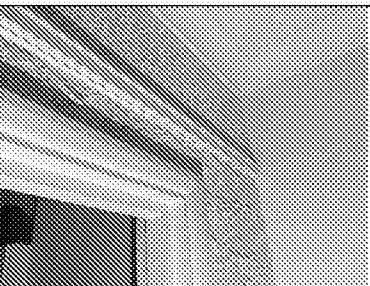
Quantity		ID		Recommendations		Comments						
1.5m2		NAD		NA		No asbestos detected in sample. Solid wall.

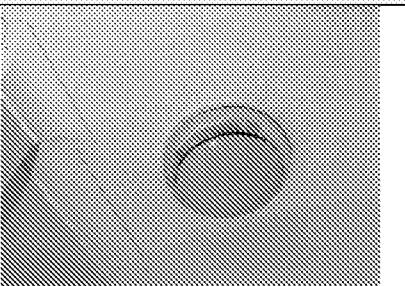
Quantity		ID		Recommendations		Comments						
1m2		AD		Remove		Plasterboard ceiling, solid walls, solid floor.						
Ref	Sample No	Floor	Location	Description	Accessibility	(A) Product Type	(B) Condition	(C) Surface Treatment	(D) Asbestos Type	Material Assessment Score (A + B + C + D)	Priority	Photo
64	As sample 020	Ground	Shower	Textured coating to ceiling	Low	1	1	0	1	3	Low

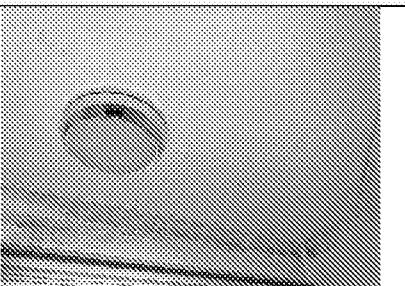
Quantity		ID		Recommendations		Comments						
4m2		AD		Remove		Plasterboard ceiling, solid and plasterboard walls, solid floor under modern vinyl, no suspect ACMs in plasterboard boxing

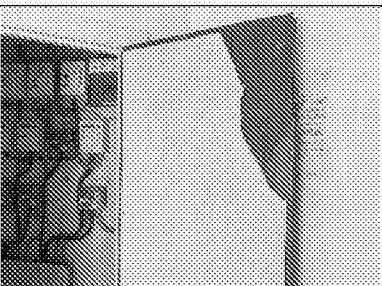
Quantity		ID	Recommendations	Comments								
1m2		NAD	NA	No asbestos detected in sample.
