Former Monrose Hotel

Demolition Management Plan

July 2024

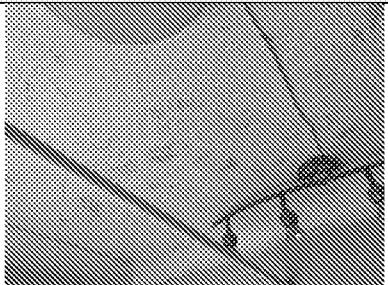
Quantity		ID	Recommendations	Comments								
3m ²		AD	Remove	Plasterboard ceiling, solid and plasterboard walls, timber floor, plastic soil pipe.

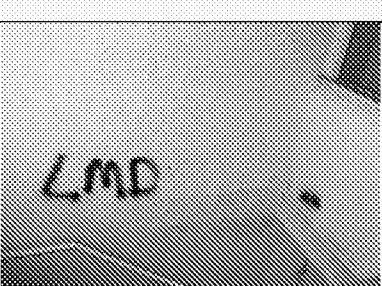
Quantity		ID	Recommendations	Comments								
15m ²		NAD	NA	No asbestos detected in sample. Solid and plasterboard walls.

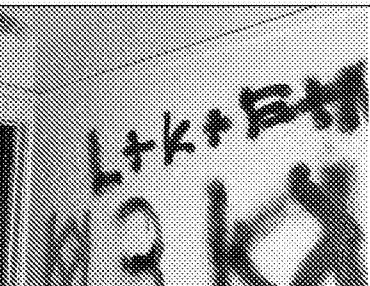
Quantity		ID	Recommendations	Comments								
15m ²		NAD	NA	No asbestos detected in sample. Solid and plasterboard walls.
