# **ARBORICULTURAL REPORT**

**28 Pinehurst Park, Aldwick**

**Reference Number: 0343**

**Date: 28 September 2018**

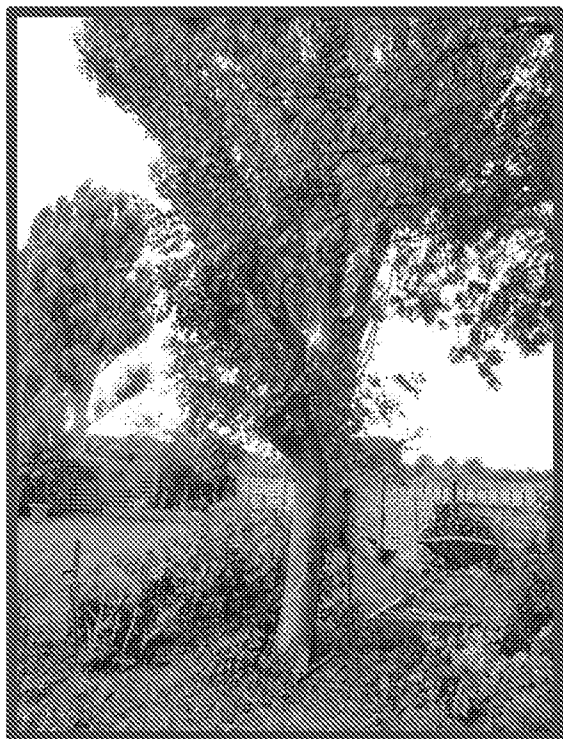
Tree T1 Eucalyptus is of low quality and outside of the main tree group; this tree has had substantial pruning operations that have resulted in the loss of tree form and size.

| Comments:<br>Tree has had most of crown removed with main trunk and new side growth. Little value. | | | | | | | | | |

Picture 1 – T1 Eucalyptus with extensive pruning and poor form.

| Recommended remedial action:<br>Fell/ Remove | | | | | | | | | |

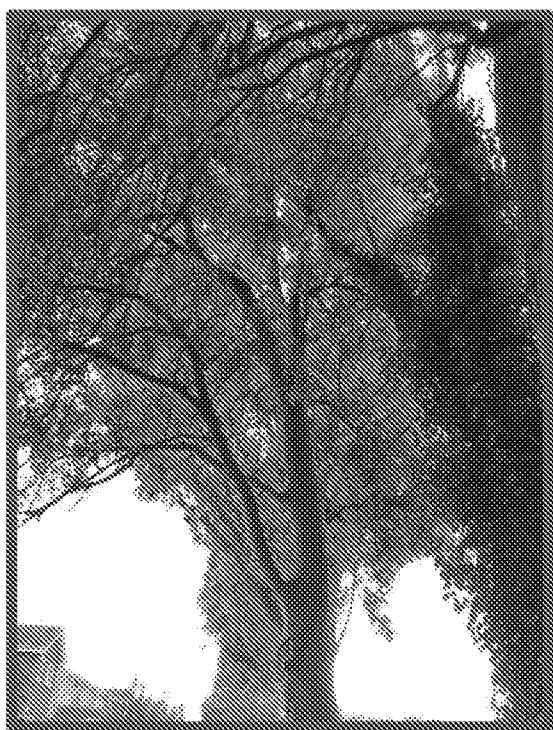
Tree T2 Ash, is of low quality with crown dieback and canker on the primary and secondary scaffolds. The tree is suppressed by the larger trees and is developing a poor form.

| Comments:<br>Tree has asymmetrical crown to southwest. Branch tip dieback by 20%, cankers on primary and secondary scaffold, deadwood throughout crown. | | | | | | | | |

Picture 2 – T2 trunk looking at southeast side with cavity.

| Recommended remedial action:<br>Fell/ Remove | | | | | | | | |

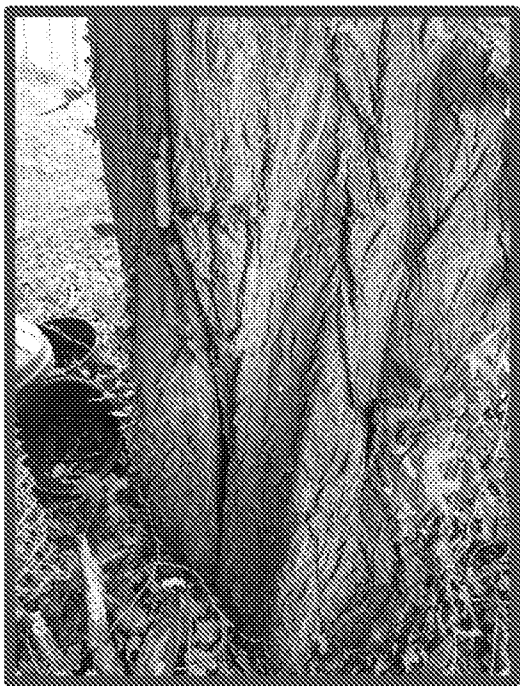
Tree T4 Poplar is within the body of the group this large tree has deadwood in the crown and a significant splitting with an area of decay at the base, this tree should be removed

| Comments:<br>Tree part of larger group and tree line with a codominant form. Ivy at tree base and up trunk into lower crown, major deadwood (over 25mm) in crown. To north of trunk at base to 1.5m is a large vertical split that travels into the trunk the split is c.30mm wide and full internal inspection is not possible. | | | | | | | | |

Picture 3 – T4 Poplar splitting of lower trunk.

| Recommended remedial action:<br>Fell and replace. | | | | | | | | |

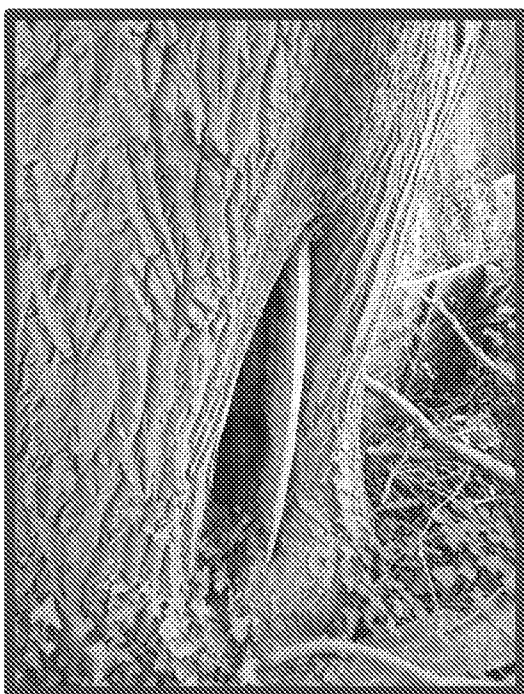
Tree T5 Willow, is a large tree in the middle of the group, the branching is in contact with in the group. On the lower trunk to the north there is a sizable area of damage with extensive internal decay that spreads up the inner trunk. It is desirable to retain this tree, the crown will be reduced significantly and the damaged area will be monitored.

| <b>Comments:</b><br>Large codominant tree in the center of the rear boundary, the tree has old dead Ivy on the trunk and into the crown as well as new Ivy growth on trunk. At the rear of the lower trunk from base to 1.5m up there is a cavity that is c.300mm wide with established decay and cavities within the trunk this area has reaction wood growth in the areas around the cavity. Lower limbs to the north are in contact with the grounds and has started to layer; there is deadwood within the crown. | | | | | | | | |

Picture 4 – T5 Willow, cavity at base to north of trunk

| <b>Recommended remedial action:</b><br>Ivy to be severed to ground level and removed as much as possible, when this is undertaken the tree parts covered by Ivy should be assessed for integrity. Major deadwood should be removed.<br>Crown reduction of 2m from the height and 4m for lateral limbs this should be done by way of topping, willow will respond well to this and form a smaller crown. | | | | | | | | |

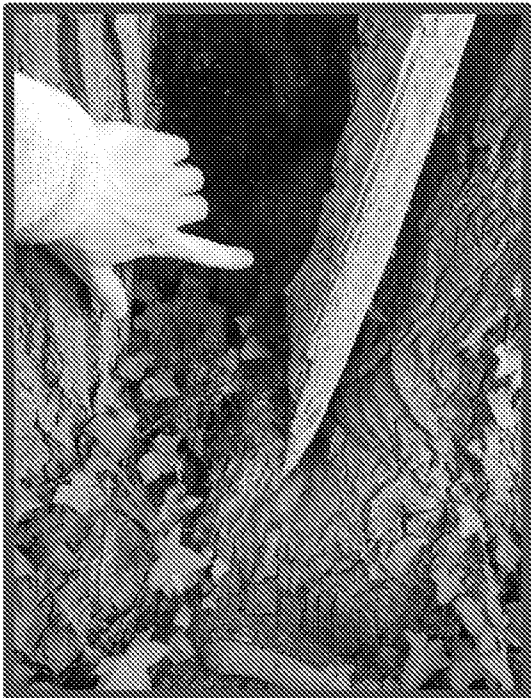
Picture 5 – T5 Willow, cavity at base to north of trunk with cavity into trunk

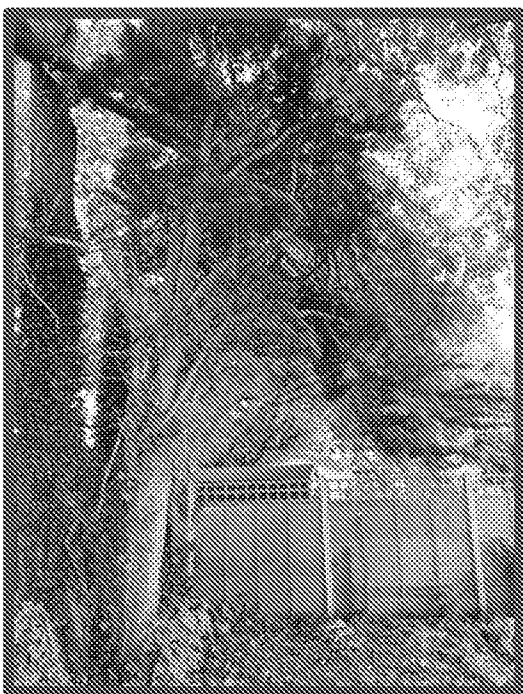
Tree T6 Monterey Cypress, this tree is the smallest within the main tree group and is of poor form with leaning trunk asymmetrical crown, suppressed growth and dieback of the lower crown. This tree should be removed and replaced.

| Comments:<br>Suppressed form with dieback and deadwood throughout crown, pruning wound to east. Tree has little merit with poor form. | | | | | | | | |

Picture 4 – T6 Monterey Cypress showing poor form and die back

| Recommended remedial action:<br>Fell and replace. | | | | | | | | |

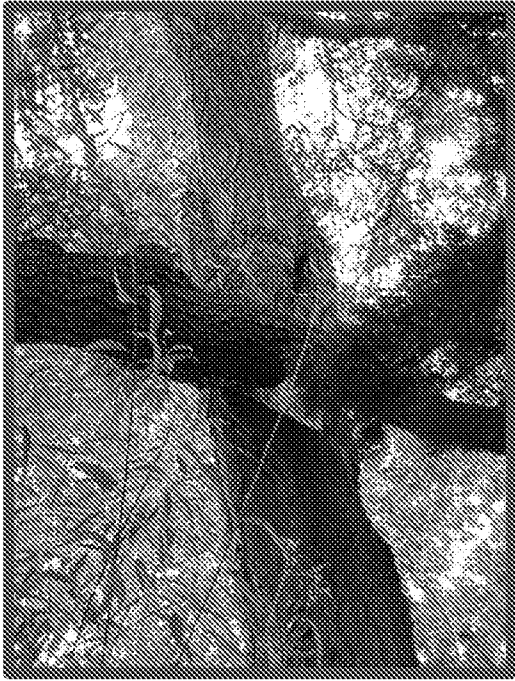
Tree T7 Poplar, this large tree has an area of damage at c.6m where the Willow tree (T5) has rubbed against the trunk. This has resulted in a significant area of damage that now has indications of internal decay at this area, this tree should be removed.

| <b>Comments:</b><br>Tree is part of larger group and tree line with a codominant form. Ivy at tree base and up trunk into lower crown, major deadwood (over 25mm) in crown. Swelling and fluting at base of tree indicating possible internal decay or reaction to stress. On trunk at circa 6m to south area of damage to main stem from interference with large limb from Willow T5, this has damaged the trunk to c.50% of the thickness, to the top of the wound there is a small hole that indicates internal decay that connects to a cavity that is located c.450mm above the primary damage. This damage and decay is substantial with a large amount of reaction wood forming around the site. With the location of the damage there is a substantial amount of tree above, Poplar trees typically are prone to damage and decay developing faster than the tree can react, this resulting in tree failure. | | | | | | | | |

Picture 5 – T7 Poplar with damage to main trunk at c.6m from branch of T5.

| <b>Recommended remedial action:</b><br>Fell and replace. | | | | | | | | |

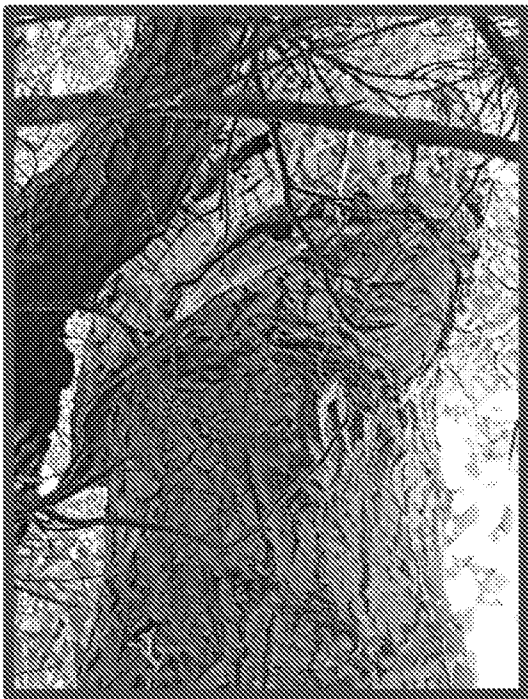
Picture 6 – T1 T7 Poplar with damage and small hole to top of wound leading to larger decay pocket above.
