**Planning Application Ref:** **AW/279/18/RES**

**Location:** **261 Aldwick Road Aldwick PO21 3QU**

**Purpose of visit:** **Ad-hoc inspection of approved Tree Protection Measures following commencement**

**Comments and observations:** Site attended – 19<sup>th</sup> February 2020, 0915 – 1000hrs

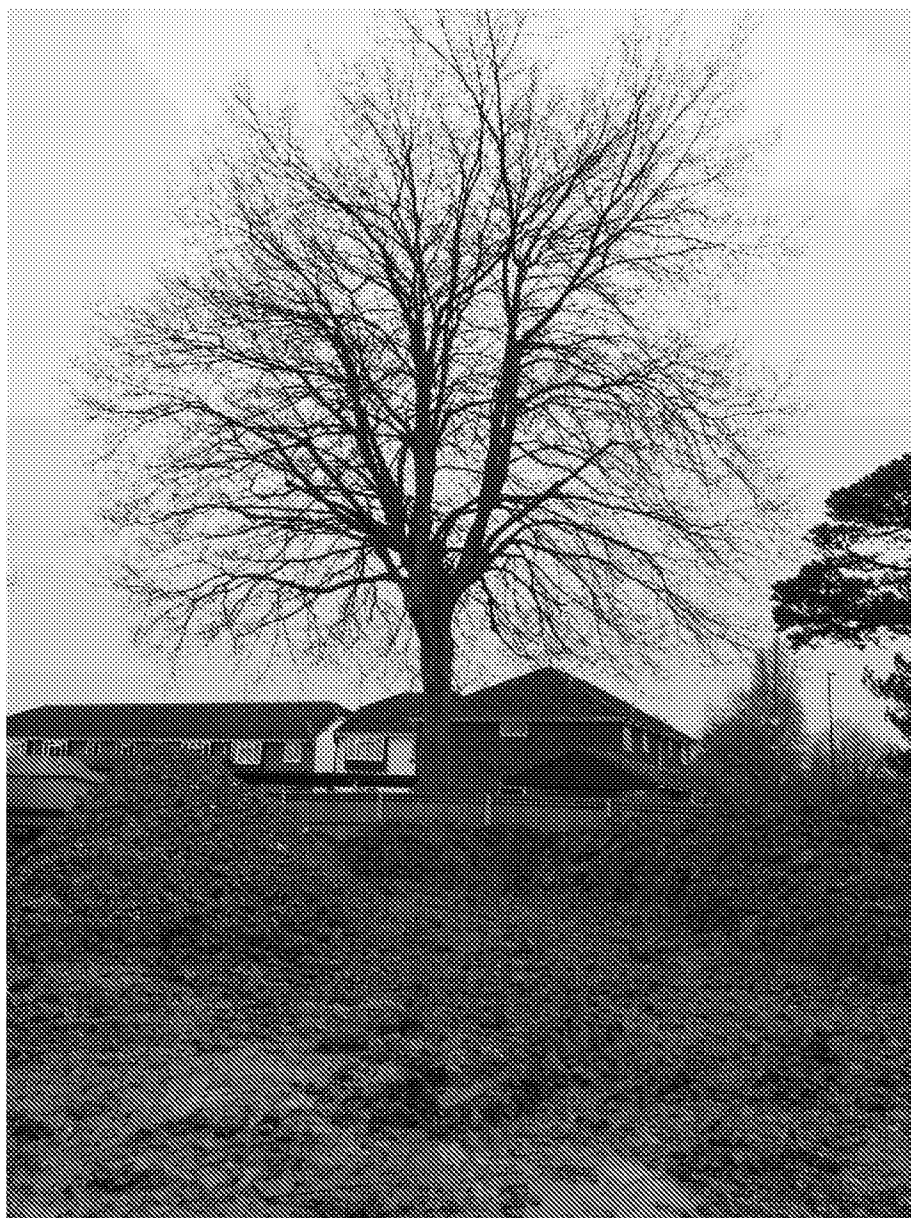
- Large volumes of heavy clay subsoil have been heaped along the site's west boundary and within the root protection area (RPA) of T04, the subject of a TPO (Fig.1 and 2).

**Fig.1.** Looking west towards T04 Turkey oak (TPO), in the grounds of Malmayne Court.

- Urgent action must be taken by the developer and their project arboriculturist to arrange for the careful removal of all excess materials (imported top/sub-soil, compacted hardcore) from within the RPA of retained trees and install ground protection and/or fencing as per the approved plan – to prevent further damage.

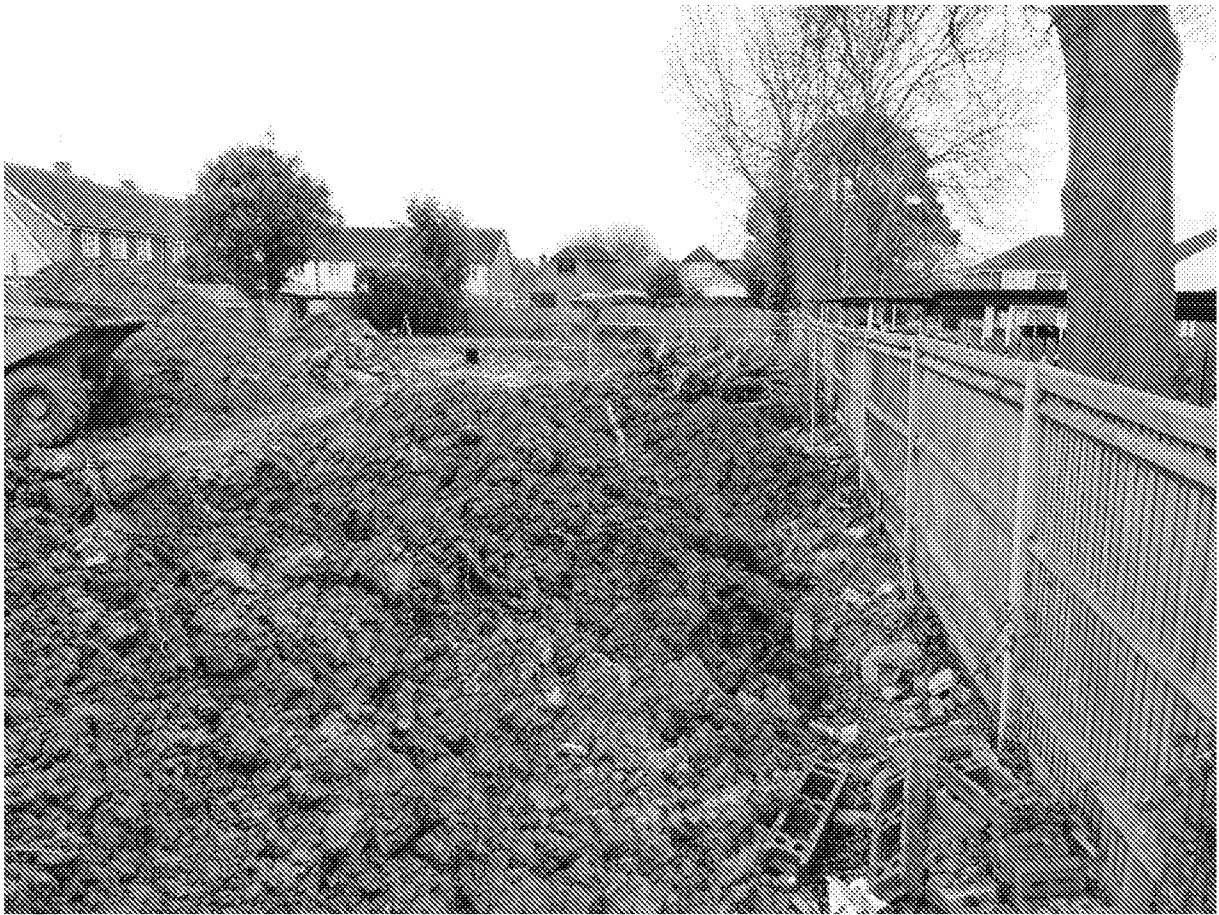
**Fig.2.** Looking south along west boundary of site. T04 right foreground.

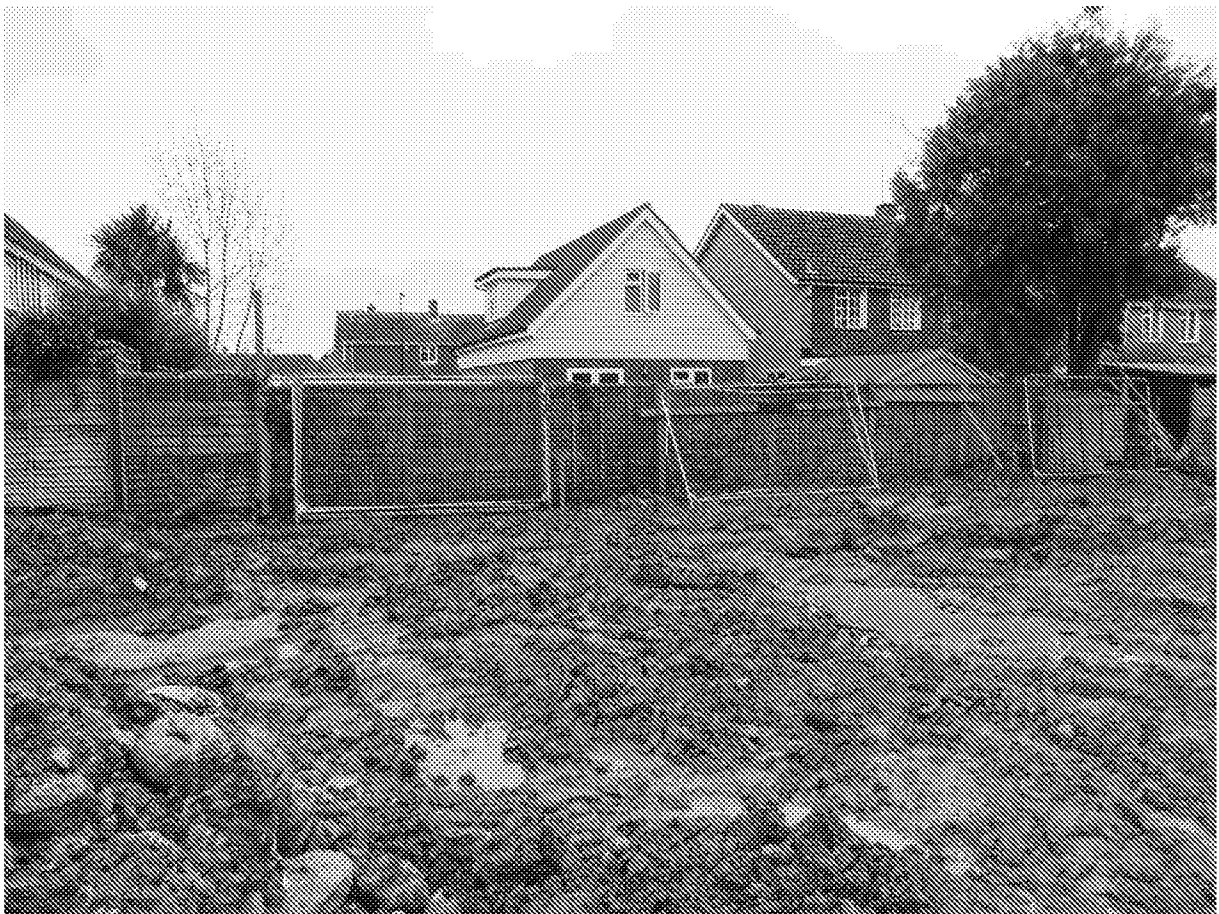
**Fig.3.** Looking east south-east to east boundary of site.

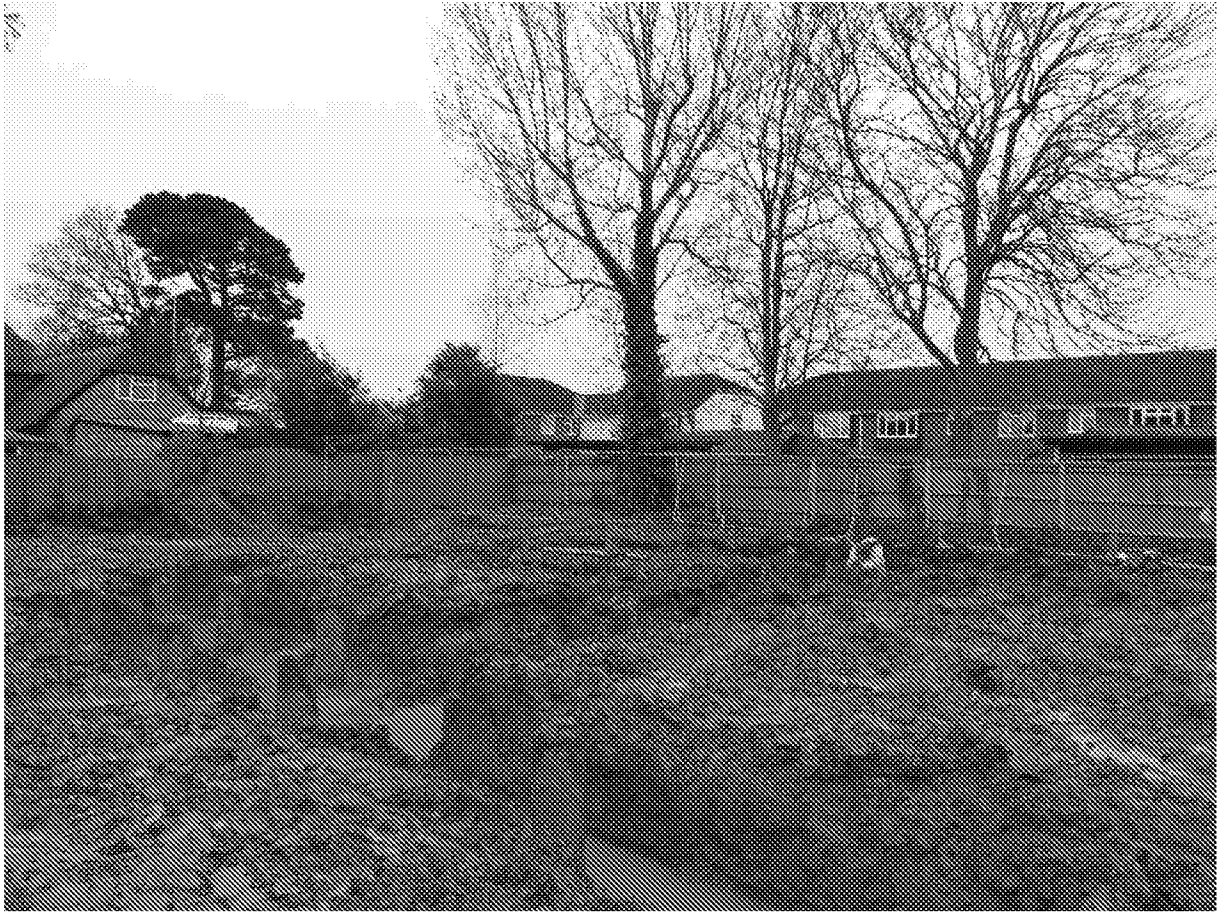
- Groundwork across the site is advanced, with the footprint of combined plots 3&4 already dug out and screw piles installed (Fig.4). You will observe significant mechanical damage to roots, most likely associated with on-site tree T01 and off-site trees T02 and T03, all of which are the subject of a Tree Preservation Order (TPO). Assuming the footprint is correctly located and root severance in principle therefore permissible; that root severance has not been undertaken as per the approved methodology nor I doubt with any arboricultural supervision.

- It is likely that significant damage to the most valuable trees affected by the development has occurred, in the form of crude mechanical root severance and exposure along with ground compaction - as a direct result of the activity by groundwork contractors employed by the developer.

**Fig.4.** Looking south-west towards (from l-r) T01, T02, T03.
