**From:** Mark Warwick <Mark.Warwick@arun.gov.uk>  
**Sent:** 19 March 2021 17:34  
**To:** Simon Davis <Simon.Davis@arun.gov.uk>  
**Cc:** Daniel Vick <Daniel.Vick@arun.gov.uk>  
**Subject:** 261 Aldwick Road, Aldwick

**Planning Application Ref:** AW/279/18/RES

**Location:** 261 Aldwick Road Aldwick PO21 3QU

**Purpose of visit:** Ad-hoc inspection of approved Tree Protection Measures

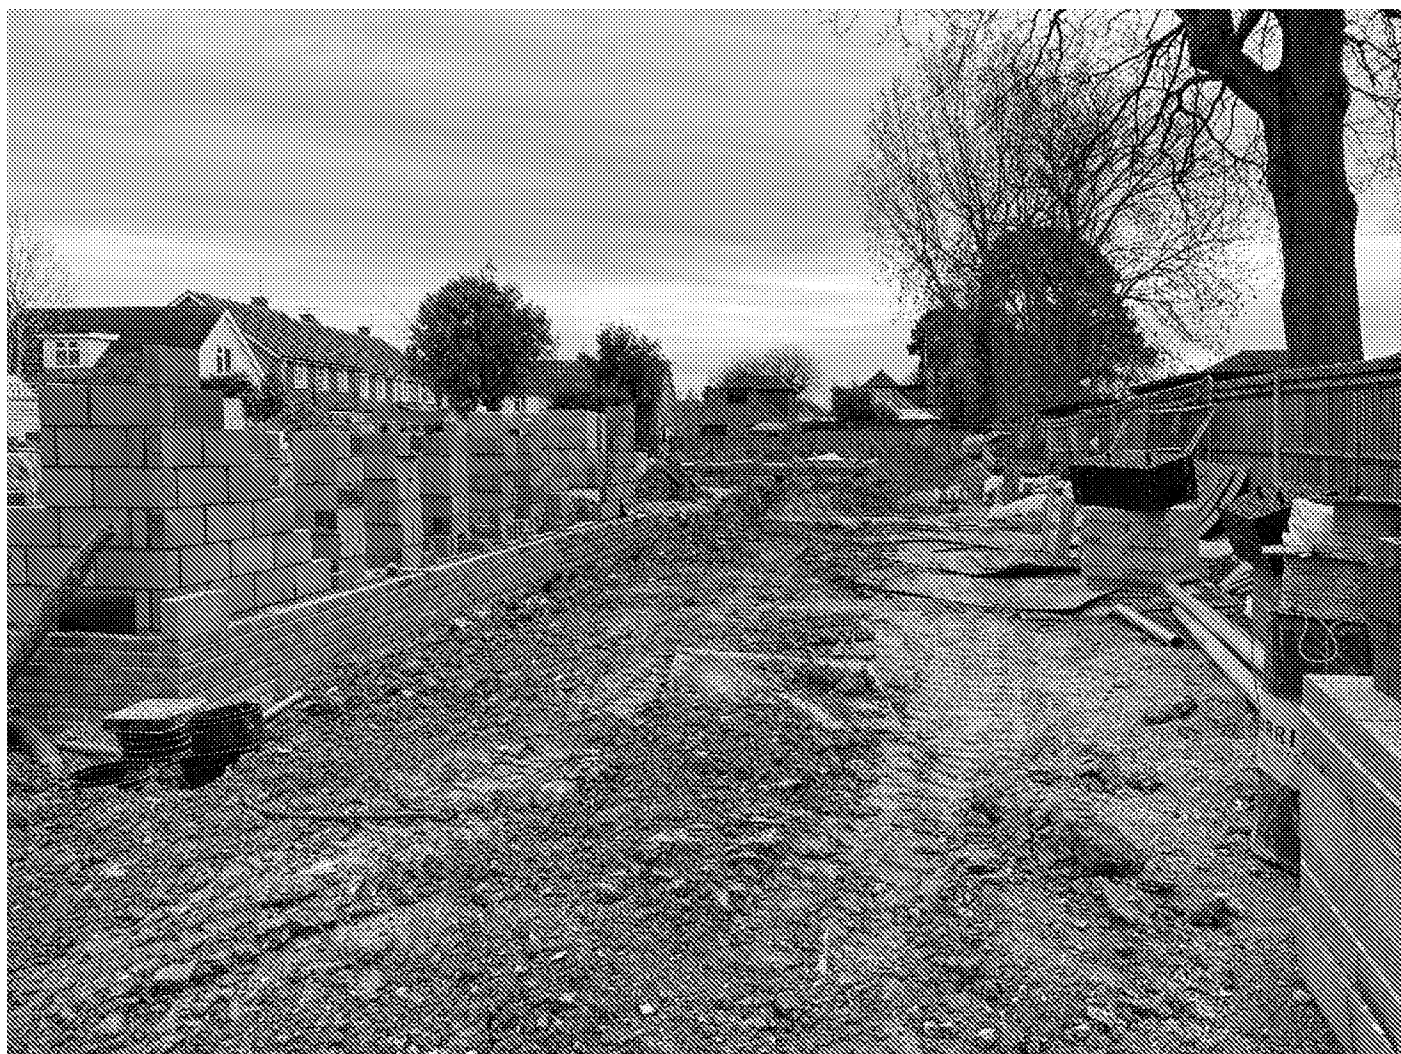
**Fig.3.** Looking south from near entrance to site, showing progress of above ground construction.
