**REPORT ON INSPECTION OF OAK TREE  
TO REAR OF**

**NO. 8 WEST DRIVE  
ALDWICK BAY  
PO21 4LY**

**Tim Laddiman  
BSc.(Hons) M.I.C.For. M.Arbor.A.  
Chartered Arboriculturist**

**Our ref: J60.99  
24<sup>th</sup> September 2021**

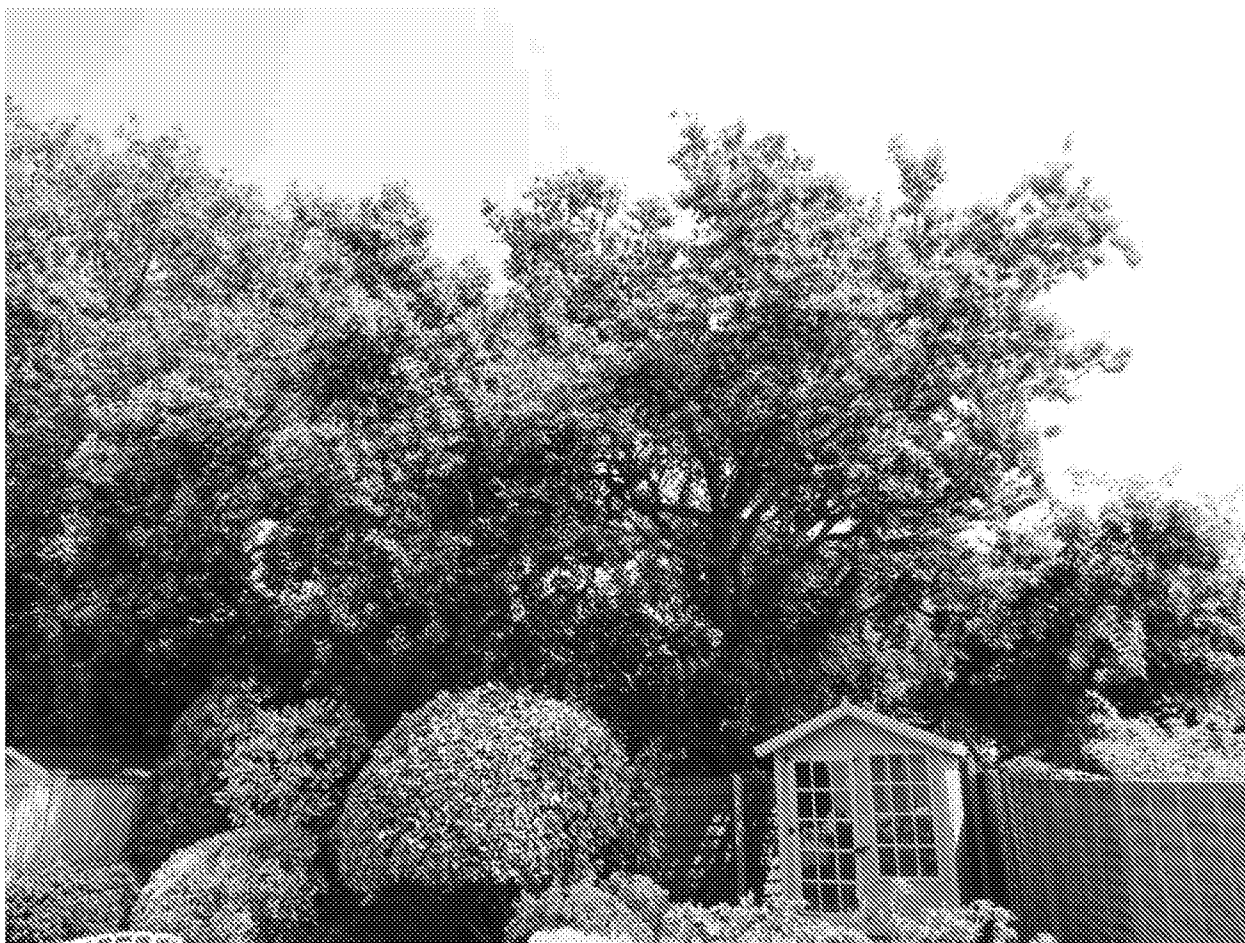
- 4.1 Localised decay is present in the wound site where the third stem was removed in the past. No basal issues are evident to suggest any instability. No decay fungi were observed.
- 4.2 The canopy is poorly formed and primarily comprises over extended limbs with end foliage at risk of collapse due to excessive end loading.

Over extended slender limbs with end loading over garden and summer house

- 4.3 The south-west stem was previously topped at 5.5m with multi stemmed regrowth having formed a squat crown of long limbs over the garden. Attachment points appear sound with no obvious defects.
- 4.4 The canopy contains more deadwood than would be typically expected and fine thinning in places suggests an underlying health issue not manifesting in any visible causal agent.
- 4.5 Potential exists for limb failures into the garden and over the roof of the summer house.

- 5.1 The tree has minimal public amenity due to its squat crown form and location, compared to the larger Oaks to the north. It is never going to be a feature tree and does not justify the TPO placed on it.
- 5.2 As the tree has over extended limbs into the garden and over the summer house and as the south-west stem has previously been heavily reduced, it is recommended the tree is brought back to a compact core structure. Resulting regrowth can then be managed on a ten year cycle of recutting.
  - Deadwood crown.
  - Reduce height by 2m.
  - Reduce back all limbs to 4m radius from stem and shape to balance.

Take back crown to S to 4m/front of summer house.  
Long low limbs to W back to 4m from stem.  
Reduce height by 2m and shape to maintainable core.
