# **ARBORICULTURAL REPORT**

**4 A'Beckets Ave**

**Reference Number: 0396**

**Date: 03 December 2018**

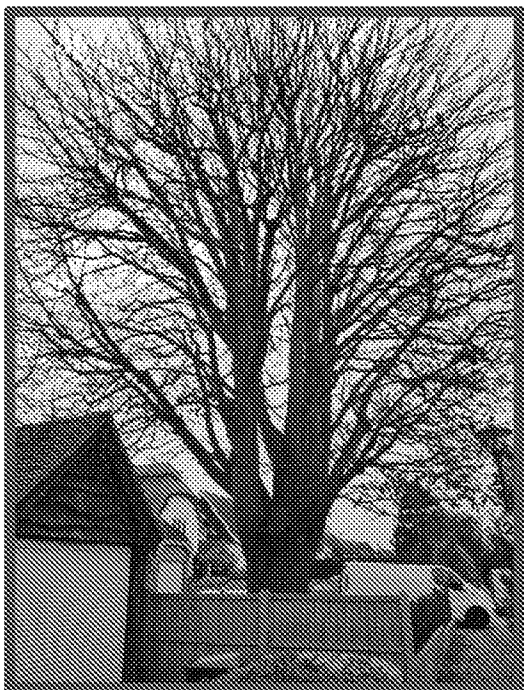
Picture 1 – T1 Horse Chestnut Overview

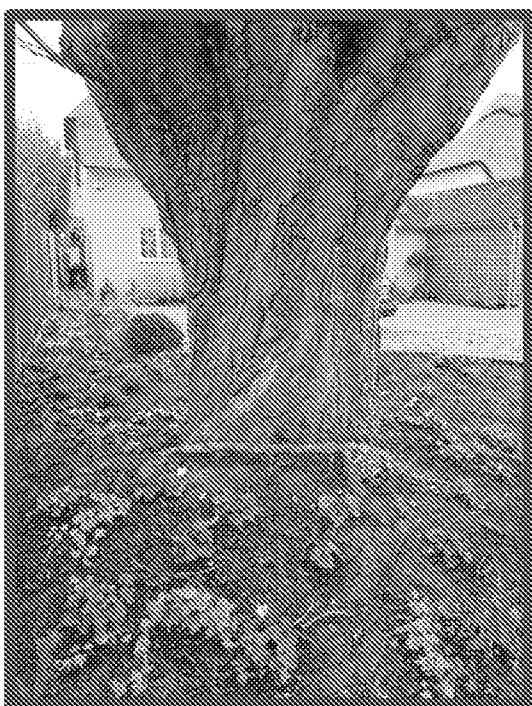
Picture 2 – T1 Horse Chestnut base area on west side

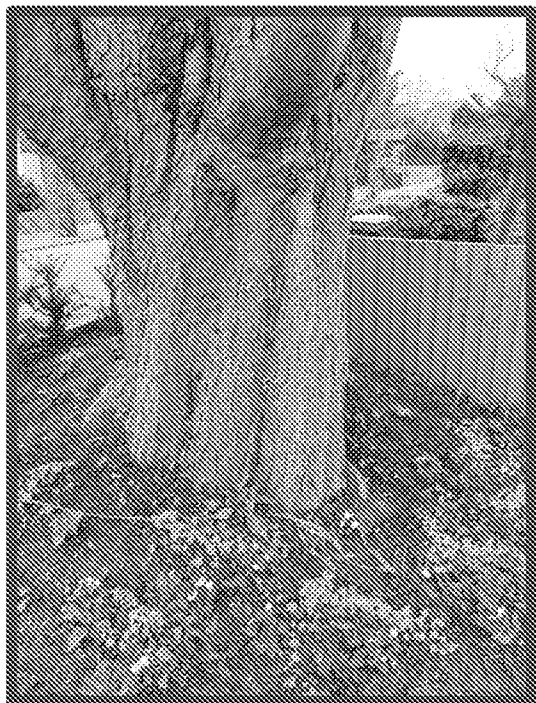
Picture 3 – T1 Horse Chestnut base area on southeast side

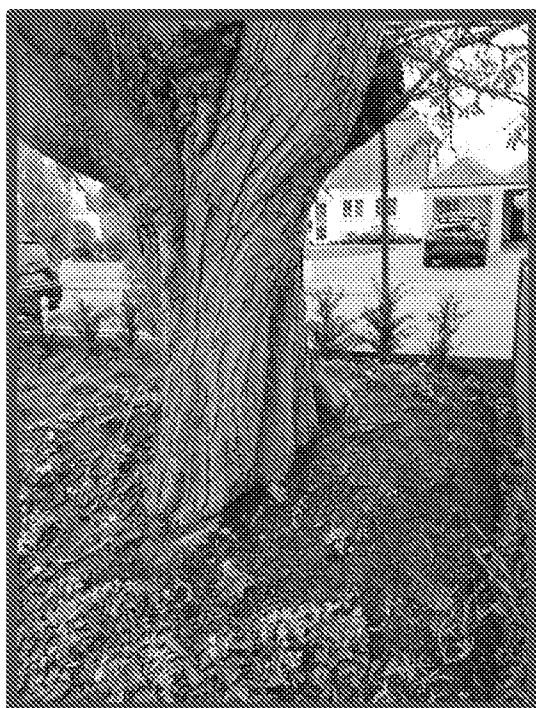
Picture 4 – T1 Horse Chestnut base area on northeast side

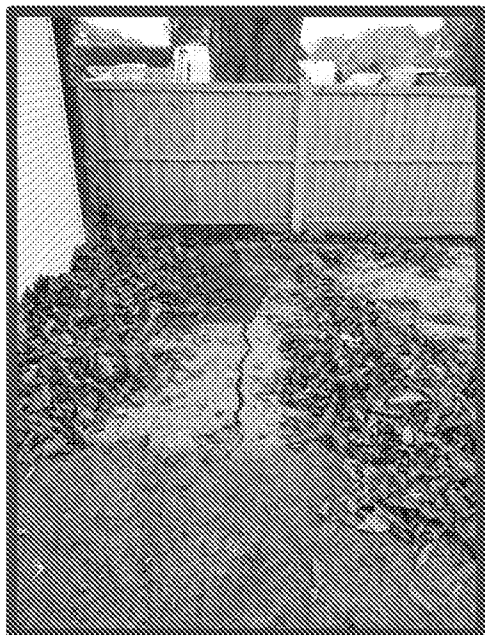
| <b>Comments:</b><br>Located to the northwest of the property of 4 A'Beckets Ave, to the front boundary overhanging the driveway of #4 and #2 as well as over the road of A'Beckets Avenue. The area around the lower trunk is a recently landscaped garden with small plants and recently planted hedging. The trunk of the tree has ridges and small areas of decay between buttress roots. The area at crown break has multiple tight union with included bark as well as historic pruning wounds that have decay; the tree crown has had recent (3-5years) crown reduction pruning this reduced the crown to a spread of 3m. The crown is of good health and vigor with a small amount of deadwood and cavities from historical pruning.<br>Tree roots to the north of the tree extent into the property of 2 A'Beckets Avenue, with shallow roots that are in contact with the fencing; the concrete driveway of #2 has cracking that follows the likely root profile, this cracked area has broken and lifting parts. | | | | | | | | |

Picture 5 – T1 Horse Chestnut viewed from #2 with cracking of concrete

| <b>Recommended remedial action:</b><br>Crown reduction of 1-2m from lateral limbs (to old pruning points) and 1-2m form the tree height (to old pruning points).<br>When reinstating the driveway at #2, the new driveway should be constructed by modified techniques this is to protect both the driveway and tree roots from damage. | | | | | | | | |

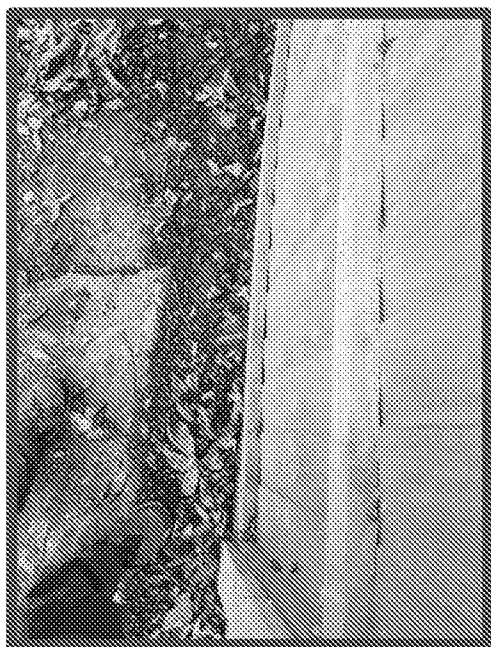
Picture 6 – T1 Horse Chestnut viewed from #2 with cracking of concrete and shallow roots in contact with fence
