# Barrack Lane

## Tree Condition Survey

### Report for Roger Nield

| <b>Job Number</b> | <b>ARB1611</b> | | |

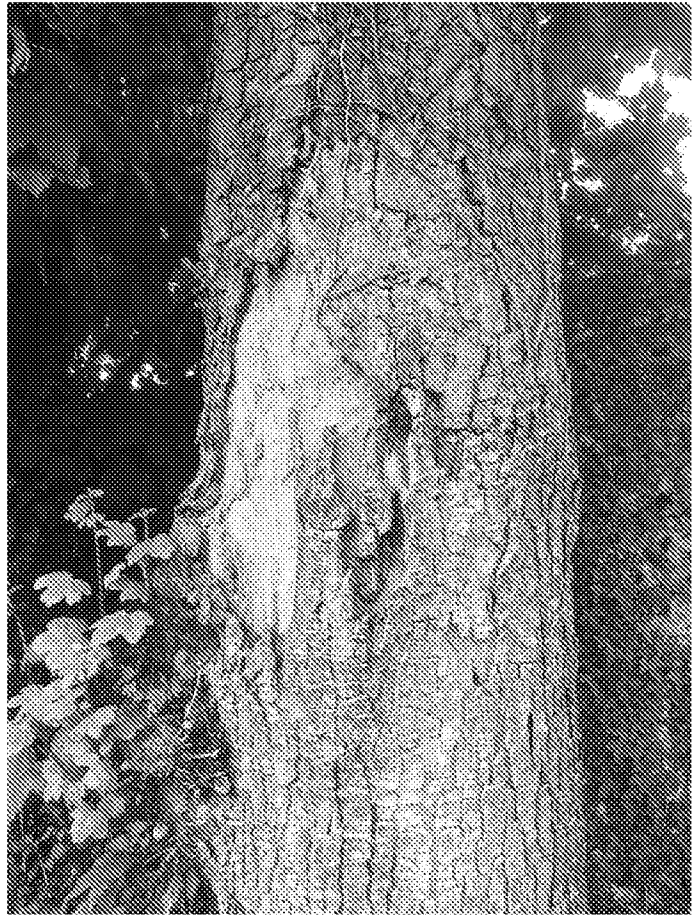
Photograph 1

- ❖ Sycamore T1 was situated to the north east corner of the site and was located adjacent to the existing driveway entrance and parking area. The tree was mature, 9m in height, had a single stem and a maximum canopy radius extending 6m from east to west. The tree appeared to be in fair structural and physiological condition, however significant bark and cambium damage caused by vehicles accessing the property was observed at 1.5m on the southern aspect of the stem. This defect feature was approximately 20cm x 30cm in size, the wound has part occluded and epicormic growth has regenerated from below the wound.

T1 Sycamore, southern aspect of stem at 1.5m. Bark and stem damage caused by vehicles accessing driveway.

- 4.7 The following tree works operations are recommended and should be completed after written approval from the Local Planning Authority.
- ✧ Trees T1, T2, T3 and T4 are recommended for removal to prevent further damage to the listed boundary wall.
  - ✧ Tree T1, T2, T3 and T4 stumps will require removal using a stump grinding machine or similar. The tree stumps should not be dug or pulled out by excavator machines as this will seriously damage the boundary wall foundations.
- 4.8 All tree felling should be carefully planned and undertaken in accordance with BS 3998:2010 Recommendations for Tree works.

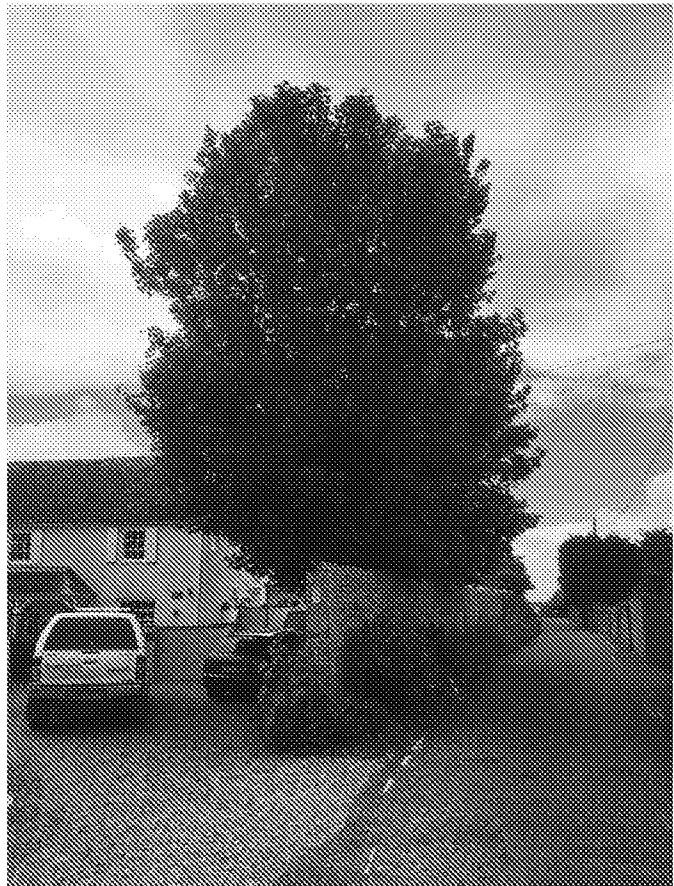
Photograph 2

View looking west towards sycamore group T1, T2, T3, and T4.

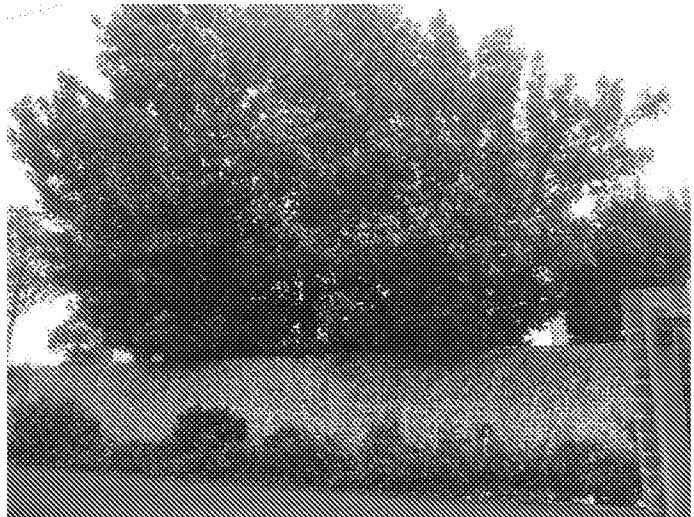
Photograph 3

The tree roots have protruded along the soil border area and under the boundary wall, where cracks have started to appear. There are signs of recent repairs to the wall by the previous land owner where roots have caused some damage.

Damage to the wall was also observed at the base of this tree where recent wall repairs were present

View of tree group T1-T4 and boundary wall.

- 4.12 It is recommended that root barriers are installed on the wall side of any new planting in order to prevent future damage to boundary wall.
- 4.13 It is recommended that specifications on aftercare and maintenance, including irrigation, as well as protection and formative pruning during establishment are included as part of the finalised tree planting proposals. Recommendations should be appropriate to the proposed planting and should be in compliance with of *BS 8545:2014 Trees from nursery to establishment in the landscape- Recommendations*.

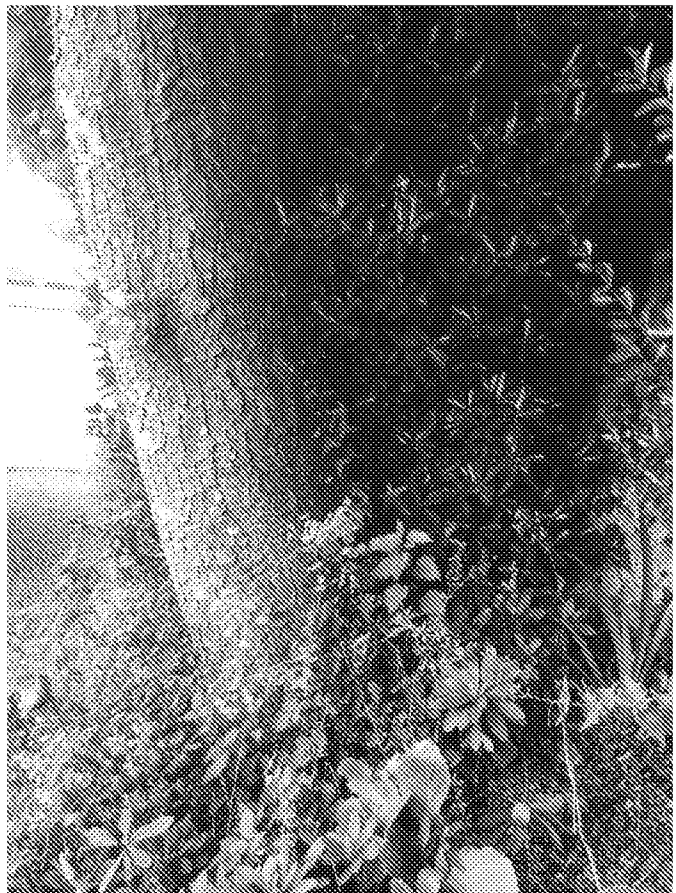
Photograph 4

| Tree Number | Tree Species | Height (M) | Spread (M) | DBH (mm) | Age class | Remaining contribution | Principal Target | Comments | Additional Comments | Recommended Action | Re-inspection frequency |
|---|---|---|---|---|---|---|---|---|---|---|---|
| T3 | Sycamore | 11 | 6 | 460 | M | 20 | Road, driveway, property and wall | Fair specimen, reduced in past, phone wire cross through canopy aphids causing a nuisance | Lean towards driveway and property | Fell and replant | NA |

T3 sycamore view looking west showing leaning towards driveway. towards box elder T27.

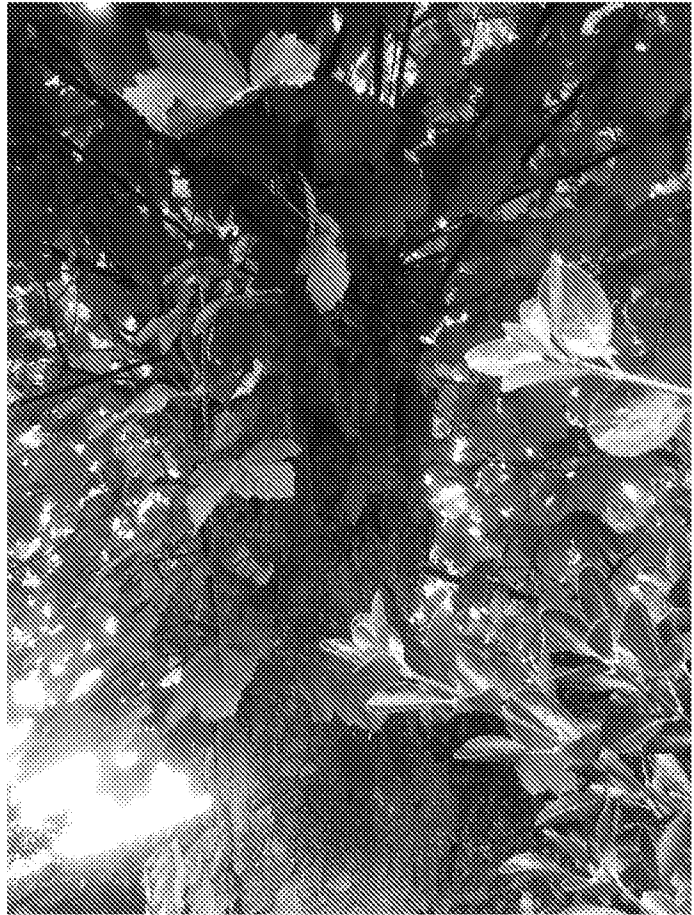
Photograph 5

- ※ Sycamore T3 and T4 was situated to the north of the site as part of the group adjacent to the boundary wall. The tree height was 11m and 9m respectively with T4 having been extensively reduced in the past. These trees have similar attributes as T1 and T2 where their dense canopy obstructs phone wires and aphids are causing a nuisance, damaging cars parked under the canopy. Recent wall repairs were also observed in this area. T3 had a minor lean towards the driveway and property causing its root system to protrude northwards under the wall foundation and potentially causing damage in this area. A cavity was observed on T4 approximately 2.5m in height on the north west aspect of the stem, this cavity was approximately 20cm x 20cm with a depth of 7cm.

T4 sycamore showing cavity in the stem at 2.5m on the eastern aspect. .

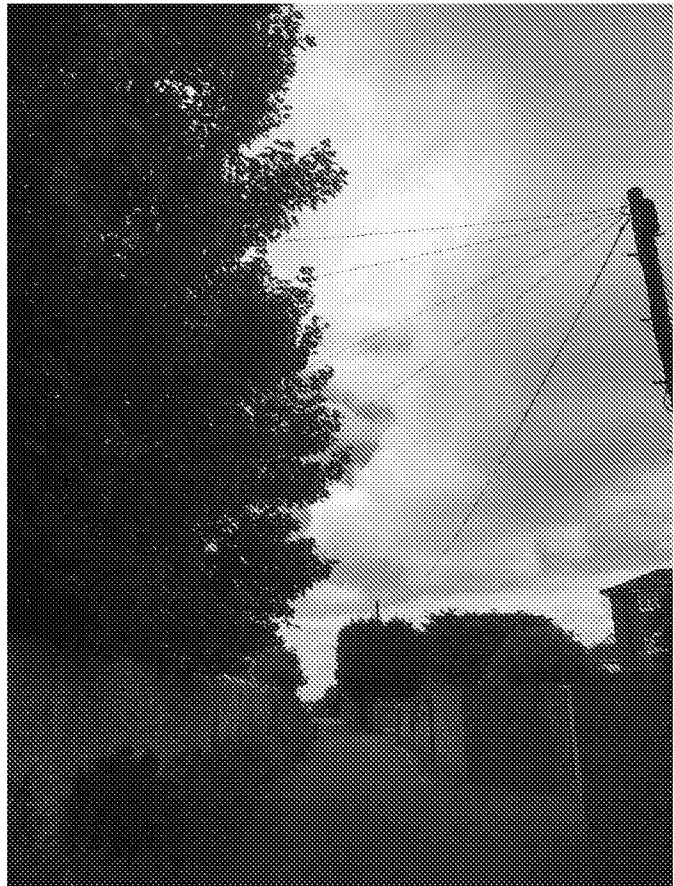
Photograph 6

- 4.5 Additionally, the encroachment of the tree's crowns into the adjacent telephone lines has caused significant disruption to local households, with home based businesses being without telephone services for several weeks.

View looking west towards sycamores T1-T4 showing canopies obstructing the phone wires
