# **ARBORICULTURAL REPORT**

## **Malin House, Aldwick Bay**

**Reference Number: 620.V1**  
**Version: One**

**Date: 02 December 2020**

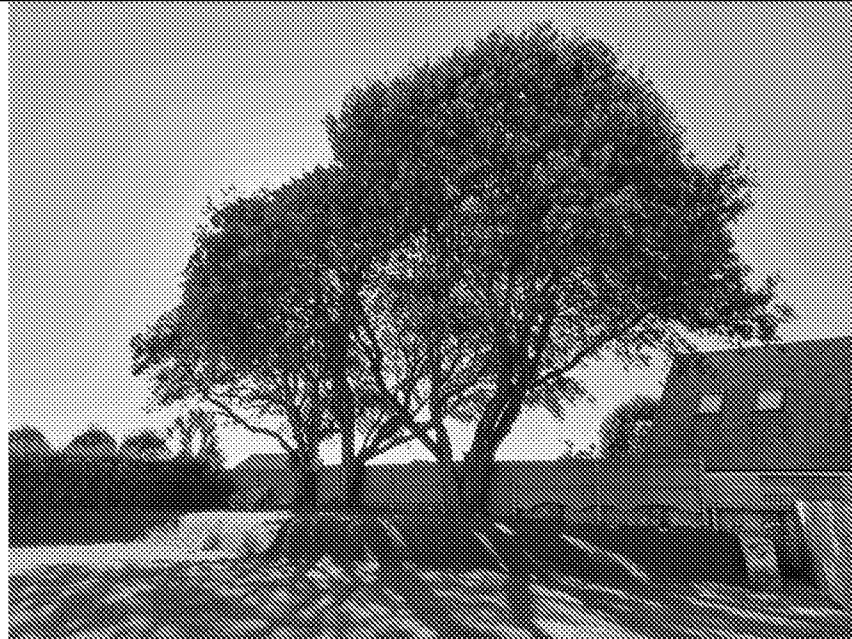
Picture 1. Overview of tree looking west from Malin House. Tree located atop of raised bank.

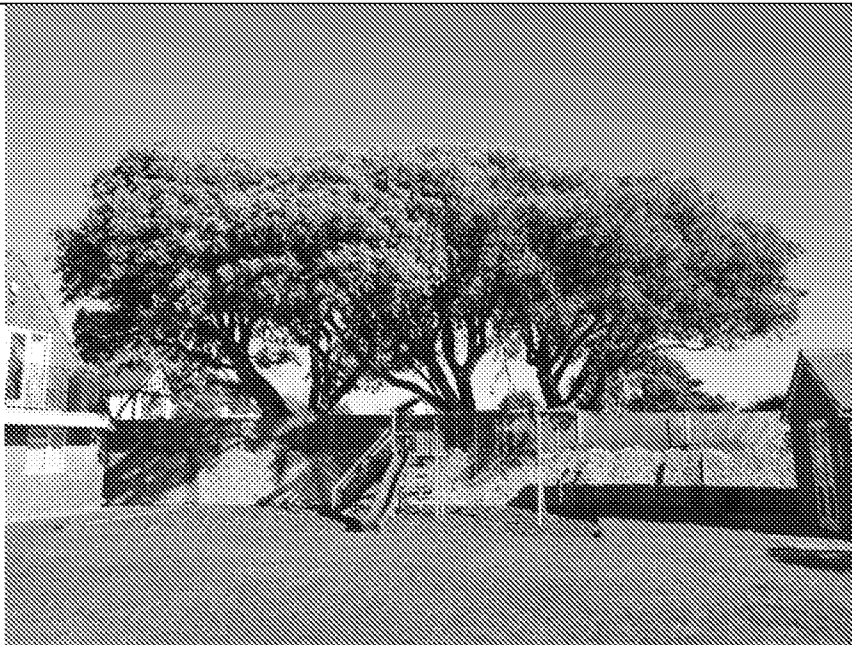
Picture 2. Overview of tree looking east from Sea Crest. Tree located atop of raised bank supported by a retaining wall

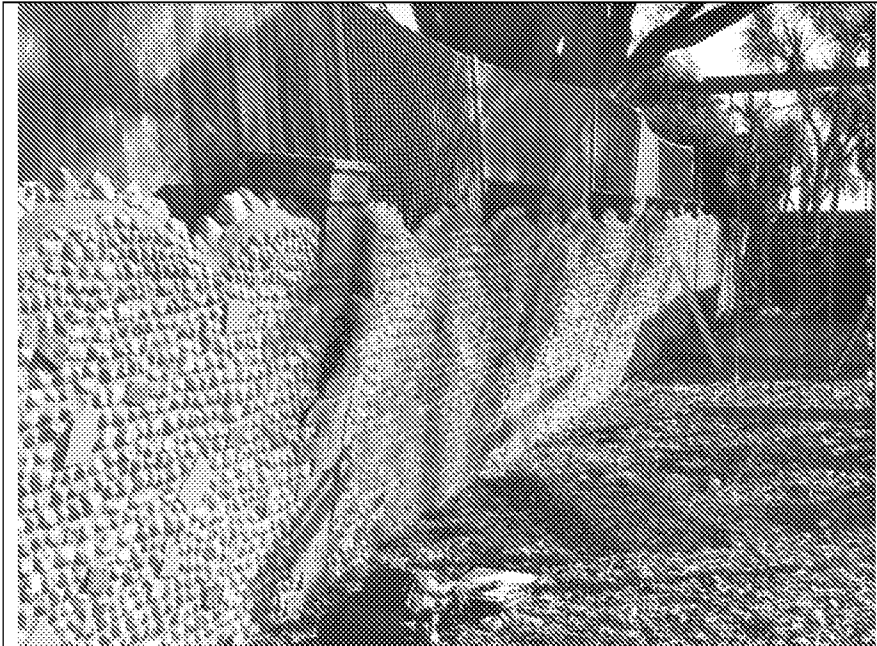
The root growth of the oaks has over a long period of time pushed upon the back of the wall so causing the current lack of verticality. This is such that the wall is now at risk of collapse and whilst at the property I did advise that the neighbours should set up an exclusion zone on their side pending resolution. The ownership of the west boundary wall is currently unknown.

The raised bank has a retaining wall on the boundary side, this wall is the responsibility of Mailin House. The wall is of flint and brick construction that traverses the length of the garden, the wall in the areas close to the trees has been pushed out from direct tree root pressure (see picture 3) this movement off the wall has created space at the higher ground level for roots to develop, the trees have grown large roots that would be considered as primary buttress, the roots occupy this space and being in contact with the wall (see pictures 4 & 5) meaning that reinstatement of the wall in the same location is not possible. The trees are located in an exposed setting on the shoreline, this frequently gets strong wind and heavy rain, this fact added to the fact that the trees retain there leaves year round means that the trees need to resist large amounts of stress, should there be a major change in the soil stability, such as from the failure of the retaining wall. With rain and tree movement from wind it is likely that trees will fail. Therefore, if the retaining wall shall completely fall I will advise the tree owner to apply for a 5 day notice to remove the trees.

Picture 3. Retaining wall in proximity to T1-T3 with significant lean and cracking

If the trees are to remain the physical space now occupied by the their roots now prevents any new boundary retaining wall construction capable of restoring verticality on its west side. Hence if it is desired to retain the trees then either a new wall will need to be constructed a distance to the west away from the boundary or an embankment formed on the neighbours side of the wall. It is I imagine unlikely that the neighbours will happily agree to such a proposition. Failing this and assuming that due permissions can be obtained the trees must be felled and roots ground out. The boundary can then be restored with a new retaining wall or alternatively the ground on the east side lowered such that the levels each side of the boundary are the same. If it is desired to retain the embankment there are many options for a new retaining wall including one of simple block construction of thickness of the order of 225mm set on new foundations say 750mm wide. Such a wall can be faced up to the west side if so desired.

The best course of action would be to reinstate a suitable retaining wall located circa 0.5m west of the current wall, this retaining wall shall be capable of resisting the soil pressure and pressures applied by the trees. This shall be designed by the project structural engineer.

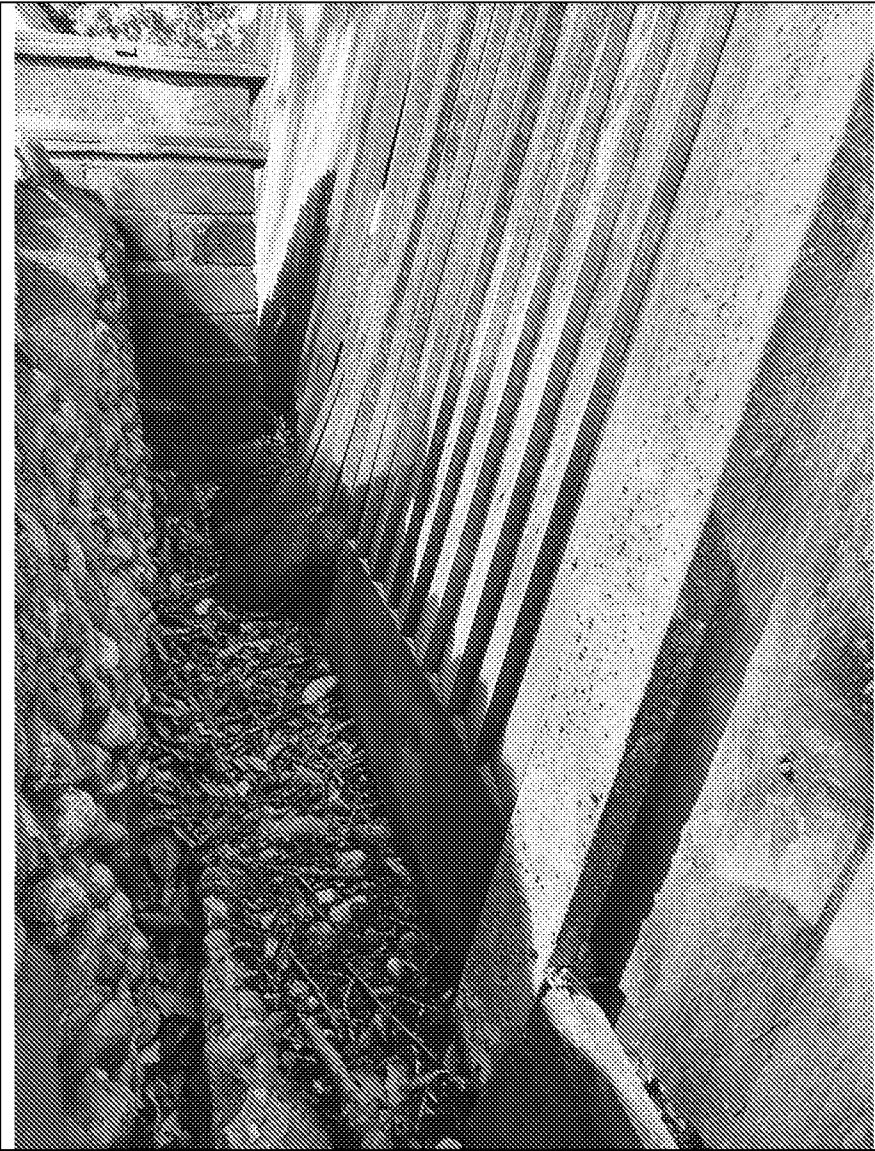
Picture 4. T1 roots in concrete with wall pillar.

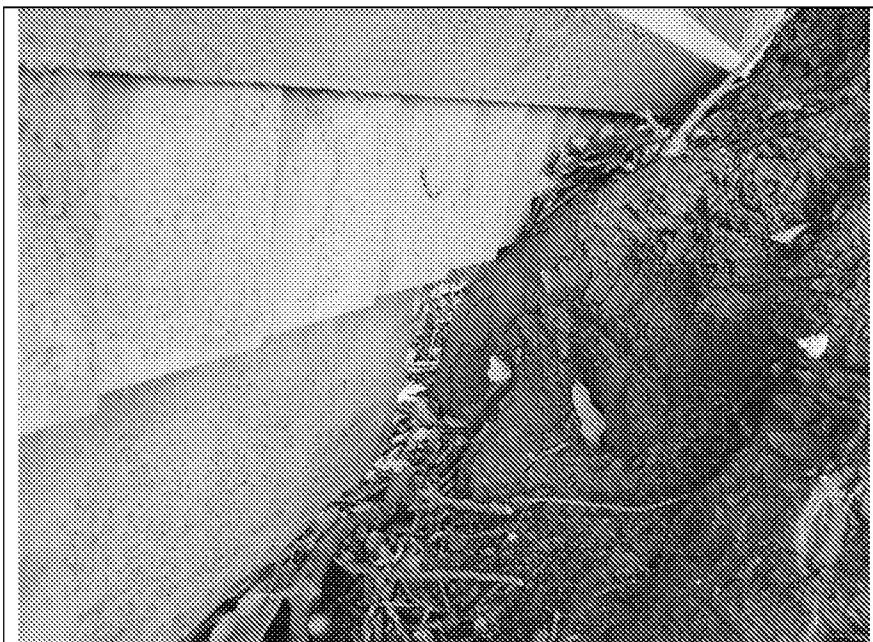
Picture 5. T3 roots in concrete with wall pillar.
