# SUSSEX BUILDING CONSULTANCY LIMITED

**Ref   Movement Cracks in House - Little Drewston, Canons Close,  
Aldwick, Bognor Regis.**

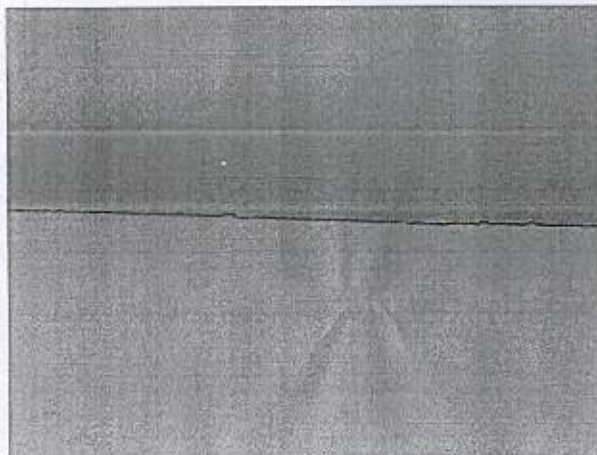
From inspection I noted internal cracking in the ground and first floor rooms facing east. Horizontal cracks of up to 5 mm in width are evident at the junction of walls and ceilings with some vertical cracking adjacent to window reveals, some distress is also shown in the ceiling finishes – see photographs.

Photo 1 – Cracking at the junction of the walls and ceiling.

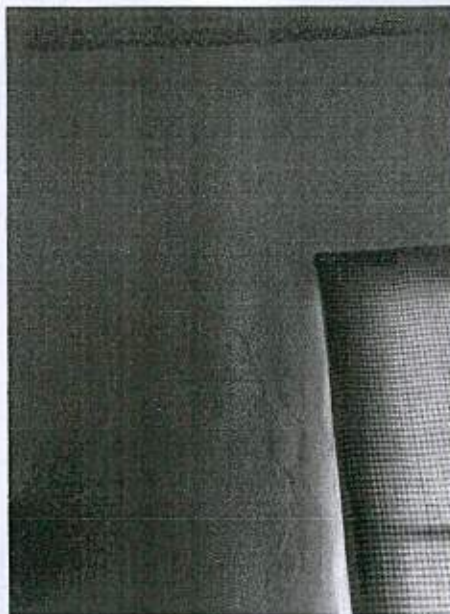
Photo 2 – Vertical cracking adjacent to window.

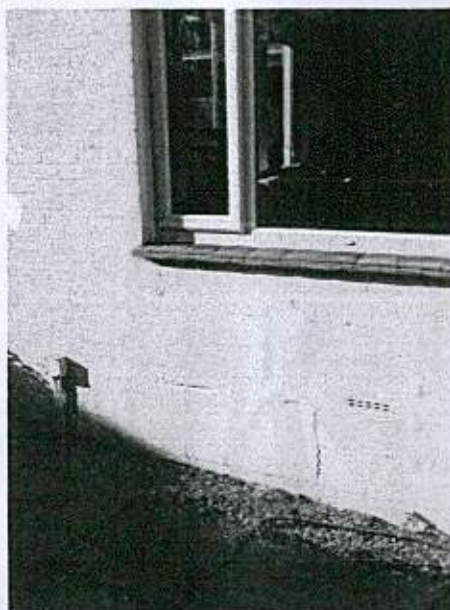
Externally and what is more of a concern is the apparent settlement cracks evident to the eastern elevation under the window with movement apparent where the lintol above this window has settled also – see photographs.

Photo 3 – External cracking below the window.

I would suggest that these settlement cracks are due to movement in the foundations to that portion of the building and when looking at the possible causes of the movement the large Oak tree at a distance of 4 – 5 metres away from the building as the likely cause – see site plan.

My advice would be to seek the removal of the tree, however, because the tree is established, this would need to be removed gradually over a period of a few years to ensure that rapid ground recovery does not result in excessive heave causing further movement of the building.

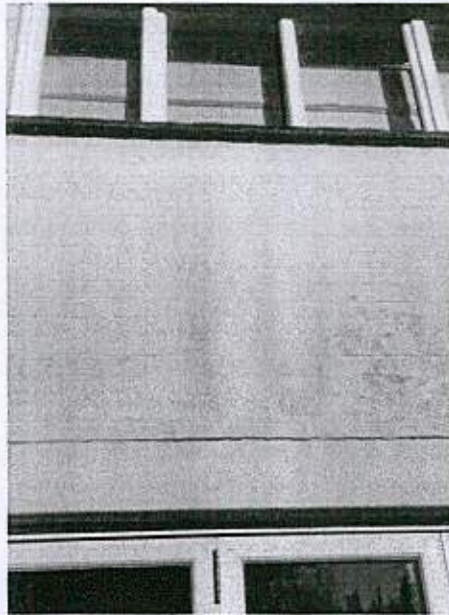
Photo 4 – External window lintol settlement cracks.

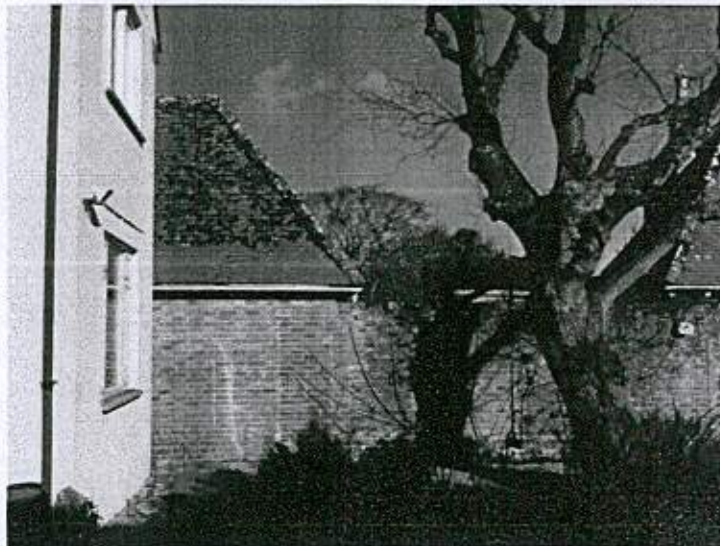
Photo 5 – The Oak tree in the rear garden.

The soil conditions in the Aldwick area are generally found to be a medium shrinkability clay with plasticity index of 20 – 40%. The Oak tree (*Quercus Rober*) is a very high water demand tree with extensive root growth when mature and even when the tree has been trimmed regularly, such is the water demand that it can cause clay shrinkage during dry seasons which can mean that the soil moves away from the underside of the foundations resulting in building settlement.

I am not aware of the depth of the foundations of that part of the building but would estimate a maximum of 1.00 metre deep. Assuming medium shrinkable soil an oak tree would normally dictate a depth of around 2.50 metres using recognised NHBC Tables.
