**From:** Mark Warwick <Mark.Warwick@arun.gov.uk>  
**Sent:** 19 March 2021 17:34  
**To:** Simon Davis <Simon.Davis@arun.gov.uk>  
**Cc:** Daniel Vick <Daniel.Vick@arun.gov.uk>  
**Subject:** 261 Aldwick Road, Aldwick

**Planning Application Ref:** AW/279/18/RES

**Location:** 261 Aldwick Road Aldwick PO21 3QU

**Purpose of visit:** Ad-hoc inspection of approved Tree Protection Measures

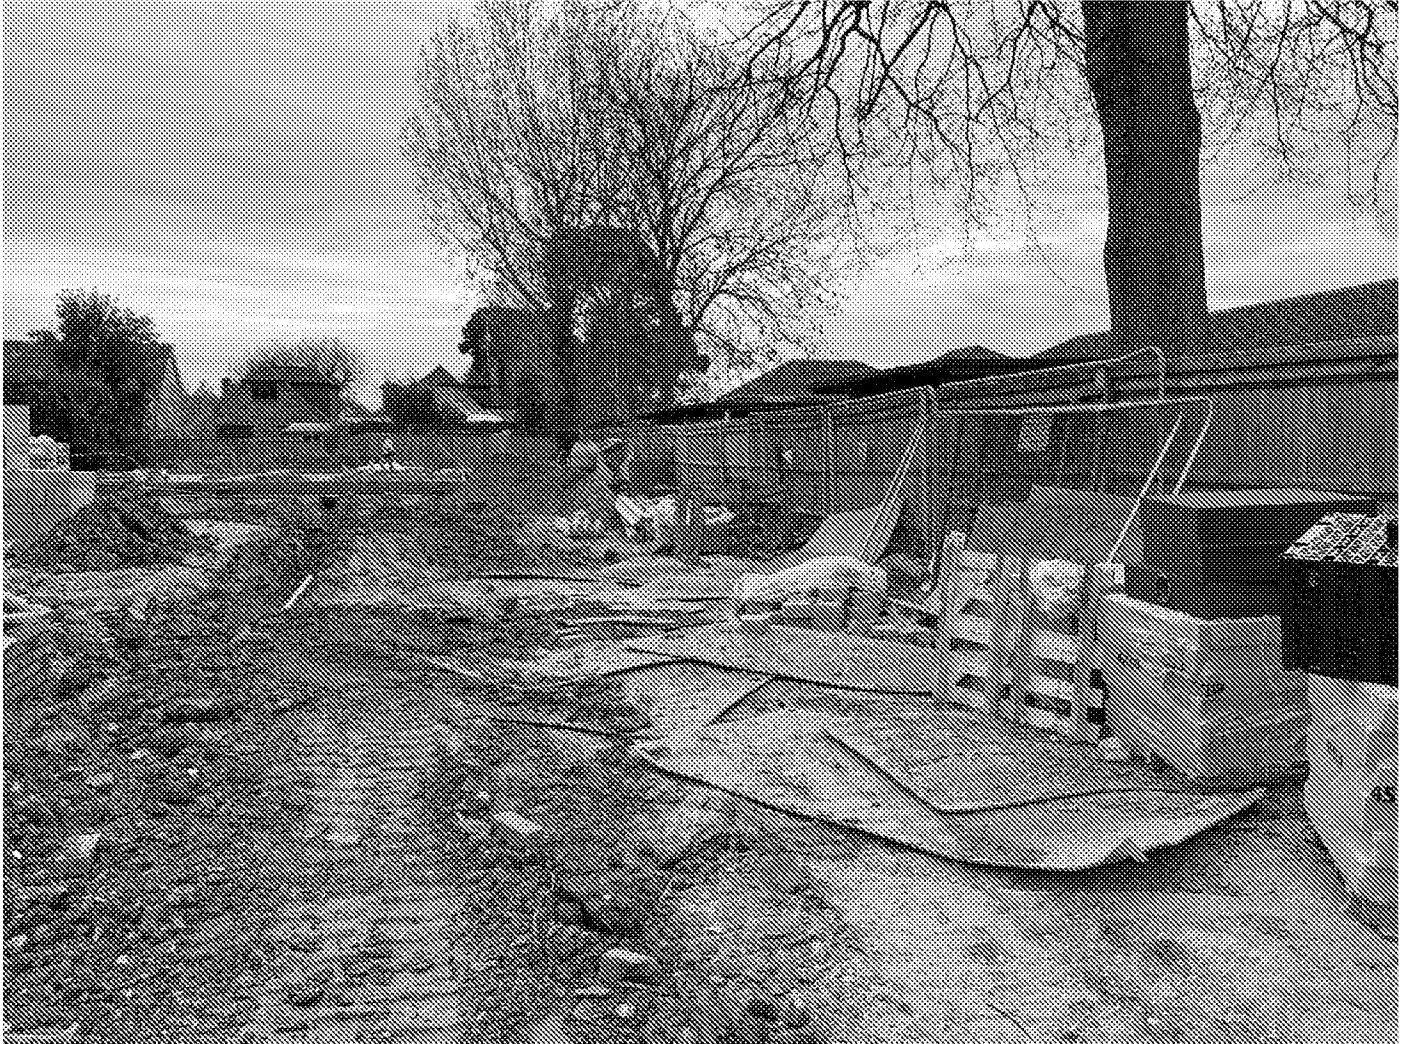
- Dan explained that this state was found when they were first attended site in the last week and that they had needed to construct a service run (open trench). This could doubtless have been achieved with the vast majority (if not all) of ground protection in place. We agreed a plan of action for the immediate short-term; that he would arrange for the boards to be dragged out to form a temporary (if only partially effective) level of protection so that they could conclude operations this week. I can confirm this had been undertaken within an hour of my attending site. I then spoke with Dan's manager, Keith Collier, [REDACTED] – who assured me that they would be finishing that phase of work today.

**Fig.1.** Looking south from near site entrance. T04 Turkey oak (TPO) to the right of frame, in the grounds of Malmayne Court. Note service run (open excavation with grey plastic duct visible) and tracked vehicle marks.

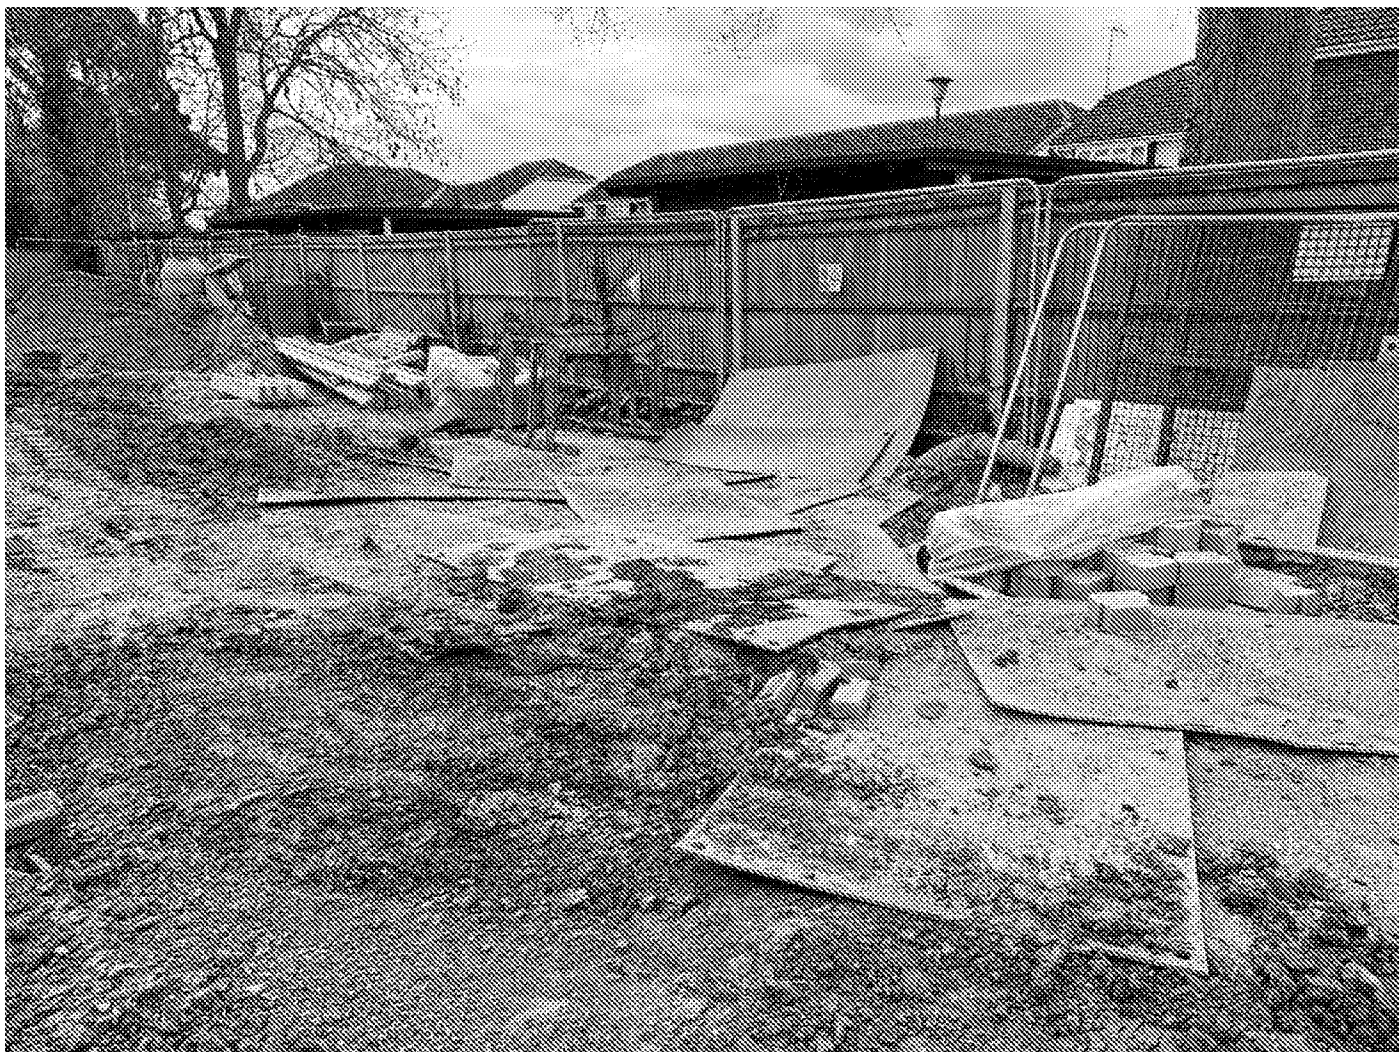
- Groundwork across the site is advanced, with the footprint of all four plots dug out and above ground construction underway.
- Having been approached by one of the operatives (Dan, High Acre Construction), I was able to gain permission to enter the site and make an assessment of T04. The protective mats had been separated and scattered, with very little evidence of topsoil/mulch or woodchip in the RPA. It must be assumed that the bulk of that material has been incorporated and compacted into the subsoil. The geotextile membrane was destroyed. It was clear that a tracked vehicle had been active across large exposed areas of the RPA with consequential smearing and compaction of the soil.

- Materials are also being stored within the now unprotected RPA of T04.
- Despite large areas of RPA being identified for 'No-dig' construction, there was no preparatory ground protection in place. This 'No-dig' area has therefore been compromised once more and we need to ensure adequate ground amelioration and protection is undertaken promptly.

- It is likely that significant damage to the most valuable tree affected by the development has occurred once more, in the form of substantial ground compaction - as a direct result of the activity by groundwork contractors employed by the developer.
- Urgent action must be taken by the developer and their project arboriculturist to arrange for the careful removal of all materials stored within the RPA of T04, effective ground amelioration and installation of ground protection as per the approved plan – as mitigation and to prevent further damage.

**Fig.2.** Looking south-west across exposed RPA of T04 showing deliberate misplacement of unsecured ground protection mats and stored materials within.

- There is clearly a lack of oversight from the developer to ensure their sub-contractors understand why the Tree Protection Plan exists and what is required of them. This should be addressed urgently with a 'toolbox talk' from the

project arboriculturist, as recommended in the approved **Arboricultural Impact Assessment and Method Statement, LLD1425.ARB-REP-001, Rev 02** (para. 5.5).

- This incident should be investigated to determine how this event occurred and referred to our enforcement team to consider any further action. Given the gravity of these omissions, the probable extent of damage sustained and risk of ongoing damage occurring; my personal recommendation is that you place a **Temporary Stop Notice** across the site until such time as we are confident that appropriate investigation, ground amelioration, installation of approved protection measures has occurred under the direction and supervision of their project arboriculturist.
