## **Tree Care Consultant**

### **ARBORICULTURAL REPORT**

**Reference:** MC/197/22

**Location:** Malmayne Court, Aldwick Fields, Bognor Regis, West Sussex, PO21 3SW

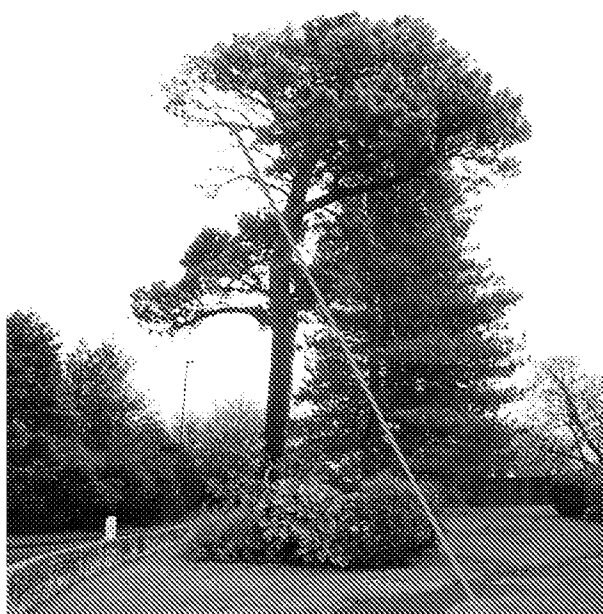
- 5.2 Overall condition stock is good and there is no evidence of recent tree works. Recommendations for work can be found in the schedule of trees.
- 5.3 The tree of most concern is the Monterey Pine T30009 next to Aldwick Road. Major dead wood, old pruning wounds, Crown dieback and a large pruning wound at buttress. Foliage is sparse. Condition suggests tree in decline but not sufficient to obtain permission to be removed by Arun District Councils Tree Officer. All that I suggest currently is to remove the deadwood in the crown. Would be worth considering planting a standard tree now to replace it, a deciduous species such as Maple, Oak or an aphid resistant Lime. This tree does not appear to have a Tpo on it but I would advise checking with Arun DC when applying for works.

**Fig 2 T3009 Monterey Pine showing dying branches**

| Tag No | Common Name | Height (m) | Stem Dia (mm) | Spread Radius (m) | Maturity | Overall condition | Recommended Work | Priority | Comments |
|---|---|---|---|---|---|---|---|---|---|
| T9<br>03009 | Monterey Pine | 20 | 900 | 5 | Over Mature | Poor | Remove Major deadwood in the crown. Review decline annually | 1 year | Major dead wood, old pruning wounds. Crown dieback. Large pruning wound at buttress. Foliage is sparse. Soil heave. Condition suggests tree in decline. |

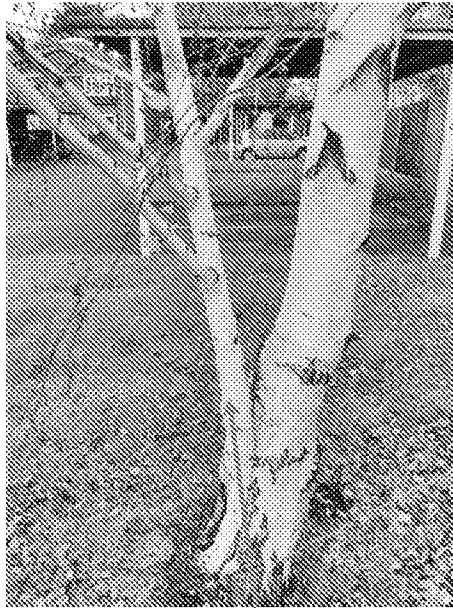
**Fig 3 T03004 Birch remove small limb at base**

| Tag No | Common Name | Height (m) | Stem Dia (mm) | Spread Radius (m) | Maturity | Overall condition | Recommended Work | Priority | Comments |
|---|---|---|---|---|---|---|---|---|---|
| T4<br>03004 | Silver Birch | 10 | 170 | 2 | Early Mature | Fair | Remove small stem at buttress and raise low canopy to 2.5m | 1 year | Secondary stem at buttress with low canopy |

- 5.4 The Silver Birch T03004 has a small secondary stem at the buttress and I recommend removing close to main stem.
- 5.5 The two Monterey Pines T03007 & 08 require crown lifting by taking low branches back to main stem to give 3m head clearance.

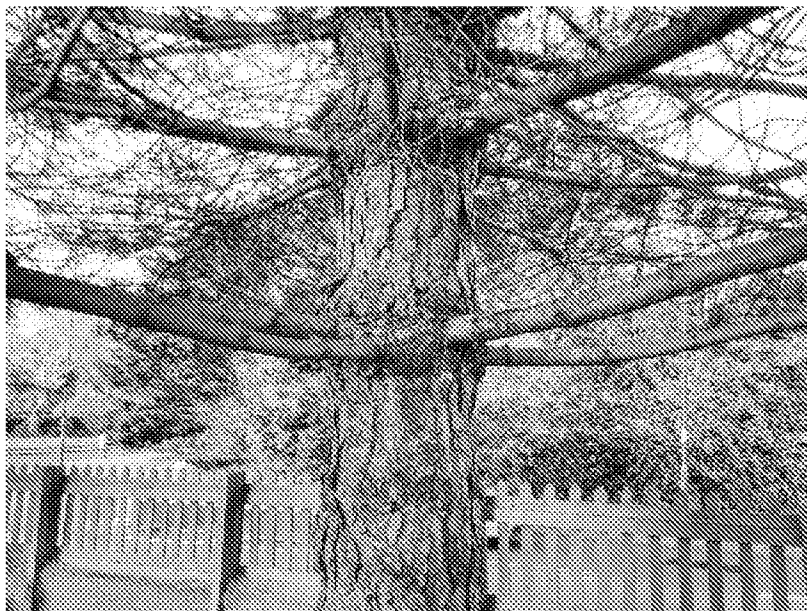
**Fig 4 T30008 Remove two lowest whorls of branches**

| Tag No | Common Name | Height (m) | Stem Dia (mm) | Spread Radius (m) | Maturity | Overall condition | Recommended Work | Priority | Comments |
|---|---|---|---|---|---|---|---|---|---|
| T8<br>03008 | Monterey Pine | 19 | 470590 | 6 | Mature | Good | Raise low canopy to 3m | 1 year | Low hanging branches, Minor dead wood with pruning wounds. Stem breaks into 4 at 3m |

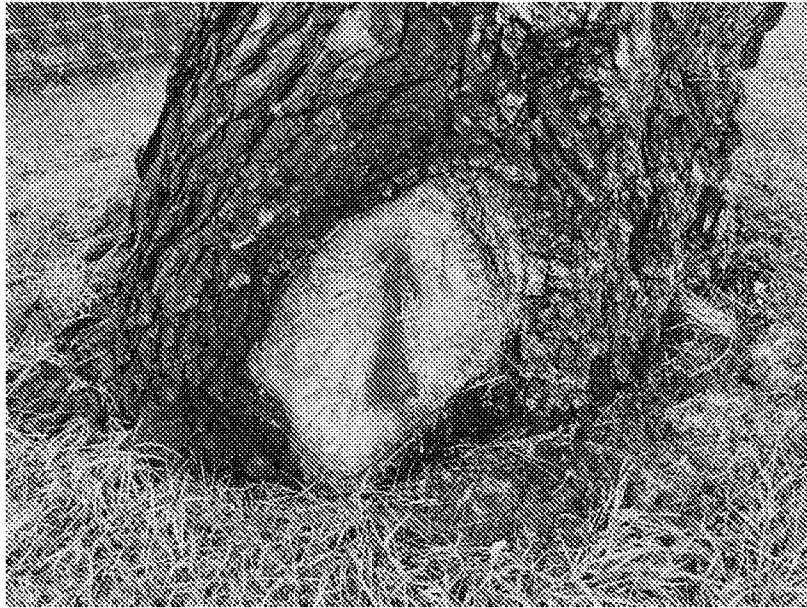
**Fig 5 Pruning wound at base of trunk of T3009**
