## TREE SURVEY REPORT

EAST DRIVE, ANGMERING, WEST SUSSEX, BN16 4JH

**August 2019**

**Report reference: CTS-0JNG-tsr-01**

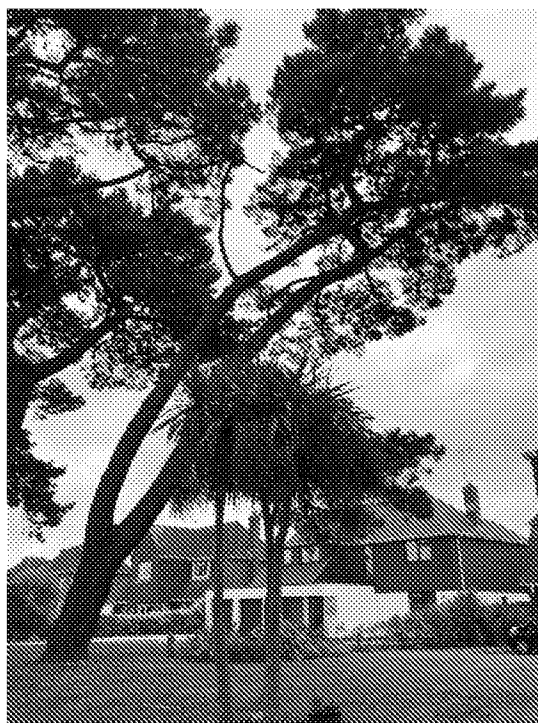
This is a heavily suppressed specimen of significant size. It has formed a compression fork and included bark at its bifurcation point at 2.5m above ground level, and the canopy is now entirely offset from its base. This is causing excessive end-weight and puts the tree at additional risk of collapse. Whilst its currently sheltered from the prevailing winds by the surrounding specimens, the proposed removal of the trees to the south-east (nos. 9, 10 and 12) would lead to an alteration in wind dynamics acting on the canopy. The relevance of wind dynamics is discussed throughout this report.

*Photograph 1: showing the heavily suppressed and leaning nature of the Monterey pine (no. 8).*

| No. | TPO no. | Species | Height | Trunk diameter | Crown Spread | Age class | Physiology | Structure | Comments | Likelihood of failure | Likelihood of impacting target | Likelihood of failure & impact | Consequences of failure | Overall risk rating |
|---|---|---|---|---|---|---|---|---|---|---|---|---|---|---|
| 8 | TPO/A/4/78 | Monterey pine ( <i>Pinus radiata</i> ) | 14m | 890mm | NE12m<br>E3m<br>S1m<br>W3m | Mature | Average | Poor | Twin-stemmed from 2.5m; trunk leans heavily to NE; canopy entirely offset from centre; species with a high propensity for branch failure, as evidenced by recent branch failures within vicinity. | Probable | Medium | Somewhat likely | Significant | Moderate |

| Tree no. | TPO ref. | Species | Pruning specification | Priority | LPA consent required? |
|---|---|---|---|---|---|
| 8 | TPO/A/4/78 | Monterey pine | Fell to ground level | 3 Months | Yes |

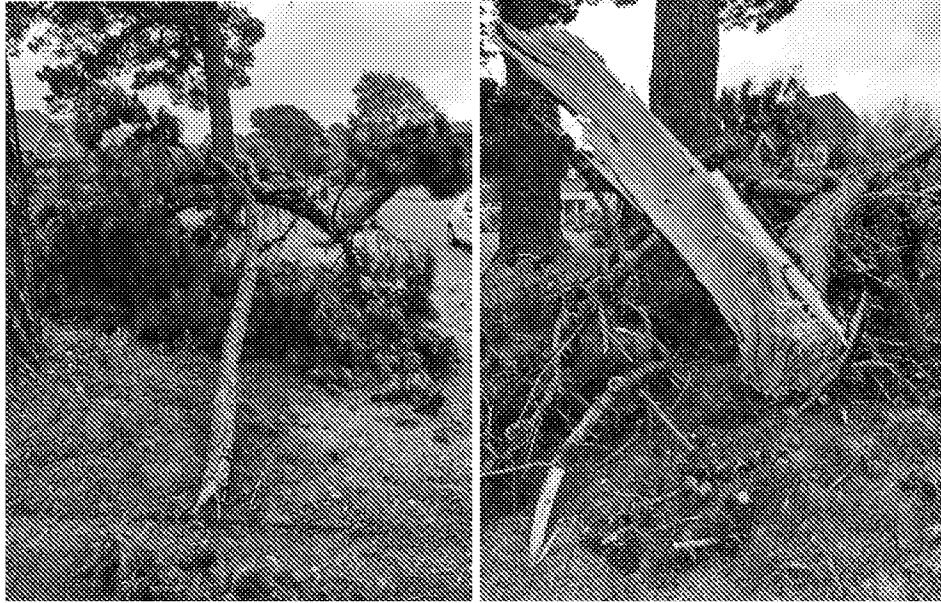
These two trees currently form an aerodynamic canopy which appears to have been managed as a single entity. However, a large branch recently failed from within the canopy of no. 10, as shown overleaf.

*Photographs 2 and 3: showing the recent branch failure from within the canopy of Monterey pine (no. 10).*

Following this failure, the canopy of no. 10 has been reduced by approximately 70% in terms of overall canopy size, and further branch failures are foreseeable.

| No. | TPO no. | Species | Height | Trunk diameter | Crown Spread | Age class | Physiology | Structure | Comments | Likelihood of failure | Likelihood of impacting target | Likelihood of failure & impact | Consequences of failure | Overall risk rating |
|---|---|---|---|---|---|---|---|---|---|---|---|---|---|---|
| 10 | TPO/A/4/80 | Monterey pine ( <i>Pinus radiata</i> ) | 23m | 790mm | 6m | Mature | Reduced | Poor | Necrotic bark noted on NW aspect of base, reveals dry, cubical sapwood; tree has recently shed one large branch from south side of canopy, resulting in loss of almost all canopy on this aspect; approx. 30% of original canopy cover remains; at risk of further branch failure; branch failure likely to have been caused by alterations to wind dynamics caused by removed of adjacent specimen (no. 11). | Probable | Medium | Somewhat likely | Significant | |

| Tree no. | TPO ref. | Species | Pruning specification | Priority | LPA consent required? |
|---|---|---|---|---|---|
| 10 | TPO/A/4/80 | Monterey pine | Fell to ground level | Urgent | Yes |

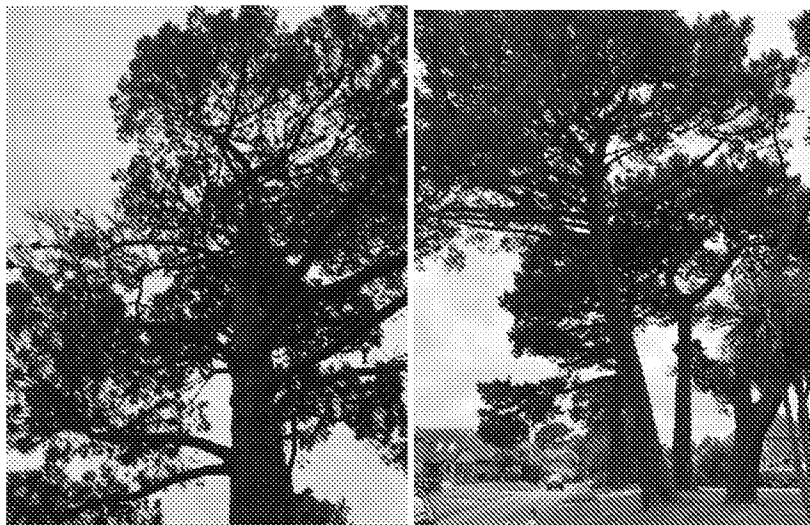
The canopy of no. 9 is become sparse towards the upper extremities. This is consistent with the general pattern of a tree dying back from its tips due to physiological decline. The removal of no. 10 in combination with the dieback identified within the canopy of no. 9 results in the only cost-effective solution being tree removal.

*Photographs 4 and 5: showing the sparse areas of no. 9 against the dense foliage of adjacent trees.*

| No. | TPO no. | Species | Height | Trunk diameter | Crown Spread | Age class | Physiology | Structure | Comments | Likelihood of failure | Likelihood of impacting target | Likelihood of failure & impact | Consequences of failure | Overall risk rating |
|---|---|---|---|---|---|---|---|---|---|---|---|---|---|---|
| 9 | TPO/A/4/79 | Monterey pine ( <i>Pinus radiata</i> ) | 21m | 1000mm | 6m | Mature | Reduced | Indifferent | Sparse needle coverage, particularly in the upper canopy; smaller than normal needle size; forms an aerodynamic canopy with adjacent tree (no. 10), and likely with the recently removed specimen (no. 11); adjacent specimen (no. 10) recently shed large branches causing alterations to wind dynamics within canopy of this tree, increasing likelihood of failure; species with a high propensity for branch failure, as evidenced by recent branch failures within vicinity. | Probable | Medium | Somewhat likely | Significant | Moderate |

| Tree no. | TPO ref. | Species | Pruning specification | Priority | LPA consent required? |
|---|---|---|---|---|---|
| 9 | TPO/A/4/79 | Monterey pine | Fell to ground level | Urgent | Yes |

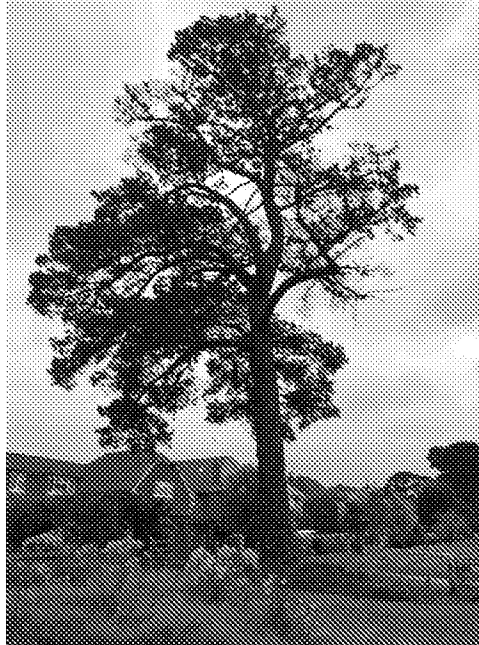
This specimen is showing significant dieback within its upper canopy and appears to be in a state of permanent and irreversible physiological decline, and so the only reasonable management option is to remove the tree.

*Photograph 6: showing significant dieback in the canopy of Monterey pine (no. 12)*

| No. | TPO no. | Species | Height | Trunk diameter | Crown Spread | Age class | Physiology | Structure | Comments | Likelihood of failure | Likelihood of impacting target | Likelihood of failure & impact | Consequences of failure | Overall risk rating |
|---|---|---|---|---|---|---|---|---|---|---|---|---|---|---|
| 12 | TPO/A/4/81 | Monterey pine ( <i>Pinus radiata</i> ) | 24m | 990mm | 8m | Mature | Poor | Hazardous | Bark platelets easily removed during inspection with acoustic mallet; bark necrosis noted around base; lack of prominent buttress roots with swollen appearance at base; large sections of dieback in upper canopy, comprising branches with estimated diameters >250mm; appears to be in a state of permanent and irreversible physiological decline. | Probable | Medium | Somewhat likely | Significant | Moderate |

| Tree no. | TPO ref. | Species | Pruning specification | Priority | LPA consent required? |
|---|---|---|---|---|---|
| 12 | TPO/A/4/81 | Monterey pine | Fell to ground level | Urgent | Yes |

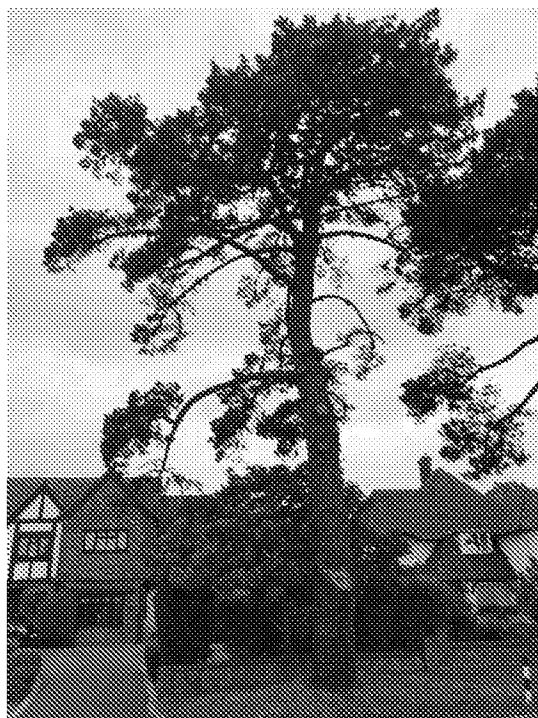
This is a sizeable tree growing at the western end of a group of trees. It has become overtopped by no. 14, the dominant specimen within the group, and now shows slight needle sparsity in its upper canopy. In addition, the lateral branches now have an etiolated appearance with the foliage being focussed even further towards the branch tips than normal. Consequently, its pre-emptive removal would mitigate the risk of branch failure in the future.

*Photograph 7: showing a reduction in physiological function leading to sparseness in the canopy of Monterey pine (no. 13)*

| No. | TPO no. | Species | Height | Trunk diameter | Crown Spread | Age class | Physiology | Structure | Comments | Likelihood of failure | Likelihood of impacting target | Likelihood of failure & impact | Consequences of failure | Overall risk rating |
|---|---|---|---|---|---|---|---|---|---|---|---|---|---|---|
| 13 | TPO/A/4/82 | Monterey pine<br>( <i>Pinus radiata</i> ) | 20m | 940mm | 8m | Mature | Reduced | Indifferent | Large bark platelets easily removed when assessed with acoustic hammer; sparse leaf coverage; minor dieback at branch tips; appears to be in the early stages of physiological decline. | Possible | Medium | Unlikely | Significant | Low |

| Tree no. | TPO ref. | Species | Pruning specification | Priority | LPA consent required? |
|---|---|---|---|---|---|
| 13 | TPO/A/4/82 | Monterey pine | Fell to ground level | 3 Months | Yes |
