GROUND CONDITION ASSESSMENT  
WATER LANE, ANGMERING

MCCARTHY STONE LIMITED  
February 2021

| VERSION | DATE | DESCRIPTION | REPORT REFERENCE | CREATED | REVIEWED |
|---|---|---|---|---|---|
| 1.0 | 26.02.21 | First issue | 5013719-RDG-XX-ST-DOC-C-01-GCA | RG/PB | RJH |

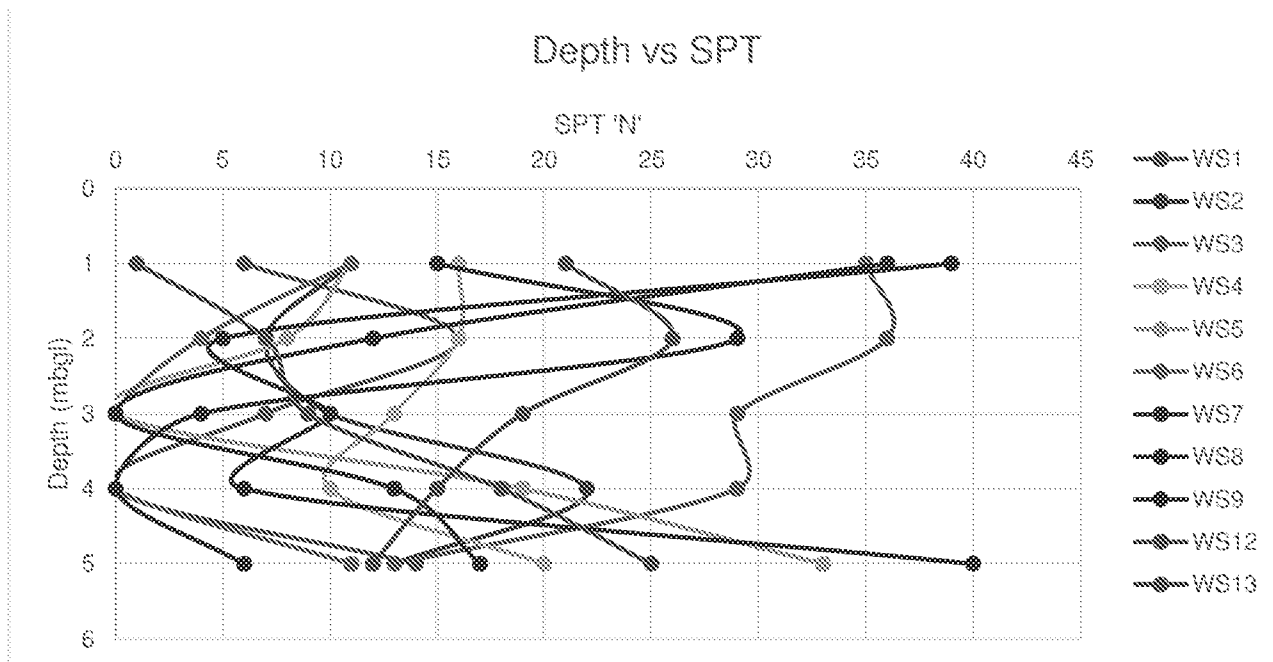
Graph 8.1: Standard Penetration Testing

Based on the variable and low SPT[N] values recorded in the upper natural materials and presence of groundwater at relatively shallow depth, it is considered that the ground conditions identified are not suitable for traditional foundations for the proposed development.

It is therefore recommended that an alternative foundation solution is pursued. It is considered that this will likely comprise piled foundations extending into competent strata expected at depth beneath the site.
