02 December 2014

our ref: e14166.001

**Re: Church Farmhouse, Rectory Lane, Angmering, West Sussex**

# APPENDIX A

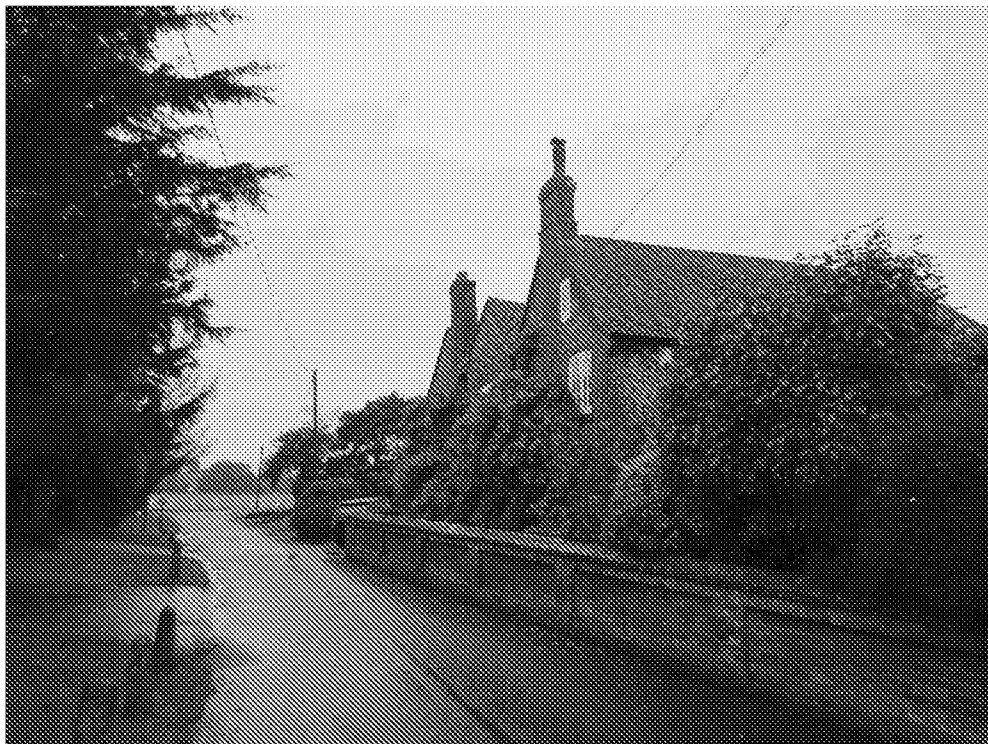
The chimney stack in question is located on the westernmost end of the southern gable to the property (Refer to Photograph 1, 2, 3 as attached to Appendix A to this Report).

The stack is brick – built as part of the south facing flintwork gable wall and extends some 2.50m above the sloping roof line to the gable.

▲ 1 South facing gable walls showing chimneys (westernmost stack in distance)

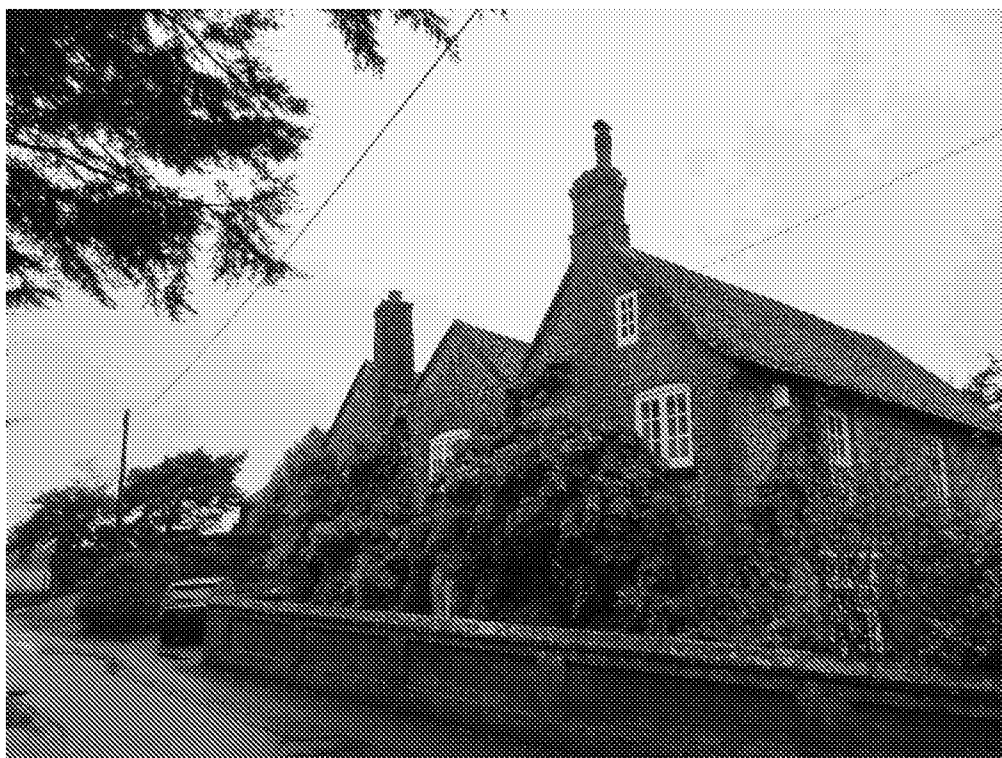
▲ 2 South facing gable walls showing chimneys (westernmost stack in distance)

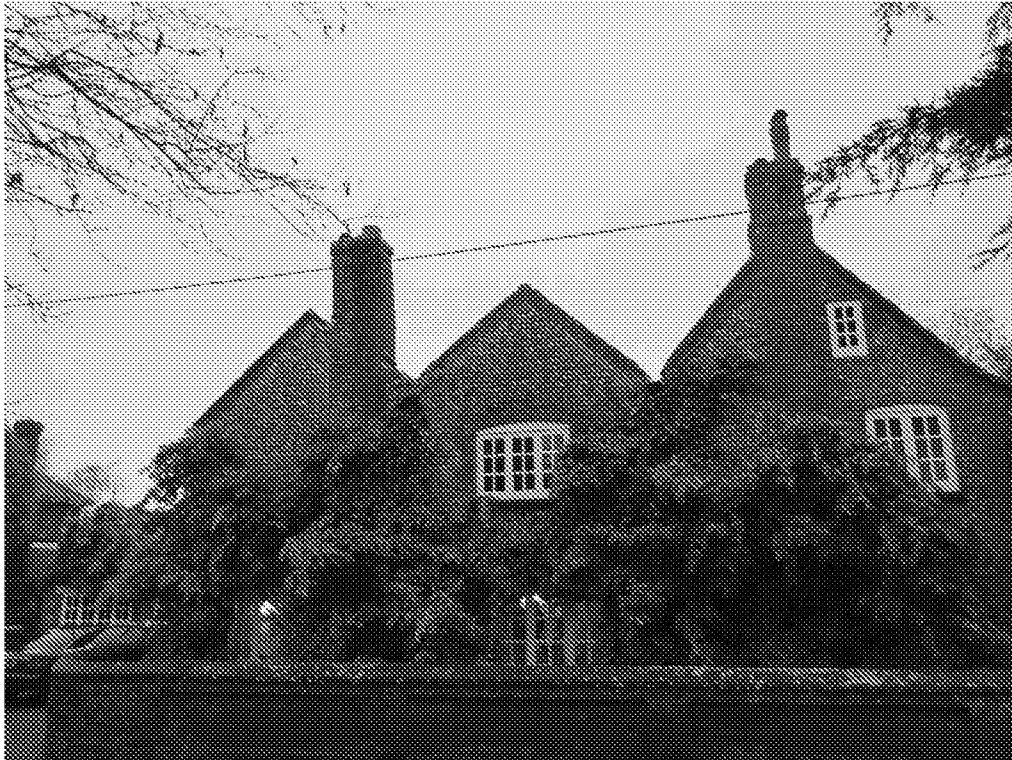
▲ 3 South facing gable wall (westernmost chimney stack shown to the left)

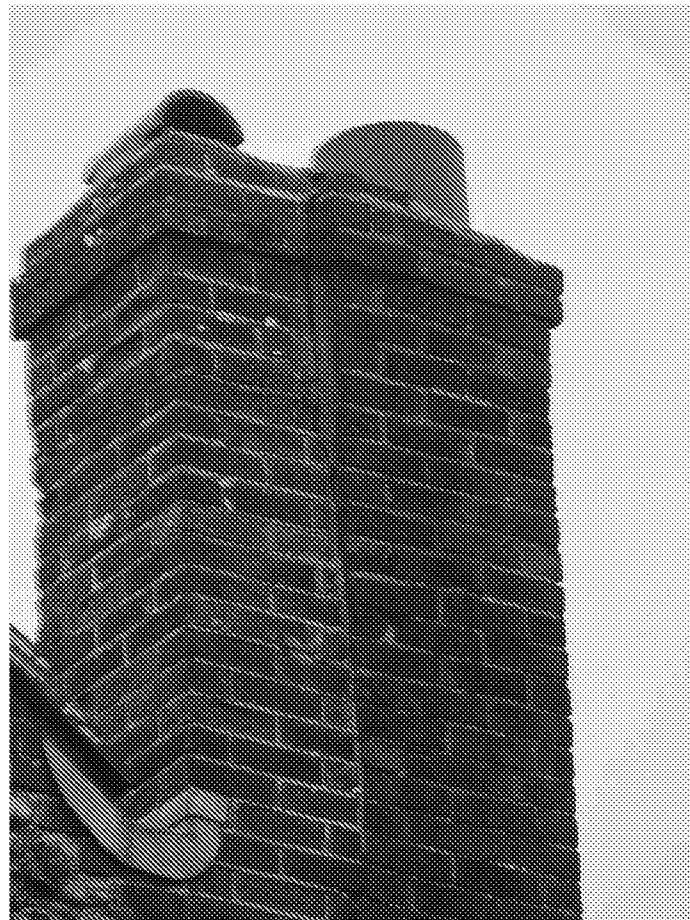
We noted that the 2 flues were not bonded together, but joined with a vertical 'butt' joint for its full height above the sloping roof line (Refer to Photograph 4, 5 as attached to Appendix A to this Report).

There has been some recent separation between the two flues as evidenced by the clear gap which can be seen between them.

▲ 4 Stack comprises 2no separate flues 'butted' together – straight vertical joint

At this stage in our opinion, it is likely that permanent works will include the complete taking down of the existing stack to roof line level, and re – building as a single fully –bonded brick stack to match existing.

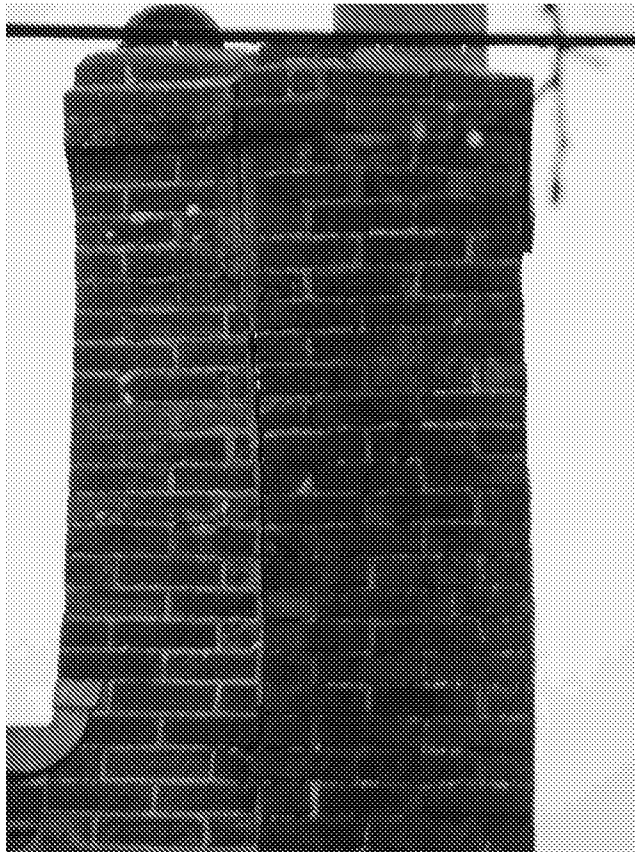
▲ 5

Stack comprises 2no separate flues 'butted' together – straight vertical joint – note daylight between

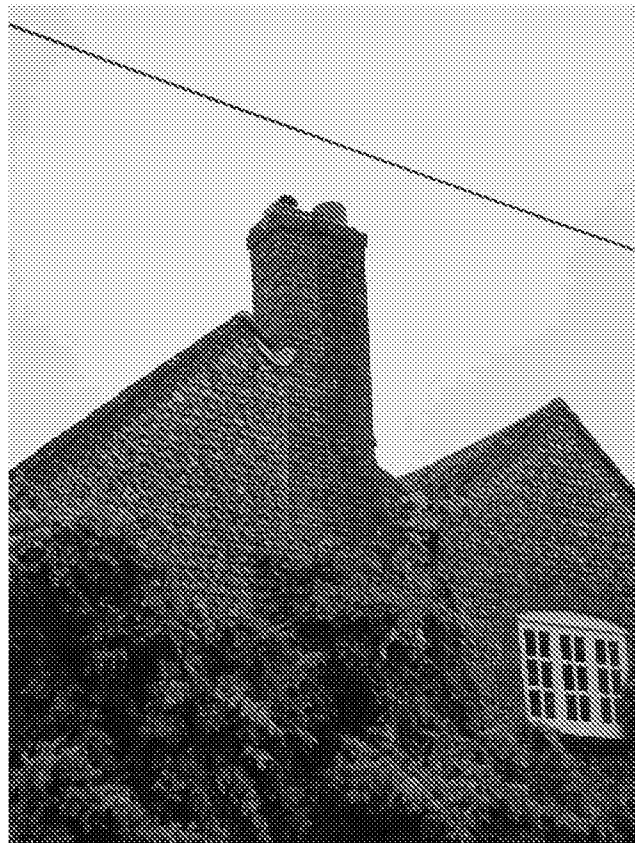
▲ 6

Both flues have a significant lean in two directions, to the west and to the south (Refer to Photograph 6, 7 as attached to Appendix A to this Report).

It would appear to us that the older flue most likely was leaning to the west and to the south, prior to the later westernmost flue being added.

The condition of the chimney stack is such that we have some significant concerns as to its structural integrity.

The significant two – directional lean of the flues together with the apparent separation of the brickwork between the flues is such that we would recommend that urgent remedial action is taken in order to render the stack structurally safe in the short term.

Stack leans to west and south

As discussed immediate short term measures would include the erection of a suitably - designed scaffold tower around the chimney stack as a structural 'cradle' in order to provide temporary lateral support.

In addition, temporary stainless steel bands should be installed around the stack itself as a secondary means of support. Care should be taken so as to ensure that the band are not over – tightened and cause the brickwork to fail in compression.

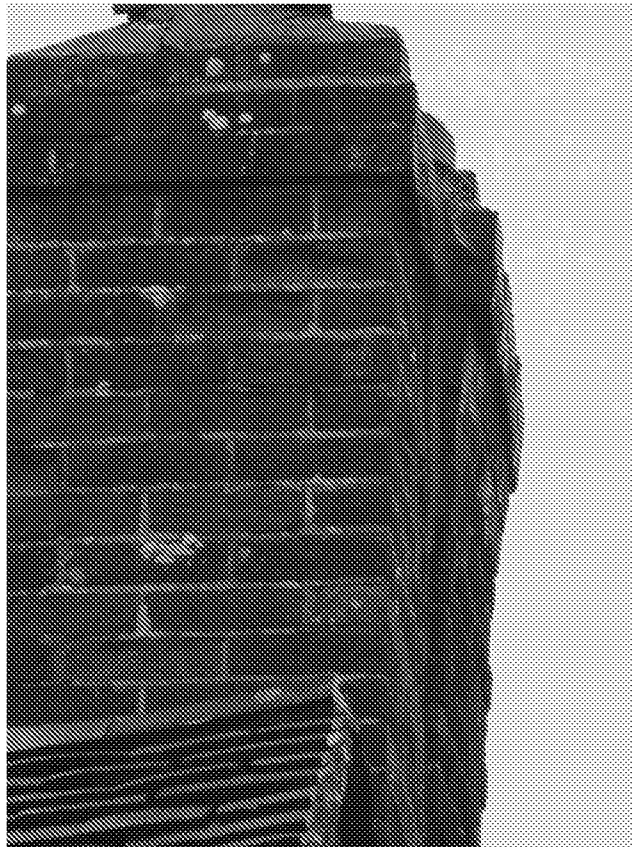
▲ 7 Stack leans to south

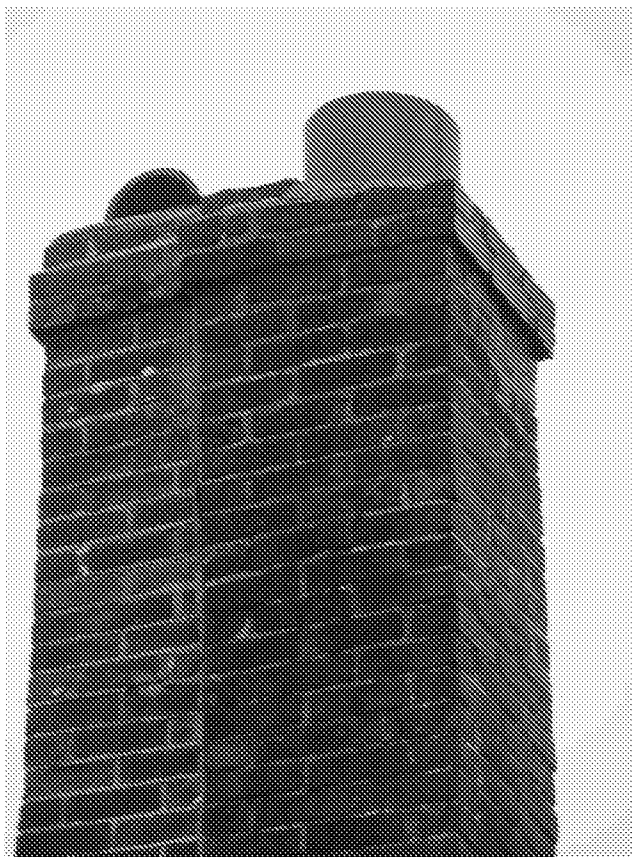
The westernmost flue was then constructed with a lean, in order to follow the line of the original flue. (Refer to Photograph 8 as attached to Appendix A to this Report).

▲ 8 Westernmost stack constructed at later date to follow 'lean' of eastern stack
