# **ARBORICULTURAL REPORT**

## **Land adjacent to Holly Lodge, Rectory Lane**

**Reference Number: 0758**  
**Version: One**

**Date: 30 May 2022**

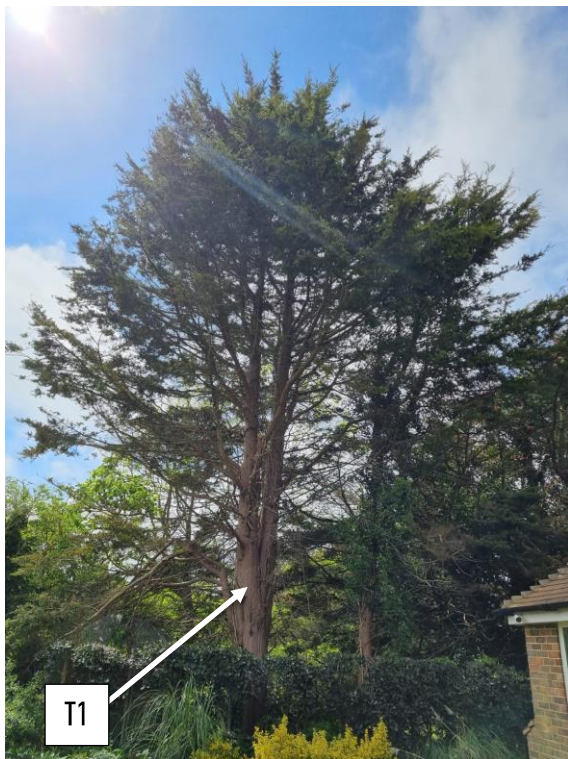
Picture 1. Overview of T1 from east with trunk shown

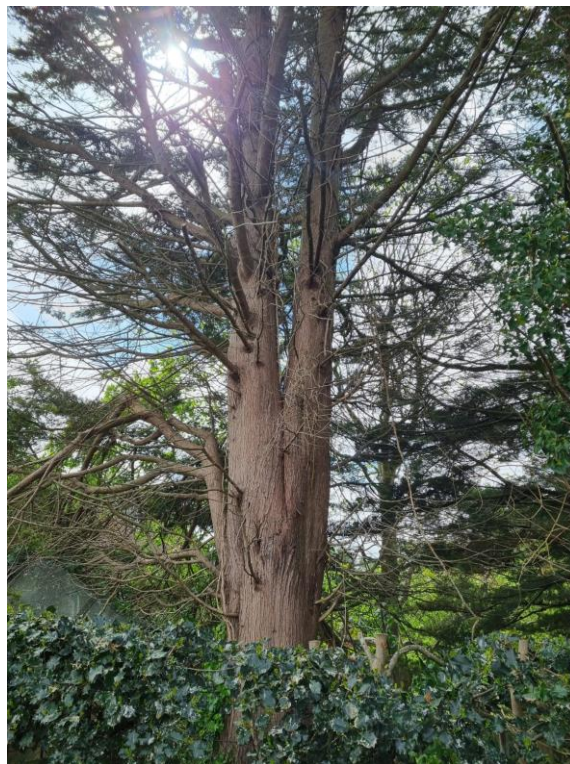
Picture 2. T2 at closer view from east showing east side of included bark union and broken branches

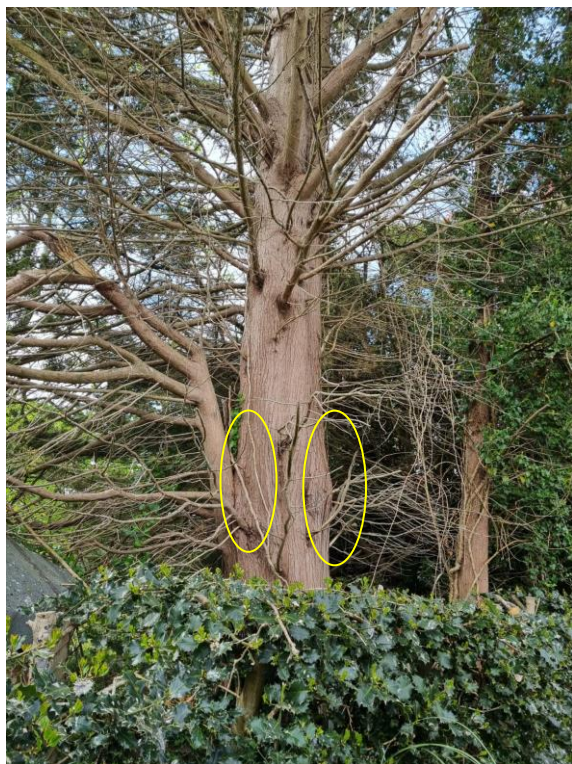
The tree T1 Leyland Cypress is codominant in that it sits within a group of trees and has developed as such, the local growing environment has recently changed with the loss of adjacent tree from failure in strong wind. T1 has a decreased level of vigour than would be expected of the species. There are broken parts to the lower crown and of major note is the include bark union where the stem bifurcates; this union is between c.2.5 and 3.5m. The union between stems transects between west and east with the eastern side having a 'big ear', this is an indication that the tree's ability to react to stress and loading at this point is compromised as there is little growth over the crack, if any. To the west of the union is a 'smaller ear' indicating that this side has a greater level of reaction growth although it is still evident of an ear and an increased zone of stress.

Picture 3. T1 from south east showing swelling at area of tight included bark union

The tree T1 Leyland Cypress shall have action taken to address the hazard it poses to the dwelling of Holly Lodge.  
It is recommend given the factors of the tree and location that the tree be felled.

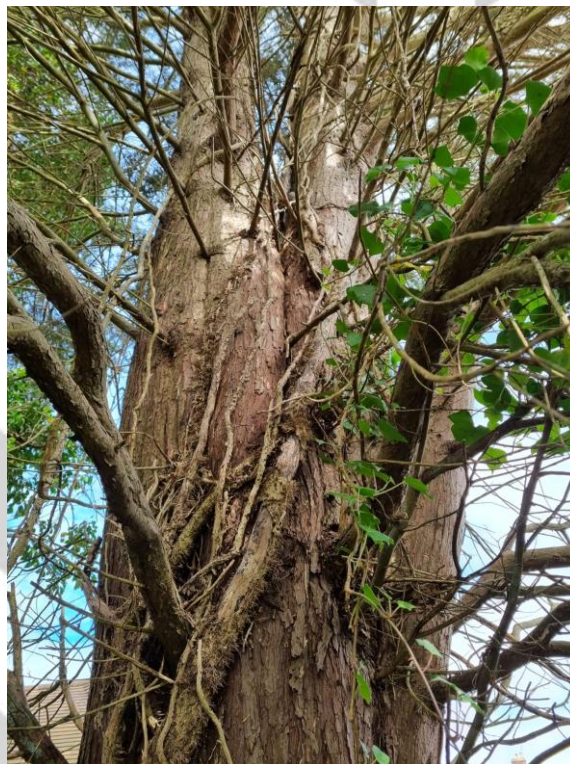
Picture 4. T1 from west side showing west side of included bark union with swelling 'ridge' or 'ear'

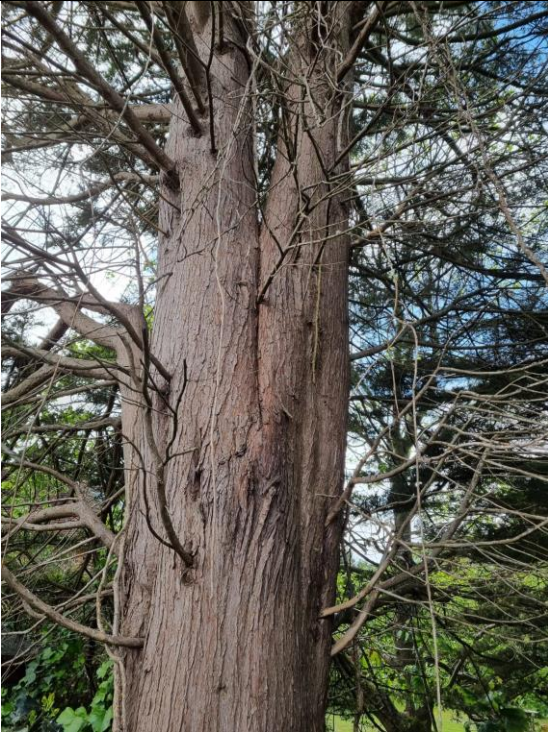
Picture 5. T1 from east side showing west side of included bark union with swelling 'ridge' or 'ear'
