**Bellamy Wallace Partnership**  
Consulting Structural Engineers

**REPORT ON VISUAL INSPECTION OF  
CONDITION OF EXISTING BUILDINGS AT  
SITE OF PROPOSED REDEVELOPMENT**

**Arundel Road  
Angmering,  
Littlehampton,  
BN16 4ET**

Job No: K2327

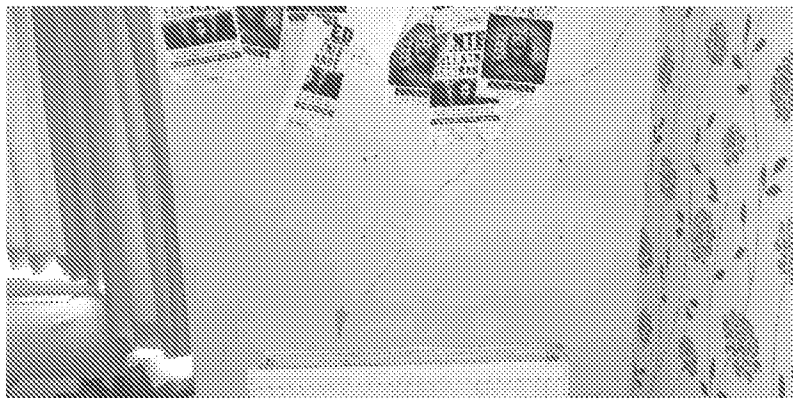
- 3.1.1 The ground bearing slab appears to be settling unevenly as evidenced by the cracking shown in the photos 6 to 10 and 13 and may be subject to heave.
- 3.1.2 Cracking of the ground bearing slab outside the house and in the drive would appear to be indicative of further settlement.
- 3.1.3 The beam propping the roof of the garage appears to have inadequate restraint.
- 3.1.4 Cracks to the walls within the building would appear to be consistent with settlement of the ground bearing slab.

Photo 6 - Block A – crack in wall to the right of the of front bay window

Given the uneven settlement of the ground bearing slab and the cracking that this appears to have caused to the walls of the house and garage it is recommended that the house and garage be demolished.

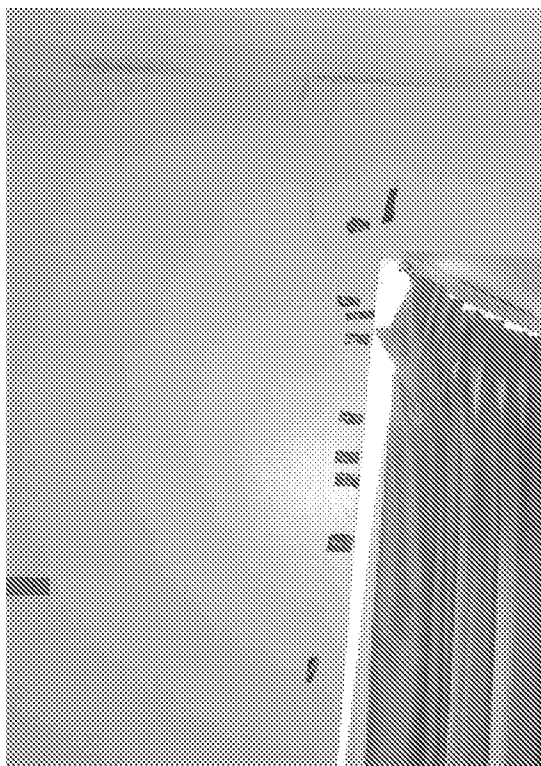
Photo 7 - Block A - crack in wall to the left of front bay window

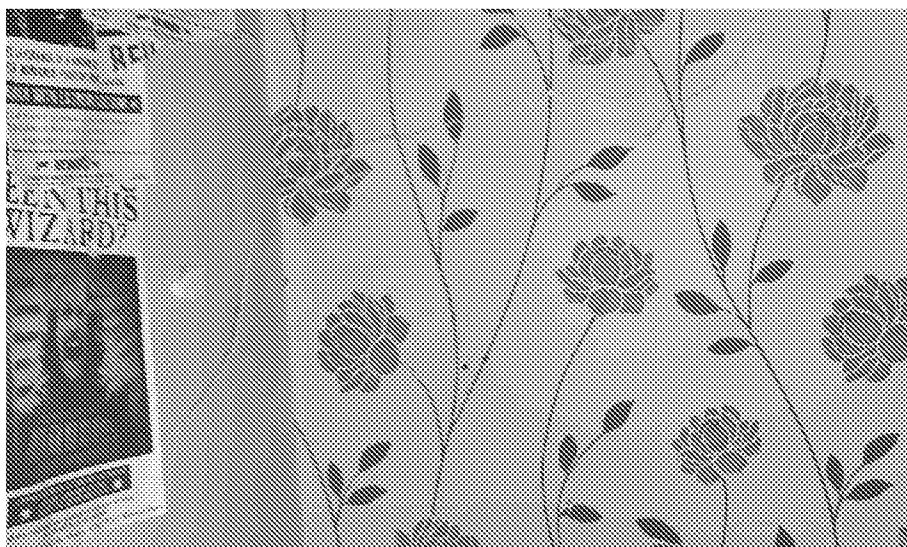
Photo 9 - Block A - crack in the return wall to the right of front bay window

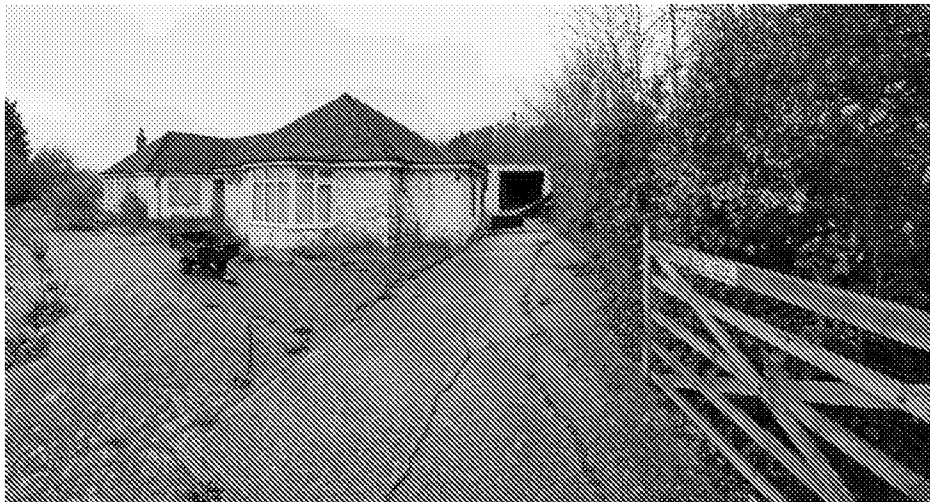
Photo 10 - Block A - view of concrete slabs at the front of the house

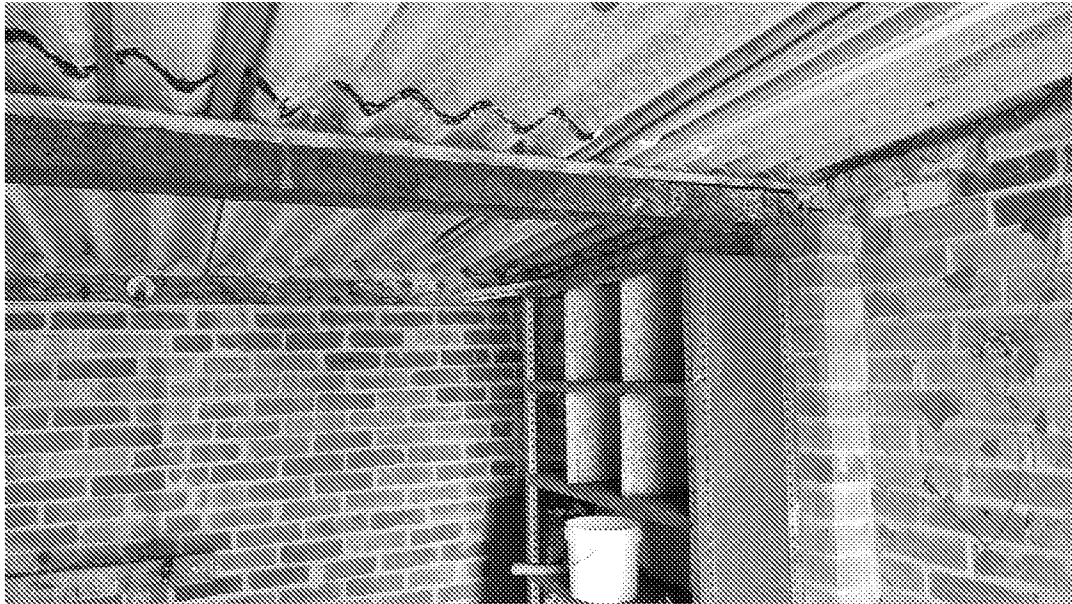
- 3.0.1 Block A comprises a brick-built bungalow with load bearing masonry walls. The roof tiles comprise concrete tiles as seen from Photos 1-5.
- 3.0.2 The house is founded on a ground bearing slab, with a raised timber floor to internal areas.
- 3.0.3 Cracking was noted to the masonry walls of the building as shown in photos 6-9.
- 3.0.4 The garage shown in photos 11 and 12 comprises single leaf brick walls. An intermediate beam props the roof mid-length of the garage.
- 3.0.5 In photo 12 cracking can be seen in the wall in the right-hand side of the photo.

Photo 12 - Block A – view of beam supporting garage roof propped on the brick pier

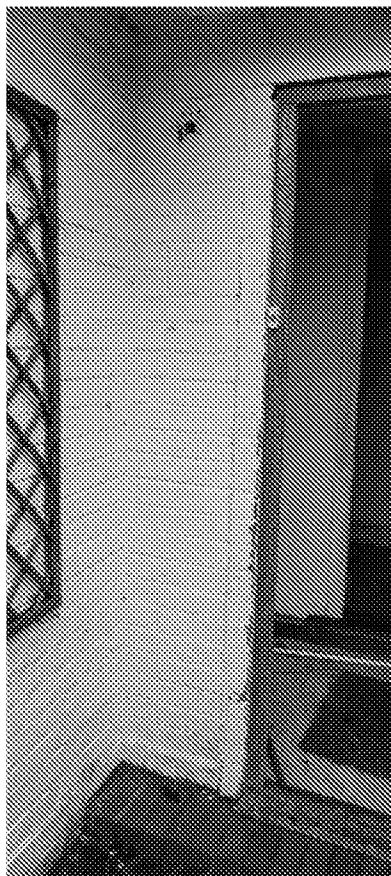
Photo 13 - Block A – Front elevation - cracking at the front door

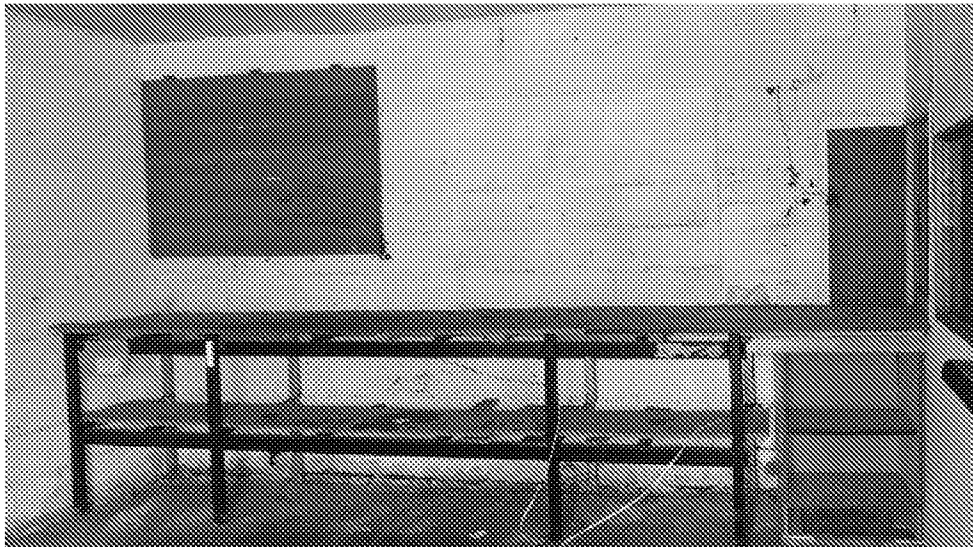
- 4.0.1 Block B comprises a large shed with load bearing masonry walls. The roof is of corrugated iron construction.
- 4.0.2 The walls comprise stone block with a concrete block vertical extension on top, as shown in photo 17.
- 4.0.3 The roof ceiling would appear to be sagging as can be seen in photo 22.
- 4.0.4 Photo 20 shows the beam that supports the roof trusses to be sagging.
- 4.0.5 Photo 21 shows a prop to support the roof beam that in turn supports the trusses.
- 4.0.6 An extension has been built to the end of the building which appears to be of rendered block. Photo 26 shows cracking to the gable end of the extension wall.

- 4.1.1 The wall detail in photo 17 with a concrete block vertical extension on top is not of robust construction and the quality of construction cannot be verified.
- 4.1.2 Photo 21 shows a prop to support the roof beam and trusses. This would appear not to meet the requirements of robustness and has the potential for collapse as the removal of this prop could cause the roof to become unsafe.
- 4.1.3 The extension at the end in rendered block is cracking in the gable wall.

Photo 26 – Block B – internal view in the end extension

The vertical wall extension is potentially unsafe, the gable end of the extension is cracking and the roof would appear to be unsafe. Given these factors it is recommended that the building be demolished.

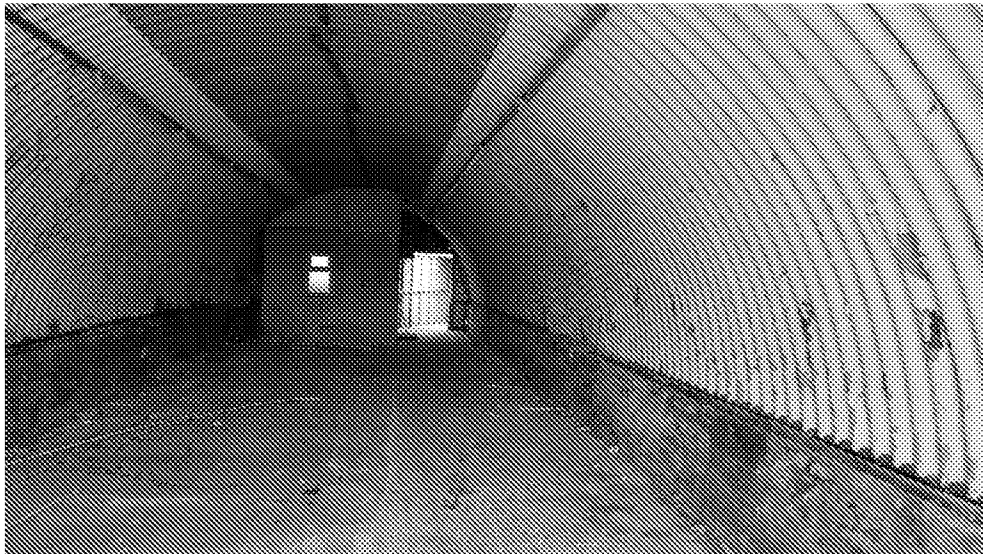
- 5.0.1 Block C comprises 5no. Nissen style huts comprising concrete block walls with a curved corrugated iron roof. The gable walls are concrete block.
- 5.0.2 In front of hut C5 there appears to be an oil storage bund or petrol interceptor. There was oil present at the site.
- 5.0.3 Photos 29 and 30 show cracking in the ground bearing slab.
- 5.0.4 Photo 35 shows damage and cracking to the gable wall of one of the huts.
- 5.0.5 Photo 36 shows cracking to the gable wall of one of the huts.
- 5.0.6 Photo 37 shows cracking to the ground bearing slab.
- 5.0.7 Photo 38 shows a steel column and beam supporting the roller shutter door in the gable wall of one of the huts. The column is in poor condition.

Photo 29 – Block C - Internal view of Hut C5

- A) The ground bearing slabs show cracking, the gable walls are cracking and damaged and there is the potential of oil contamination in the ground. Given these factors it is recommended that the buildings be demolished.
- B) The existing petrol interceptor should be further inspected in order to ascertain its setting out and extent i.e. depth and form of construction.

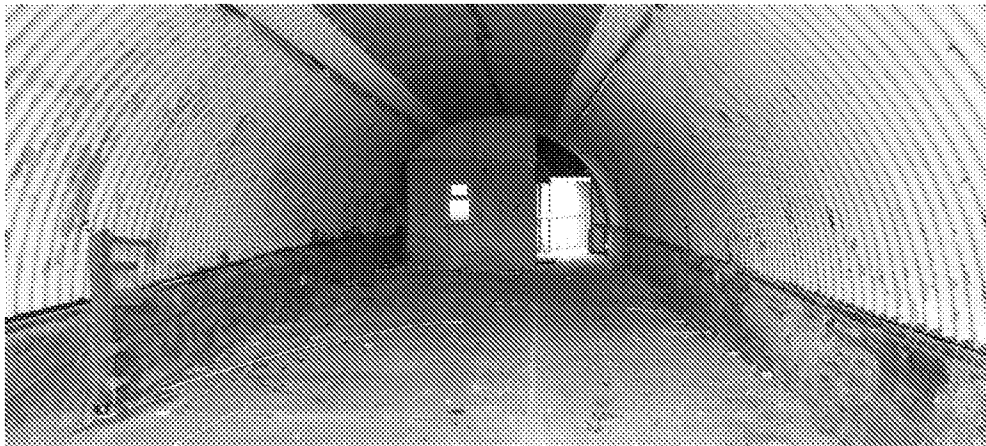
Photo 30 – Block C – Internal view of Hut C5

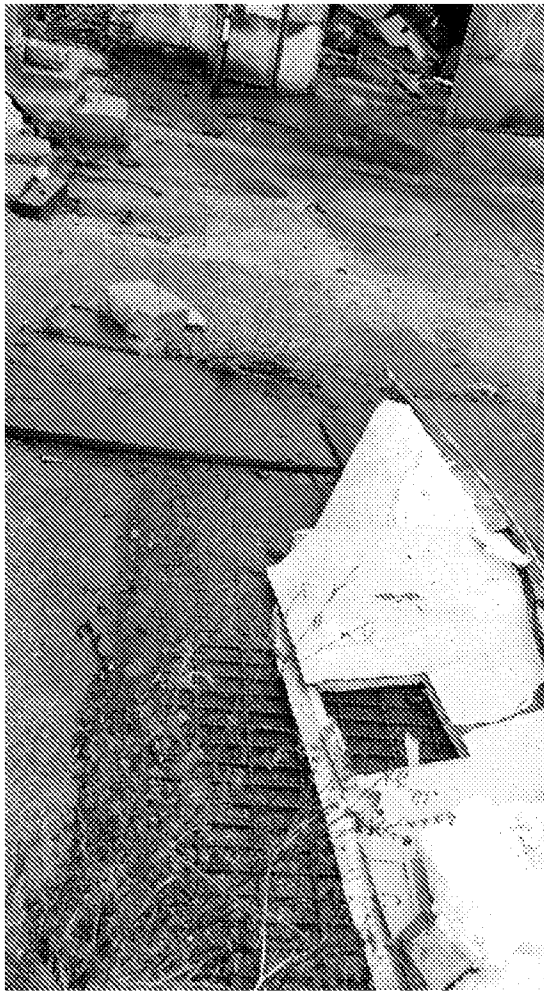
- 5.1.1 There is cracking and some damage to the gable walls of the huts.
- 5.1.2 There is cracking indicative of settlement in some of the ground bearing slabs.
- 5.1.3 There was a smell of oil in some of the huts and an oil storage bund or petrol interceptor in front of hut C5. Therefore, there is potentially oil contamination in the ground which might necessitate removing and replacing the ground as part of remediation.

Photo 32 – Block C – Oil contamination visible outside Hut C4

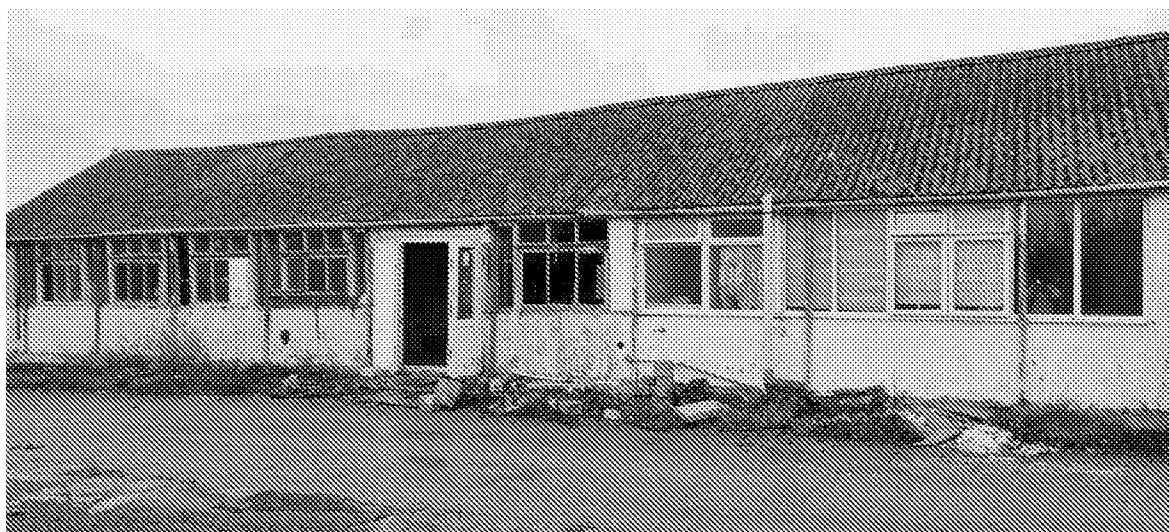
- 6.0.1 Block D comprises a single building in load bearing blockwork with a corrugated cement roof.
- 6.0.2 Photo 41 shows the roof to be sagging unevenly across its length.
- 6.0.3 Photo 44 shows the rear wall of the building leaning outwards
- 6.0.4 Photo 45 shows the roof to be propped with steel props.
- 6.0.5 Photo 46 shows cracking in the ground bearing slab.

- 6.1.1 The roof is sagging and the props supporting the roof appear to be temporary props rather than permanent construction.
- 6.1.2 There is cracking indicative of settlement in the ground bearing slab.
- 6.1.3 The rear wall is leaning outwards in which could be spread from the roof load above.

Photo 41 – Block D – Side elevation view

The ground bearing slab is cracking and the rear wall and roof are non-robust and potentially unsafe. The ground bearing slab is cracking, which implies some ground movement and subject to further soils investigation should be removed. The existing roof structure would appear to be of a sub-standard form of construction and is propped temporarily throughout. Spread of the roof at the eaves would appear to have affected the perimeter walls, which now appear out of tolerance. Given these factors it is recommended that the buildings be demolished.

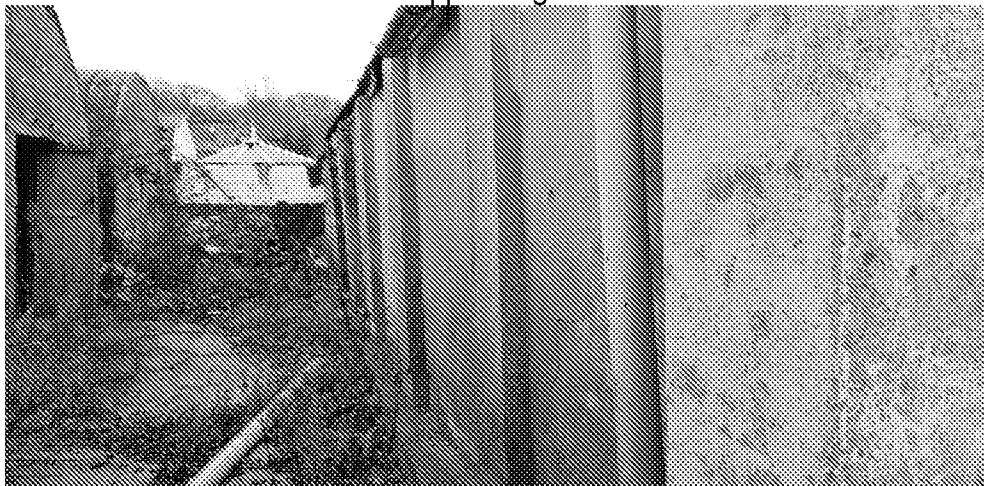
Photo 44 – Block D – View along side rear elevation showing wall leaning

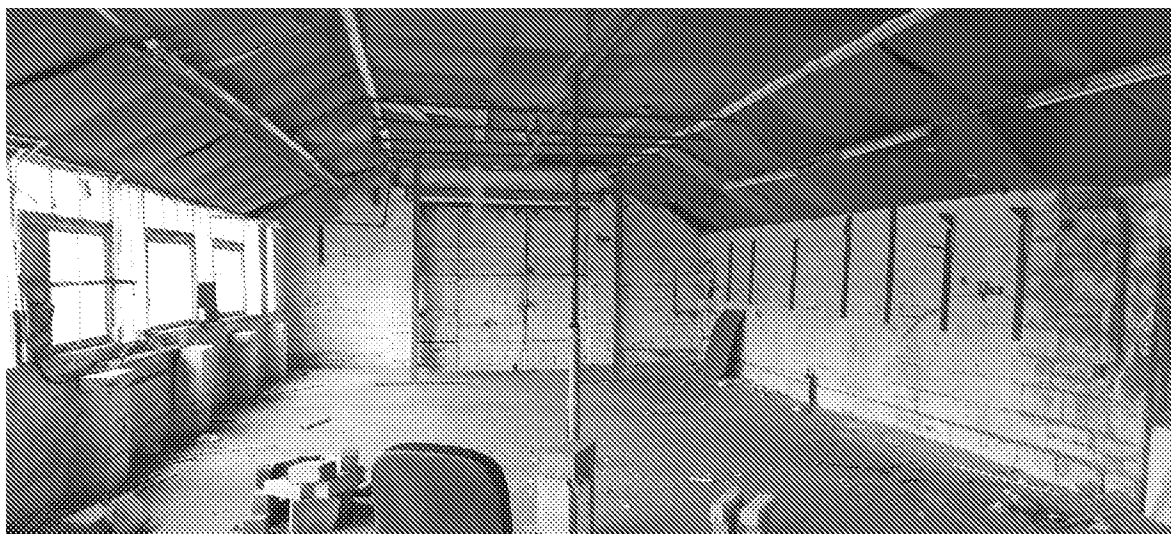
Photo 45 – Block D – view of roof showing vertical prop

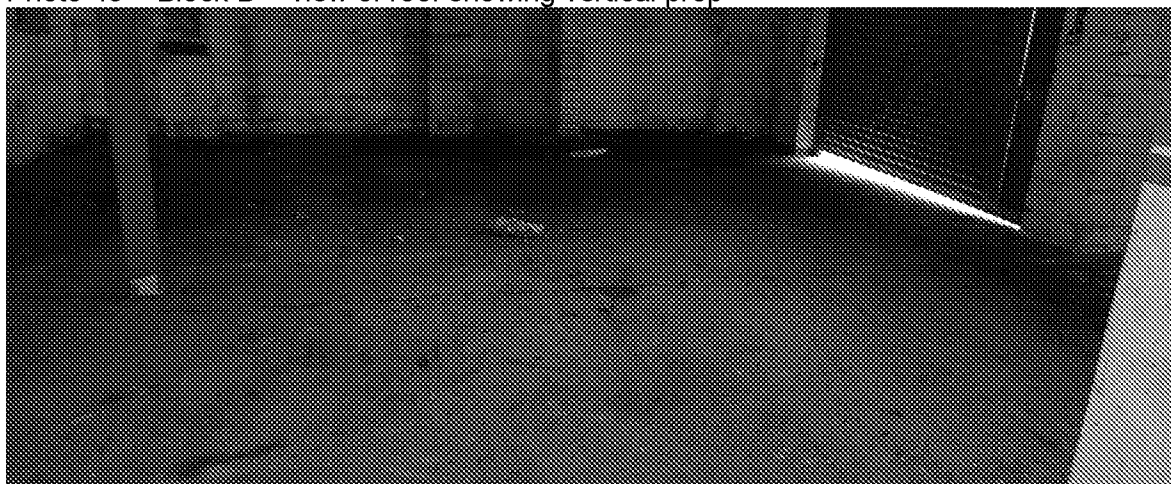
Photo 46 – Block D – cracking in the concrete floor

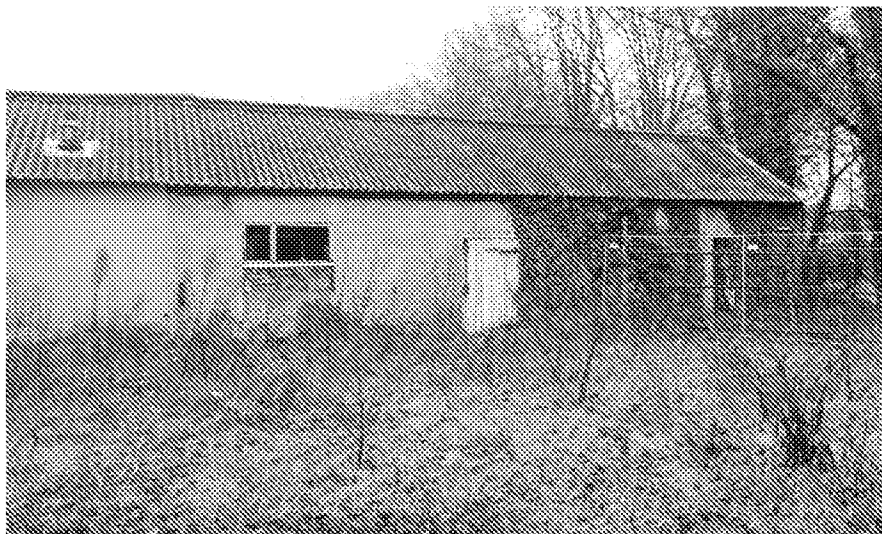
- 7.0.1 Block E comprises a single building in load bearing rendered blockwork with a corrugated iron roof.
- 7.0.2 Photo 48 shows the roof to be sagging unevenly.
- 7.0.3 Photo 51 shows cracking in the entrance gable wall.
- 7.0.4 Photo 52 shows the walls propped laterally using precast concrete posts that are strapped to the wall to provide lateral propping to the blockwork wall panels.

- 7.1.1 The roof is sagging.
- 7.1.2 The gable wall is cracked.
- 7.1.3 The construction method of propping the wall laterally is not robust and is in poor condition. Precast concrete posts are strapped to the wall to provide lateral propping to the blockwork wall panels. This does not appear to be a robust method of propping, which could leave the wall panel without adequate lateral support.

Photo 48 – Block E – View of side elevation

Given the factors listed in 7.1 is recommended that the buildings be demolished.

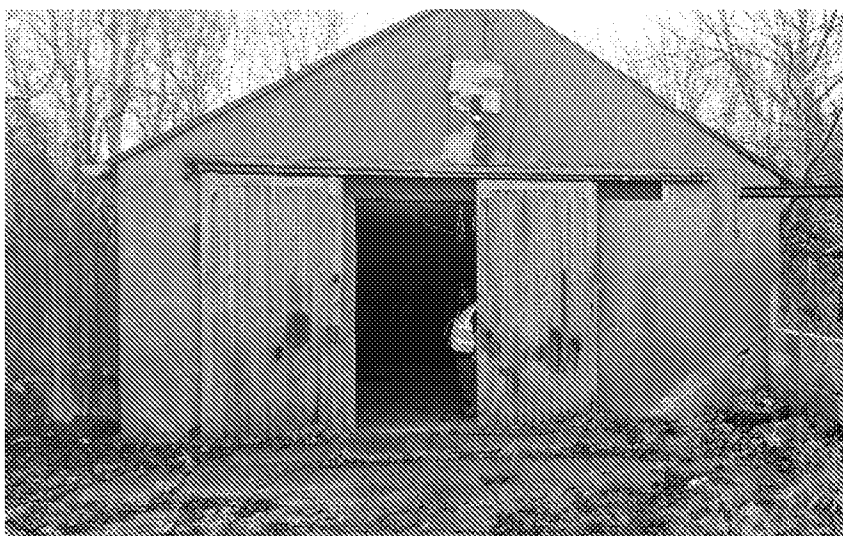
Photo 51 – Block E – View of gable end

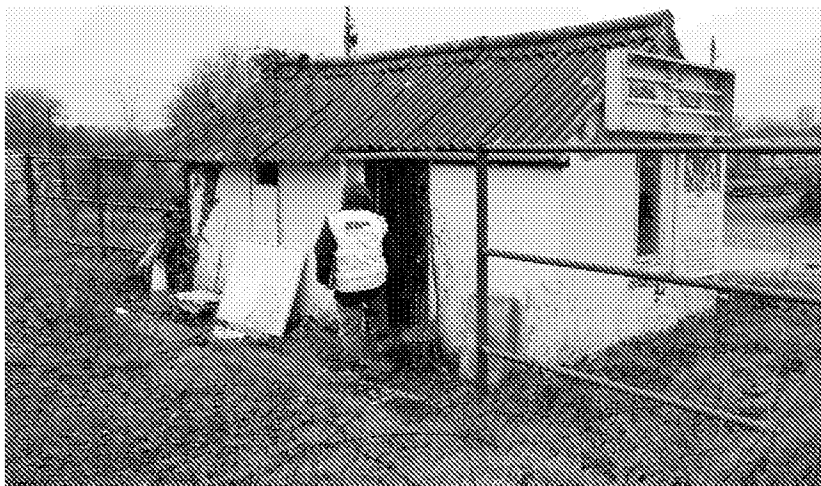
8.2 Photo 56 shows the roof to be sagging unevenly along its ridge and also cable ducts outside the building.

8.1.1 Access was not possible during our site visit, therefore it is difficult to provide any further comments. However, given the uneven sag of the existing roof ridge and bearing in mind the remaining structures surveyed it would be our conclusion that similar aspects also affect this small building.

8.1.2 Cable ducts outside the building indicate that it might have been a plant room. The cable ducts are redundant and will need to be removed as part of the development.

Photo 56 – Block F – View of the building. The cable ducts are visible outside.

Given the factors listed in 8.1 is recommended that the building be demolished.

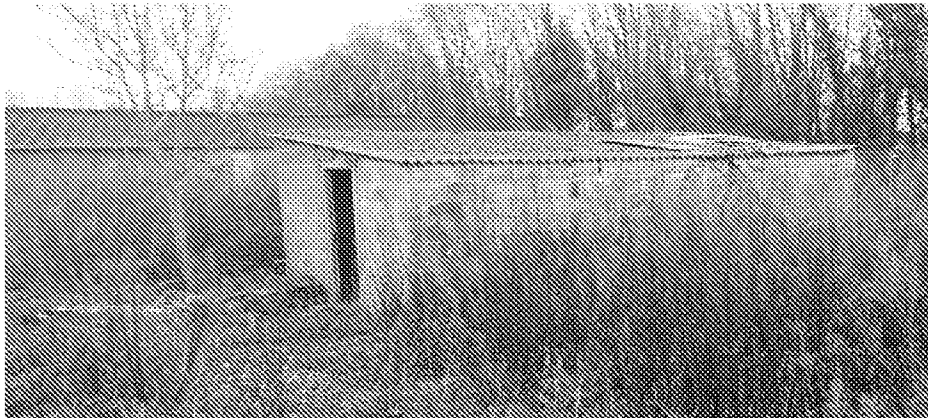
10.0.2 It appears that the building was constructed using a combination of stone and concrete blocks. Photo 60 shows the side wall in stone block and the gable wall in concrete block.

10.1.1 The building seems to be a composite construction of a wall in stonework coupled with a wall in blockwork and the two wall types do not seem to be keyed-in properly at the corner where they meet. The building is dilapidated state possibly due to its age and/ or neglect.

Photo 60 – Block H – Side view – Gable end is in concrete block and the side elevations are in stone block.

Given the factors listed in 10.1 it is recommended that the building be demolished.

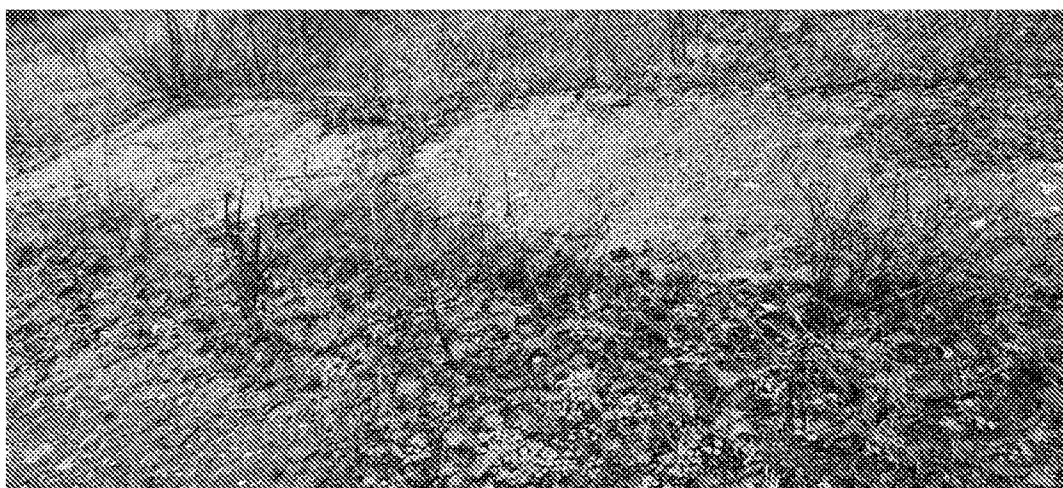
12.0.1 Several isolated ground bearing slabs were identified in the area generally. Given that the area was overgrown it was not possible to inspect the entire site to determine how many such ground bearing slabs there were. Photos 63 and 64 show typical ground bearing slabs.

12.1.1 The isolated ground bearing slabs would appear to be redundant along with the cable ducts.

Photo 64 – Adjacent to Block E - Isolated ground bearing slab

Given the factor listed in 12.1 it is recommended that the items listed be removed.
