# ASBESTOS SURVEY REPORT

MERRY ENGLAND FARM BUILDINGS  
DAPPERS LANE  
ANMERING  
WEST SUSSEX  
BN16 4EN

22 AUGUST 2019

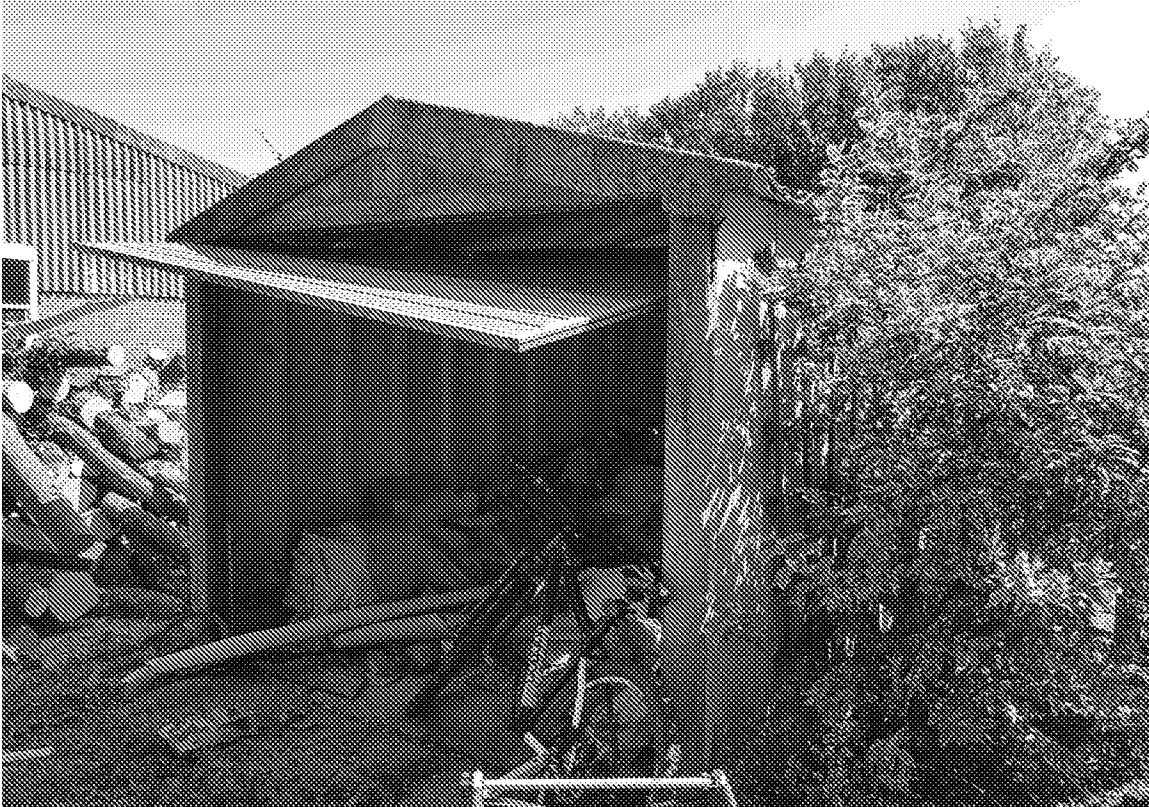
SAMPLE 1 GARAGE ROOF - CORRUGATED CEMENT PANELS

| Sample 1 | |
|---|---|
| Product description | CORRUGATED ASBESTOS CEMENT PANELS |
| Amount | APPROX 20 SQ MT |
| Asbestos Type | CHRYSTILE |

| Sample Reference | ME 1 |
|---|---|
| VERY LOW POTENTIAL TO RELEASE FIBRES | |

| Sample Reference | Location | Material | Quantity |
|---|---|---|---|
| 22.8.19 | CHRYSTILE | 4 | REMOVE<br>DIS PLAY ASBESTOS<br>AWARE SIGNS |

| Sample reference | Recommended action | Comments |
|---|---|---|
| ME 1 | APPLY ASBESTOS BEWARE SIGNS<br>MAINTAIN ASBESTOS REGISTER<br>REMOVE | MANAGEMENT PLAN MUST<br>ADVISE INCOMING TRADESMEN<br>OF LOCATION OF THE ASBESTOS |

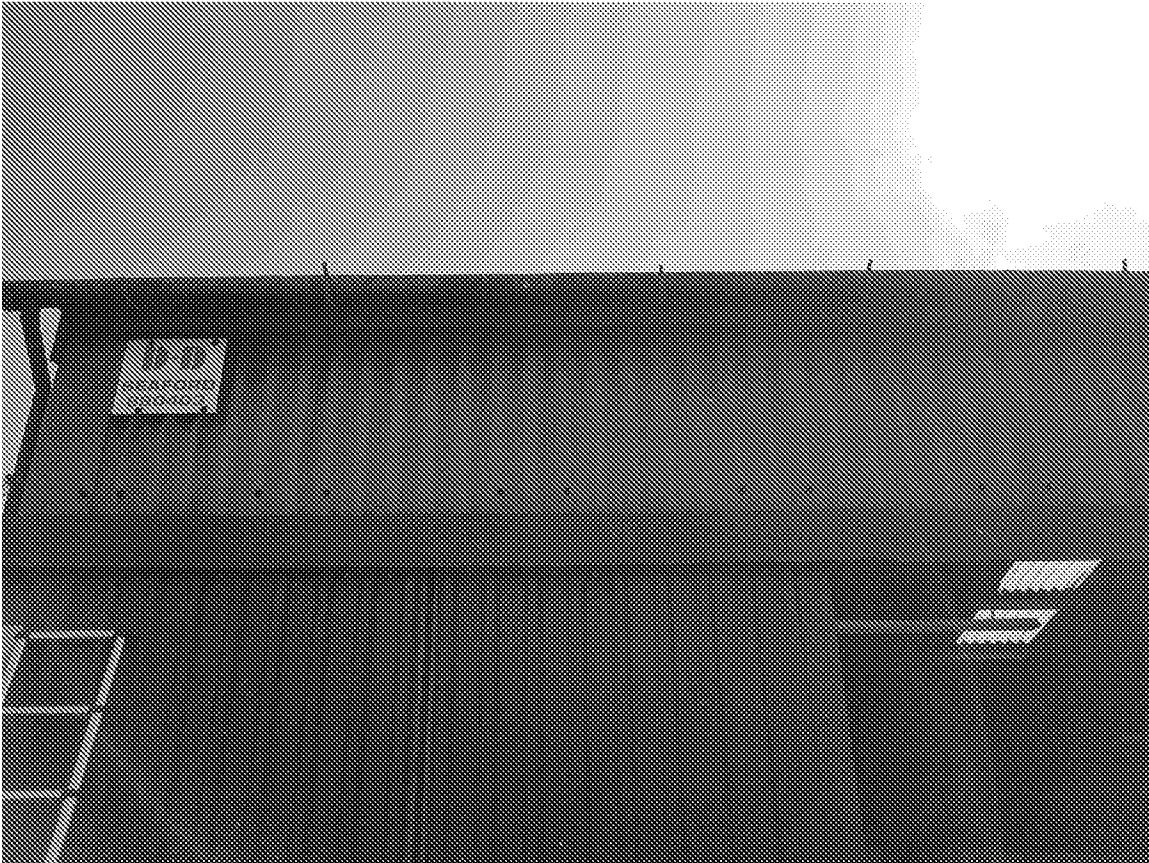
SAMPLE 2 MAIN BARN - GREEN CORRUGATED COMPOSITE PANELS ABOVE  
BRICKWORK

| Sample 2 | |
|---|---|
| Asbestos Type | NO ASBESTOS DETECTED |

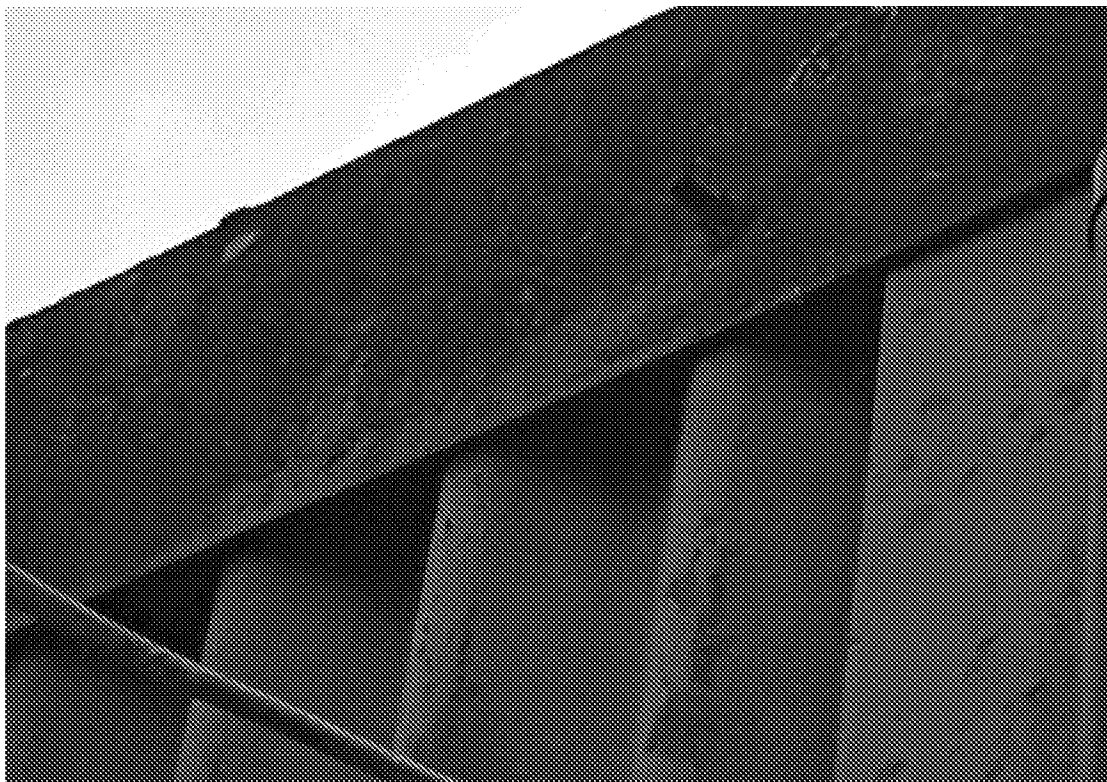
SAMPLE 3 MAIN BARN ROOF - CORRUGATED CEMENT PANELS

| Sample 3 | |
|---|---|
| Product description | CORRUGATED ASBESTOS CEMENT PANELS |
| Amount | APPROX 60 SQ MT |
| Asbestos Type | CHRYSTILE |

| Sample Reference | ME 2 |
|---|---|
| VERY LOW POTENTIAL TO RELEASE FIBRES | |

| Sample Reference | Location | Material | Quantity |
|---|---|---|---|
| 22.8.19 | CHRYSTILE | 4 | REMOVE<br>DIS PLAY ASBESTOS<br>AWARE SIGNS |

| Sample reference | Recommended action | Comments |
|---|---|---|
| ME 3 | APPLY ASBESTOS BEWARE SIGNS<br>MAINTAIN ASBESTOS REGISTER<br>REMOVE | MANAGEMENT PLAN MUST<br>ADVISE INCOMING TRADESMEN<br>OF LOCATION OF THE ASBESTOS |

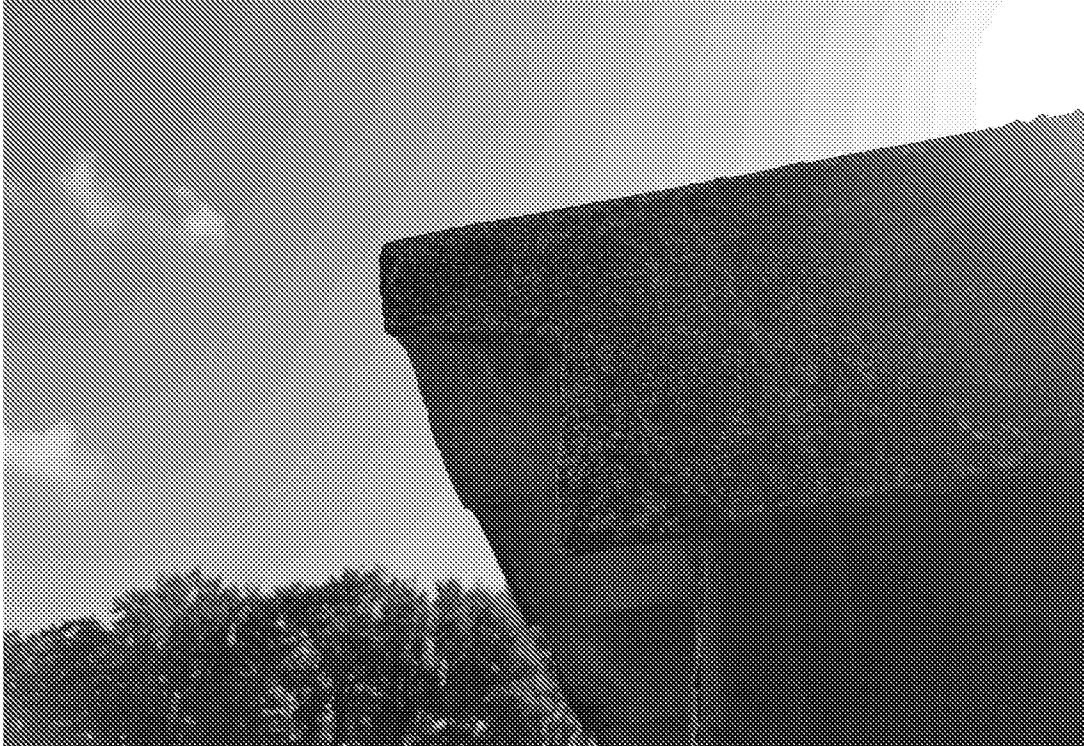
SAMPLE 4 LOOSE BOX NO 1 ROOF - CORRUGATED CEMENT PANELS

| Sample 4 | |
|---|---|
| Product description | CORRUGATED ASBESTOS CEMENT PANELS |
| Amount | APPROX 44 SQ MT |
| Asbestos Type | CHRYSTILE |

| Sample Reference | ME 4 |
|---|---|
| VERY LOW POTENTIAL TO RELEASE FIBRES | |

| Sample Reference | Location | Material | Quantity |
|---|---|---|---|
| 22.8.19 | CHRYSTILE | 4 | REMOVE<br>DIS PLAY ASBESTOS<br>AWARE SIGNS |

| Sample reference | Recommended action | Comments |
|---|---|---|
| ME 4 | APPLY ASBESTOS BEWARE SIGNS<br>MAINTAIN ASBESTOS REGISTER<br>REMOVE | MANAGEMENT PLAN MUST<br>ADVISE INCOMING TRADESMEN<br>OF LOCATION OF THE ASBESTOS |

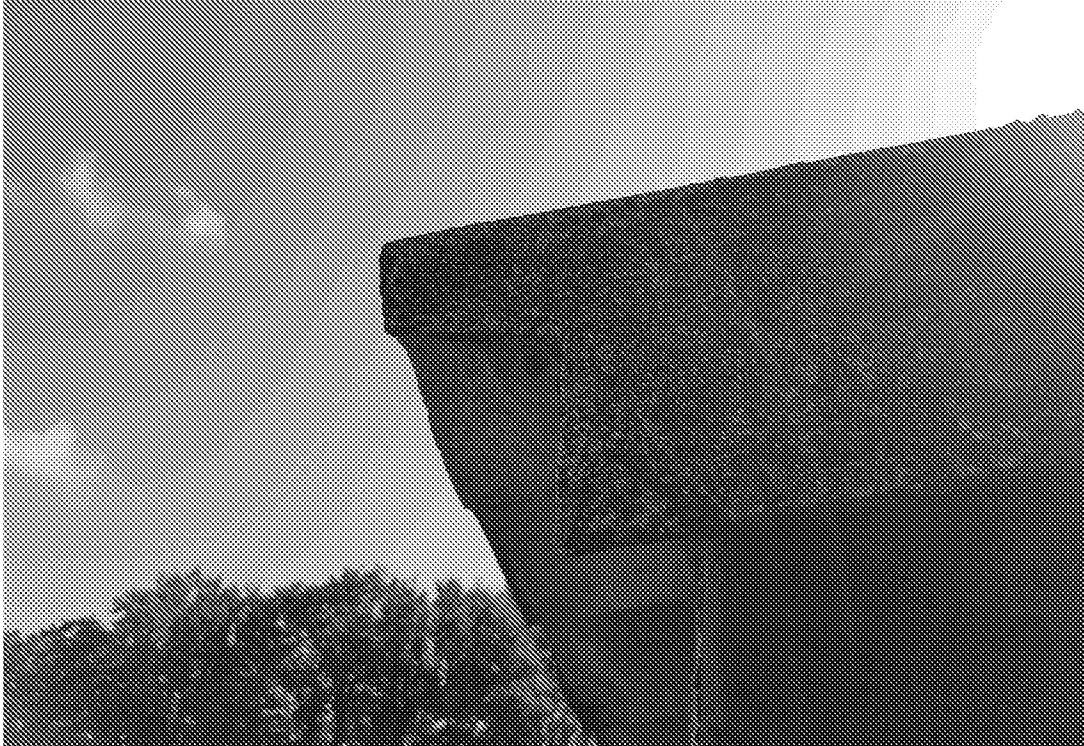
SAMPLE 5 LOOSE BOX NO 2 ROOF - CORRUGATED CEMENT PANELS

| Sample 5 | |
|---|---|
| Product description | CORRUGATED ASBESTOS CEMENT PANELS |
| Amount | APPROX 32 SQ MT |
| Asbestos Type | CHRYSTILE |

| Sample Reference | ME 5 |
|---|---|
| VERY LOW POTENTIAL TO RELEASE FIBRES | |

| Sample Reference | Location | Material | Quantity |
|---|---|---|---|
| 22.8.19 | CHRYSTILE | 4 | REMOVE<br>DISPLAY ASBESTOS<br>AWARE SIGNS |

| Sample reference | Recommended action | Comments |
|---|---|---|
| ME 5 | APPLY ASBESTOS BEWARE SIGNS<br>MAINTAIN ASBESTOS REGISTER<br>REMOVE | MANAGEMENT PLAN MUST<br>ADVISE INCOMING TRADESMEN<br>OF LOCATION OF THE ASBESTOS |

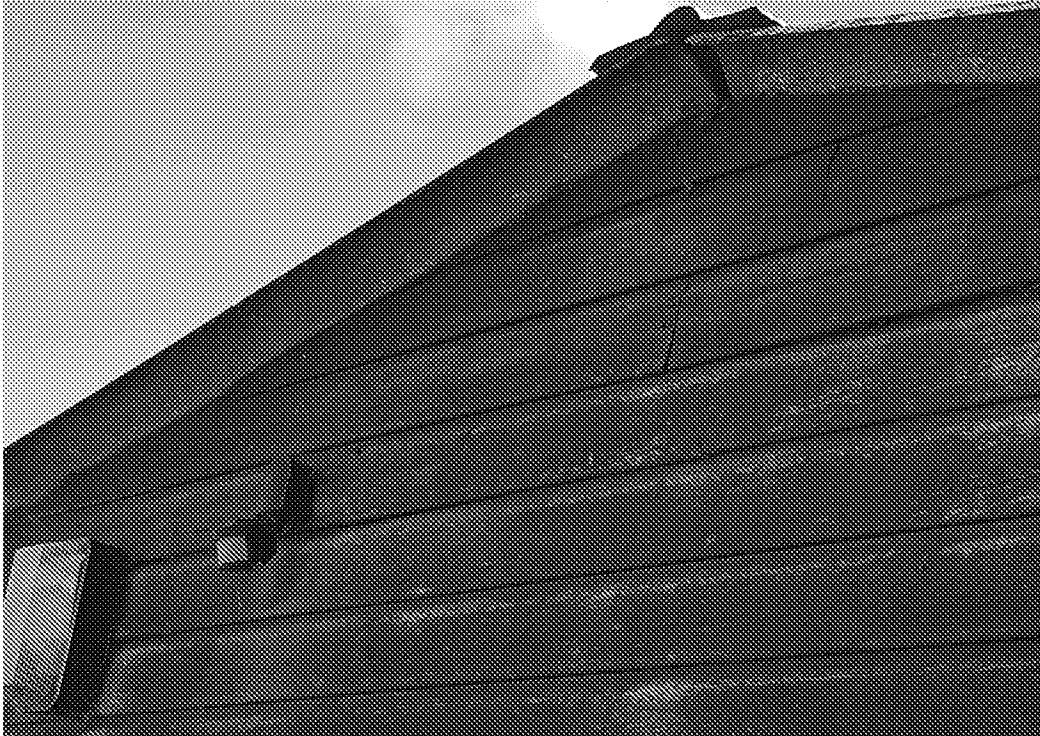
SAMPLE 6 LOOSE BOX NO 3 ROOF - CORRUGATED CEMENT PANELS

| Sample 6 | |
|---|---|
| Product description | CORRUGATED ASBESTOS CEMENT PANELS |
| Amount | APPROX 44 SQ MT |
| Asbestos Type | CHRYSTILE |

| Sample Reference | ME 6 |
|---|---|
| VERY LOW POTENTIAL TO RELEASE FIBRES | |

| Sample Reference | Location | Material | Quantity |
|---|---|---|---|
| 22.8.19 | CHRYSTILE | 4 | REMOVE<br>DISPLAY ASBESTOS<br>AWARE SIGNS |

| Sample reference | Recommended action | Comments |
|---|---|---|
| ME 6 | APPLY ASBESTOS BEWARE SIGNS<br>MAINTAIN ASBESTOS REGISTER<br>REMOVE | MANAGEMENT PLAN MUST<br>ADVISE INCOMING TRADESMEN<br>OF LOCATION OF THE ASBESTOS |
