## Tree risk management report

St Margaret's Church

Arundel Road Angmering

Our Ref: 1021-9084-JGS

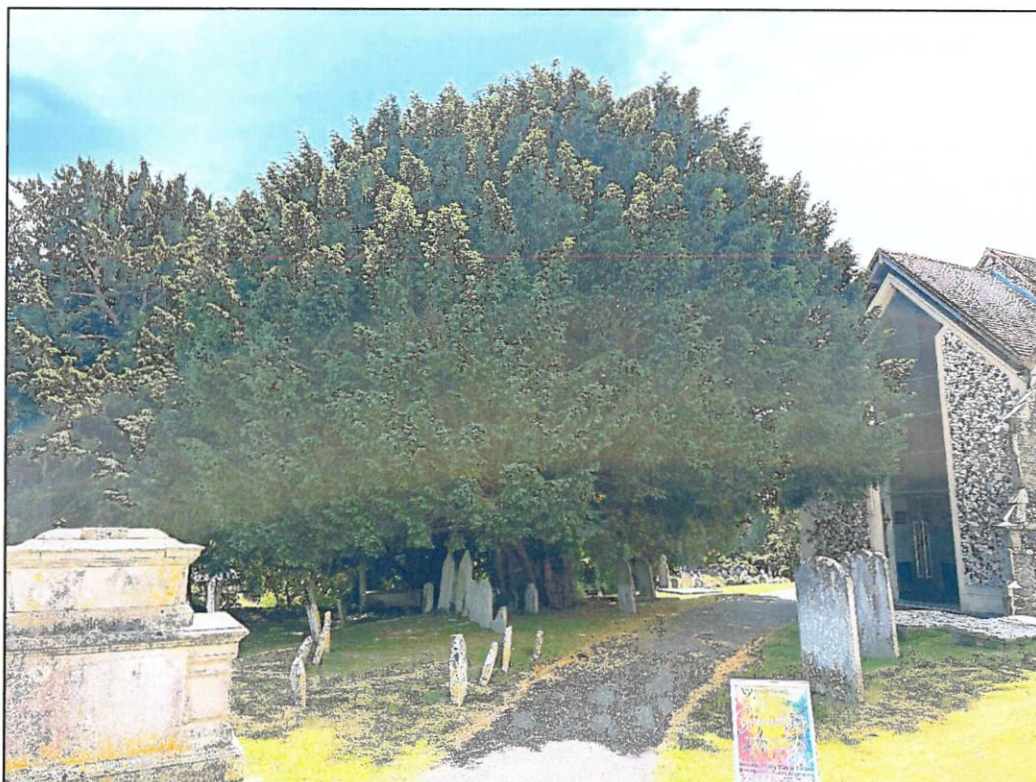
- 3.1.2. We noted an important veteran yew tree close to the church entrance that seems to have been heavily pruned in the past (Figure 2), and whilst no work has been recommend at the moment, it is likely that pruning will become necessary again in the future to ensure that it does not suffer from failures as the branches continue to grow and become heavier, and loading increases on the trunk. Given the trees' age and importance, we think that it would benefit from a bespoke veteran management plan to ensure that any work is carefully planned, allowing for the tree to continue contributing to the local environment for years to come.

**Figure 2:** Showing the veteran yew tree located close to the Church entrance. It seems to have been heavily pruned in the past, as it is likely that pruning will be necessary again in the future as the branches continue to grow, and loading increases on the trunk. This work must be managed carefully because the tree is so old and important, and we think it would be best to identify the requirements in a bespoke veteran management plan.
