19-283 WATER LANE, ANGMERING, WEST SUSSEX

Subject: Site Inspection

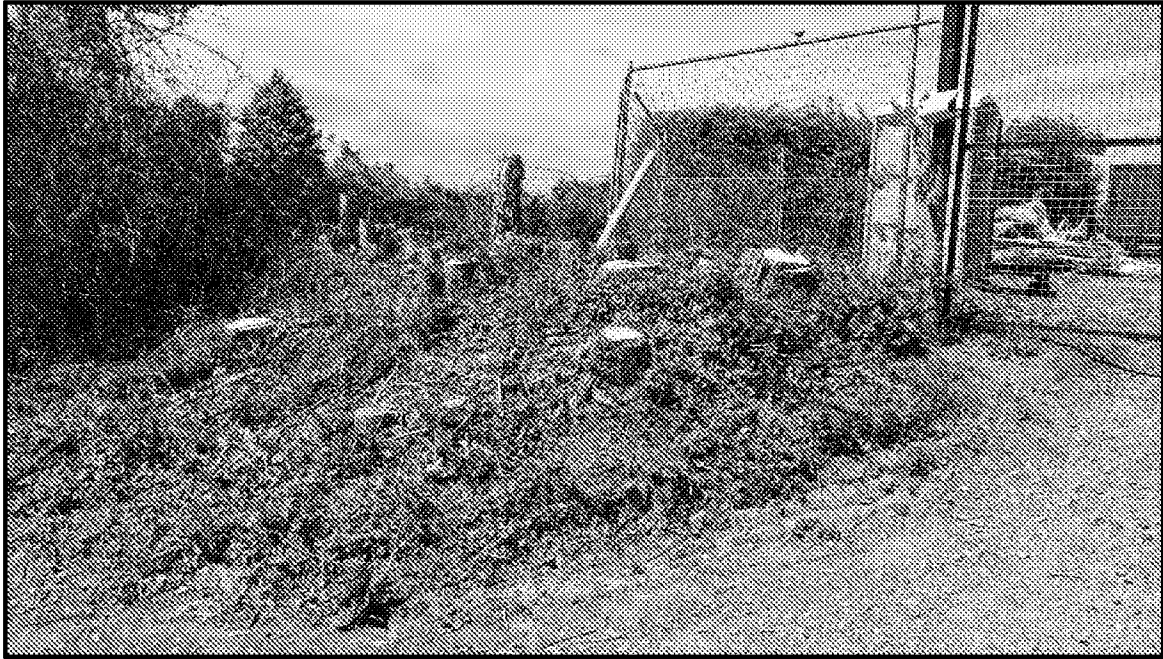
- 2.1 Tree removal of G62 (**Photograph 1**), G23 - G25 & T26 - T30 (**Photograph 5**) and H42 and G15 (**Photograph 17**) has taken place satisfactorily.

**Photograph 1** (above). G62, elm, removed located to the west of the main site entrance. Viewed looking towards the north-west.

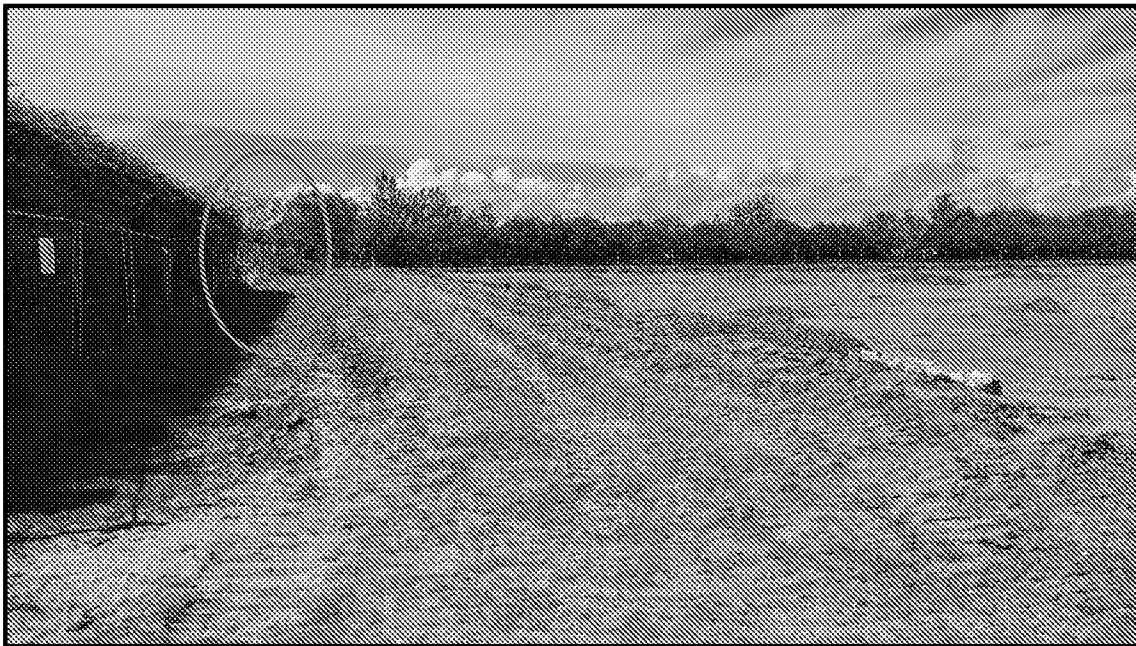
- 2.2 Fencing extended around the entire boundary protecting hedgerow H60 and off-site tree T61 (**Photograph 2**). Ideally the fencing should have extended into the site to fully protect the entire RPA of T61. Fencing was constructed by attaching standard 'heras-type' welded mesh panels to scaffold poles inserted into the ground at regular intervals using coupling clamps to attach the panels to the poles. Thus, fulfilling the objective of a permanent protective fence that cannot be easily moved as specified in BS5837:2012. (**Photographs 3 & 9**)

**Photograph 2:** Tree protection fencing located around H60 and H38 in the south-west corner of the site. Note lack of fencing extension within the site around T61 (circled). Viewed looking towards the west.

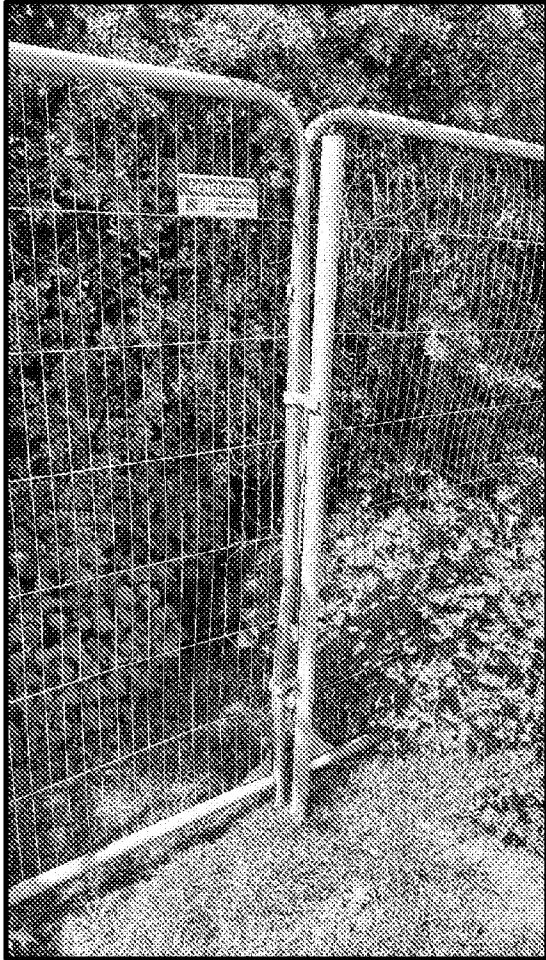
**Photograph 3** (left) Close-up of typical fencing construction. Showing scaffold pole with bolted coupling clamps attaching weldmesh panels.

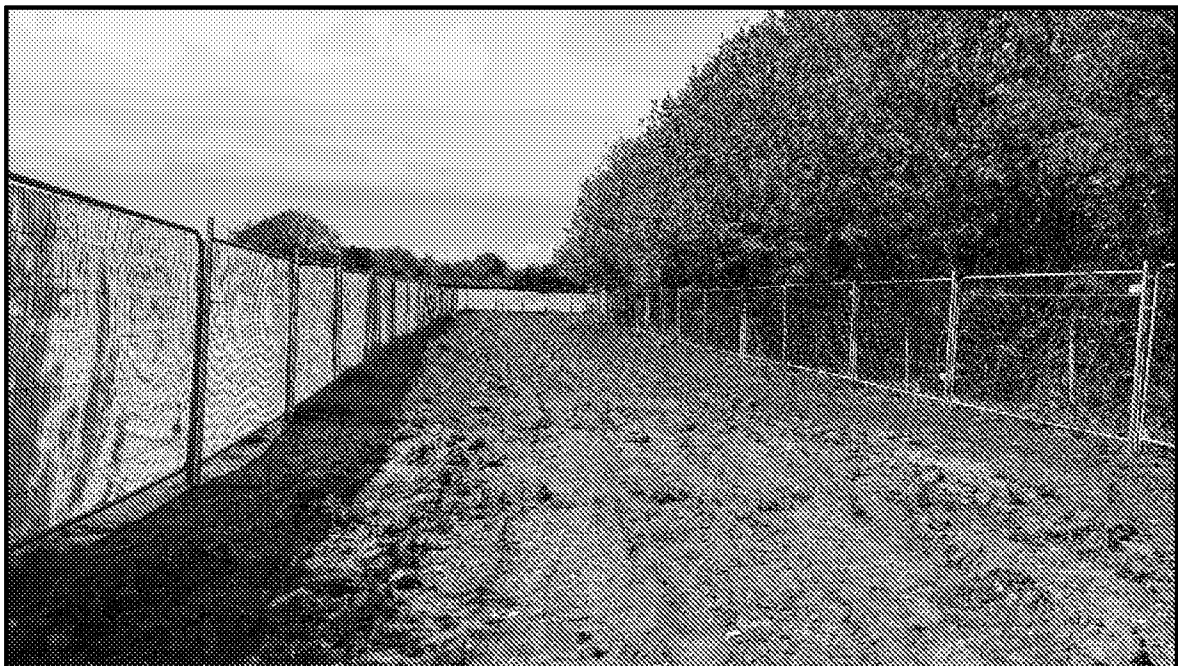
**Photograph 4** (below) Complete fencing along linking access to western part of the site. Showing protection for G37 and T37. Viewed looking towards the west.

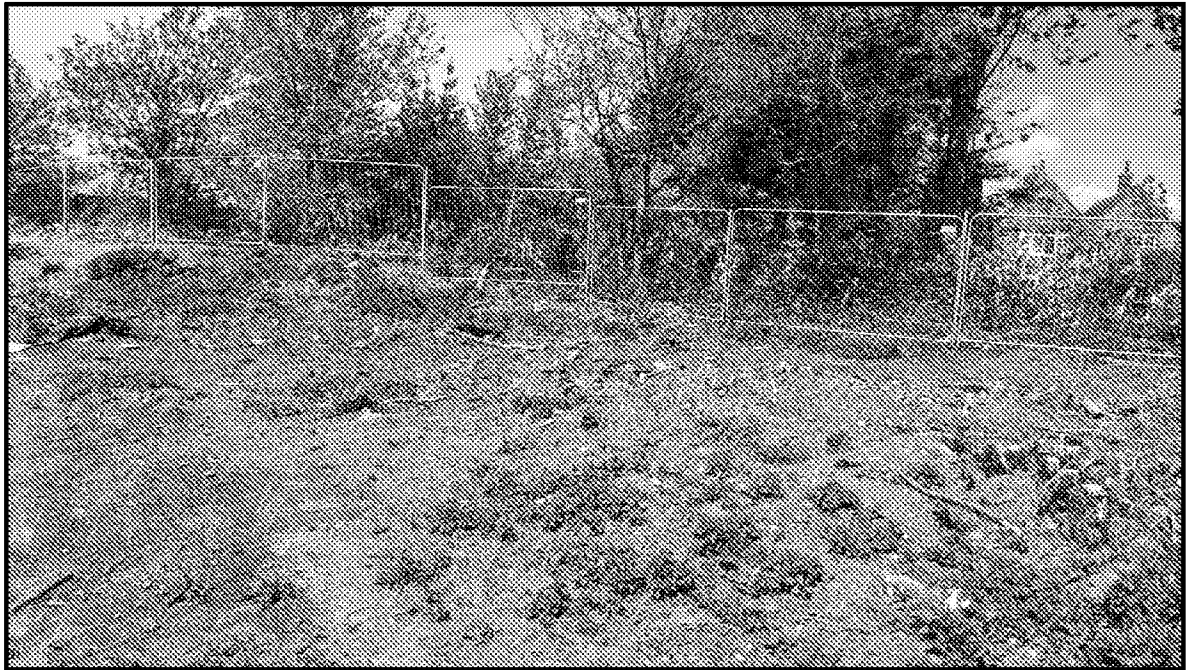
proximity of work taking place around the retained trees. (**Photographs 5, 6, 7, 8, 10, 11, 12, 13 and 16**)

**Photograph 5** (above). Tree removal, G23 - G25 & T26 - T30, along linking access to western part of the site. Showing protection fencing for T21, T22 and T34. Viewed looking towards the north.

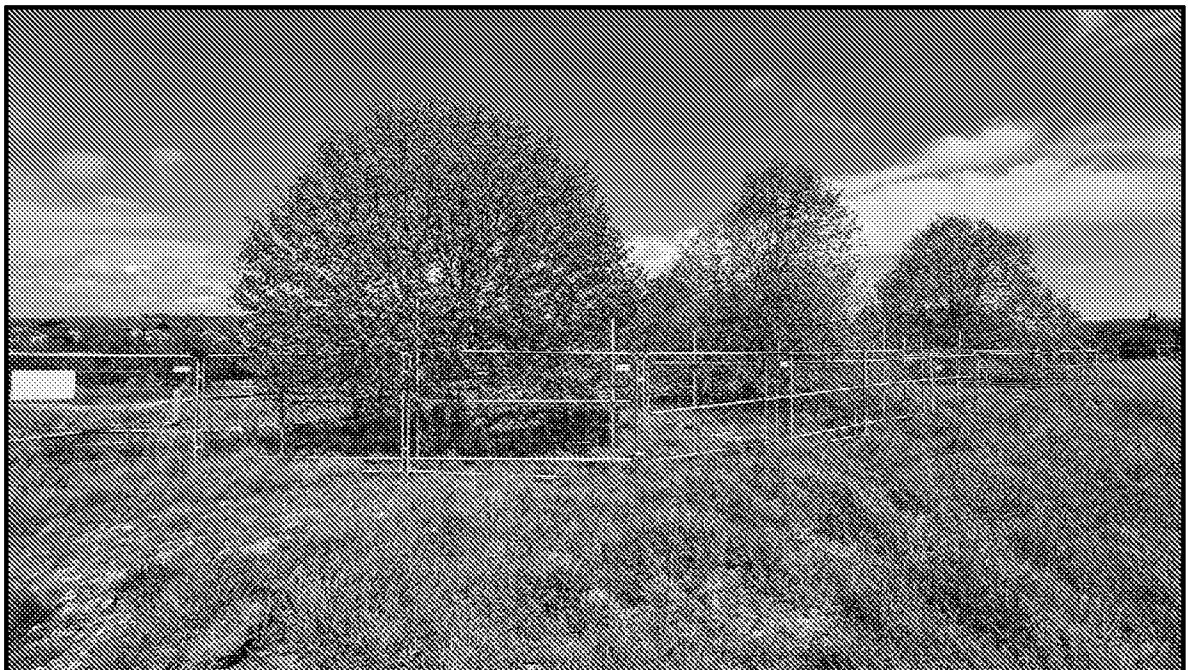
**Photograph 6.** Tree protection fencing along the northern section of the western parcel of land around, from right-to-left, T1, T2 and T3. Fencing needs to move further away from T3. Viewed looking towards the north-east.

- 3.2 Move fencing away from trees T3 and T13 to fully protect the RPA radii of 4.3m and 5.4m respectively.
- 3.3 Add and move fencing respectively in the northern part of the site, around trees T57 (**Photograph 14**) and G51 and T52 (**Photograph 15**).

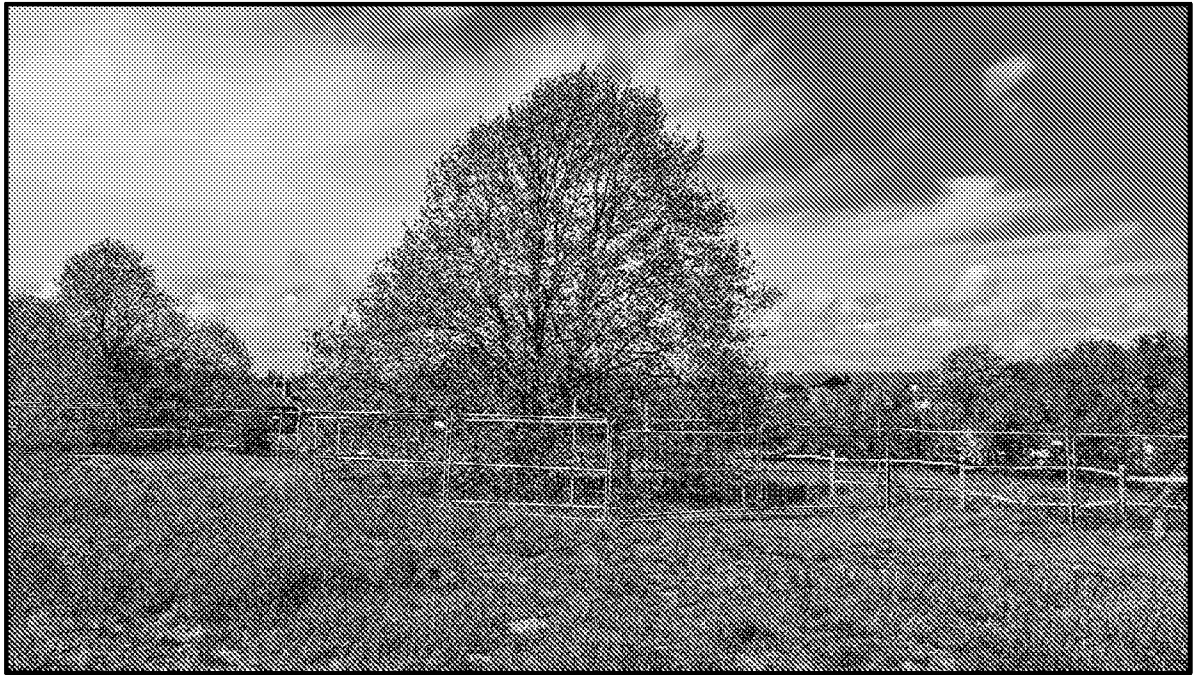
**Photograph 7** (above). Tree protection fencing along the northern section of the western parcel of land around T4. Viewed looking towards the north-west.

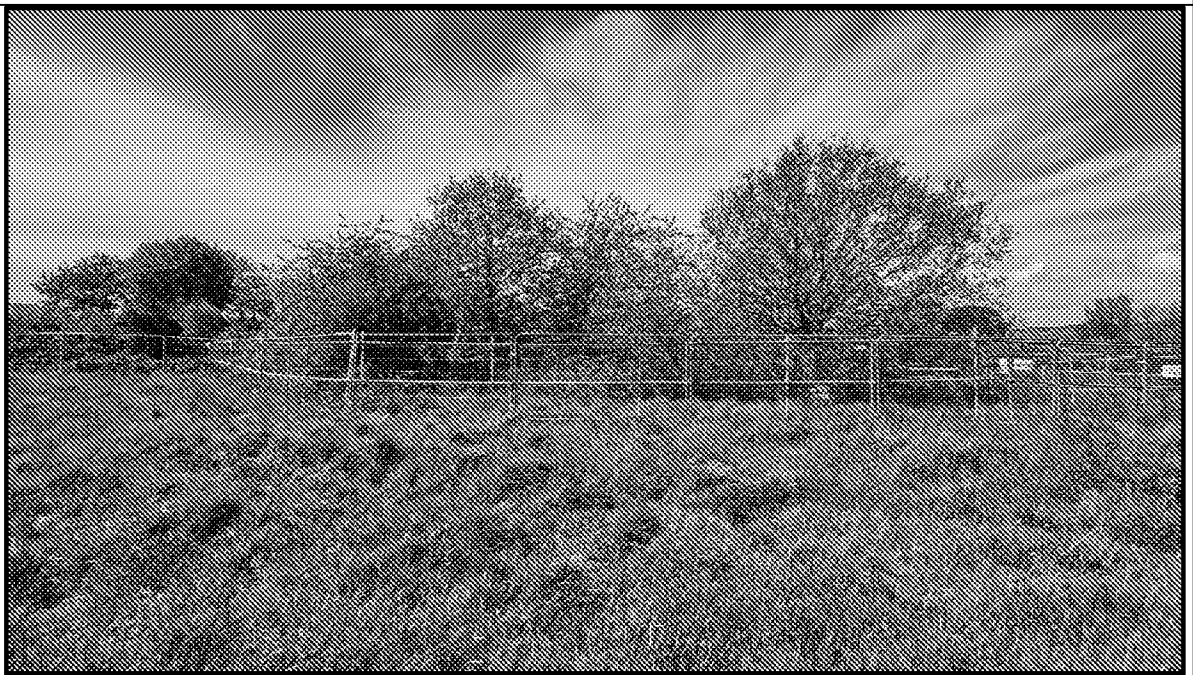
**Photograph 8.** Tree protection fencing in the north-western corner of the western parcel of land around T5 – T11 and G12. Viewed looking towards the west.

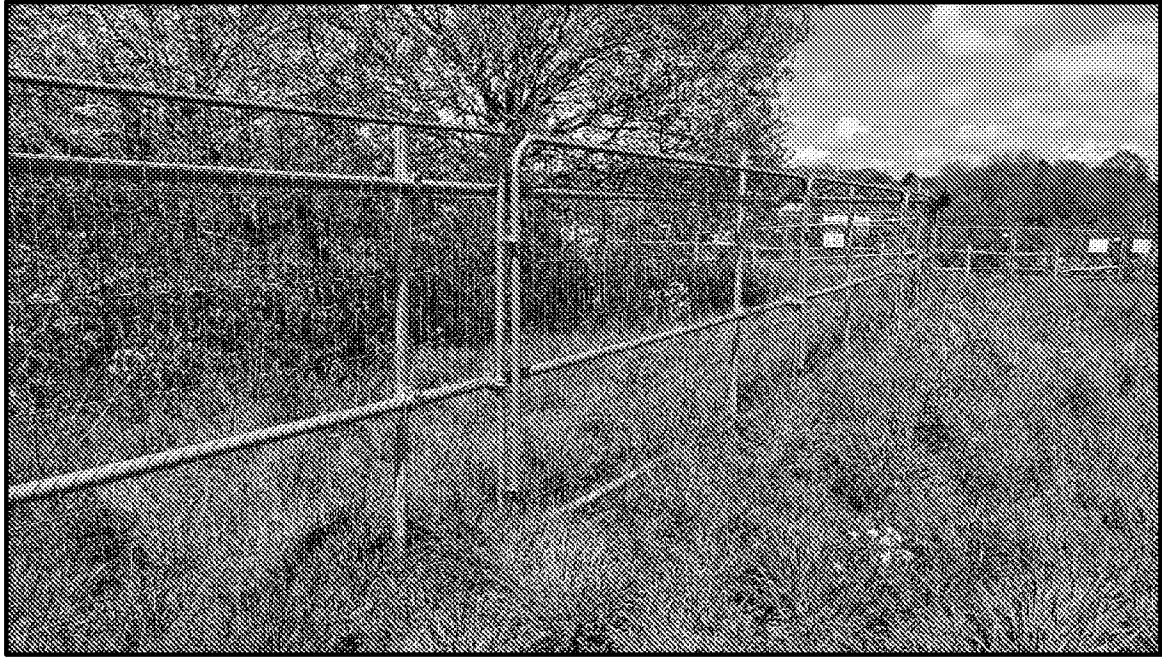
**Photograph 9** (above). Close-up of fencing construction. Showing scaffold poles inserted into the ground with 'Heras-type' wire panels clamped rigidly to it.

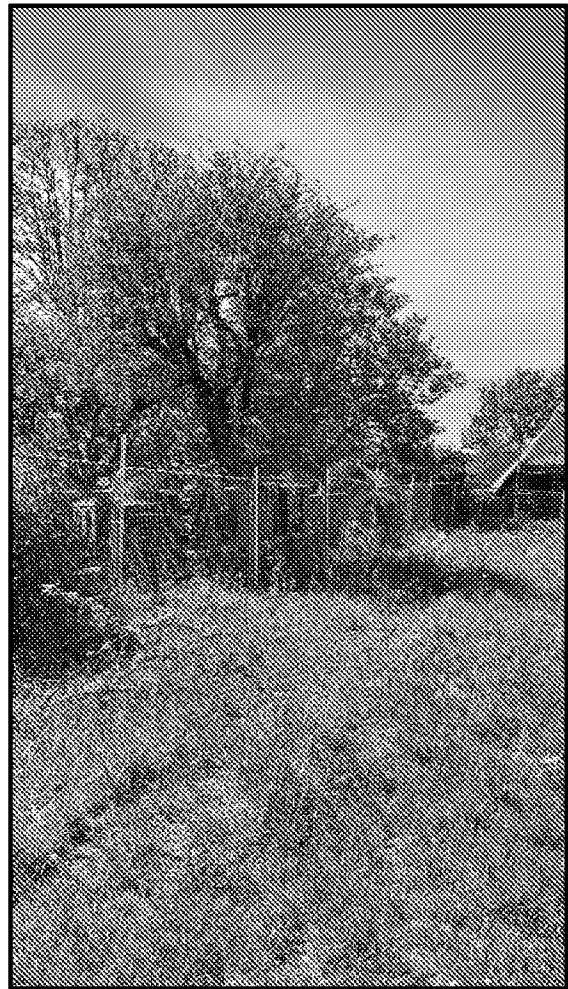
**Photograph 10** (right). Tree protection fencing along the southern section of the western parcel of land around T13. Fencing should be further away from the tree at this point. Viewed looking towards the west.

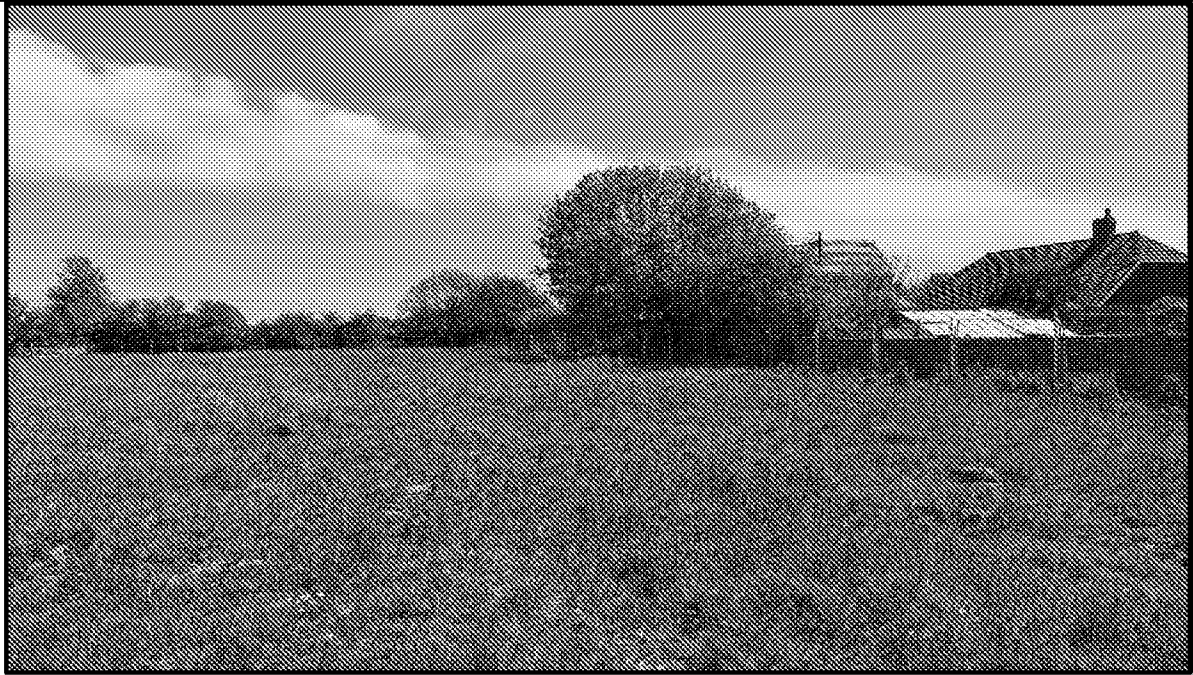
**Photograph 11** (above). Tree protection fencing along the southern section of the western parcel of land around G14 and G15. Viewed looking towards the south-east.

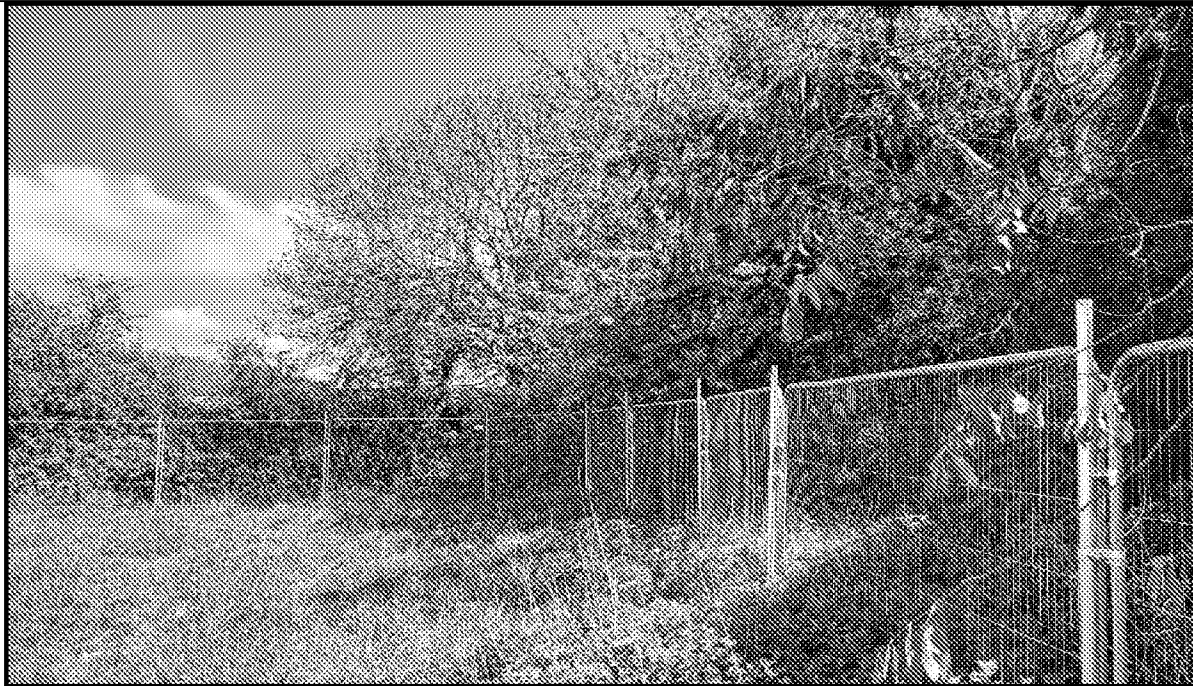
**Photograph 12.** Tree protection fencing in the south-east corner of the western parcel of land around T16, G17 and T18, G14 and G15. Viewed looking towards the east.

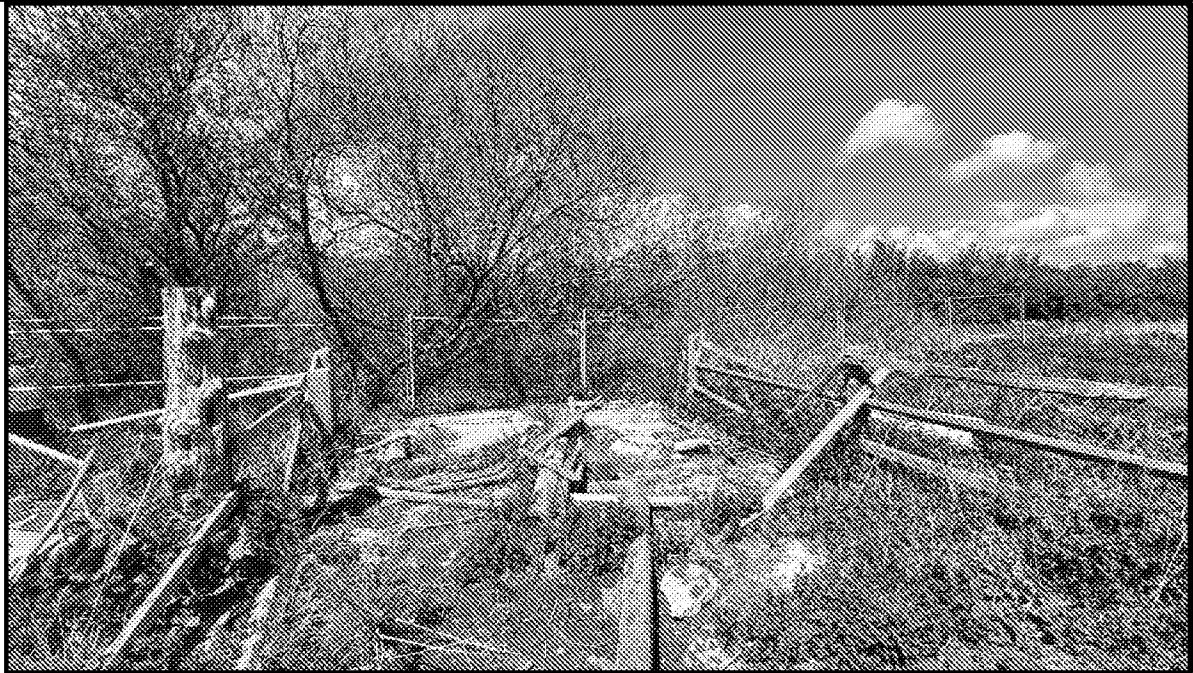
**Photograph 13** (above). Tree protection fencing along the southern section of the western parcel of land around G43, T43, T45, G46, T47 and T48. Viewed looking towards the north.

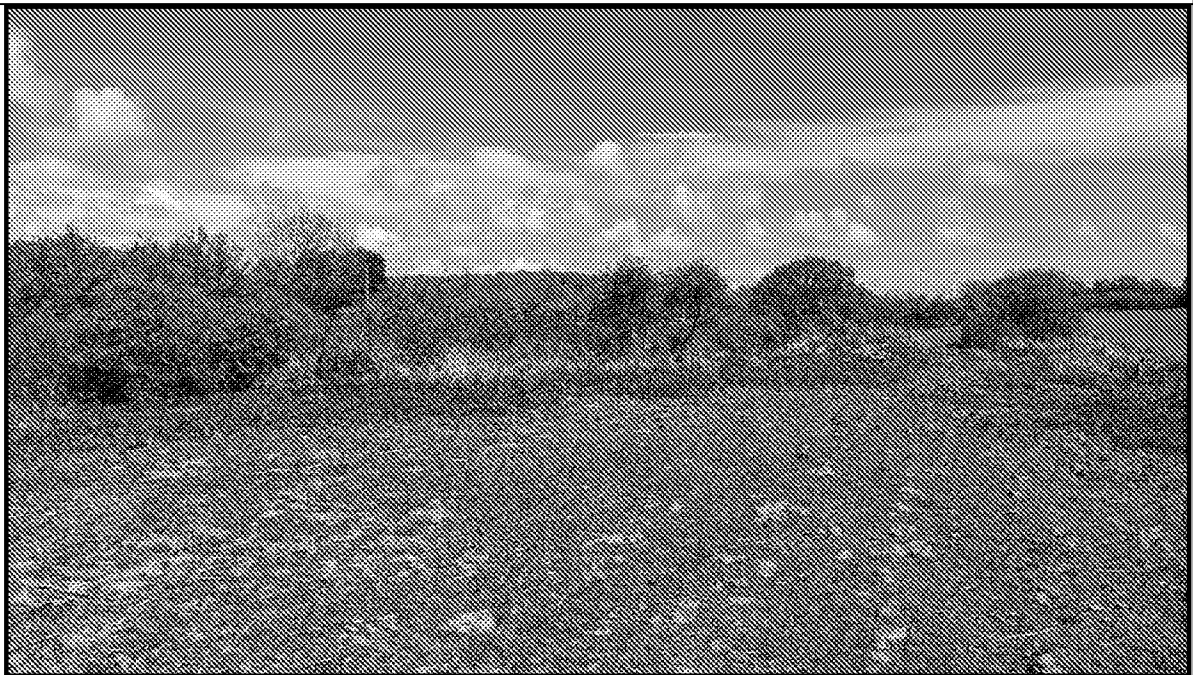
**Photograph 14.** Views of the north of the site, showing additional tree protection fencing required around T57. Viewed looking towards the north-east.

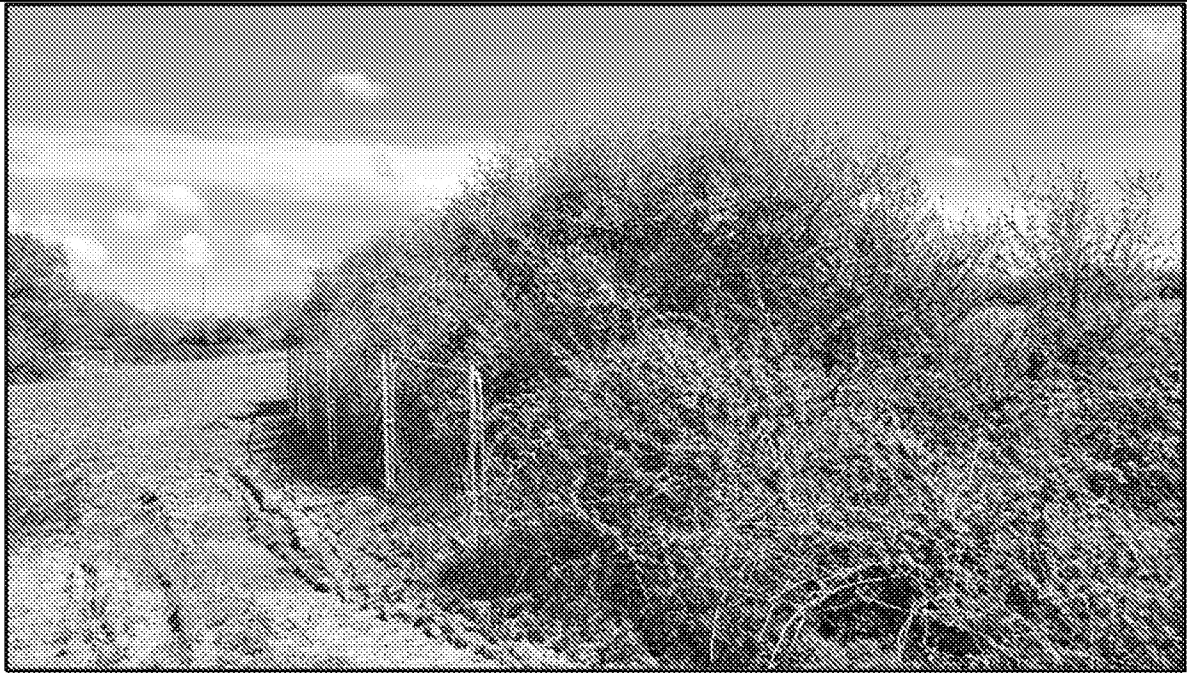
- 2.4 Signage should be included at regular interval and permanently attached to the weld mesh panels to inform personnel of the purpose of the fencing and that it should not be move, until all construction is complete. Typical Tree protection Signage is shown in **Appendix 2**.
- 2.5 In some cases fencing has been installed slightly closer to the trees than specified in the tree protection plan, T3 and T13, not fully protecting the RPA.
- 2.6 In other cases, the fencing has been installed, but to the north rather than the south of trees, G51 and T52, requiring protection as specified in the tree protection plan.

**Photograph 15** (above). Views of G51 and T52, showing fencing protection incorrectly installed to the north of the group rather than to the south. Viewed looking towards the east.

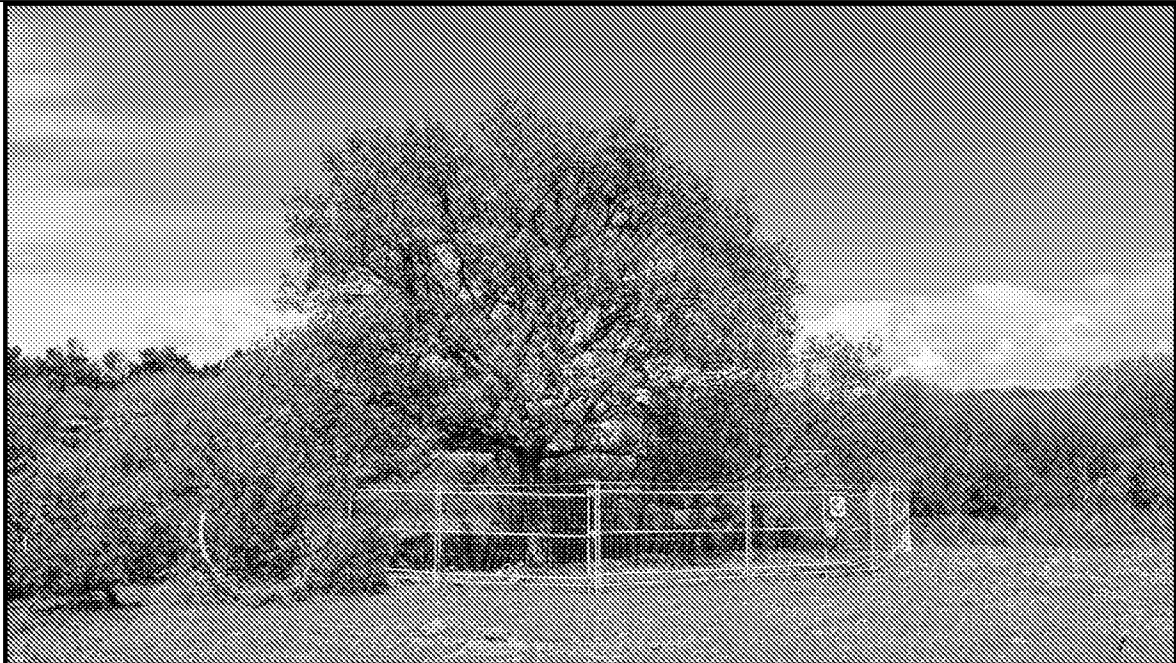
**Photograph 16.** Tree protection fencing correctly installed around T55. Viewed looking towards the north-east.

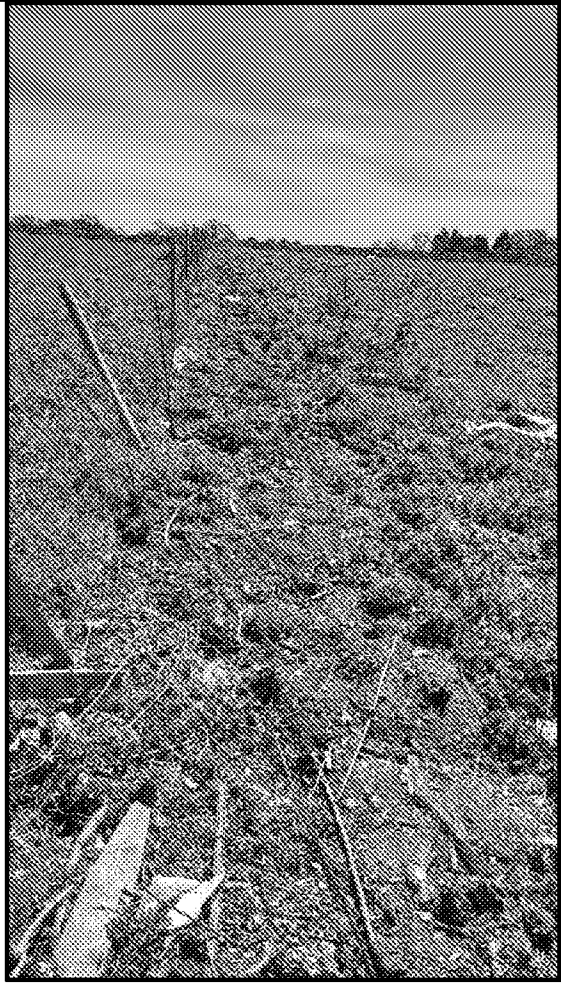
**Photograph 17.** Tree removal of H42 and H41 in the centre of the northern parcel of land. Viewed looking towards the south.
