## PHOTOGRAPHIC LOG

Site Location: Land at West End Nursery, Angmering – SE POS

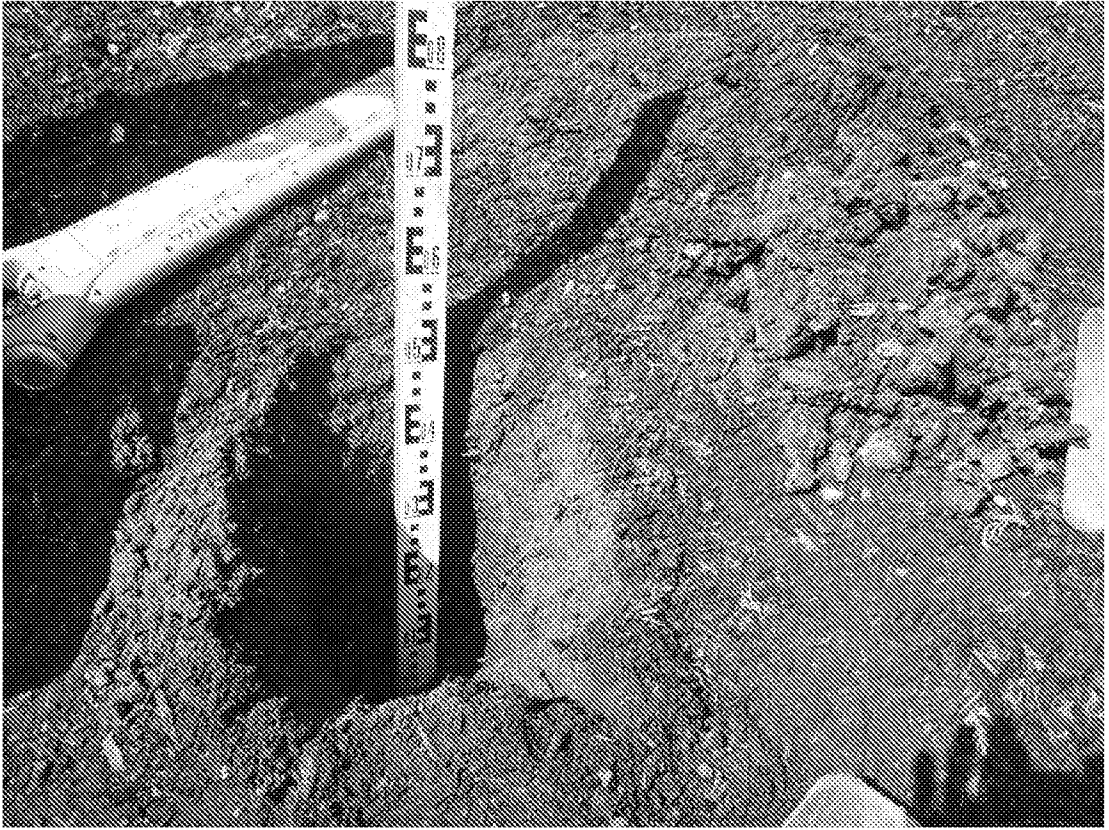
| <p><b>Photo No.</b><br/>1</p> | |

| <p>Overview of HDP101</p> | |

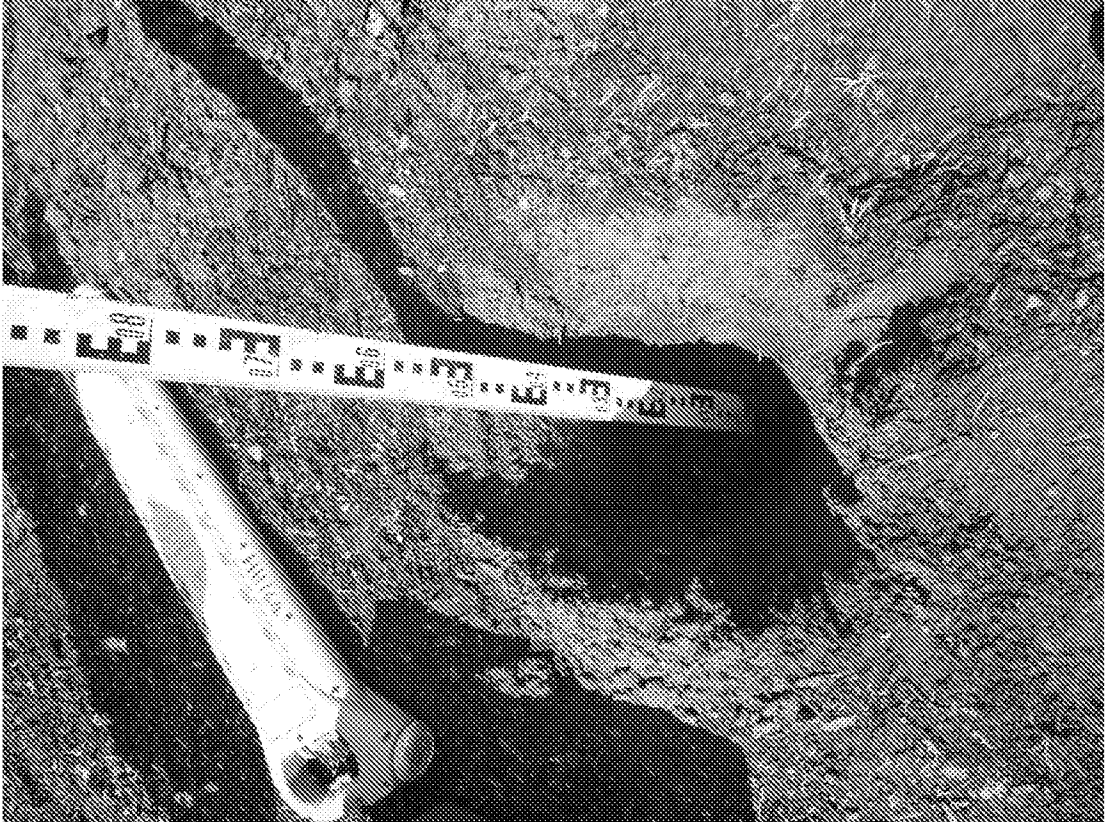
| <p><b>Photo No.</b><br/>2</p> | |

| <p>View showing the depth of clean capping within HDP101 to be at least 600 mm thick</p> | |

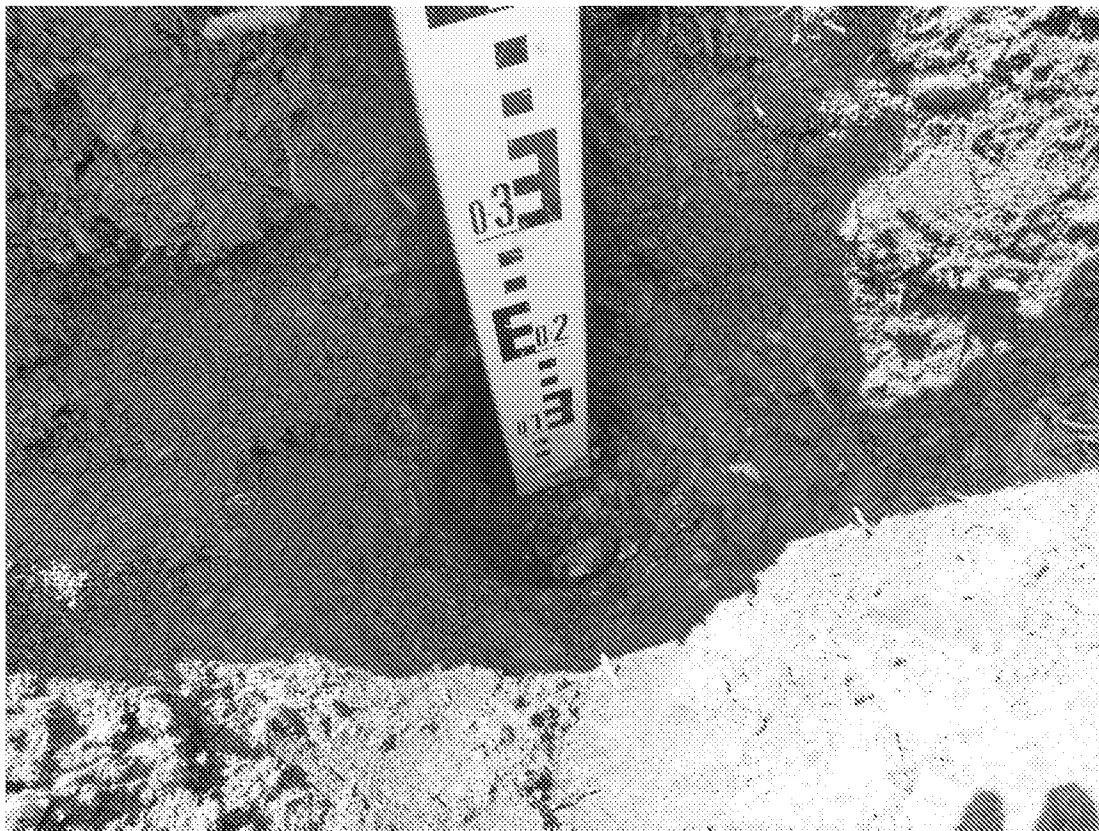
Photo No.  
3

HDP101  
capping layer  
observed to  
be underlain  
by a geo-  
marker  
membrane

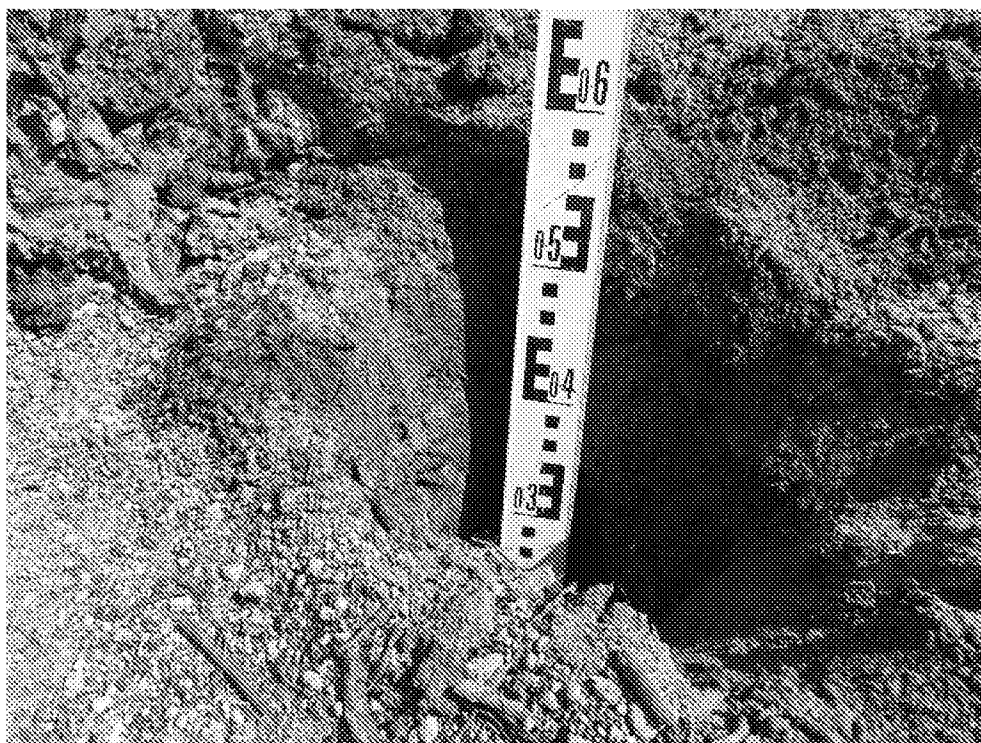
Photo No.  
4

View  
showing the  
depth of  
clean  
capping  
within  
HDP102 to  
be at least  
600 mm thick

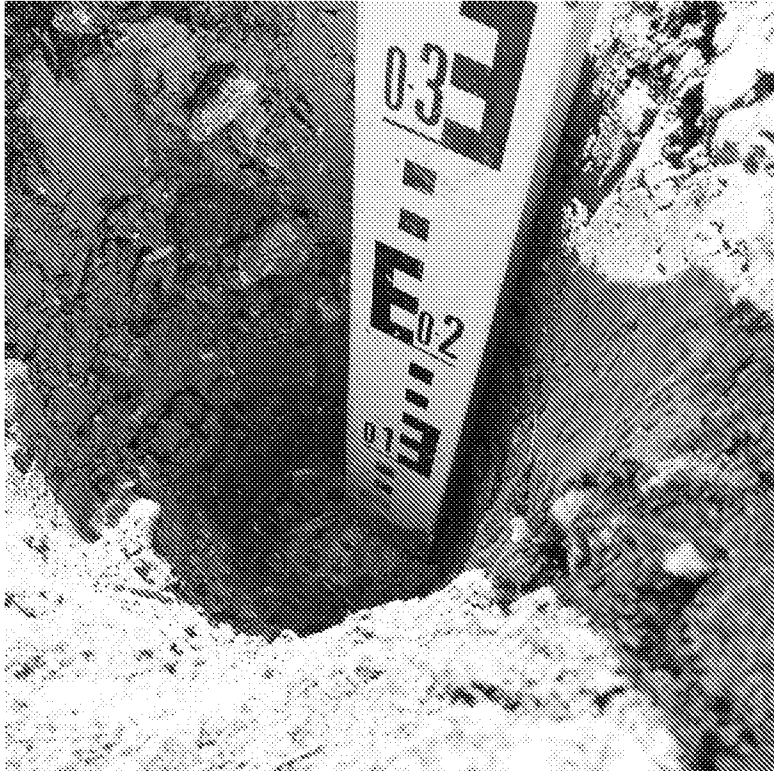
| <p><b>Photo No.</b><br/>5</p> | |

| <p>HDP102 capping layer observed to be underlain by a geo-marker membrane</p> | |

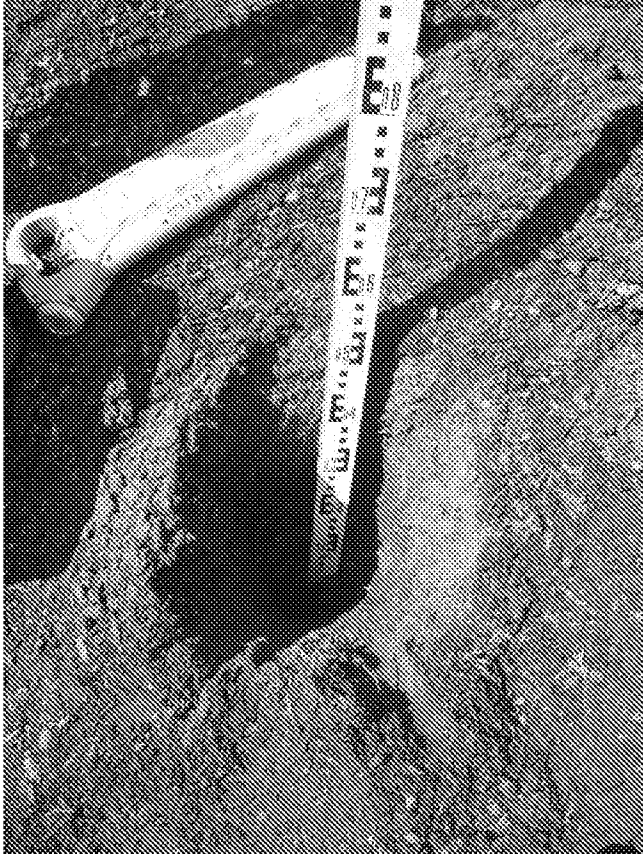
| <p><b>Photo No.</b><br/>6</p> | |

| <p>View showing the depth of clean capping within HDP103 to be at least 600 mm thick</p> | |

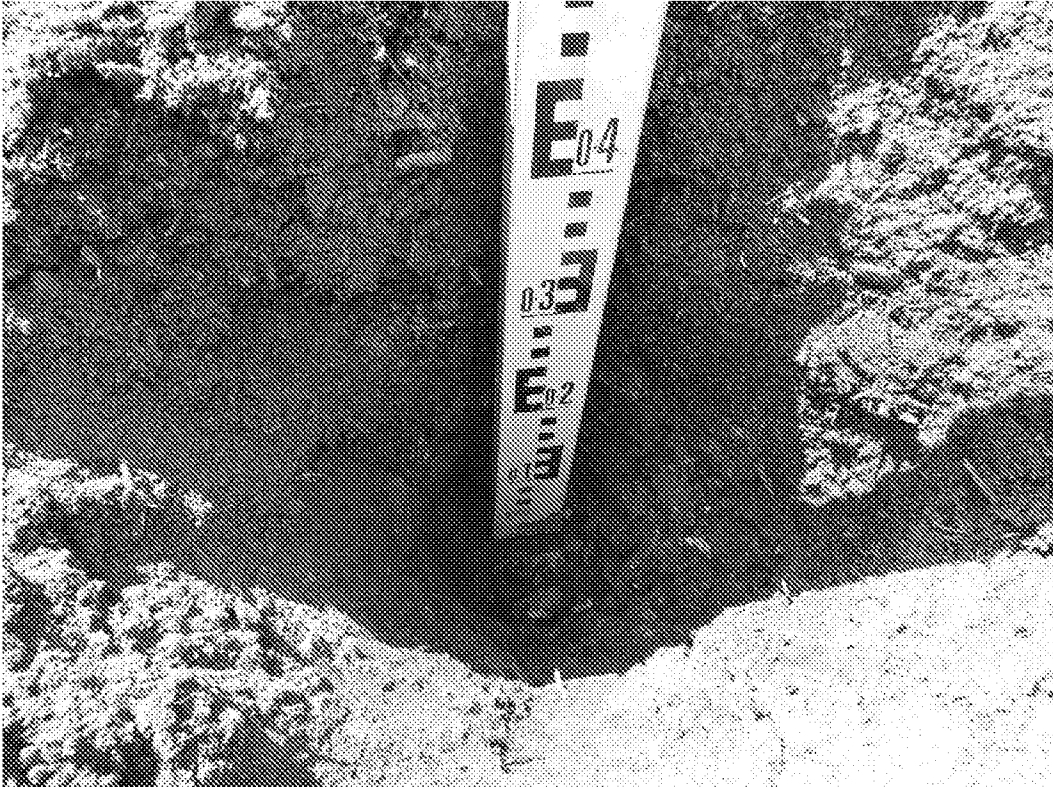
| <p><b>Photo No.</b><br/>7</p> | |

| <p>HDP103<br/>capping layer<br/>observed to<br/>be underlain<br/>by a geo-<br/>marker<br/>membrane</p> | |

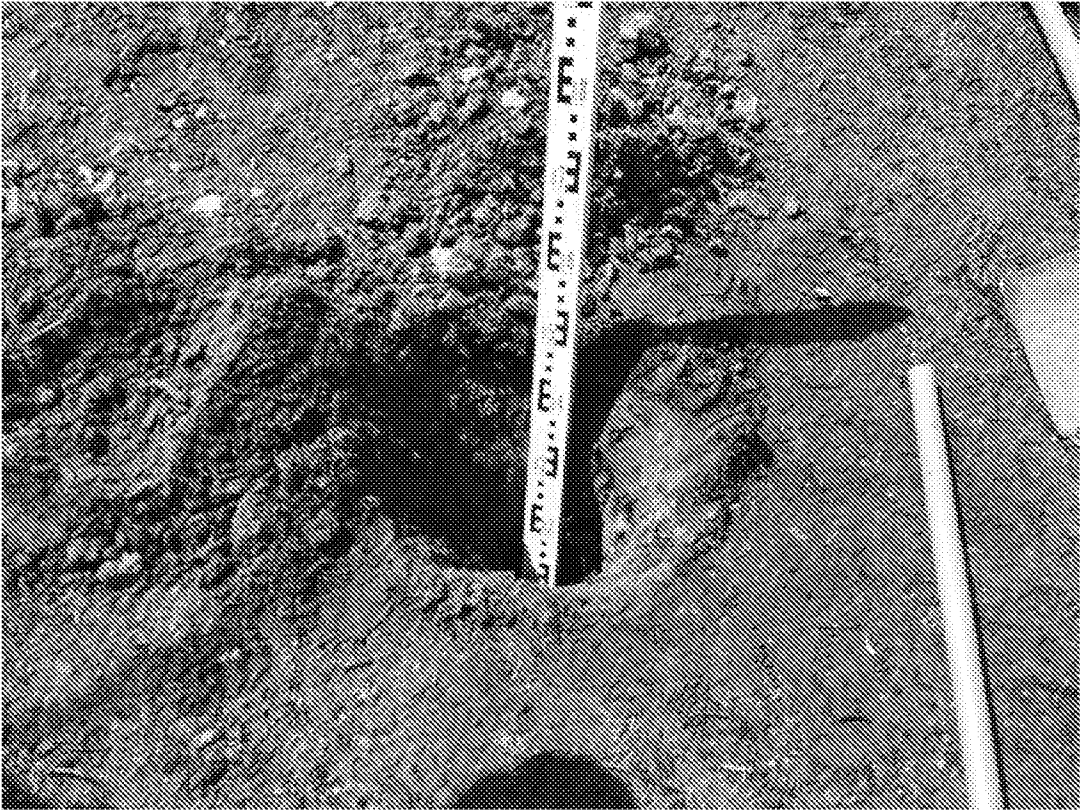
| <p><b>Photo No.</b><br/>8</p> | |

| <p>Overview of<br/>HDP104</p> | |

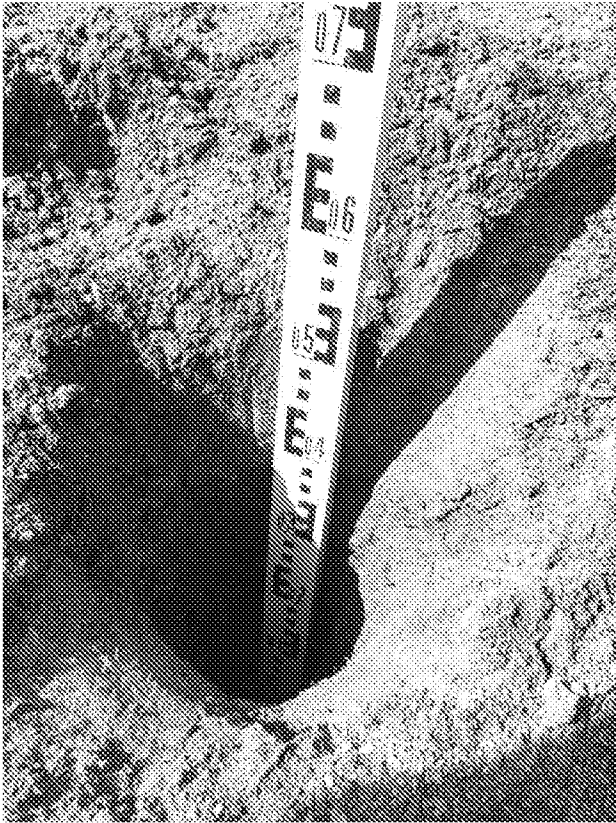
| <p><b>Photo No.</b><br/>9</p> | |

| <p>View showing the depth of clean capping within HDP104 to be at least 600 mm thick</p> | |

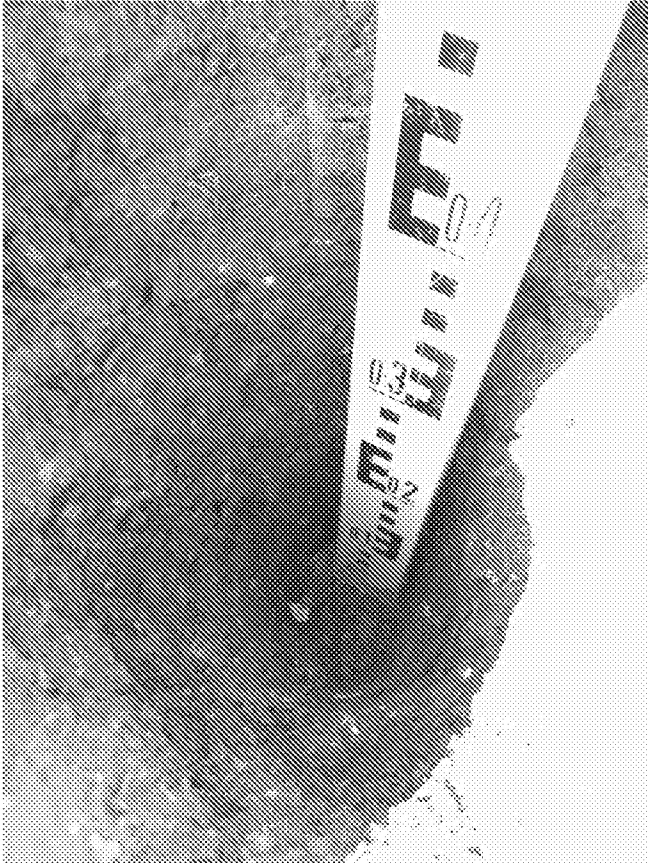
| <p><b>Photo No.</b><br/>10</p> | |

| <p>HDP104 capping layer observed to be underlain by a geo-marker membrane</p> | |

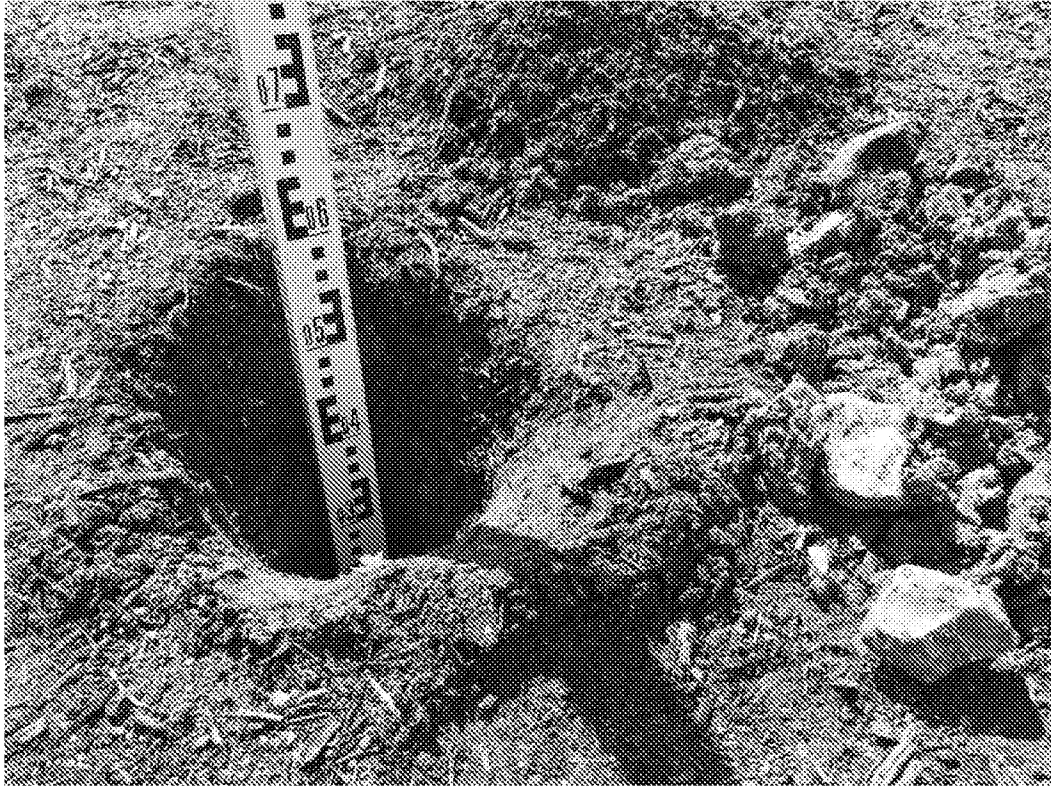
| PHOTOGRAPHIC LOG | |
|---|---|
| <b>Photo No.</b><br>11 | |

| PHOTOGRAPHIC LOG | |
|---|---|
| View showing the depth of clean capping within HDP105 to be at least 600 mm thick | |

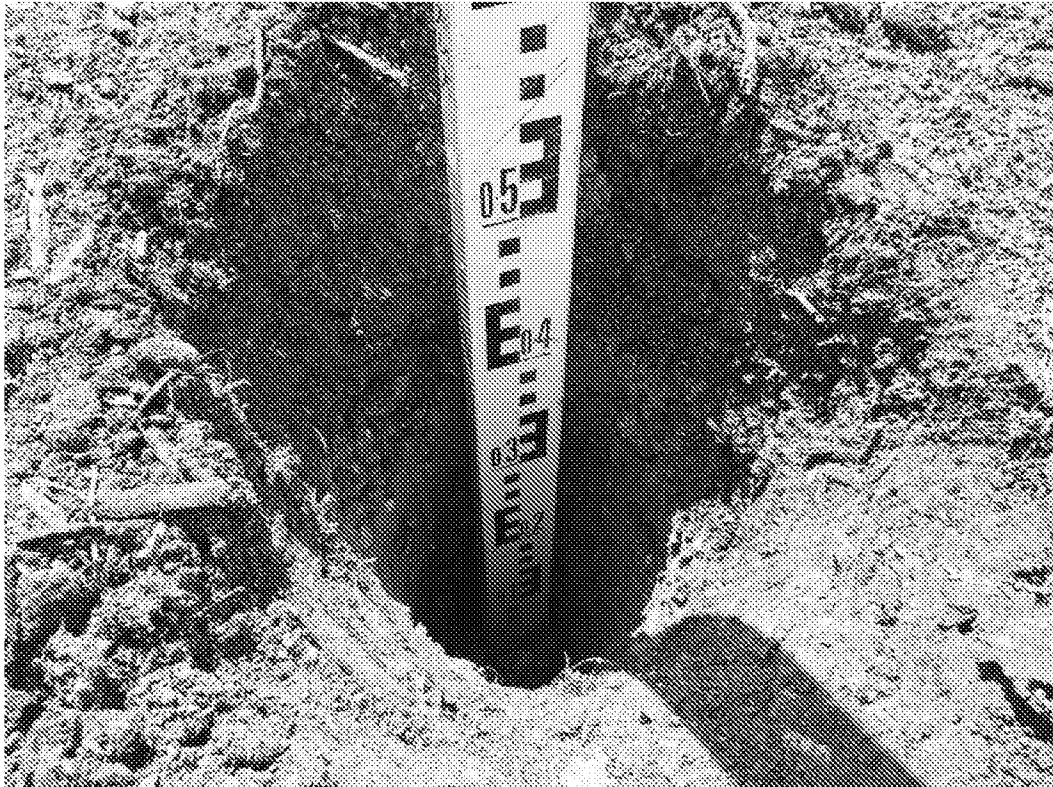
| PHOTOGRAPHIC LOG | |
|---|---|
| <b>Photo No.</b><br>12 | |

| PHOTOGRAPHIC LOG | |
|---|---|
| View of capping layer in HDP105 | |

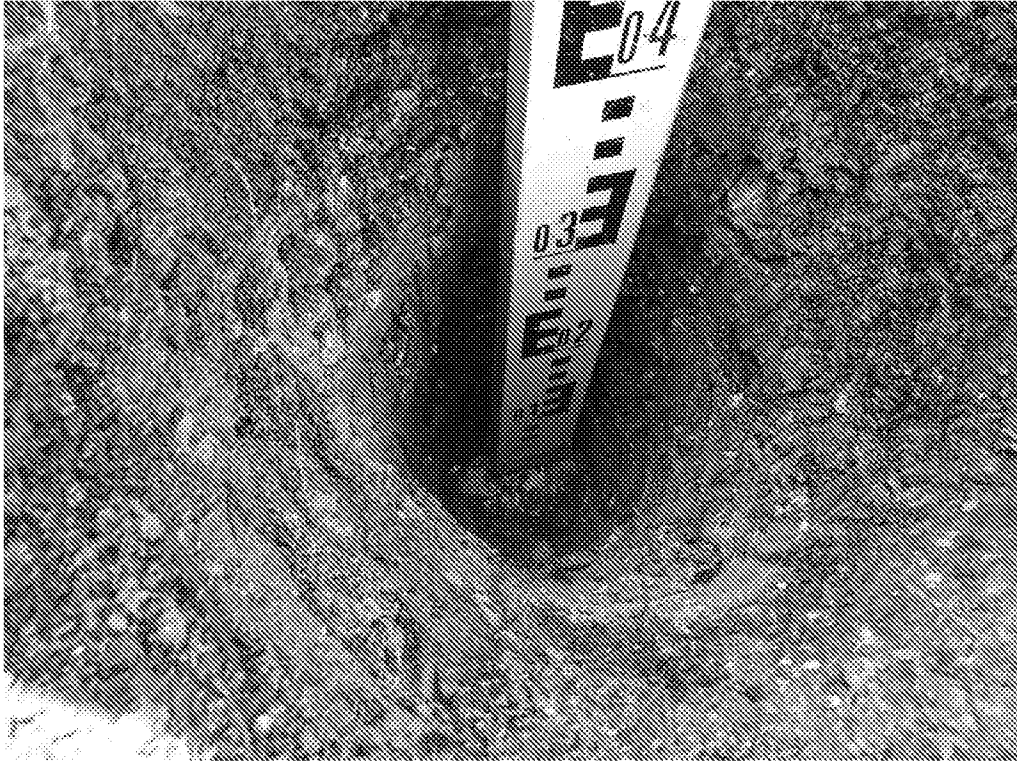
| PHOTOGRAPHIC LOG | |
|---|---|
| <b>Photo No.</b><br>13 | |

| PHOTOGRAPHIC LOG | |
|---|---|
| HDP105 capping layer observed to be underlain by a geo-marker membrane | |

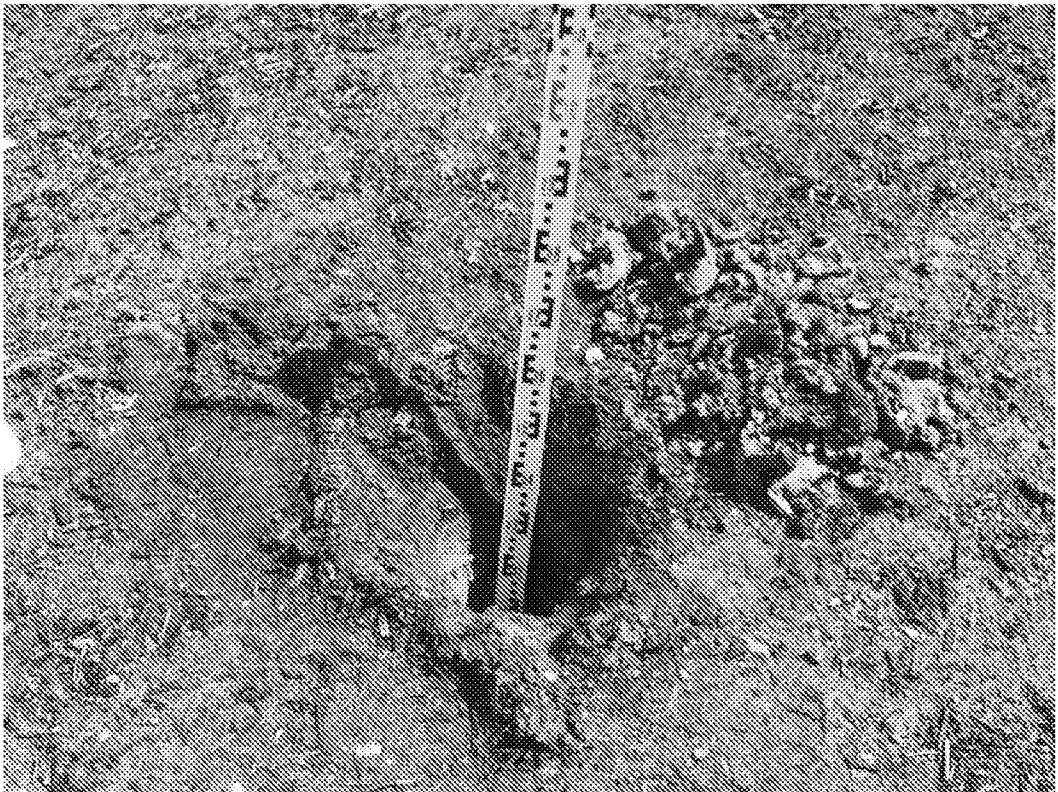
| PHOTOGRAPHIC LOG | |
|---|---|
| <b>Photo No.</b><br>14 | |

| PHOTOGRAPHIC LOG | |
|---|---|
| Overview of HDP106 | |

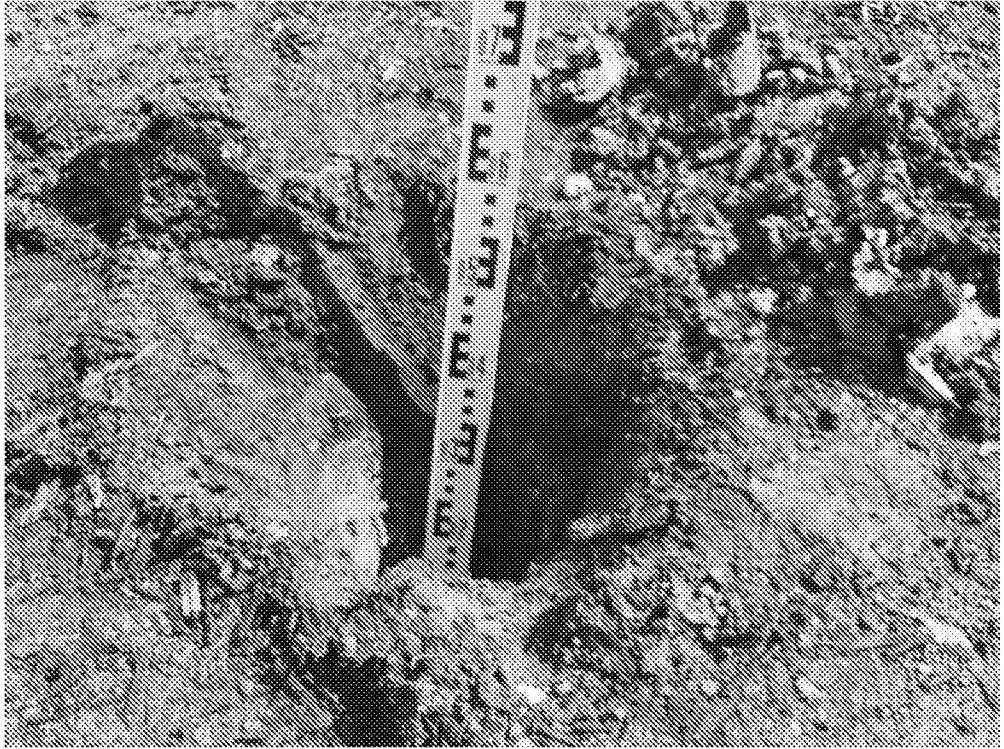
| PHOTOGRAPHIC LOG | |
|---|---|
| <b>Photo No.</b><br>15 | |

| PHOTOGRAPHIC LOG | |
|---|---|
| View showing the depth of clean capping within HDP106 to be at least 600 mm thick | |

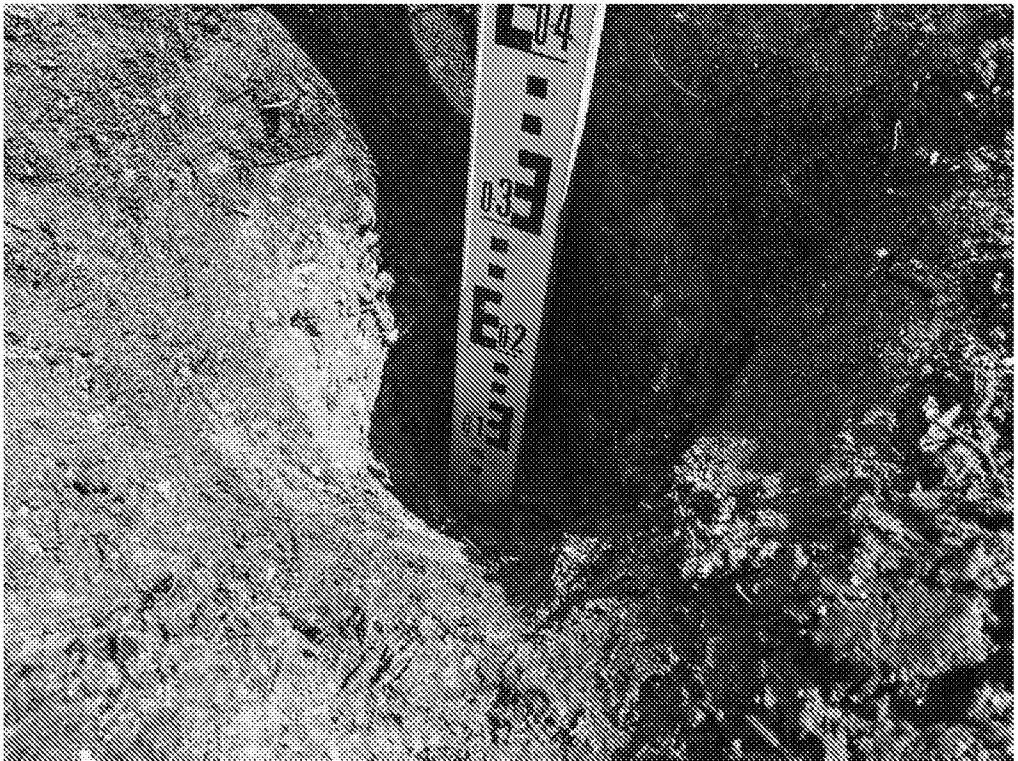
| PHOTOGRAPHIC LOG | |
|---|---|
| <b>Photo No.</b><br>16 | |

| PHOTOGRAPHIC LOG | |
|---|---|
| HDP106 capping layer observed to be underlain by a geo-marker membrane | |

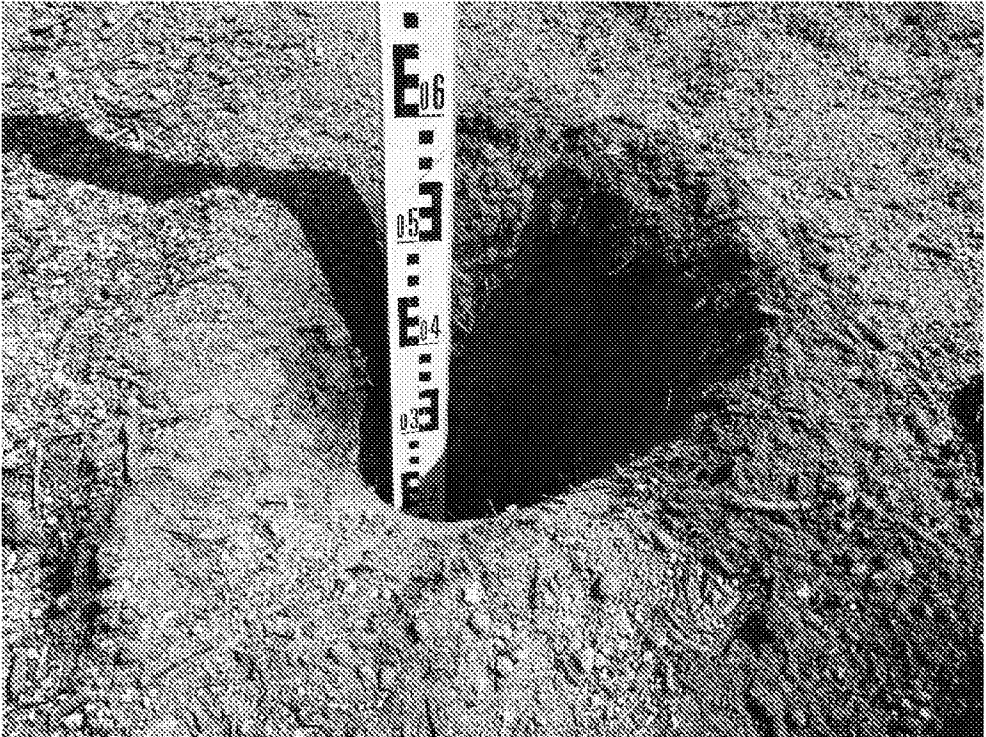
| <p><b>Photo No.</b><br/>17</p> | |

| <p>View showing the depth of clean capping within HDP107 to be at least 600 mm thick</p> | |

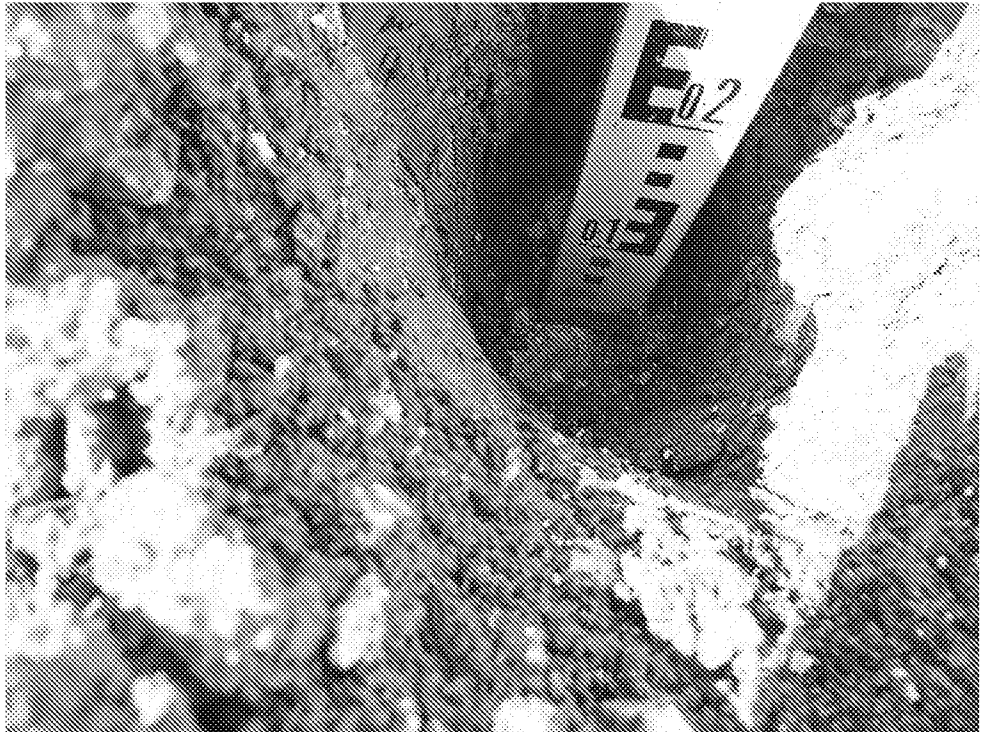
| <p><b>Photo No.</b><br/>18</p> | |

| <p>HDP107 capping layer observed to be underlain by a geo-marker membrane</p> | |

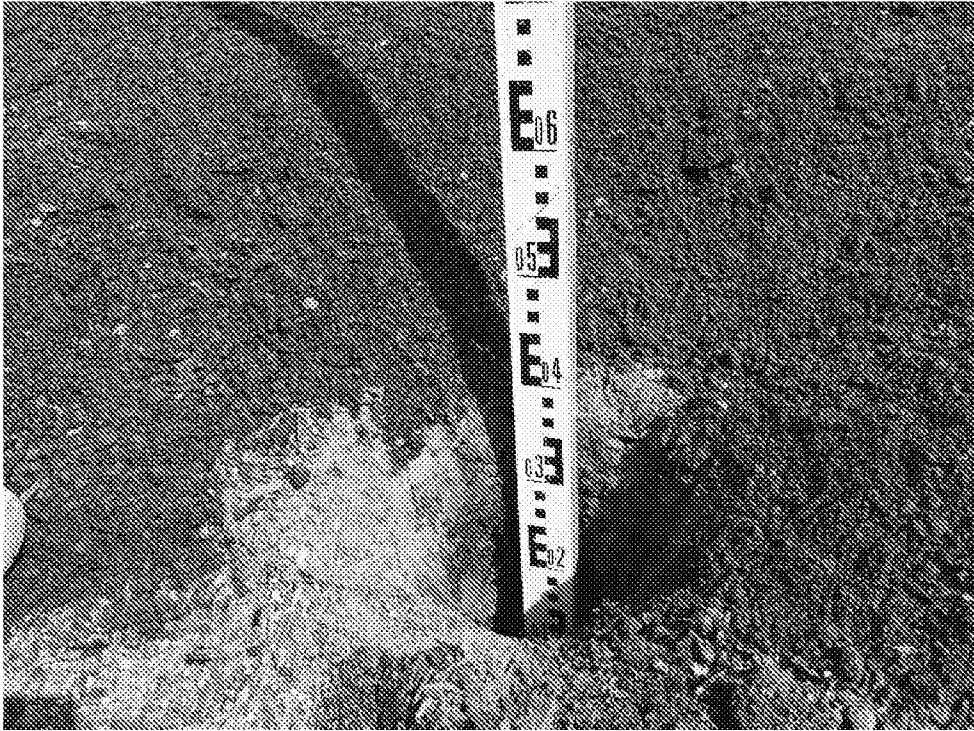
| <p><b>Photo No.</b><br/>19</p> | |

| <p>View showing the depth of clean capping within HDP108 to be at least 600 mm thick</p> | |

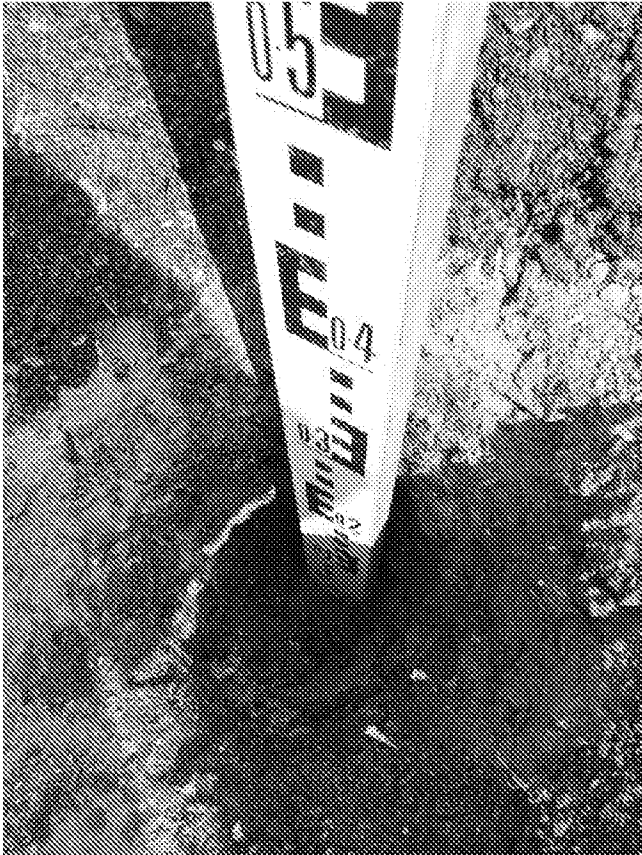
| <p><b>Photo No.</b><br/>20</p> | |

| <p>View of capping layer in HDP108</p> | |

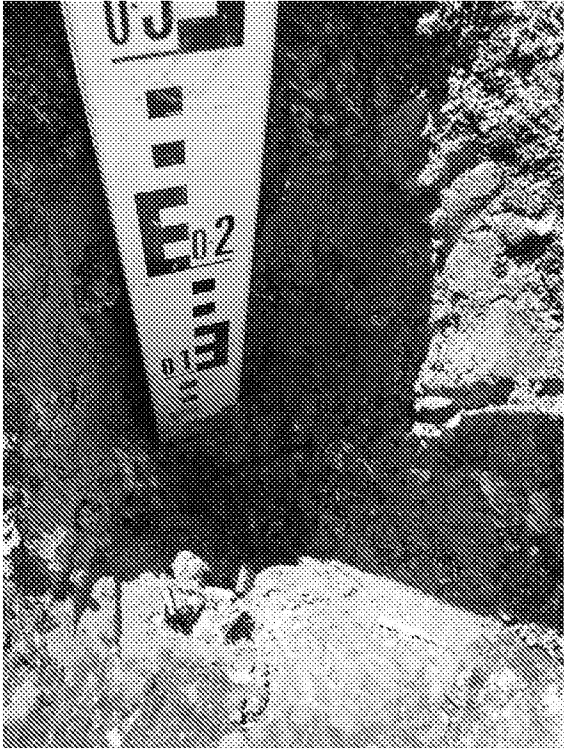
| <p><b>Photo No.</b><br/>21</p> | |

| <p>HDP108 capping layer observed to be underlain by a geo-marker membrane</p> | |

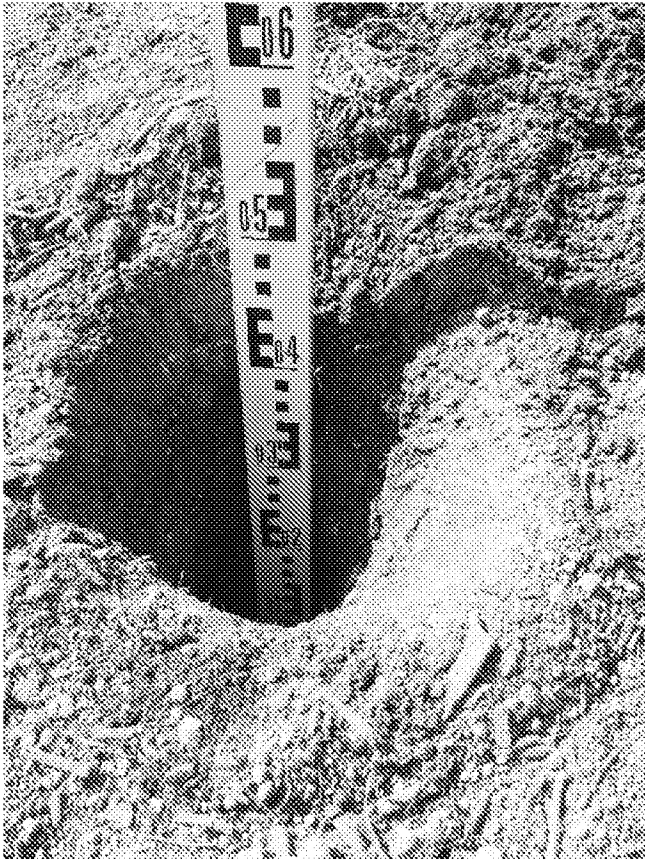
| <p><b>Photo No.</b><br/>22</p> | |

| <p>View showing the depth of clean capping within HDP109 to be at least 600 mm thick</p> | |

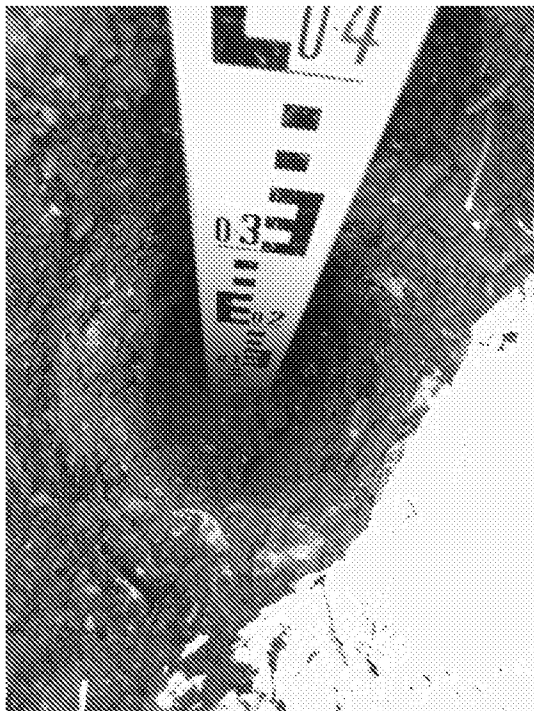
| <p><b>Photo No.</b><br/>23</p> | |

| <p>View of capping material in HDP109</p> | |

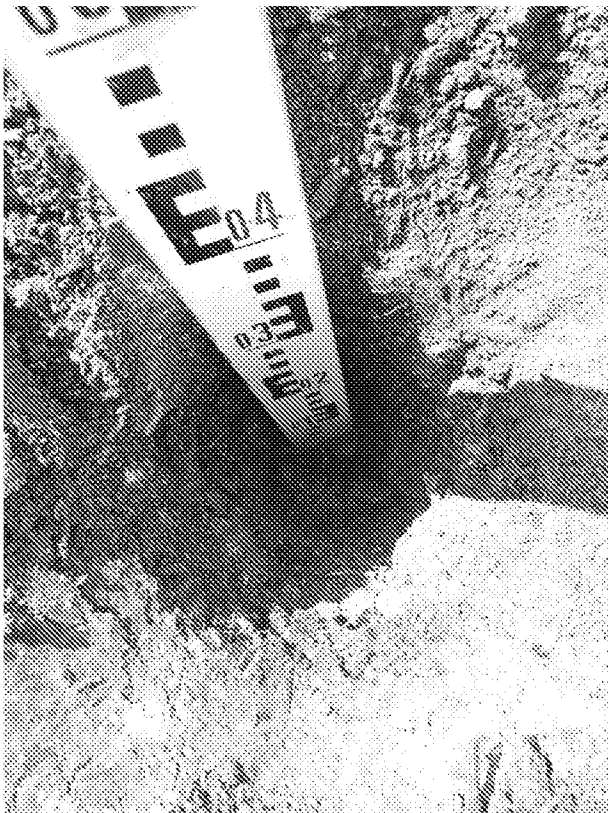
| <p><b>Photo No.</b><br/>24</p> | |

| <p>HDP109 capping layer observed to be underlain by a geo-marker membrane</p> | |

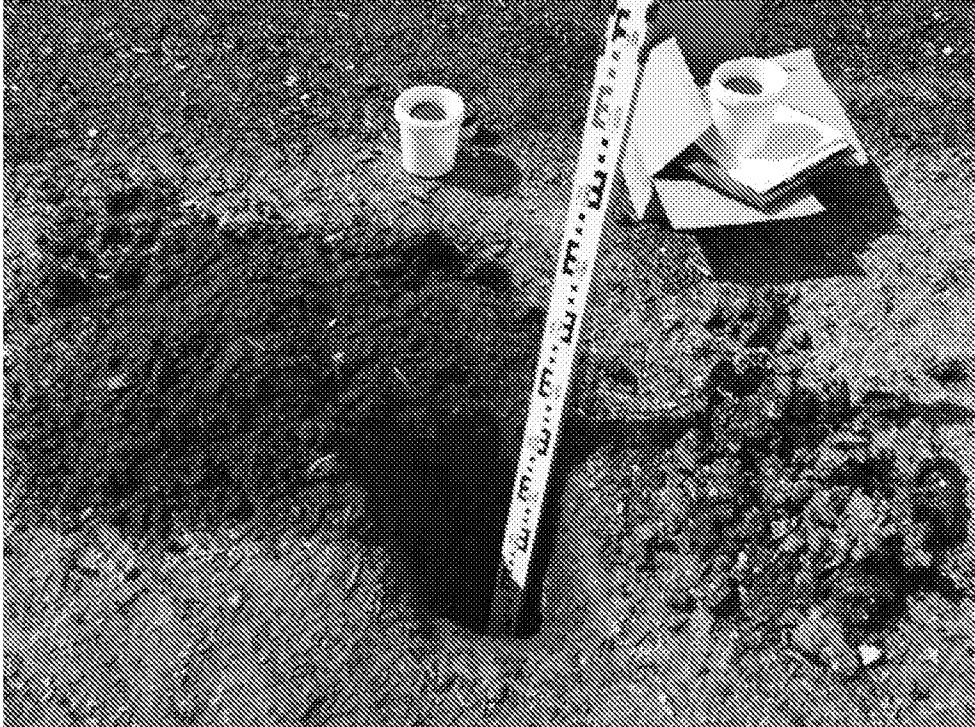
| <p><b>Photo No.</b><br/>25</p> | |

| <p>View showing the depth of clean capping within HDP110 to be at least 600 mm thick</p> | |

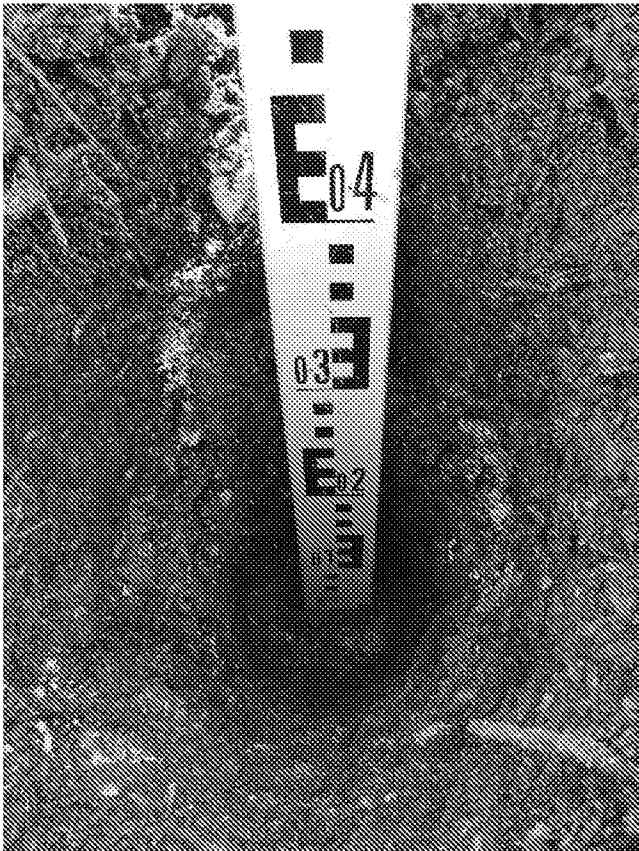
| <p><b>Photo No.</b><br/>26</p> | |

| <p>HDP110 capping layer observed to be underlain by a geo-marker membrane</p> | |

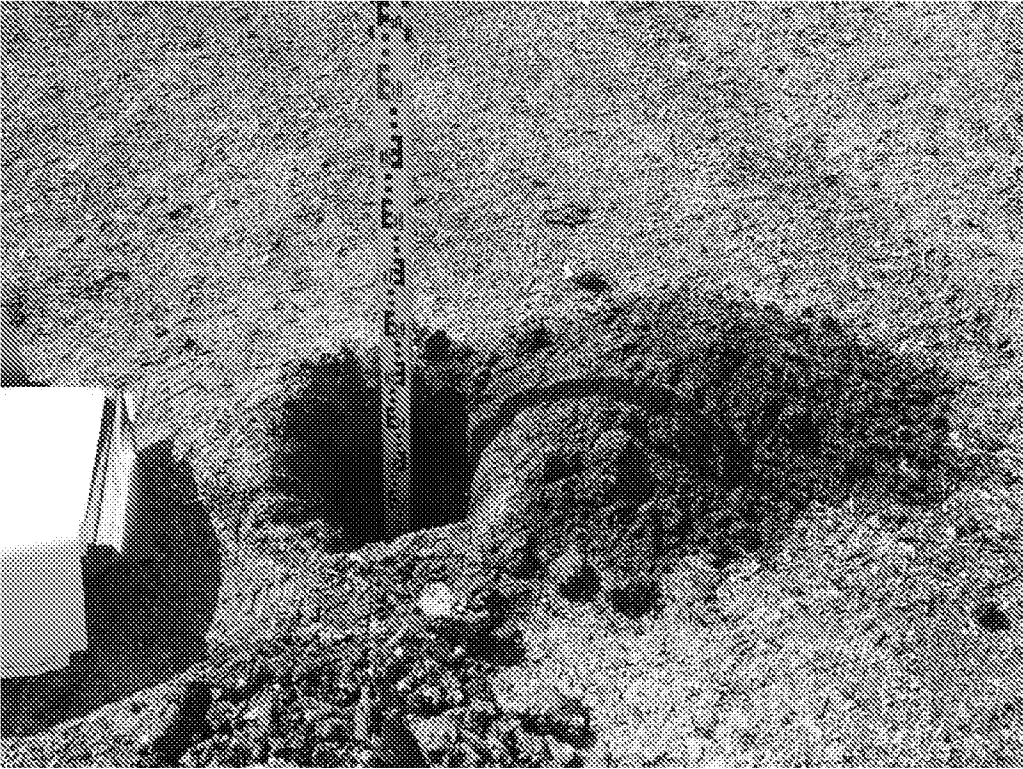
| <p><b>Photo No.</b><br/>27</p> | |

| <p>View showing the depth of clean capping within HDP111 to be at least 600 mm thick</p> | |

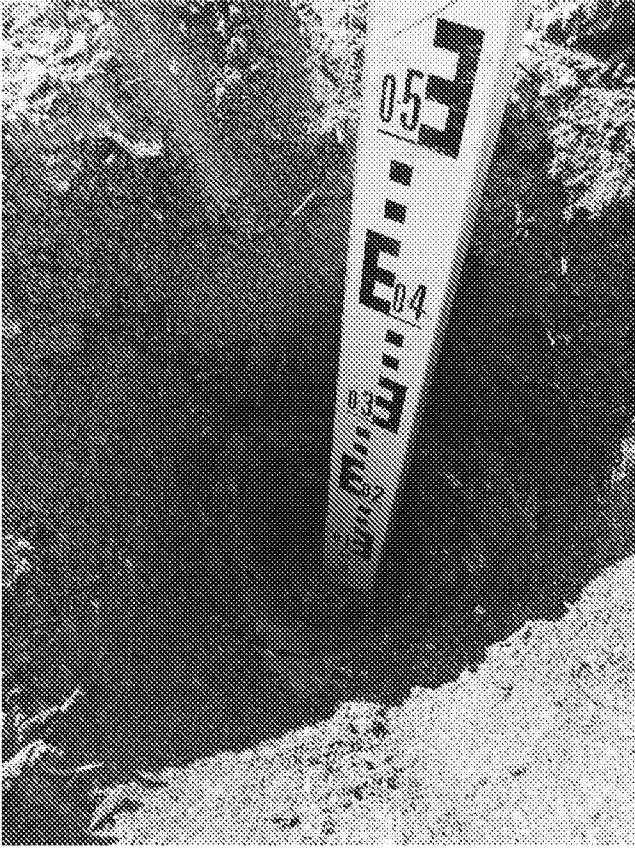
| <p><b>Photo No.</b><br/>28</p> | |

| <p>HDP111 capping layer observed to be underlain by a geo-marker membrane</p> | |

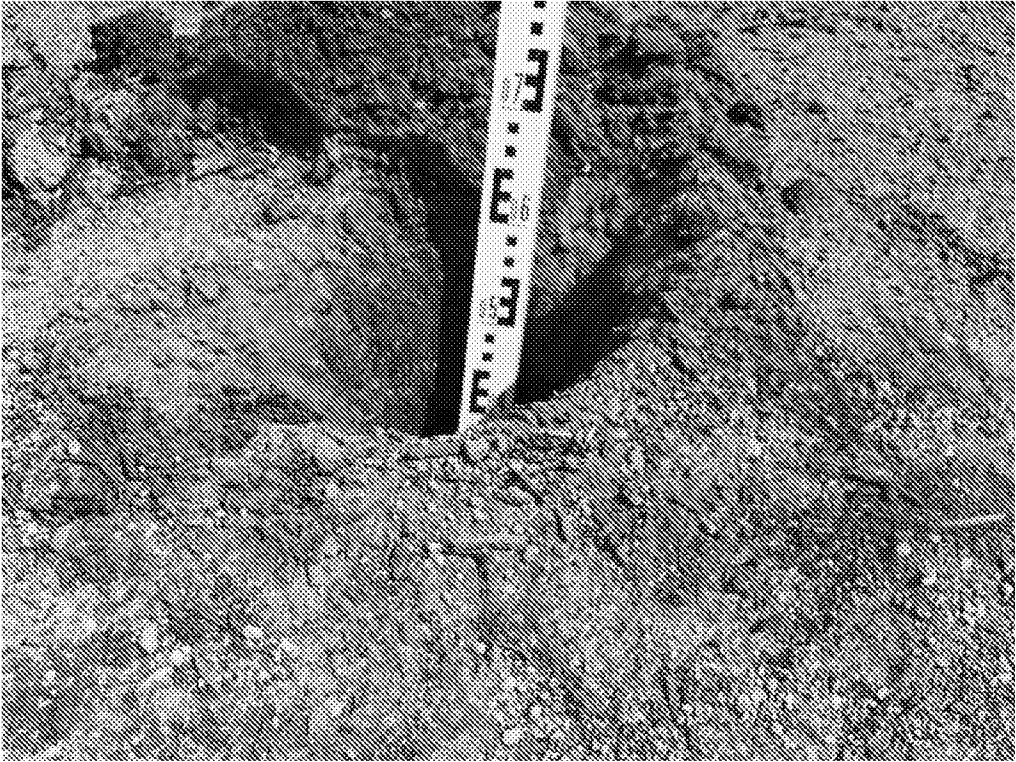
| <p><b>Photo No.</b><br/>29</p> | |

| <p>Overview of HDP112</p> | |

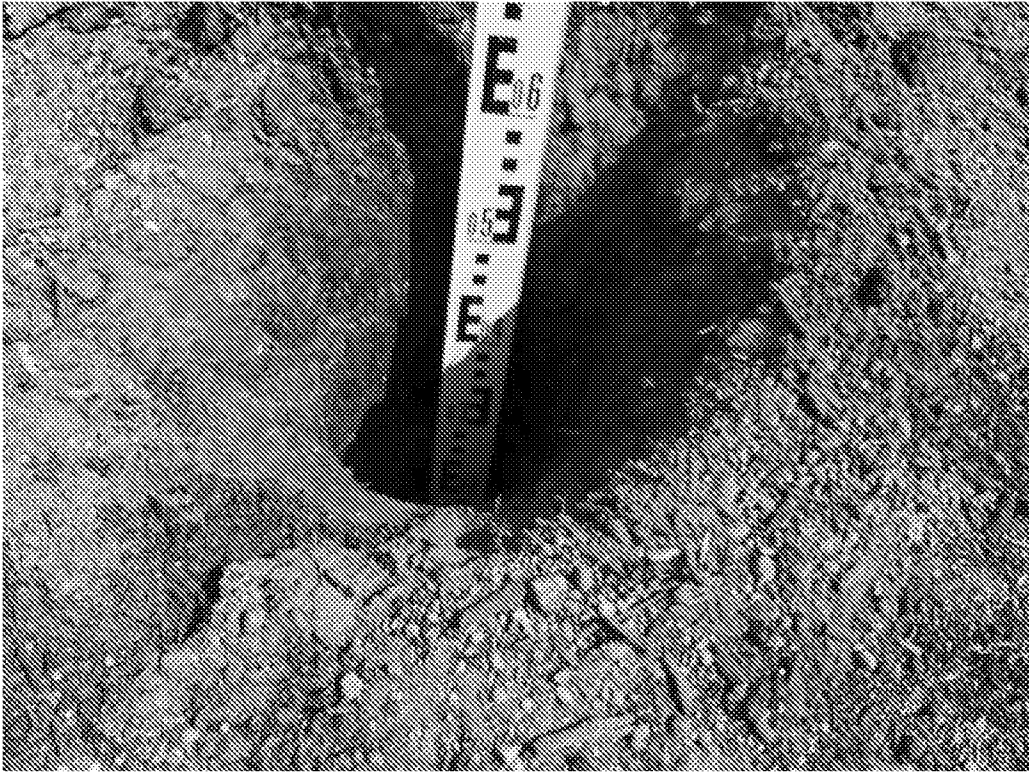
| <p><b>Photo No.</b><br/>30</p> | |

| <p>View showing the depth of clean capping within HDP112 to be at least 600 mm thick</p> | |

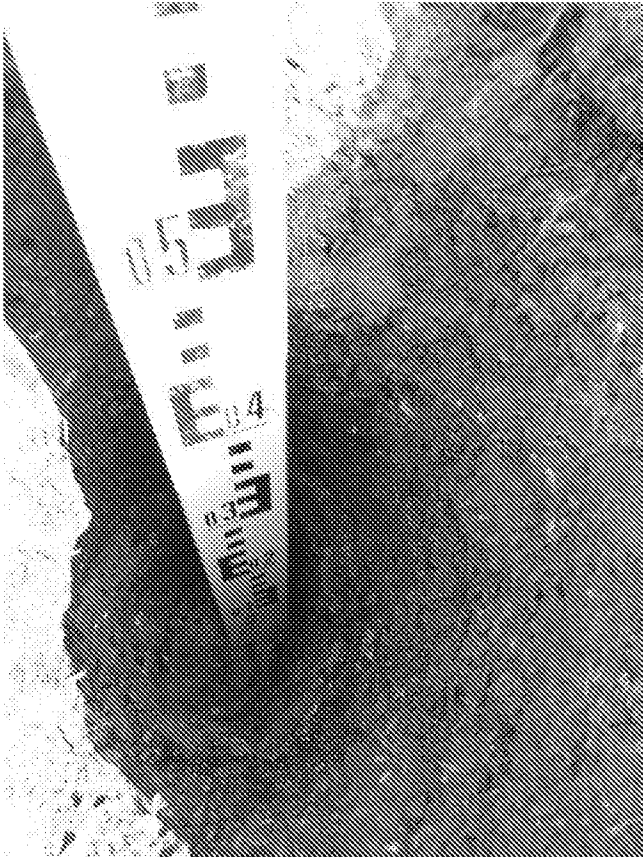
| <p><b>Photo No.</b><br/>31</p> | |

| <p>HDP112 capping layer observed to be underlain by a geo-marker membrane</p> | |

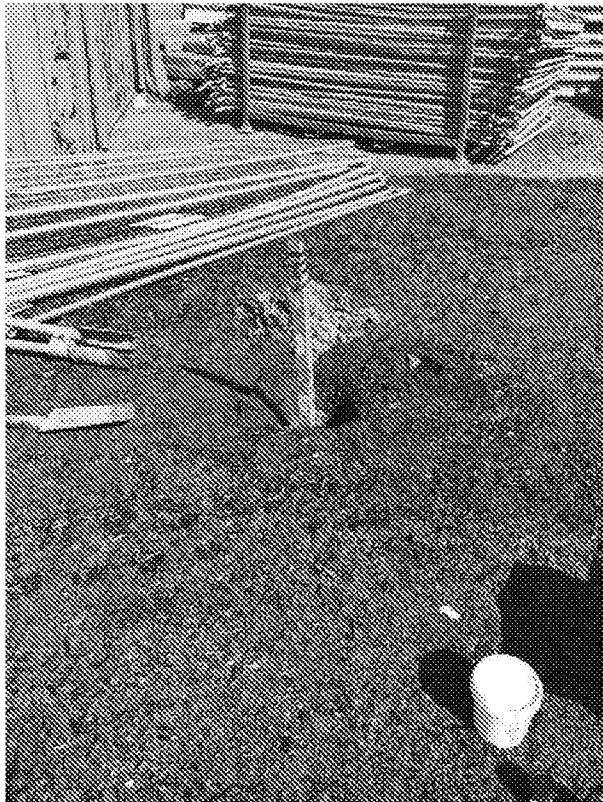
| <p><b>Photo No.</b><br/>32</p> | |

| <p>Overview of HDP113</p> | |
