## PHOTOGRAPHIC LOG

Site Location: Land at West End Nursery, Angmering – SE POS

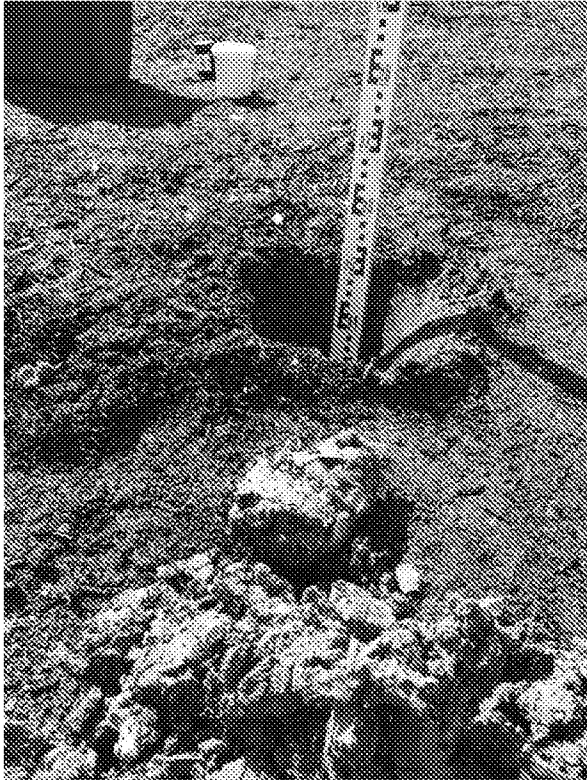
| PHOTOGRAPHIC LOG | |
|---|---|
| <b>Photo No.</b><br>33 | |

| PHOTOGRAPHIC LOG | |
|---|---|
| View showing the depth of clean capping within HDP113 to be at least 600 mm thick | |

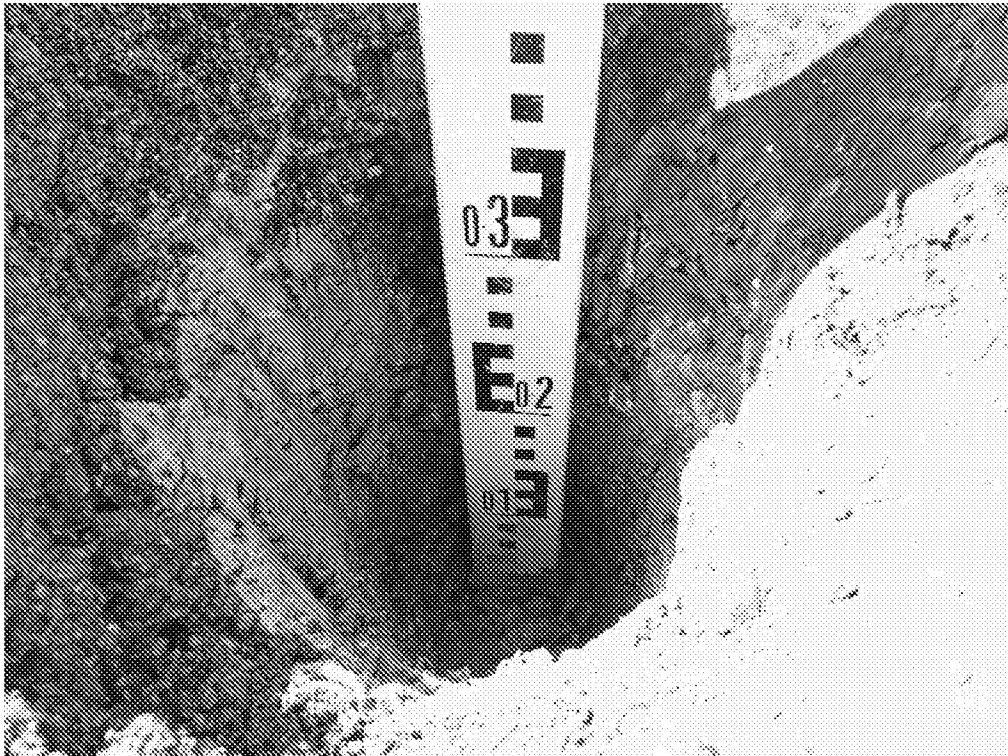
| PHOTOGRAPHIC LOG | |
|---|---|
| <b>Photo No.</b><br>34 | |

| PHOTOGRAPHIC LOG | |
|---|---|
| HDP113 capping layer observed to be underlain by a geo-marker membrane | |

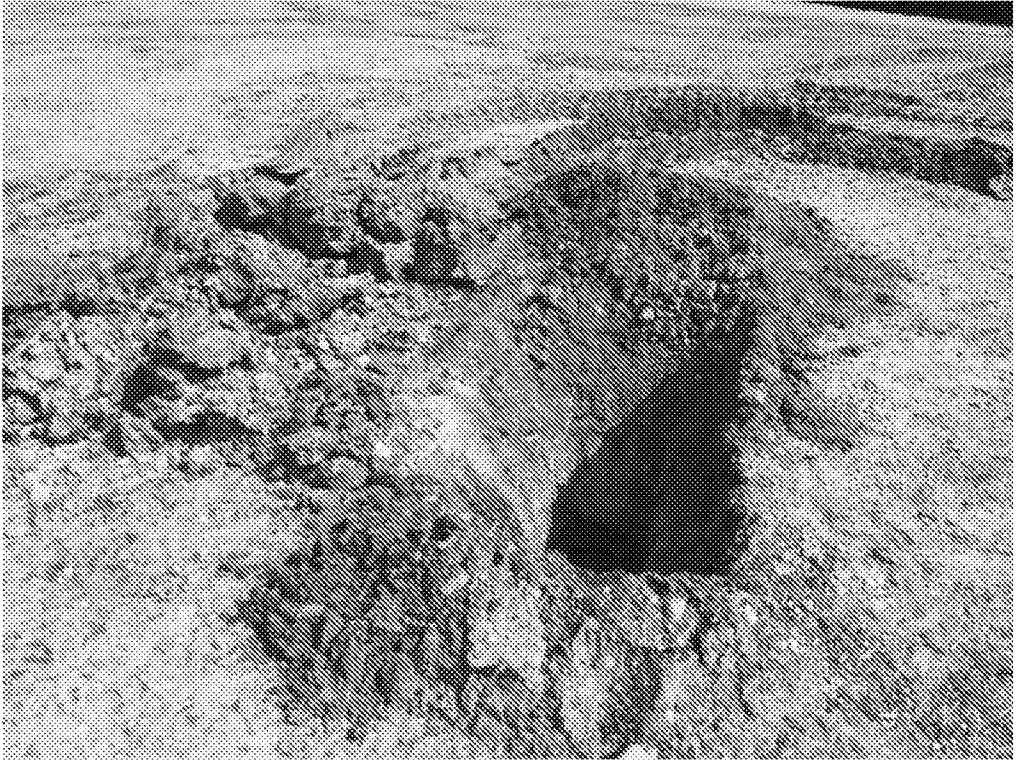
| PHOTOGRAPHIC LOG | |
|---|---|
| <b>Photo No.</b><br>35 | |

| PHOTOGRAPHIC LOG | |
|---|---|
| Overview of HDP114 | |

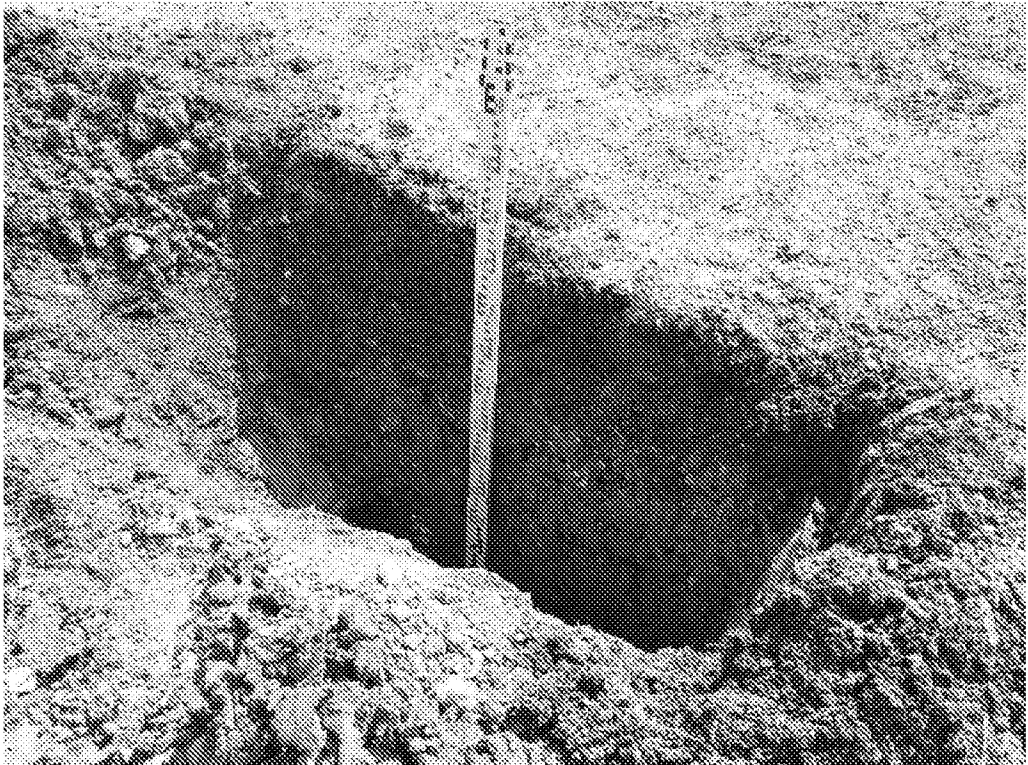
| PHOTOGRAPHIC LOG | |
|---|---|
| <b>Photo No.</b><br>36 | |

| PHOTOGRAPHIC LOG | |
|---|---|
| View showing the depth of clean capping within HDP114 to be at least 600 mm thick | |

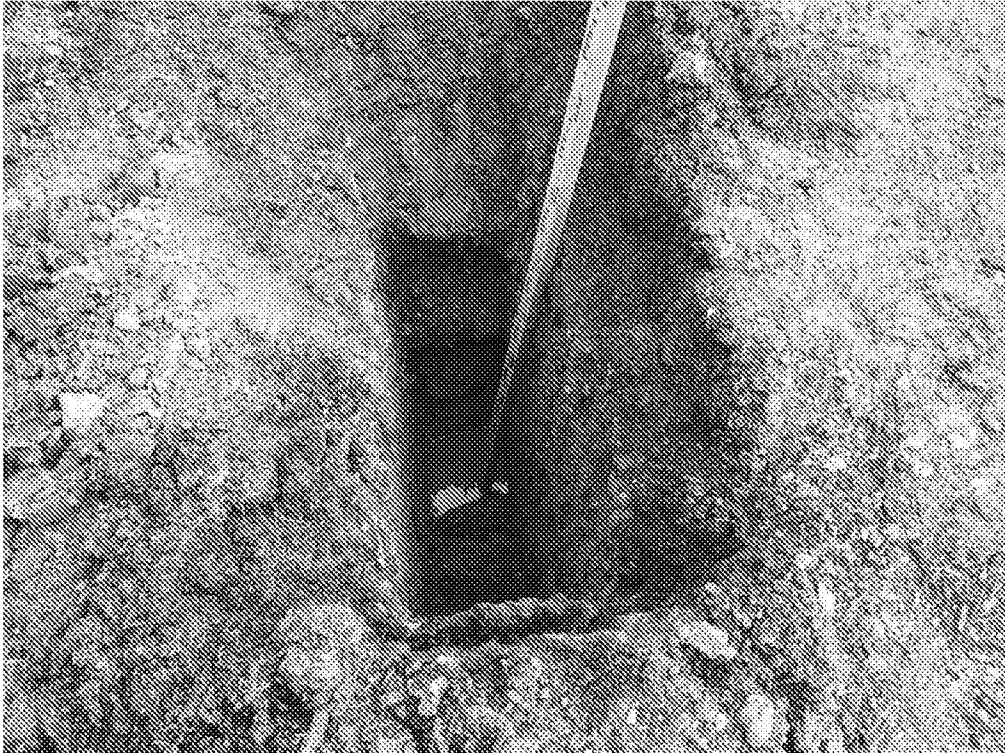
| PHOTOGRAPHIC LOG | |
|---|---|
| <b>Photo No.</b><br>37 | |

| PHOTOGRAPHIC LOG | |
|---|---|
| View of<br>HDP114 -<br>water<br>perched on<br>top of geo-<br>marker layer | |

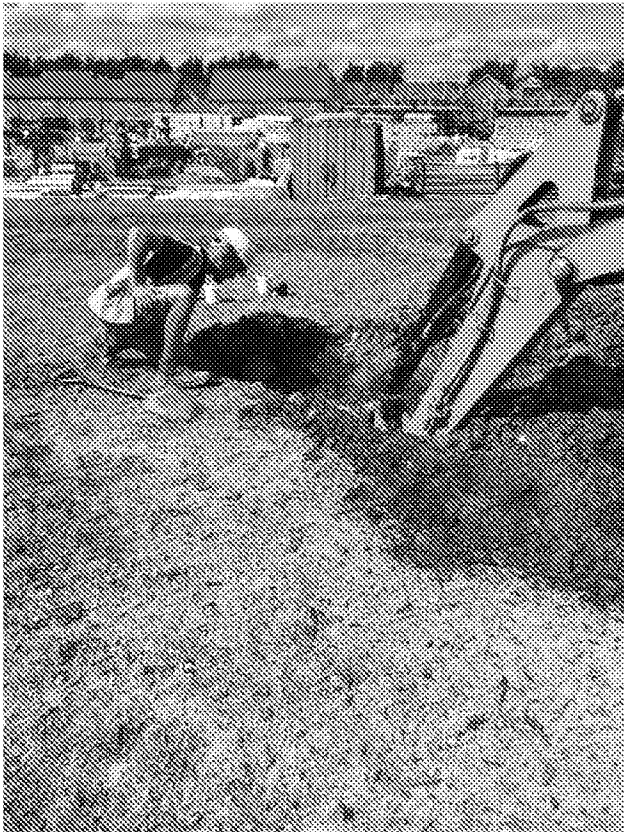
| PHOTOGRAPHIC LOG | |
|---|---|
| <b>Photo No.</b><br>38 | |

| PHOTOGRAPHIC LOG | |
|---|---|
| Overview of<br>HDP115 | |

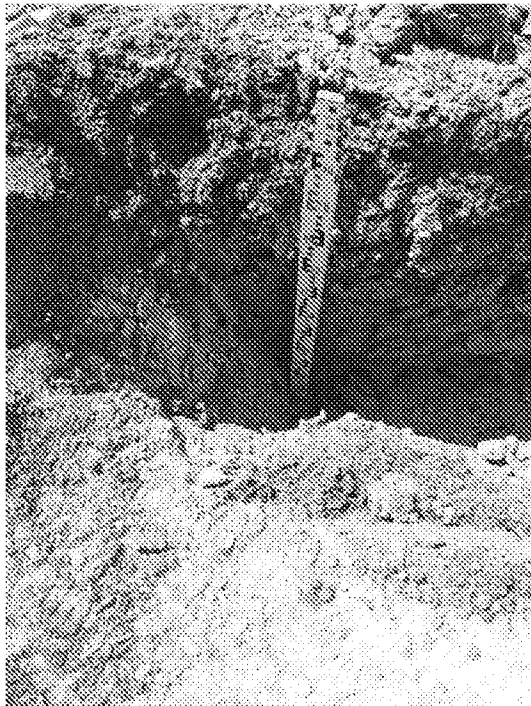
| PHOTOGRAPHIC LOG | |
|---|---|
| <b>Photo No.</b><br>39 | |

| PHOTOGRAPHIC LOG | |
|---|---|
| View showing the depth of clean capping within HDP115 to be at least 600 mm thick | |

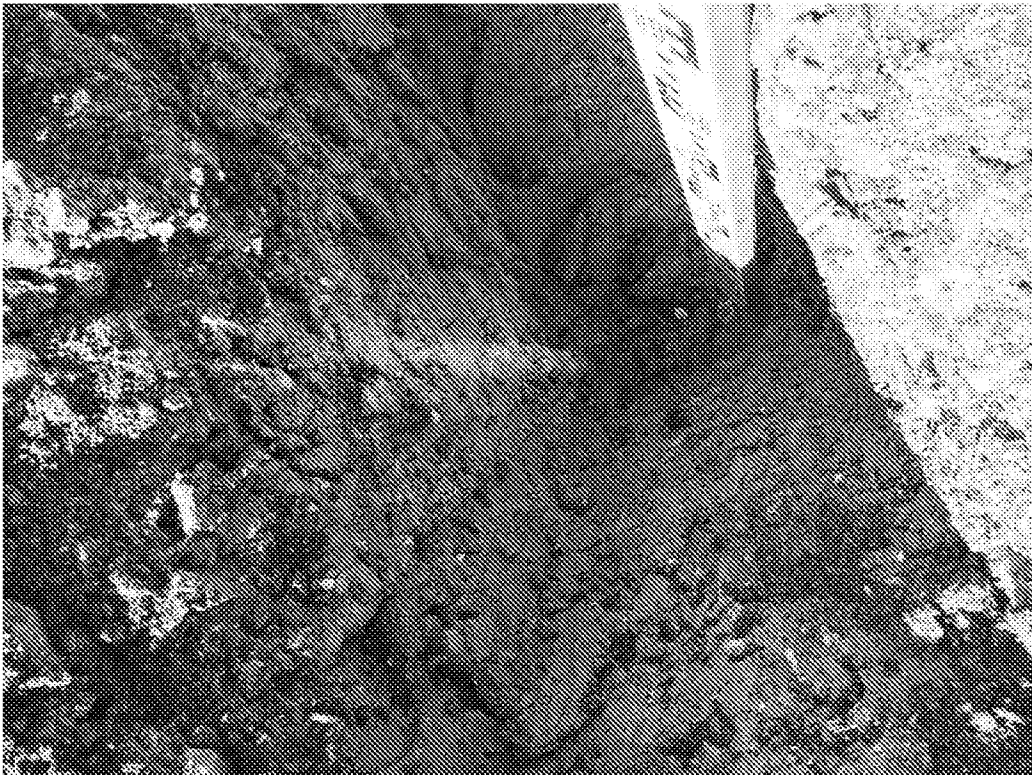
| PHOTOGRAPHIC LOG | |
|---|---|
| <b>Photo No.</b><br>40 | |

| PHOTOGRAPHIC LOG | |
|---|---|
| HDP115 capping layer observed to be underlain by a geo-marker membrane | |

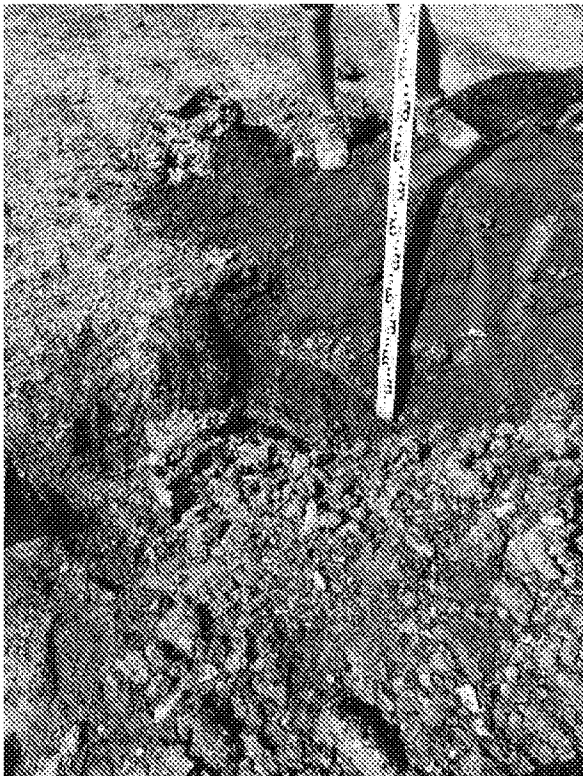
| PHOTOGRAPHIC LOG | |
|---|---|
| <b>Photo No.</b><br>41 | |

| PHOTOGRAPHIC LOG | |
|---|---|
| Overview of HDP116 | |

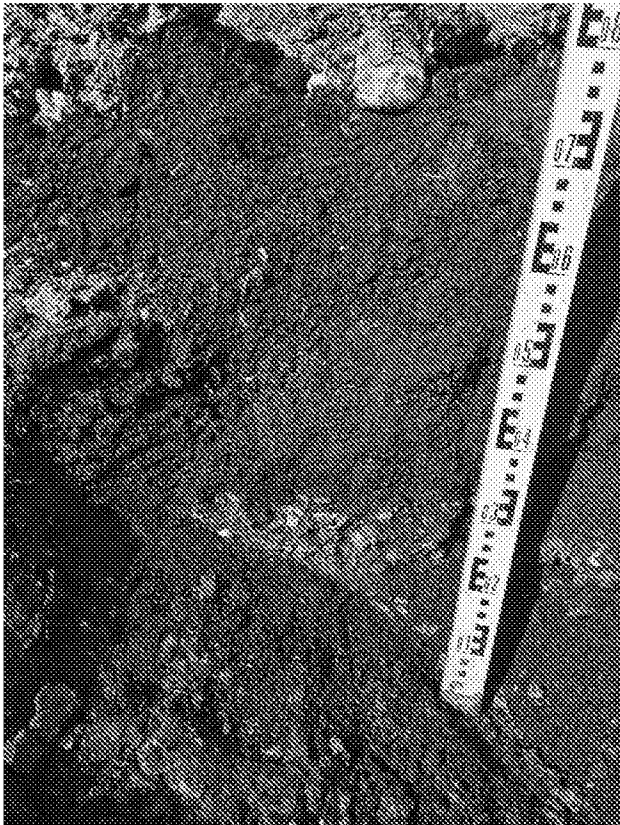
| PHOTOGRAPHIC LOG | |
|---|---|
| <b>Photo No.</b><br>42 | |

| PHOTOGRAPHIC LOG | |
|---|---|
| View showing the depth of clean capping within HDP116 to be at least 600 mm thick | |

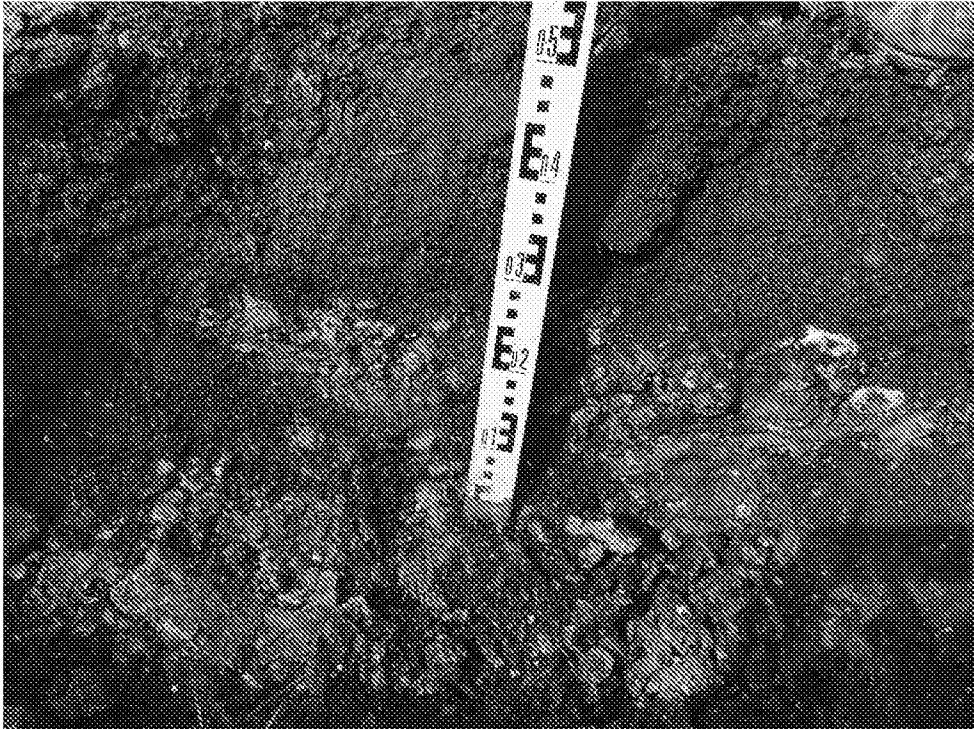
| <p><b>Photo No.</b><br/>43</p> | |

| <p>HDP116<br/>capping layer<br/>observed to<br/>be underlain<br/>by a geo-<br/>marker<br/>membrane</p> | |

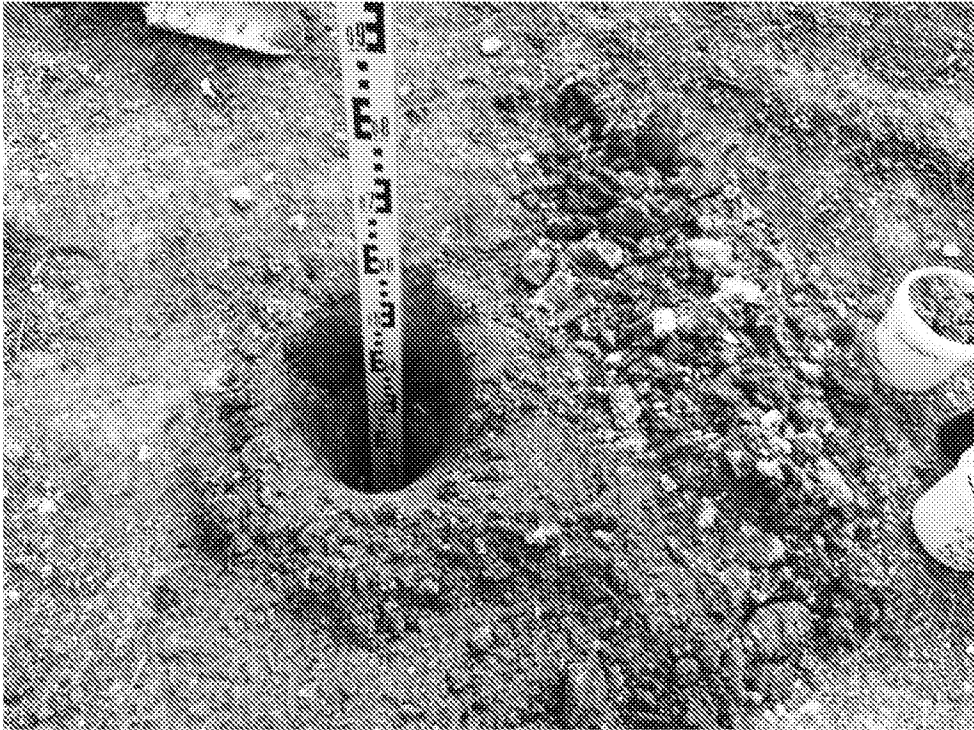
| <p><b>Photo No.</b><br/>44</p> | |

| <p>Overview of<br/>HDP117</p> | |

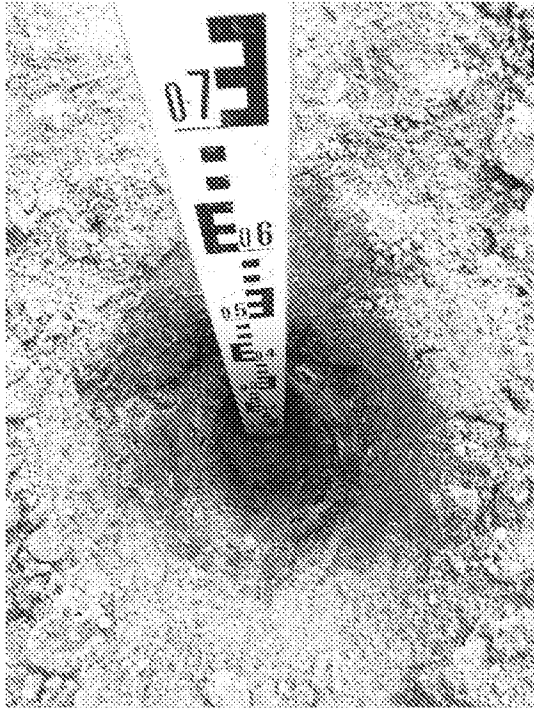
| <p><b>Photo No.</b><br/>45</p> | |

| <p>View showing the depth of clean capping within HDP117 to be at least 600 mm thick</p> | |

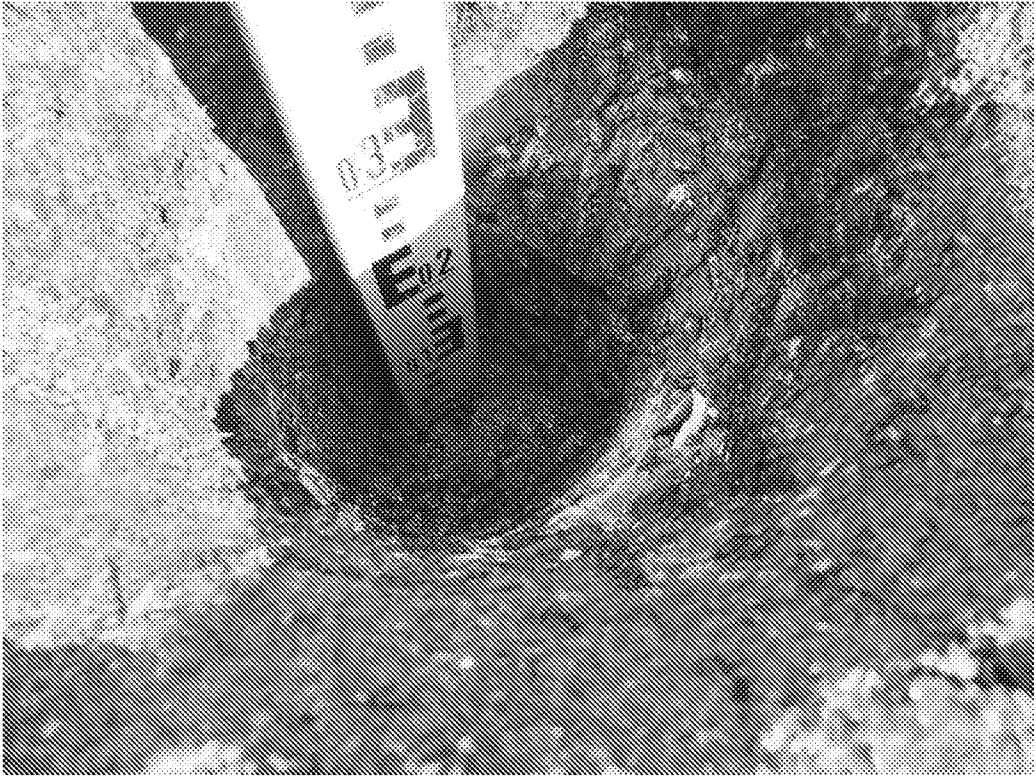
| <p><b>Photo No.</b><br/>46</p> | |

| <p>HDP117 capping layer observed to be underlain by a geo-marker membrane</p> | |

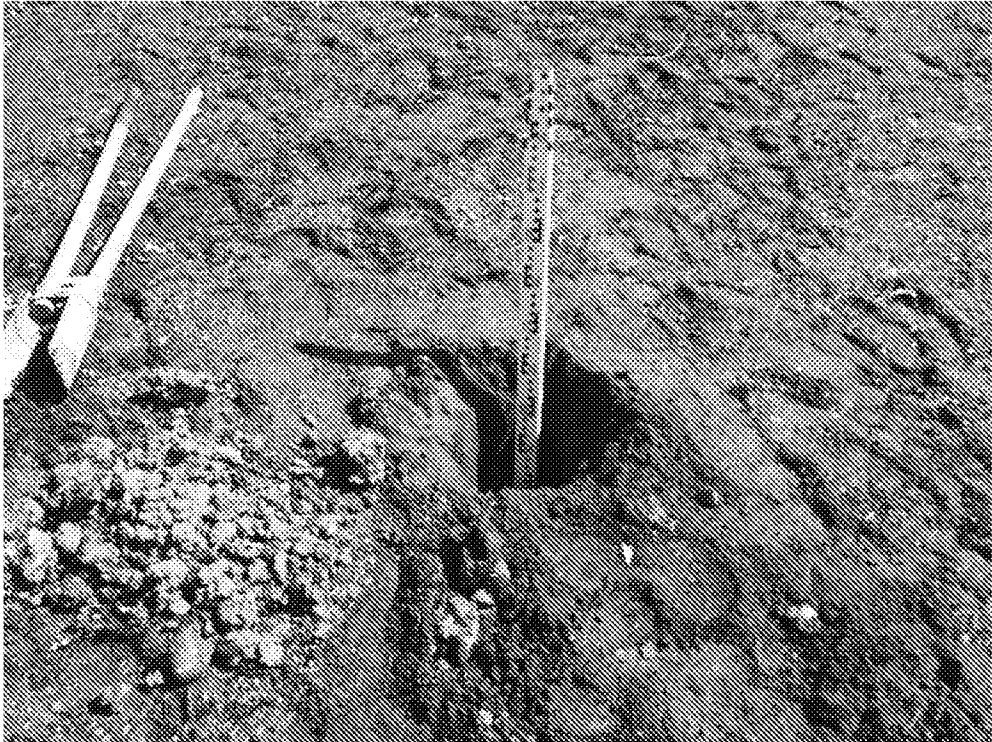
| <p><b>Photo No.</b><br/>47</p> | |

| <p>Overview of<br/>HDP118</p> | |

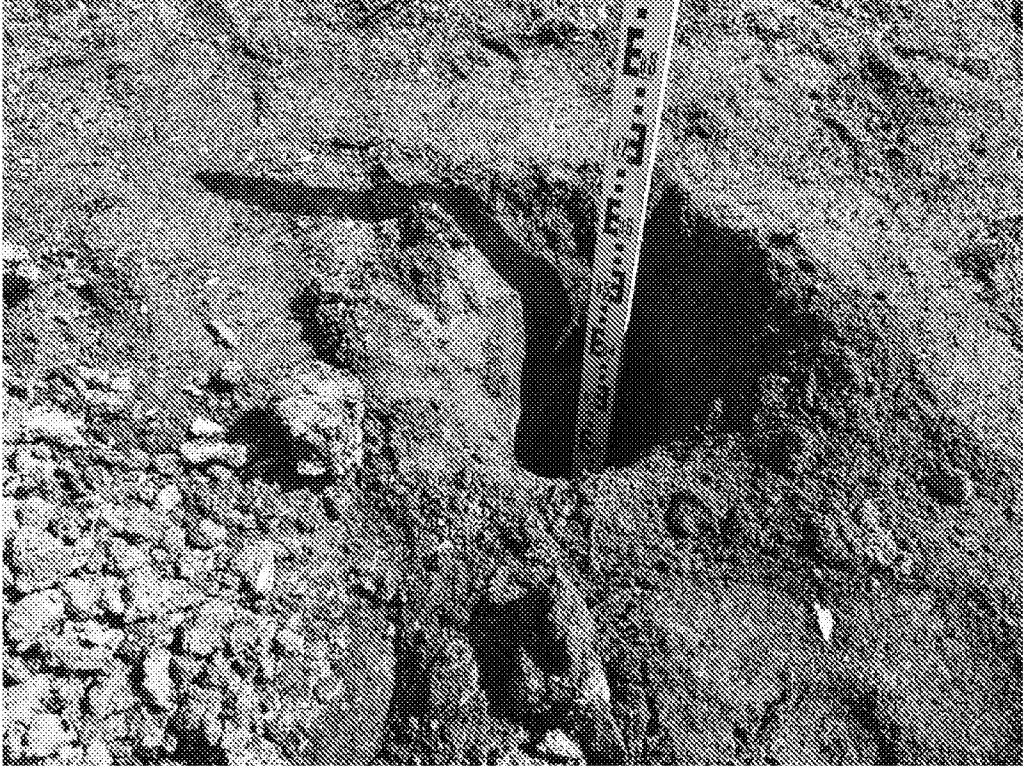
| <p><b>Photo No.</b><br/>48</p> | |

| <p>View<br/>showing the<br/>depth of<br/>clean<br/>capping<br/>within<br/>HDP118 to<br/>be at least<br/>600 mm thick</p> | |

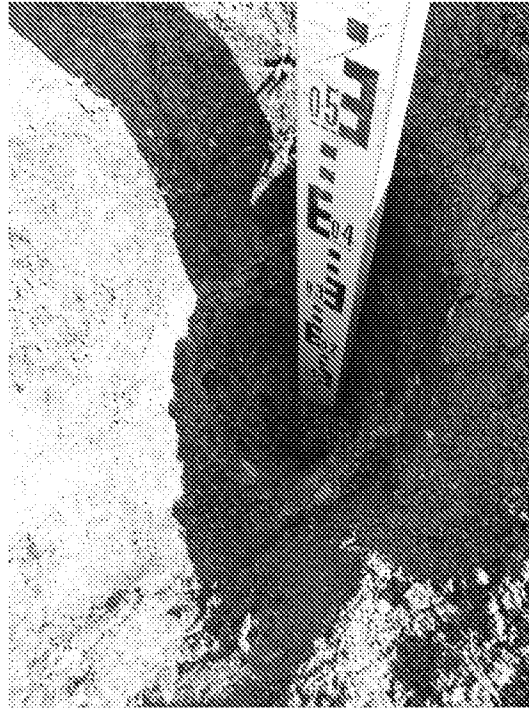
Photo No.  
49

HDP118  
capping layer  
observed to  
be underlain  
by a geo-  
marker  
membrane
