## PHOTOGRAPHIC LOG

**Site Location:** Land at West End Nursery, Angmering

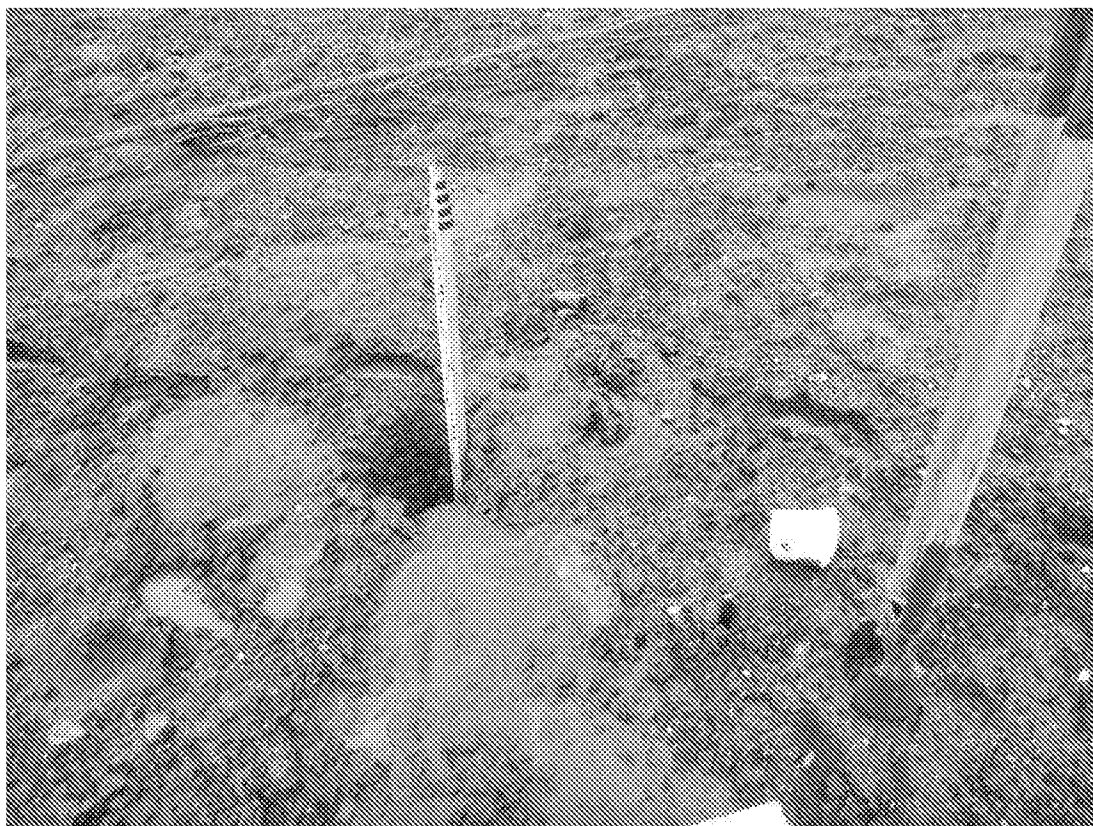
**Photo No.**  
1

View showing an overview of the HP1 in the Central POS area.

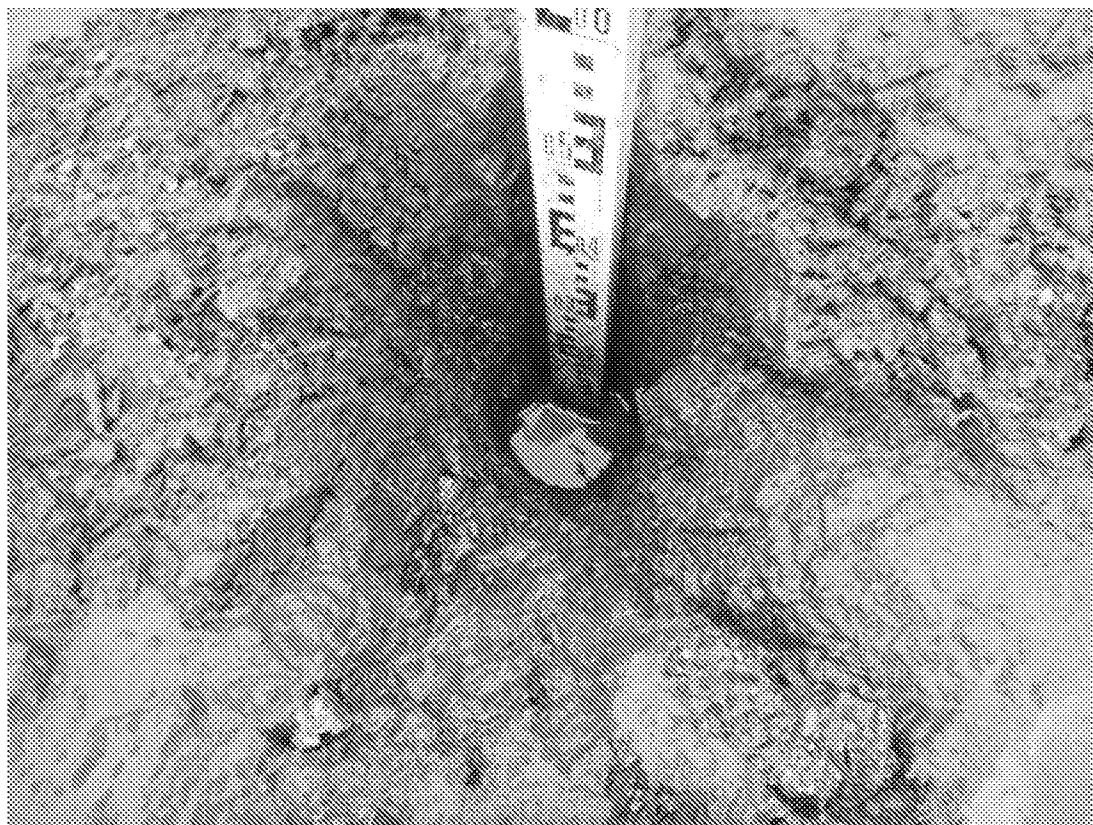
**Photo No.**  
2

View showing the base of HP1 at 600 mm bgl with perched water from the Topsoil. Noted, presence of geo-marker membrane validated in preceding works (RSK report 27621 R06 (00)).

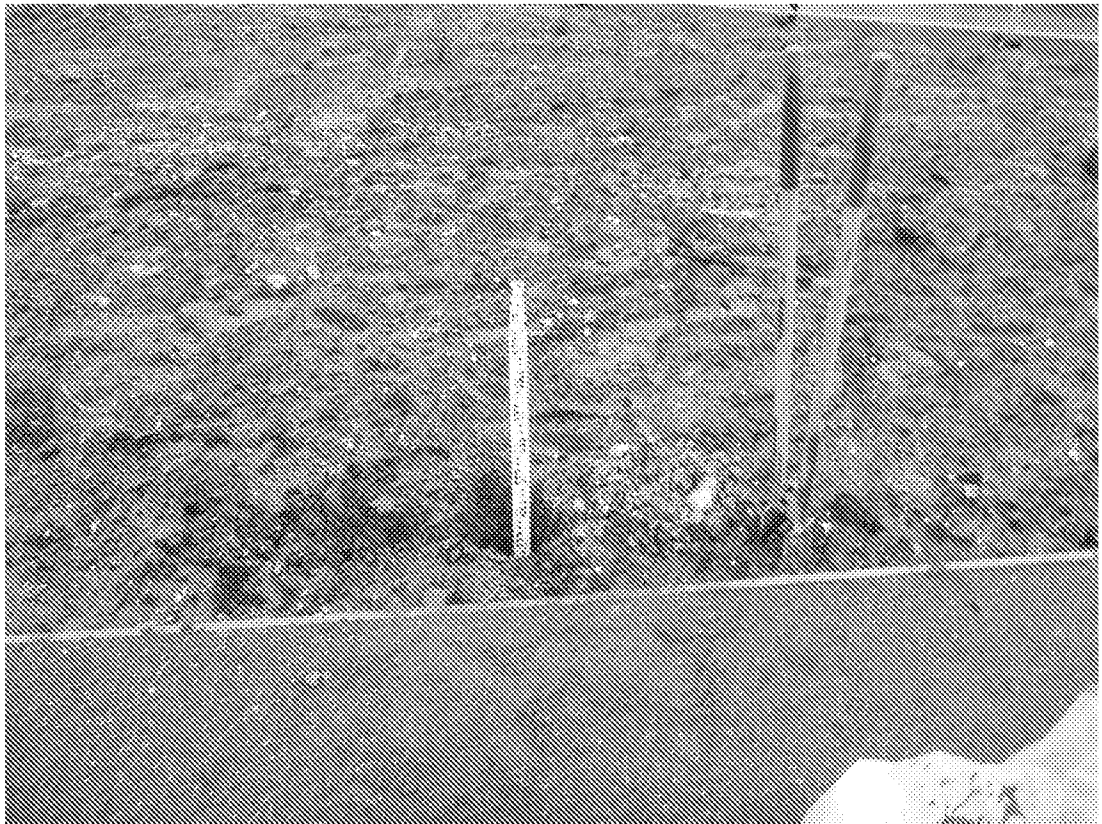
**Photo No.**  
3

View showing an overview of HP2 in the Central POS area.

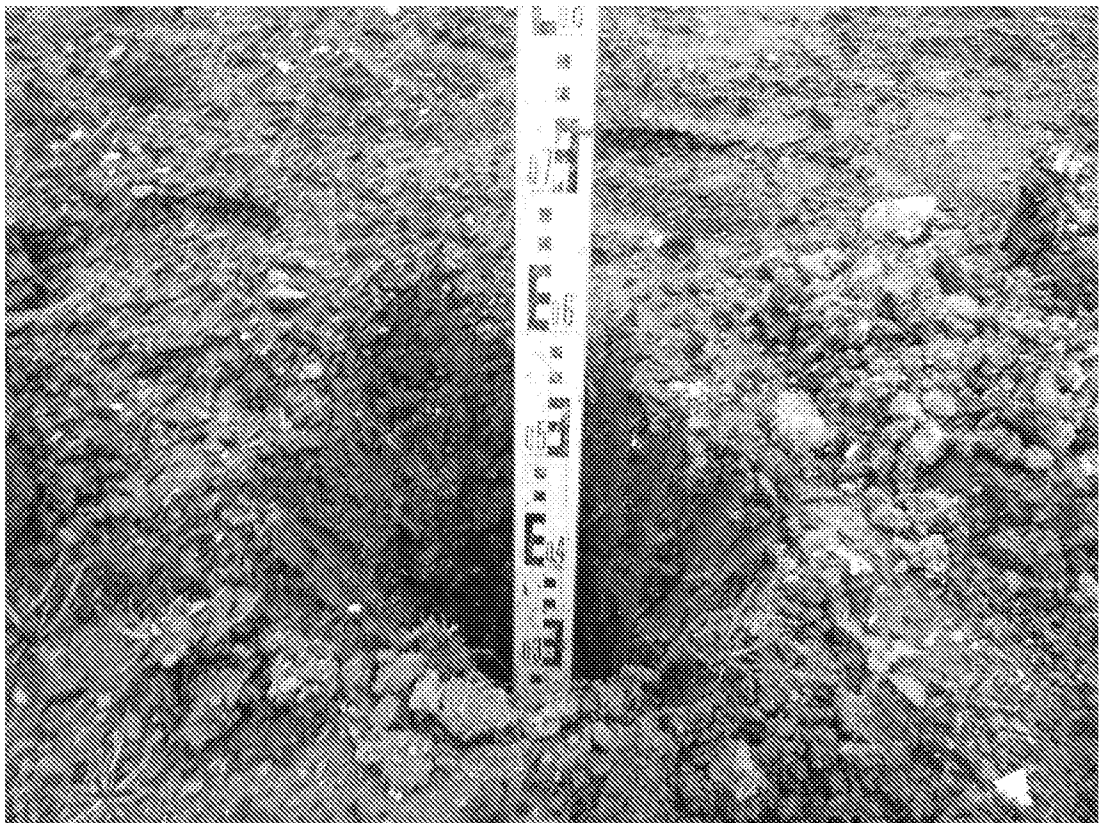
**Photo No.**  
4

View showing the depth of clean capping within HP2 to be at least 600 mm. Noted, presence of geo-marker membrane validated in preceding works (RSK report 27621 R06 (00)).

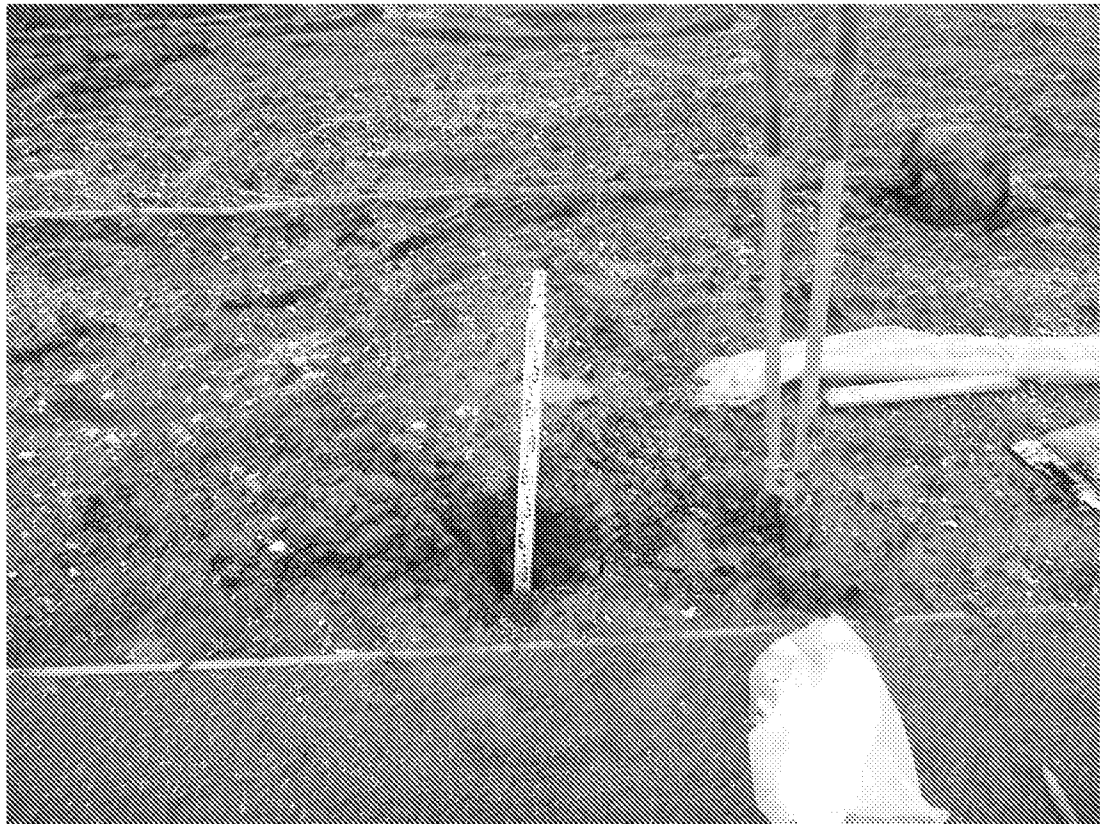
**Photo No.**  
5

View showing an overview of HP3 in the Central POS area.

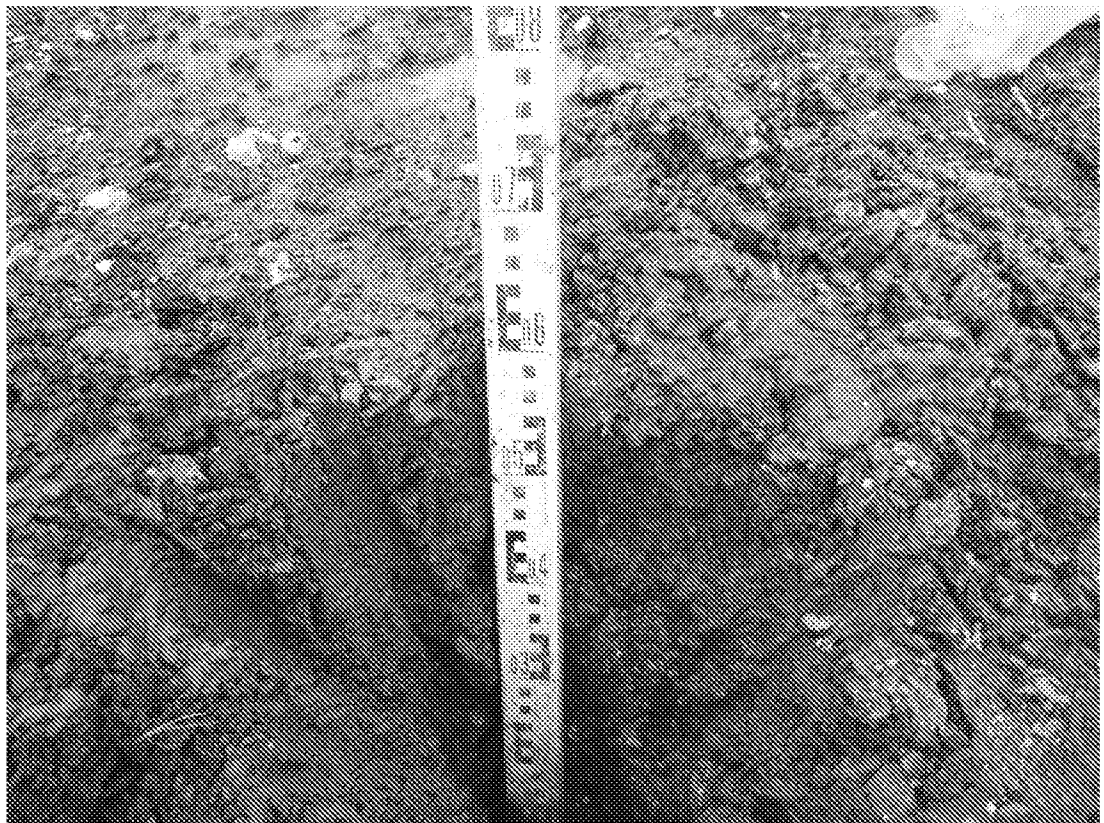
**Photo No.**  
6

View showing the depth of clean capping within HP3 to be at least 600 mm. Noted, presence of geo-marker membrane validated in preceding works (RSK report 27621 R06 (00)).

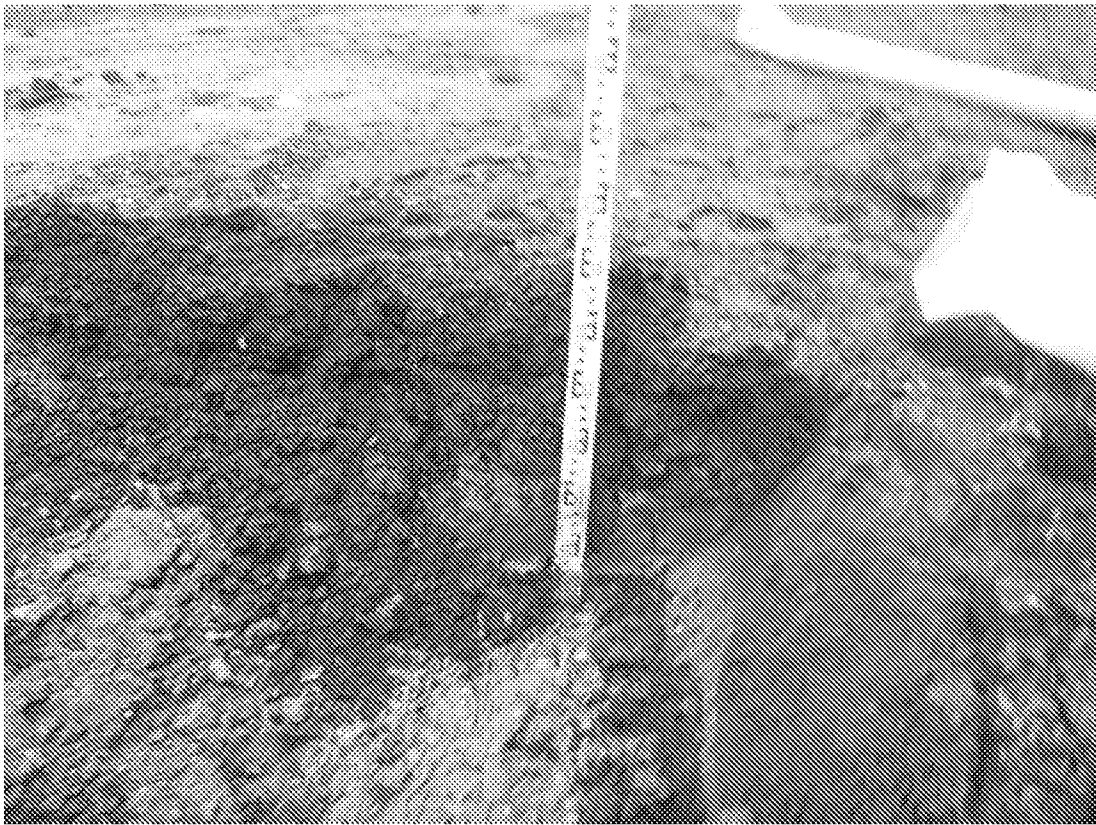
| PHOTOGRAPHIC LOG | |
|---|---|
| <b>Photo No.</b><br>7 | |

| PHOTOGRAPHIC LOG | |
|---|---|
| View showing an overview of HP4 in the Central POS area. | |

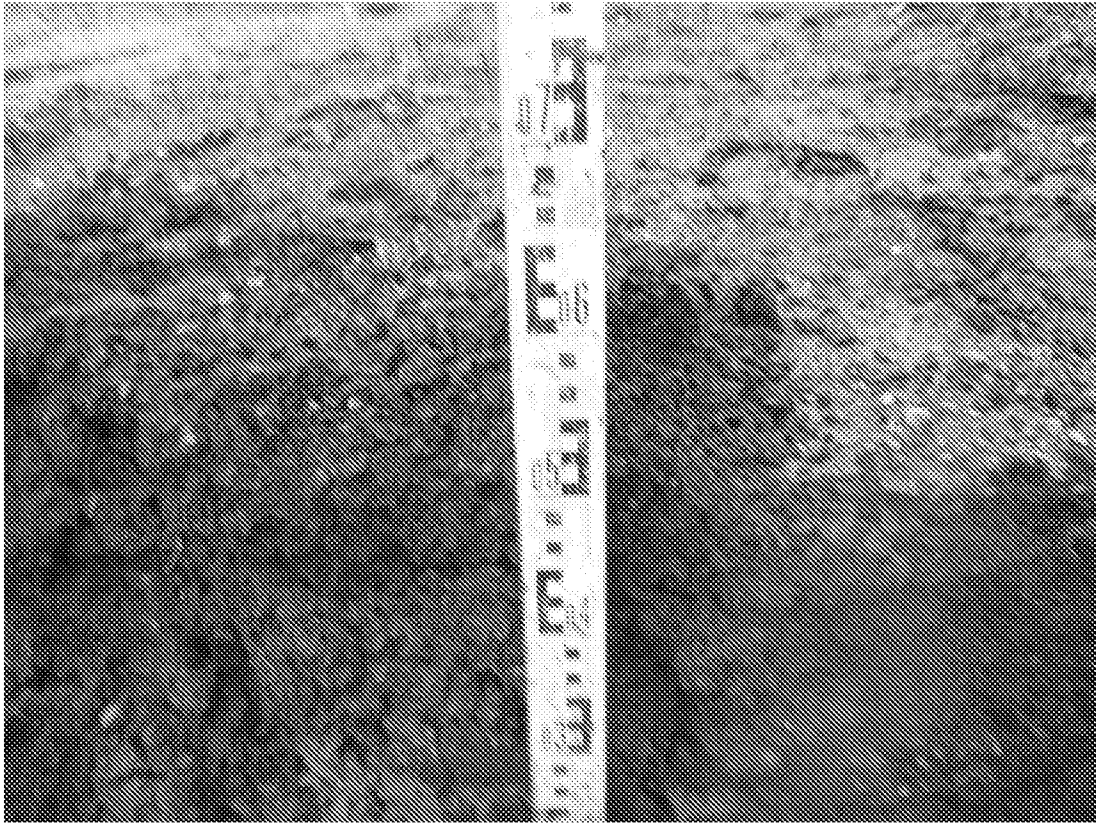
| PHOTOGRAPHIC LOG | |
|---|---|
| <b>Photo No.</b><br>8 | |

| PHOTOGRAPHIC LOG | |
|---|---|
| View showing the depth of clean capping within HP4 to be at least 600 mm. Noted, presence of geo-marker membrane validated in preceding works (RSK report 27621 R06 (00)). | |

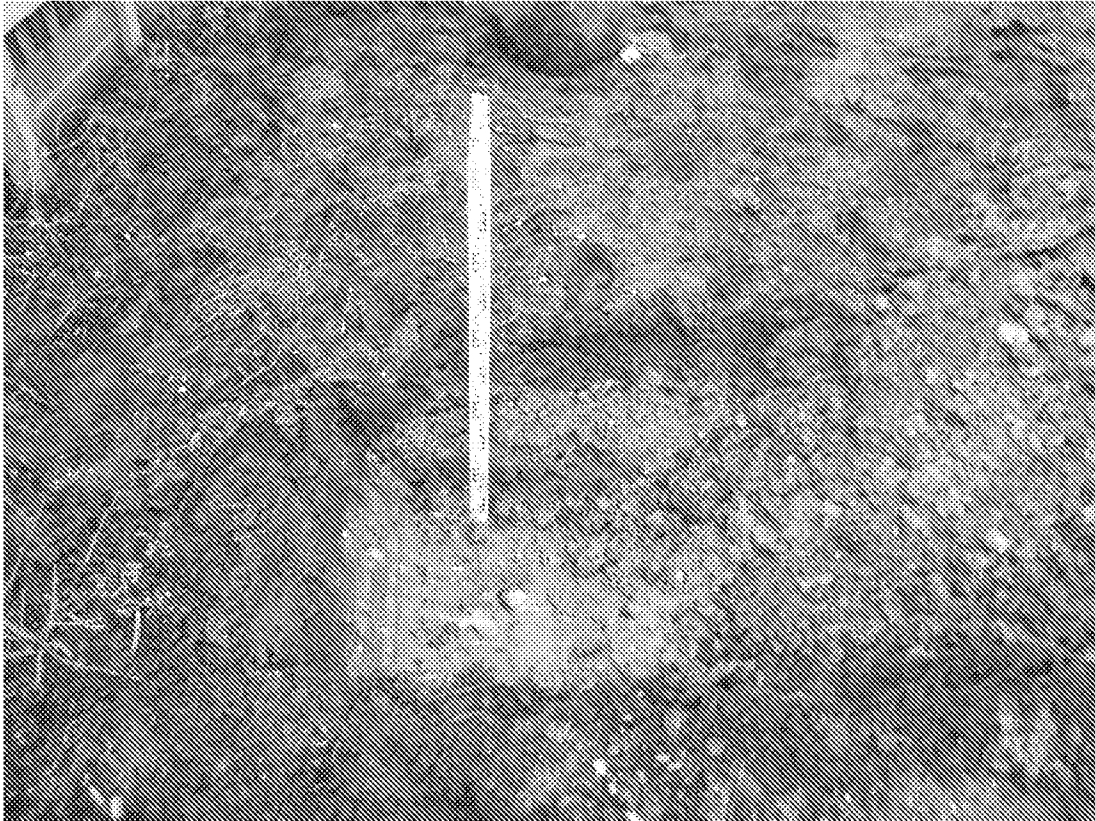
| PHOTOGRAPHIC LOG | |
|---|---|
| <b>Photo No.</b><br>9 | |

| PHOTOGRAPHIC LOG | |
|---|---|
| View showing an overview of HP5 in the Central POS area. | |

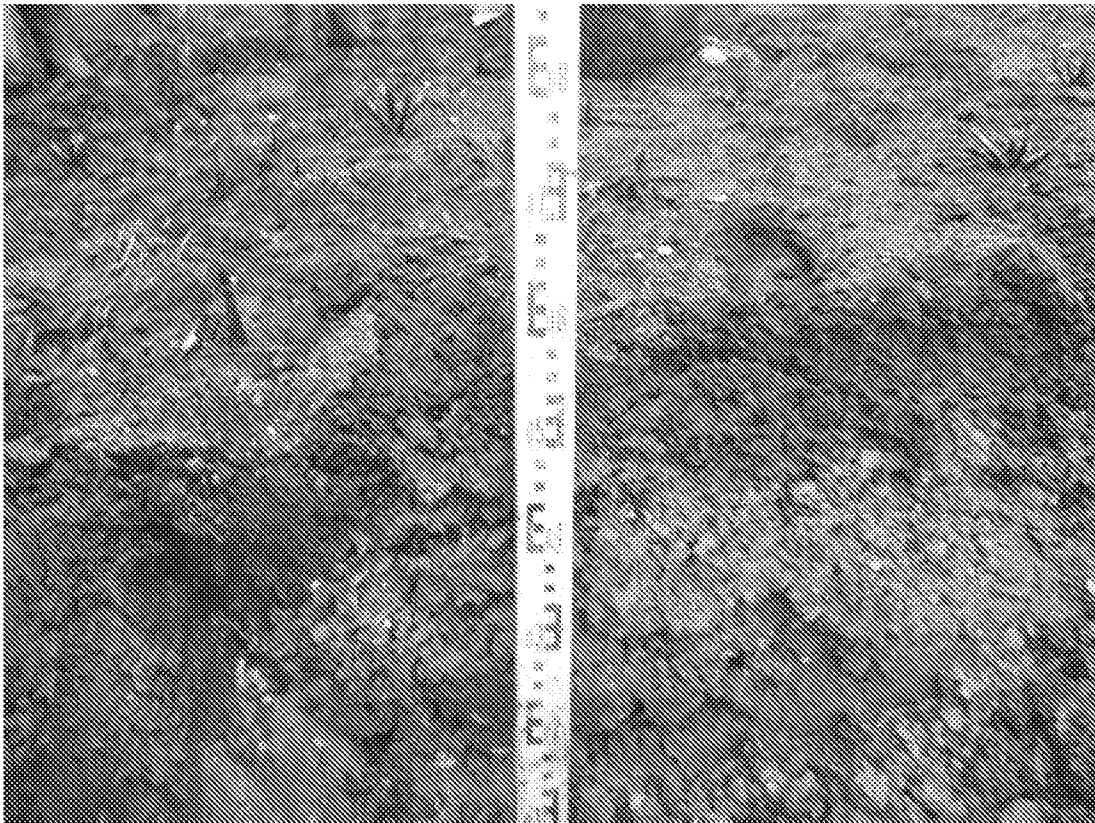
| PHOTOGRAPHIC LOG | |
|---|---|
| <b>Photo No.</b><br>10 | |

| PHOTOGRAPHIC LOG | |
|---|---|
| View showing the depth of clean capping within HP5 to be at least 600 mm. Noted, presence of geo-marker membrane validated in preceding works (RSK report 27621 R06 (00)). | |

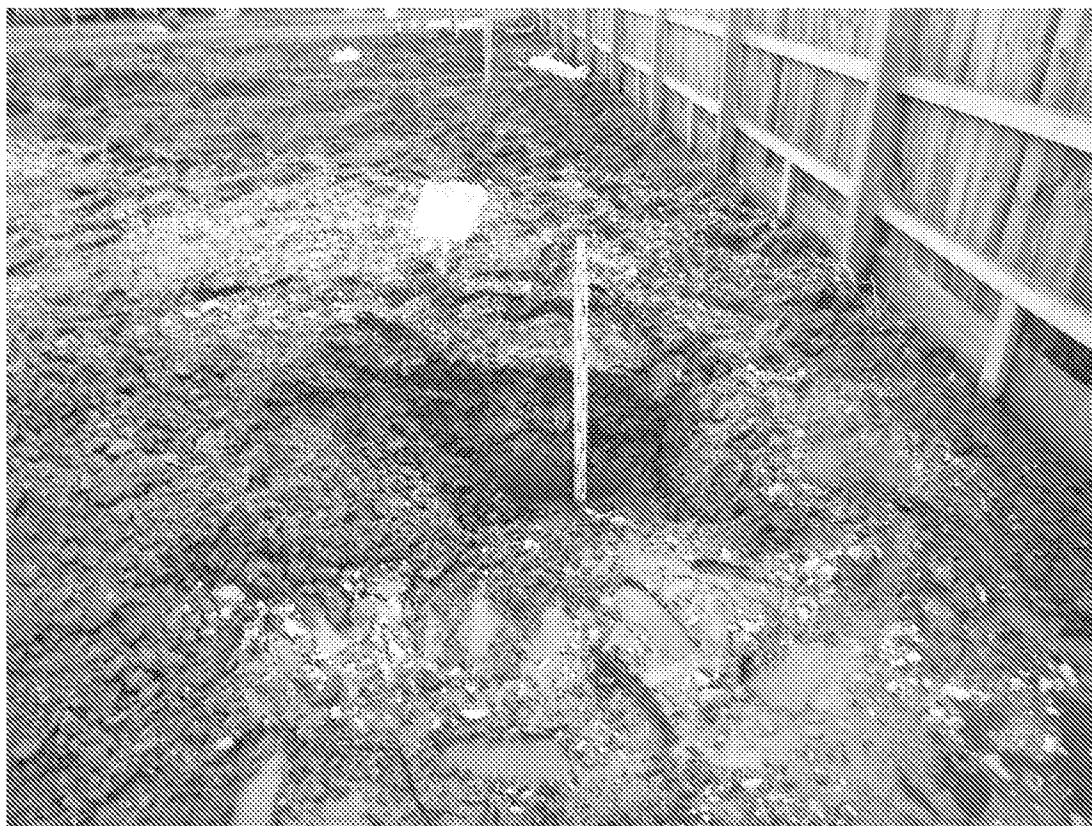
**Photo No.**  
11

View showing an overview of HP6 in the Central POS area.

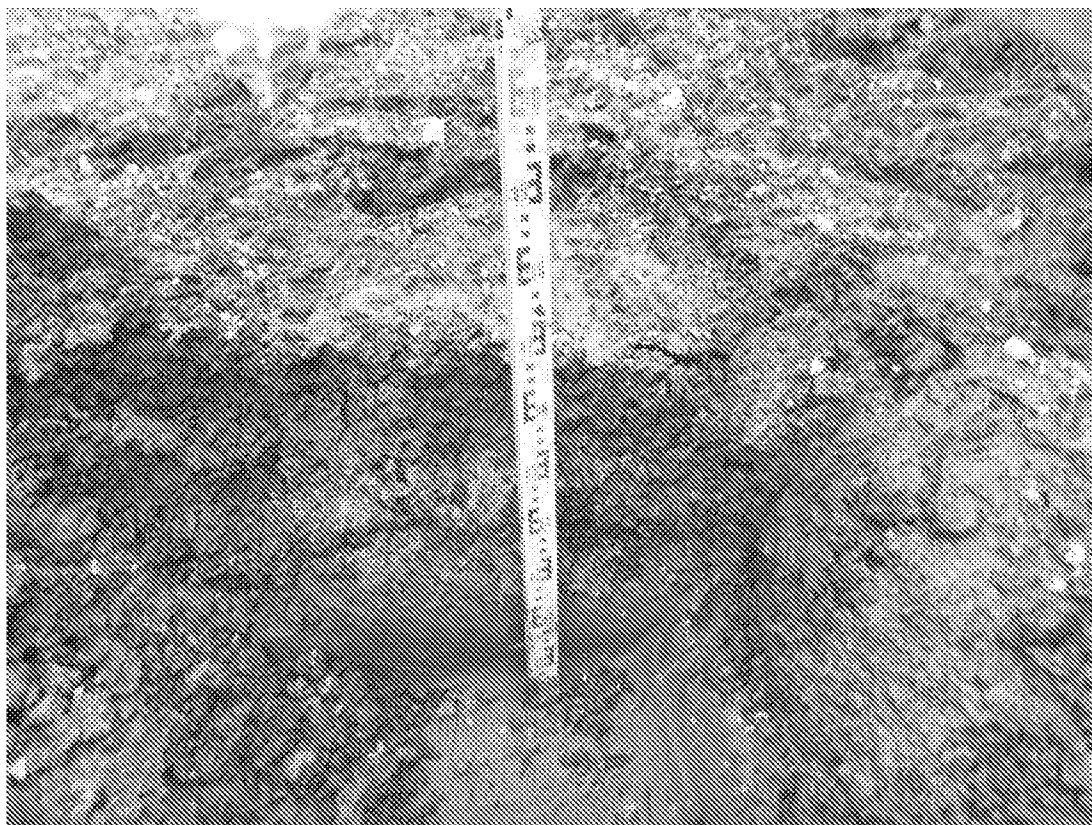
**Photo No.**  
12

View showing the depth of clean capping within HP6 to be at least 700 mm. Noted, presence of geo-marker membrane validated in preceding works (RSK report 27621 R06 (00)).

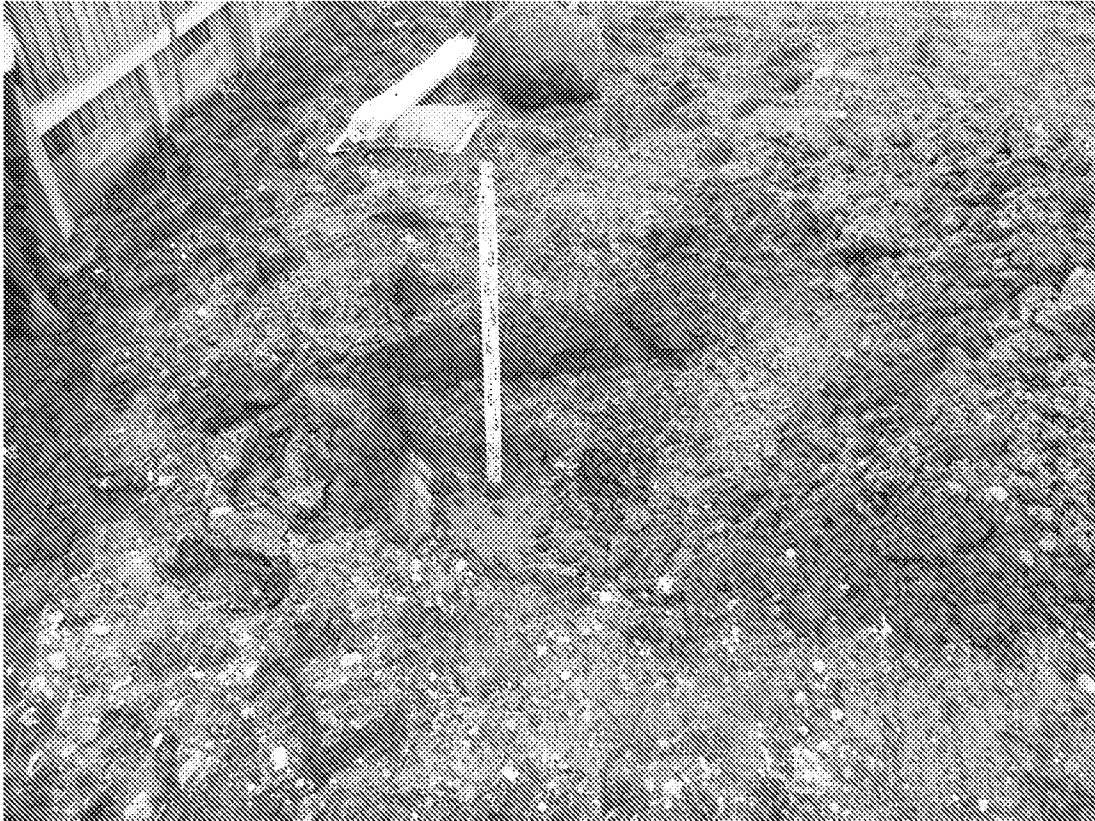
| PHOTOGRAPHIC LOG | |
|---|---|
| <b>Photo No.</b><br>13 | |

| PHOTOGRAPHIC LOG | |
|---|---|
| View showing an overview of HP7 in the Central POS area. | |

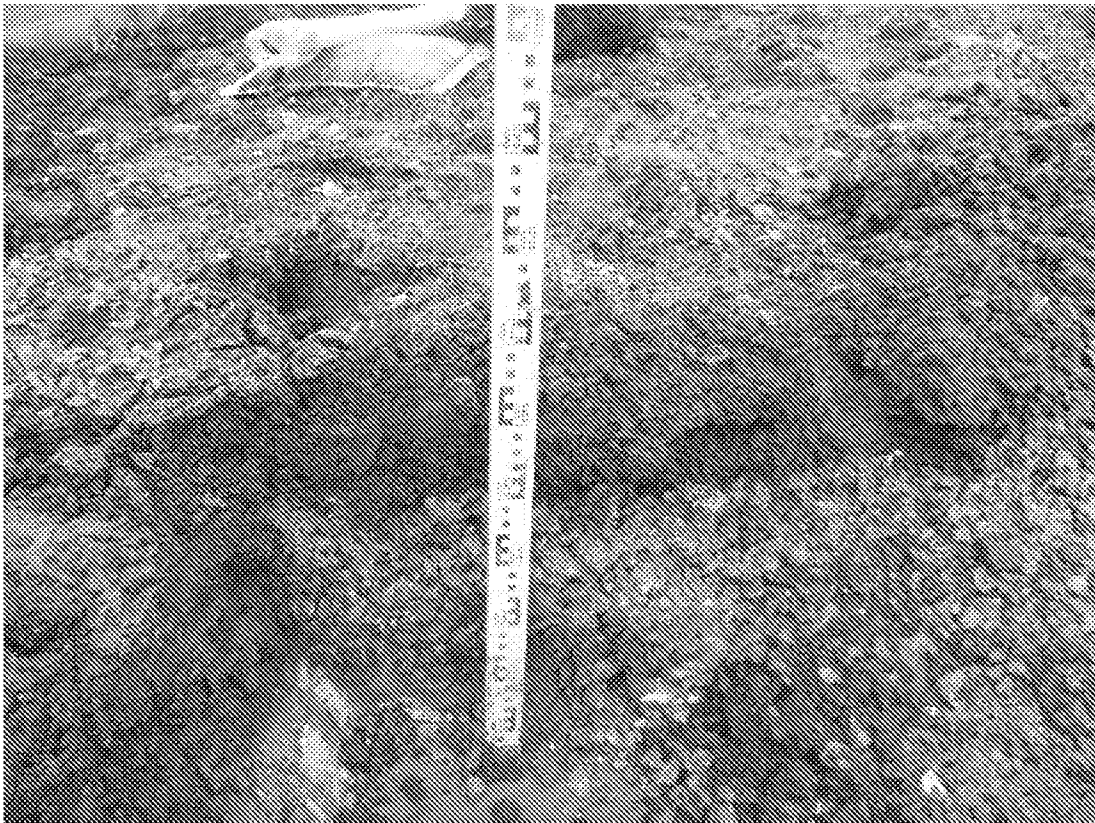
| PHOTOGRAPHIC LOG | |
|---|---|
| <b>Photo No.</b><br>14 | |

| PHOTOGRAPHIC LOG | |
|---|---|
| View showing the depth of clean capping within HP7 to be at least 600 mm. Noted, presence of geo-marker membrane validated in preceding works (RSK report 27621 R06 (00)). | |

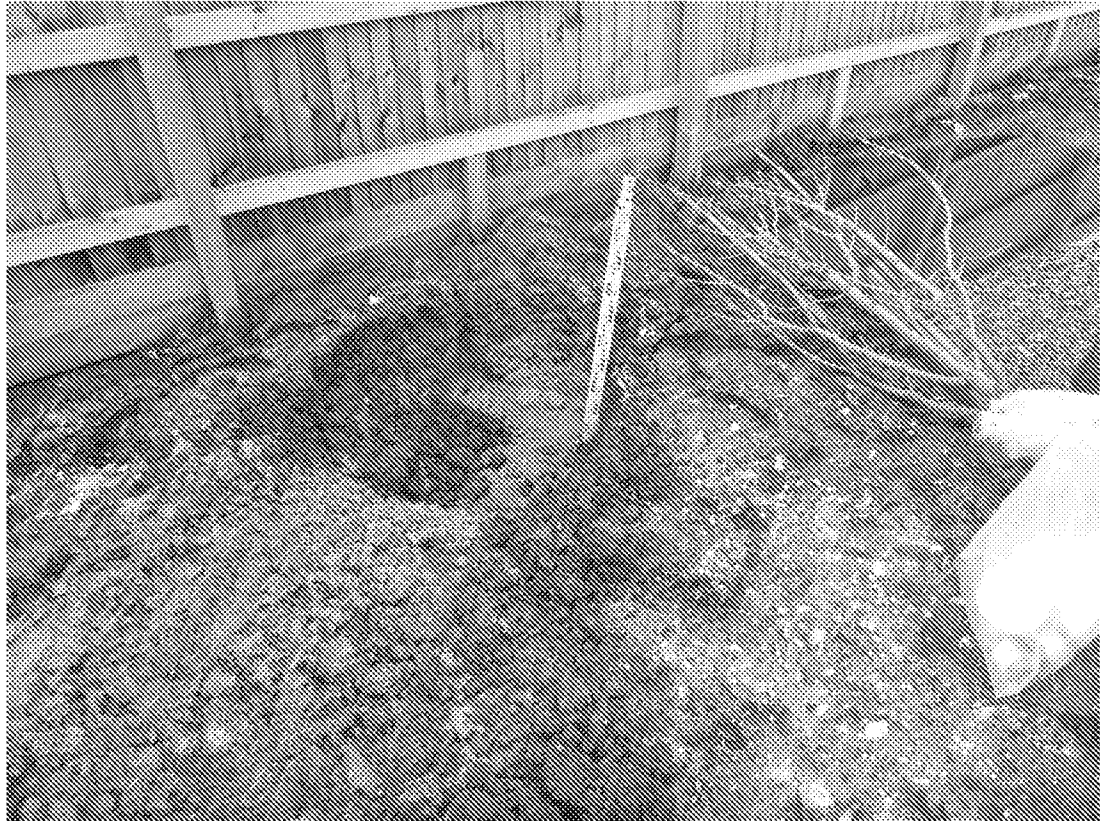
**Photo No.**  
15

View showing an overview of HP8 in the Central POS area.

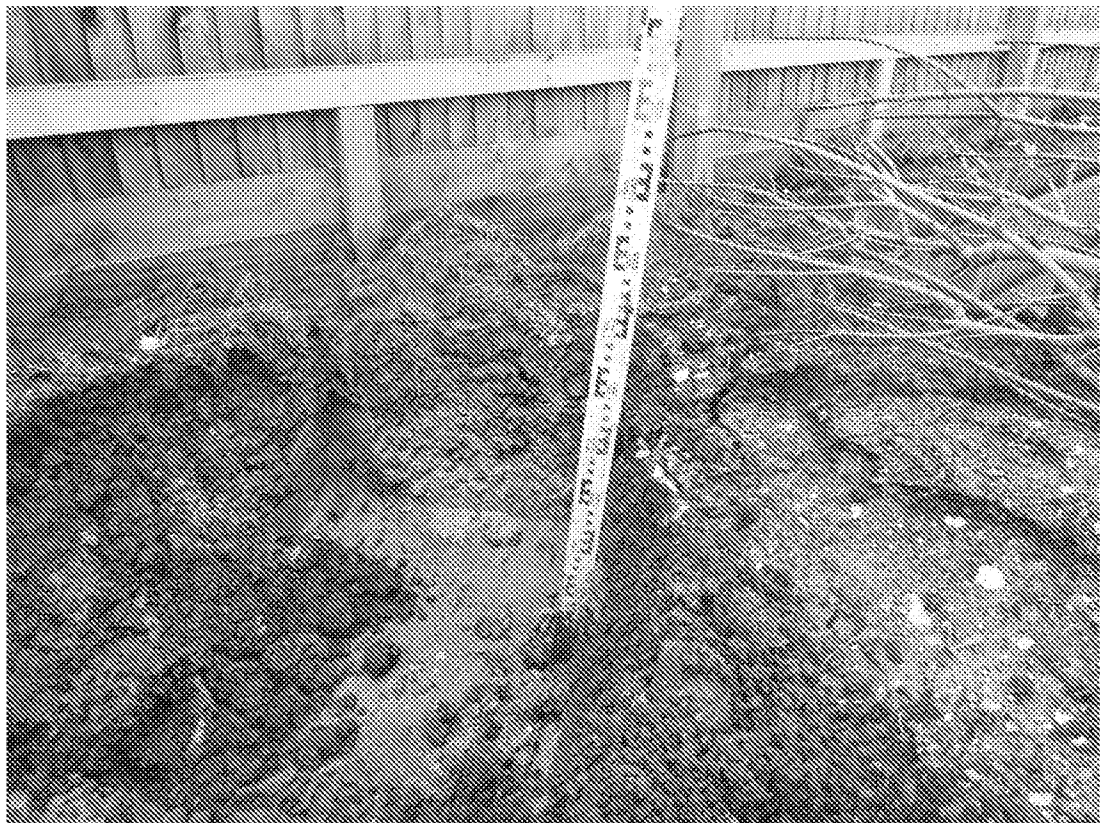
**Photo No.**  
16

View showing the depth of clean capping within HP8 to be at least 600 mm. Noted, presence of geo-marker membrane validated in preceding works (RSK report 27621 R06 (00)).

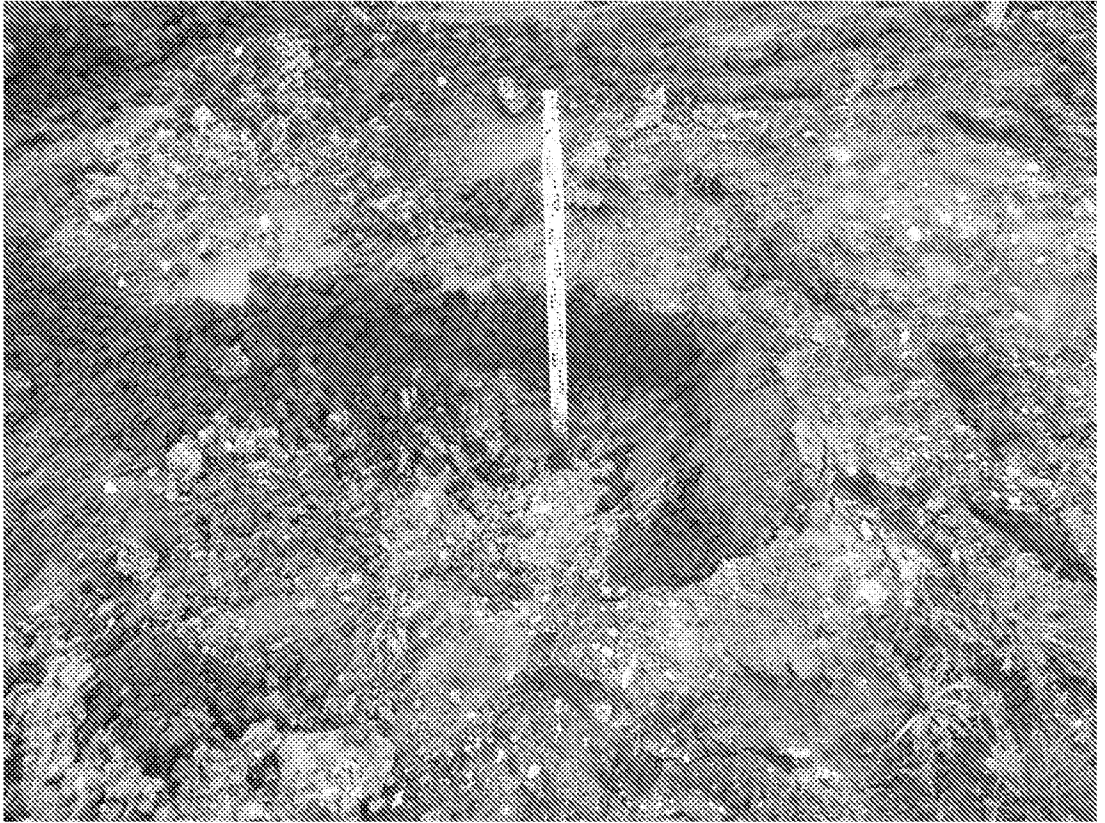
| PHOTOGRAPHIC LOG | |
|---|---|
| <b>Photo No.</b><br>17 | |

| PHOTOGRAPHIC LOG | |
|---|---|
| View showing an overview of HP9 in the Central POS area. | |

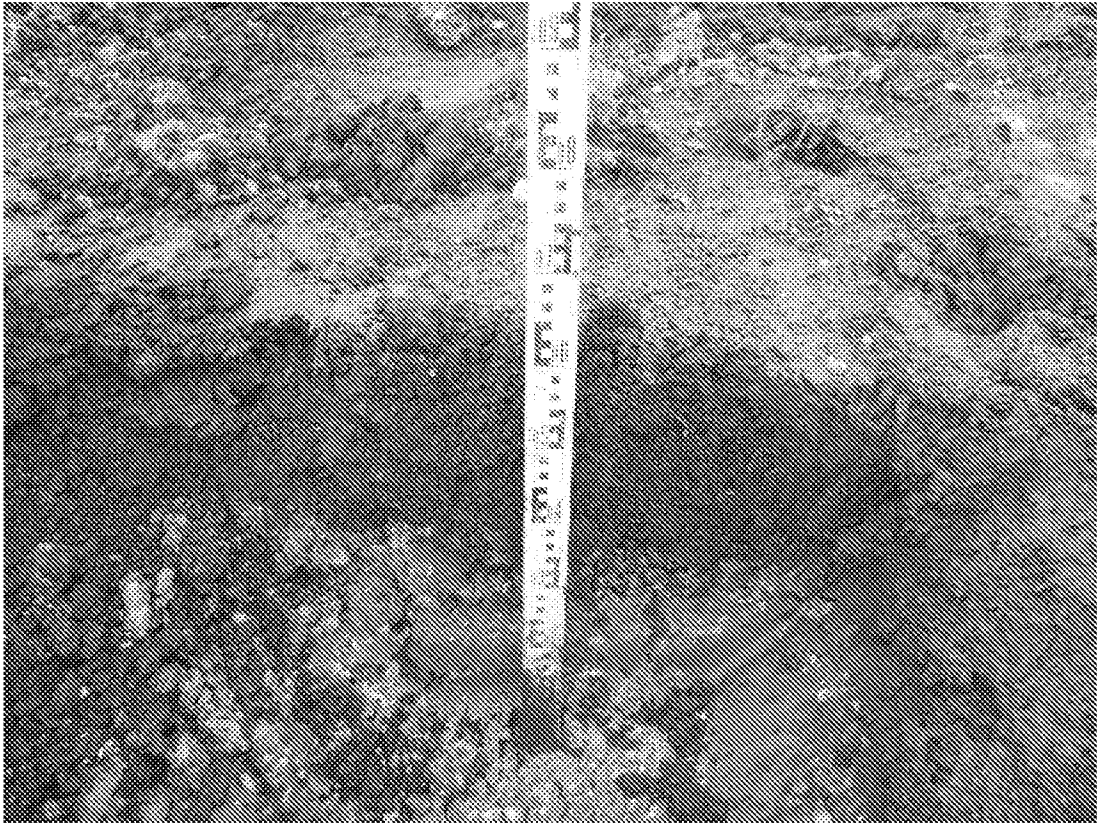
| PHOTOGRAPHIC LOG | |
|---|---|
| <b>Photo No.</b><br>18 | |

| PHOTOGRAPHIC LOG | |
|---|---|
| View showing the depth of clean capping within HP9 to be at least 600 mm. Noted, presence of geo-marker membrane validated in preceding works (RSK report 27621 R06 (00)). | |

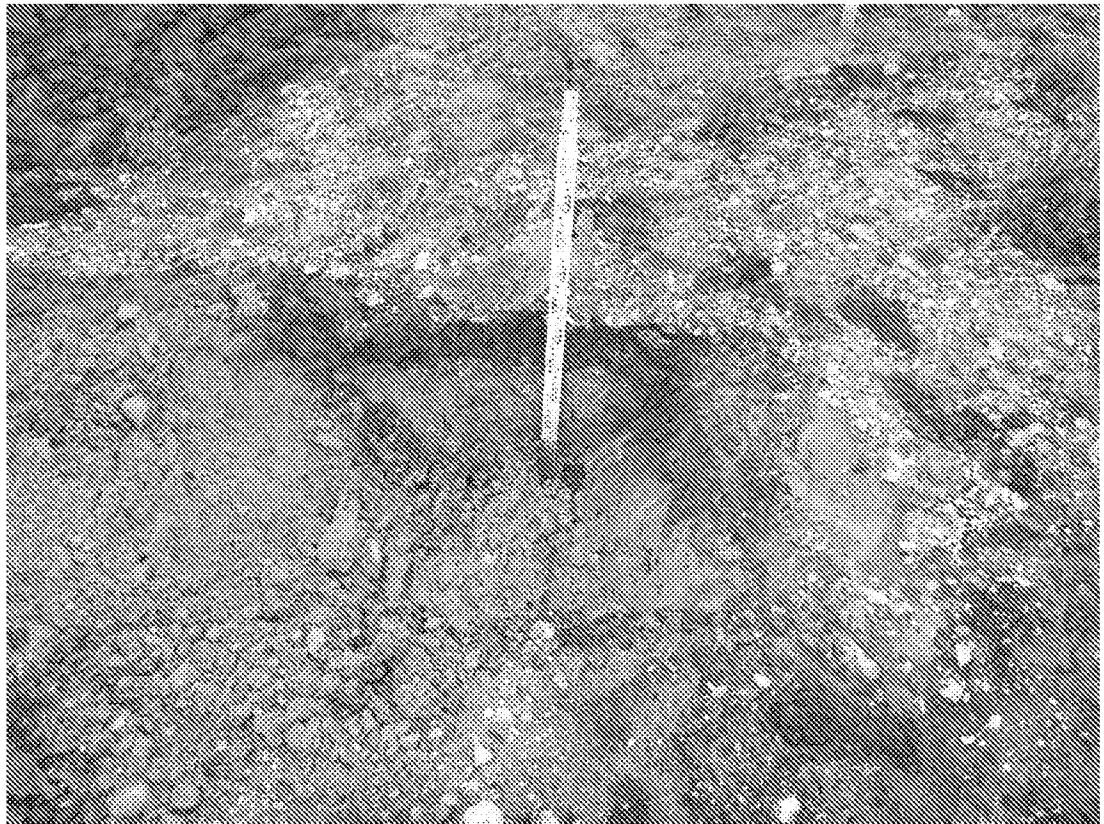
**Photo No.**  
19

View showing an overview of HP10 in the Central POS area.

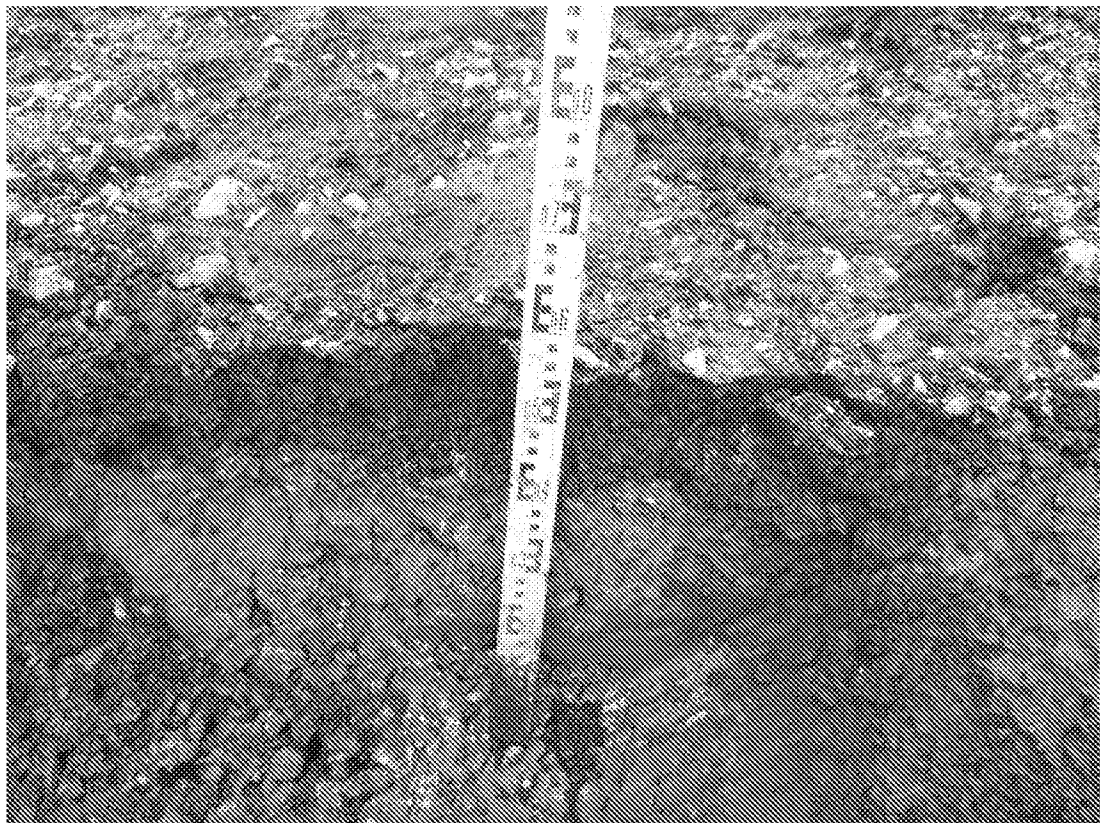
**Photo No.**  
20

View showing the depth of clean capping within HP10 to be at least 600 mm. Noted, presence of geo-marker membrane validated in preceding works (RSK report 27621 R06 (00)).

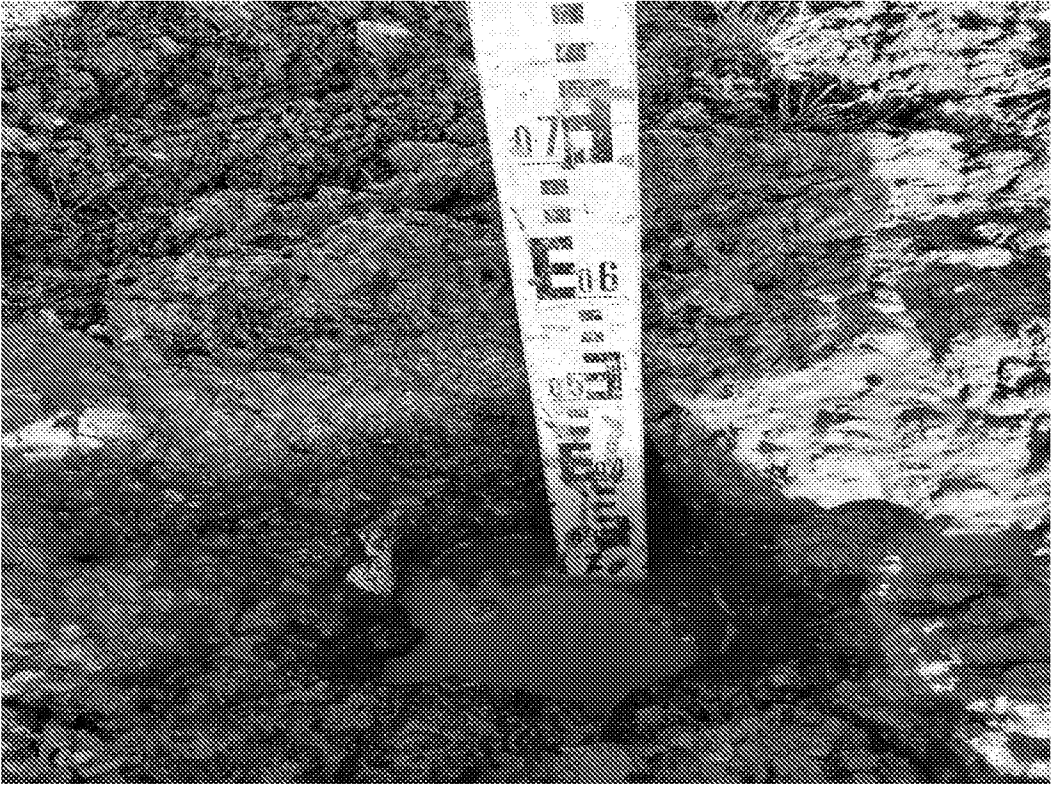
| <p><b>Photo No.</b><br/>21</p> | |

| <p>View showing the depth of clean capping within HP11 to be at least 600 mm. Noted, presence of geo-marker membrane validated in preceding works (RSK report 27621 R06 (00)).</p> | |

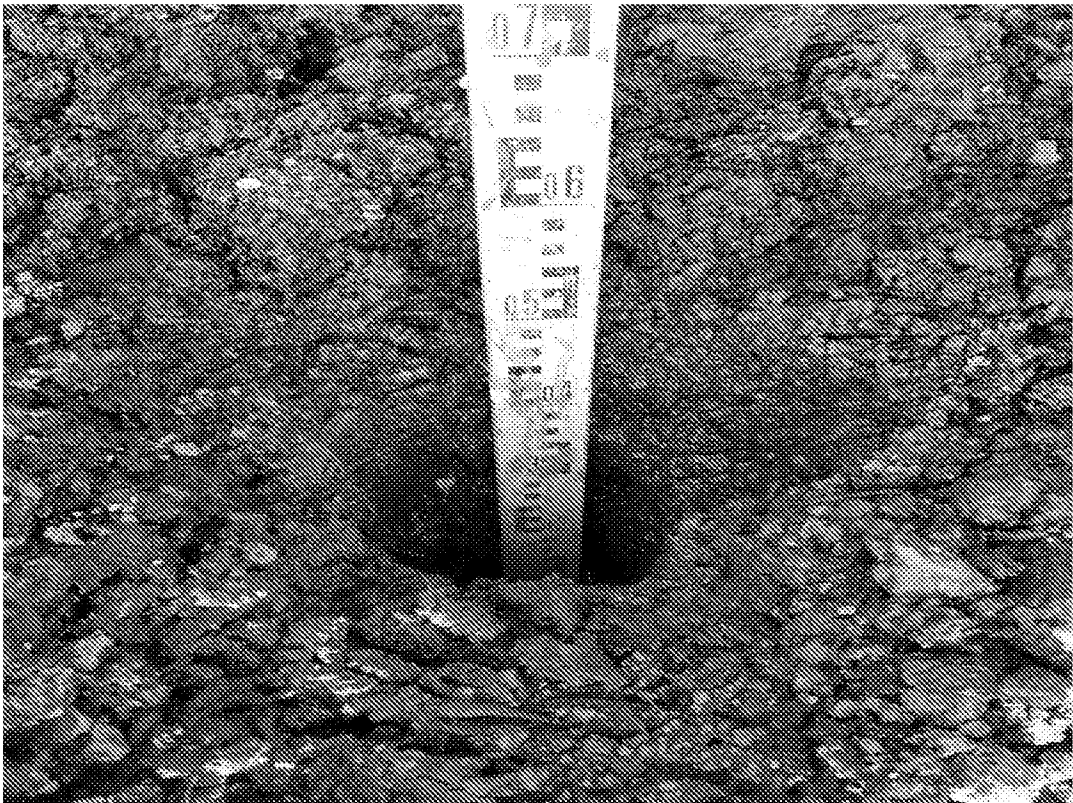
| <p><b>Photo No.</b><br/>22</p> | |

| <p>View showing the depth of clean capping within HP12 to be at least 600 mm. Noted, presence of geo-marker membrane validated in preceding works (RSK report 27621 R06 (00)).</p> | |

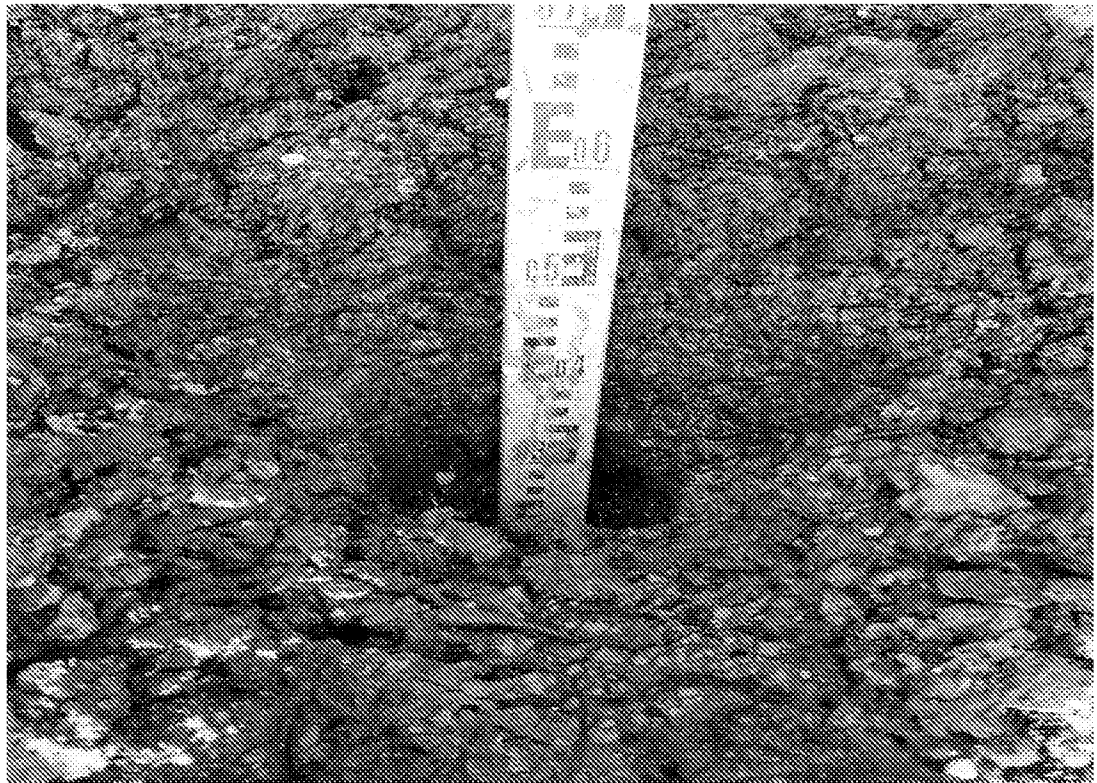
**Photo No.**  
23

View showing the depth of clean capping within HP13 to be at least 600 mm. Noted, presence of geo-marker membrane validated in preceding works (RSK report 27621 R06 (00)).

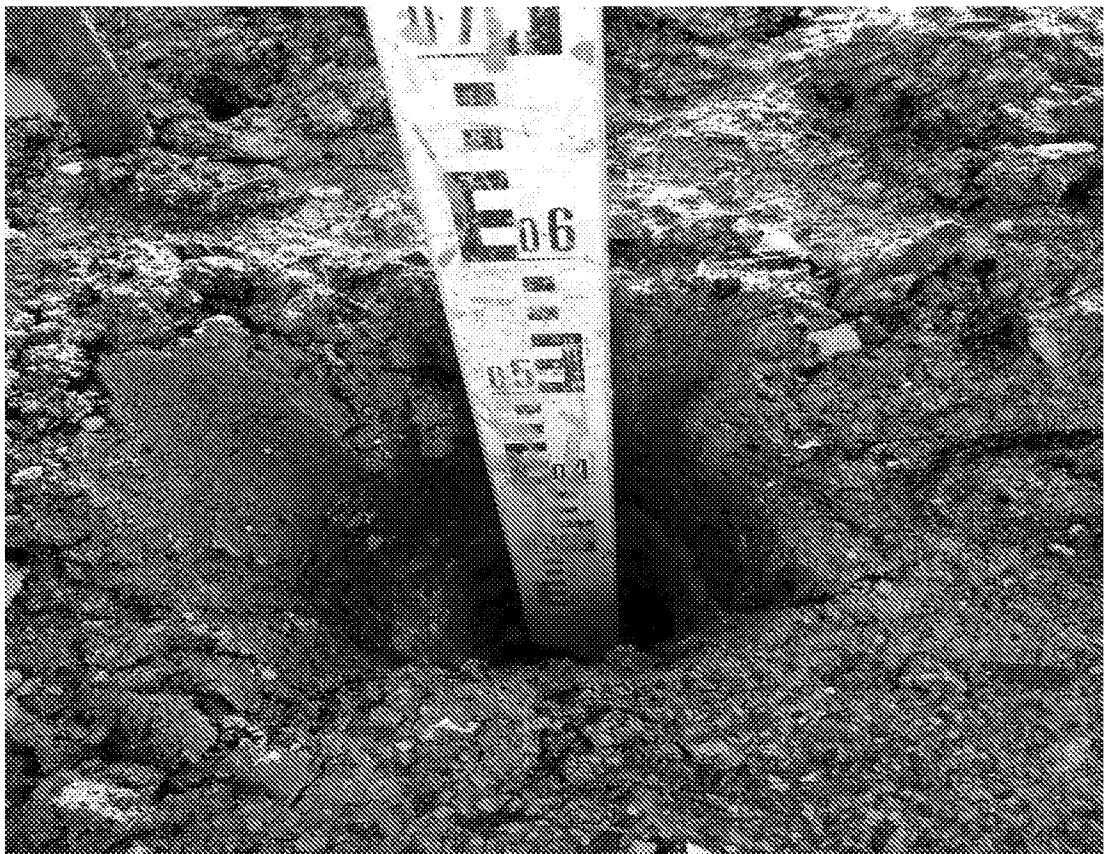
**Photo No.**  
24

View showing the depth of clean capping within HP14 to be at least 600 mm. Noted, presence of geo-marker membrane validated in preceding works (RSK report 27621 R06 (00)).
