## PHOTOGRAPHIC LOG

**Site Location:** Land at West End Nursery, Angmering

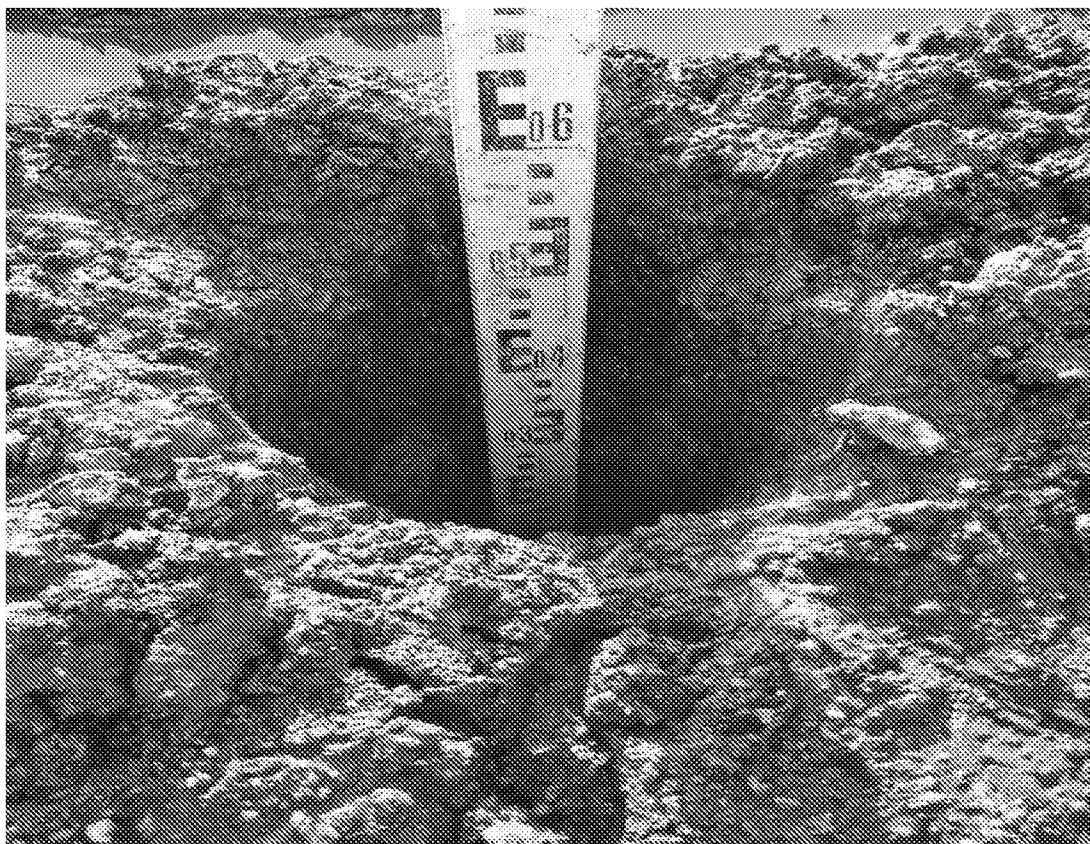
**Photo No.**  
25

View showing the depth of clean capping within HP15 to be at least 600 mm. Noted, presence of geo-marker membrane validated in preceding works (RSK report 27621 R06 (00)).

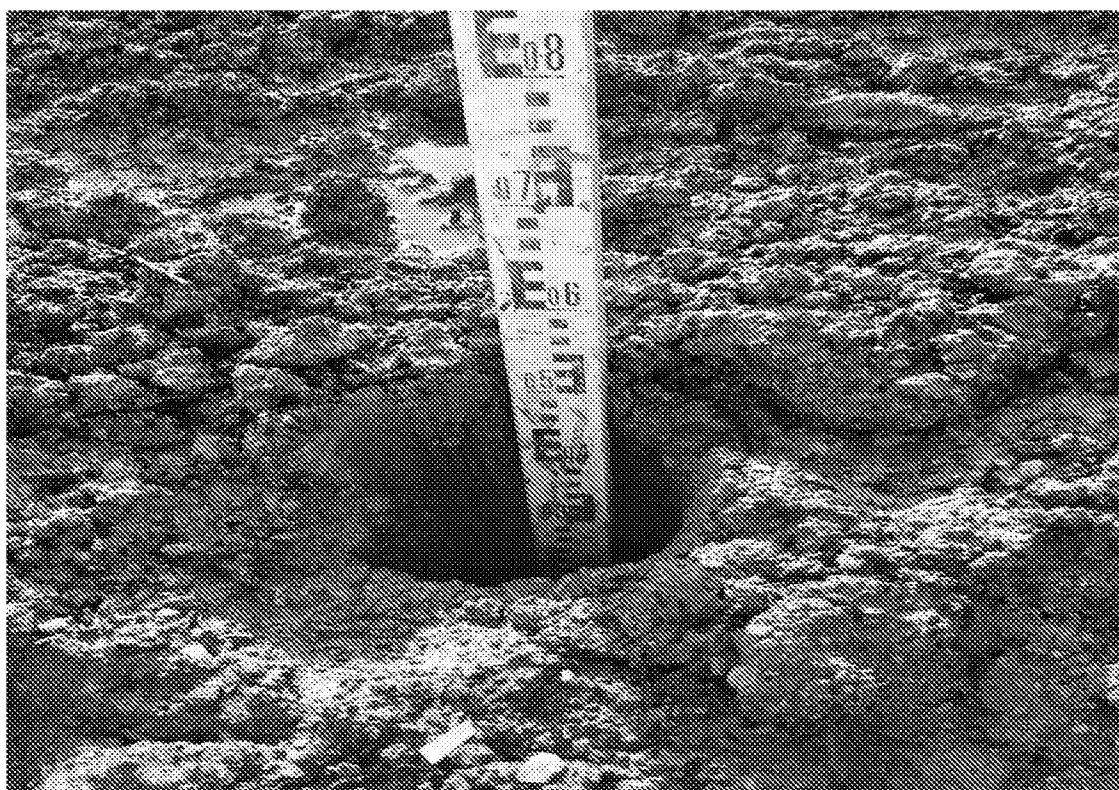
**Photo No.**  
26

View showing the depth of clean capping within HP16 to be at least 600 mm. Noted, presence of geo-marker membrane validated in preceding works (RSK report 27621 R06 (00)).

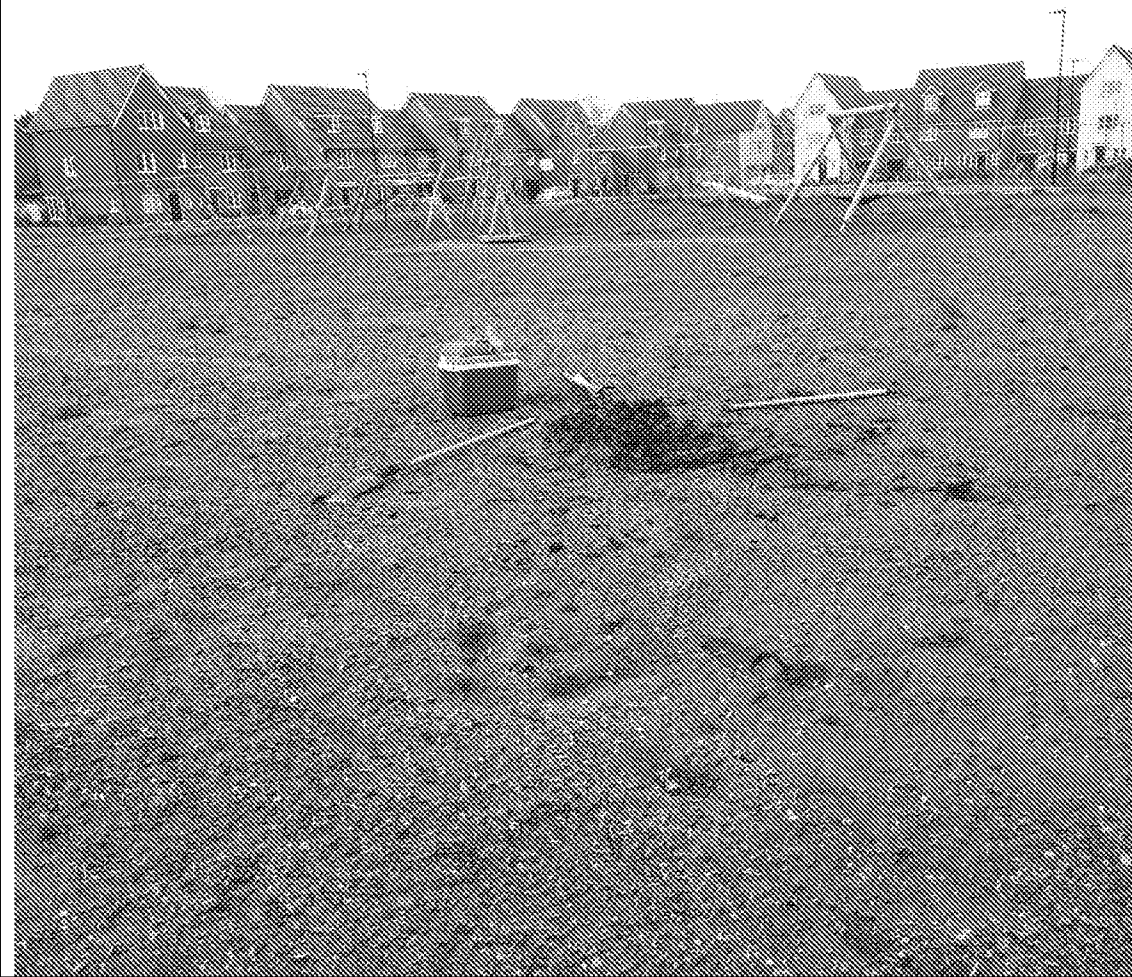
| <p><b>Photo No.</b><br/><b>27</b></p> | |

| <p>Overview of<br/>HP17</p> | |

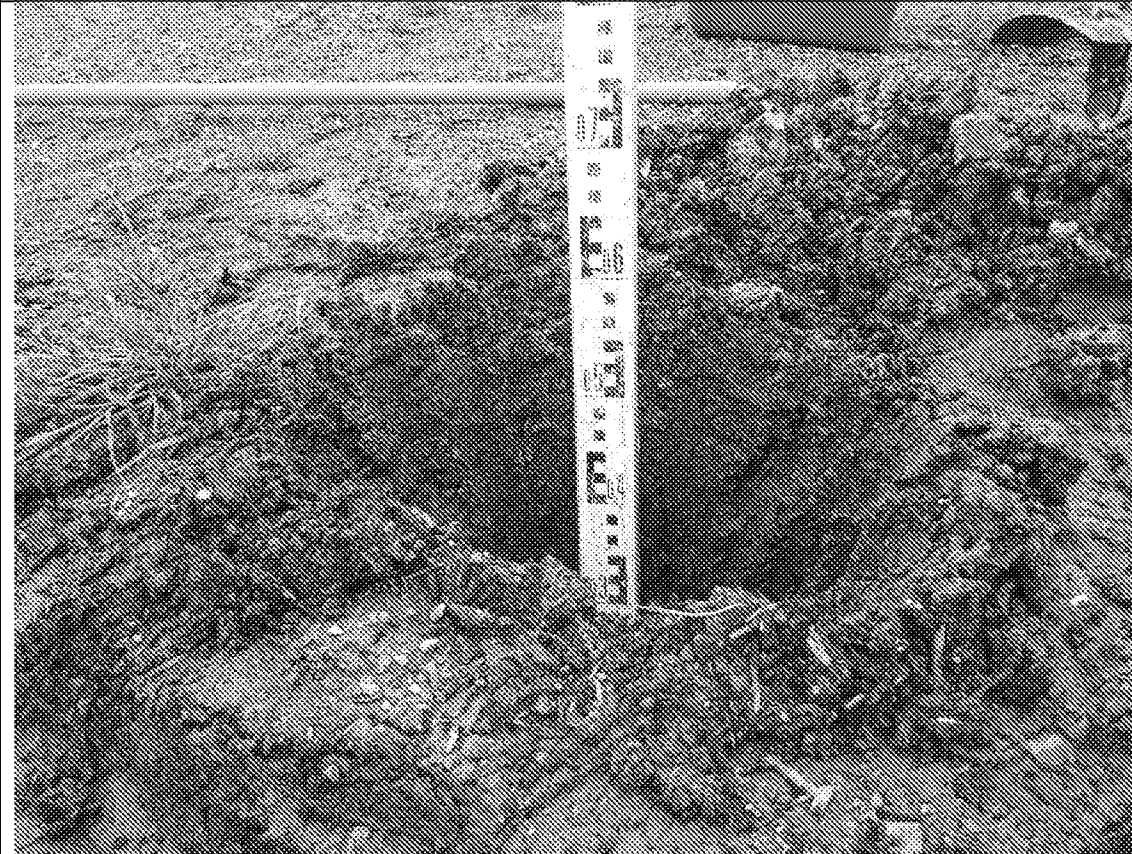
| <p><b>Photo No.</b><br/><b>28</b></p> | |

| <p>View of hand<br/>dug pit HP17<br/>capping layer<br/>observed to<br/>be at least<br/>600 mm<br/>thick. Noted,<br/>presence of<br/>geo-marker<br/>membrane<br/>validated in<br/>preceding<br/>works (RSK<br/>report 27621<br/>R06 (00).</p> | |

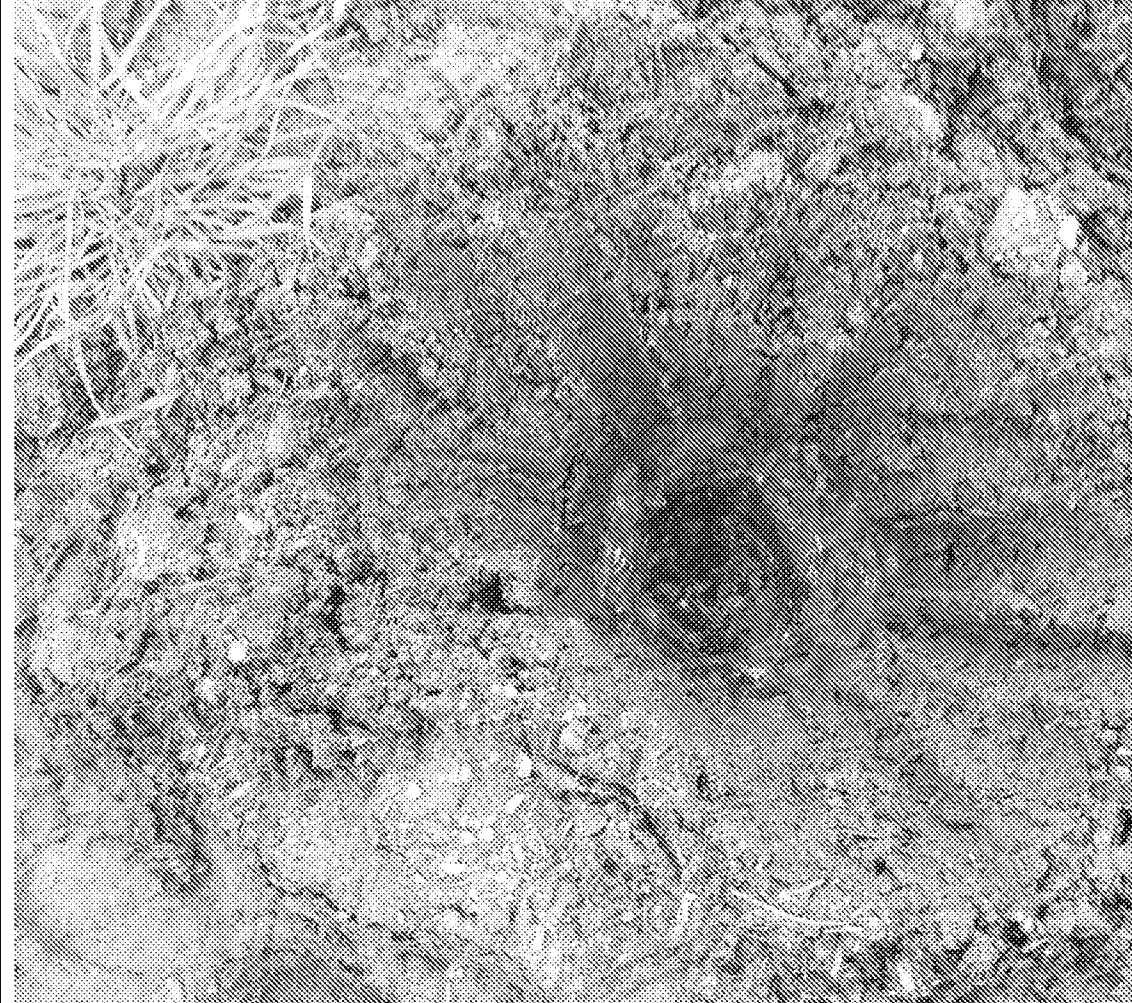
| <p><b>Photo No.</b><br/><b>29</b></p> | |

| <p>View of hand dug pit HP17, capping layer observed.</p> | |

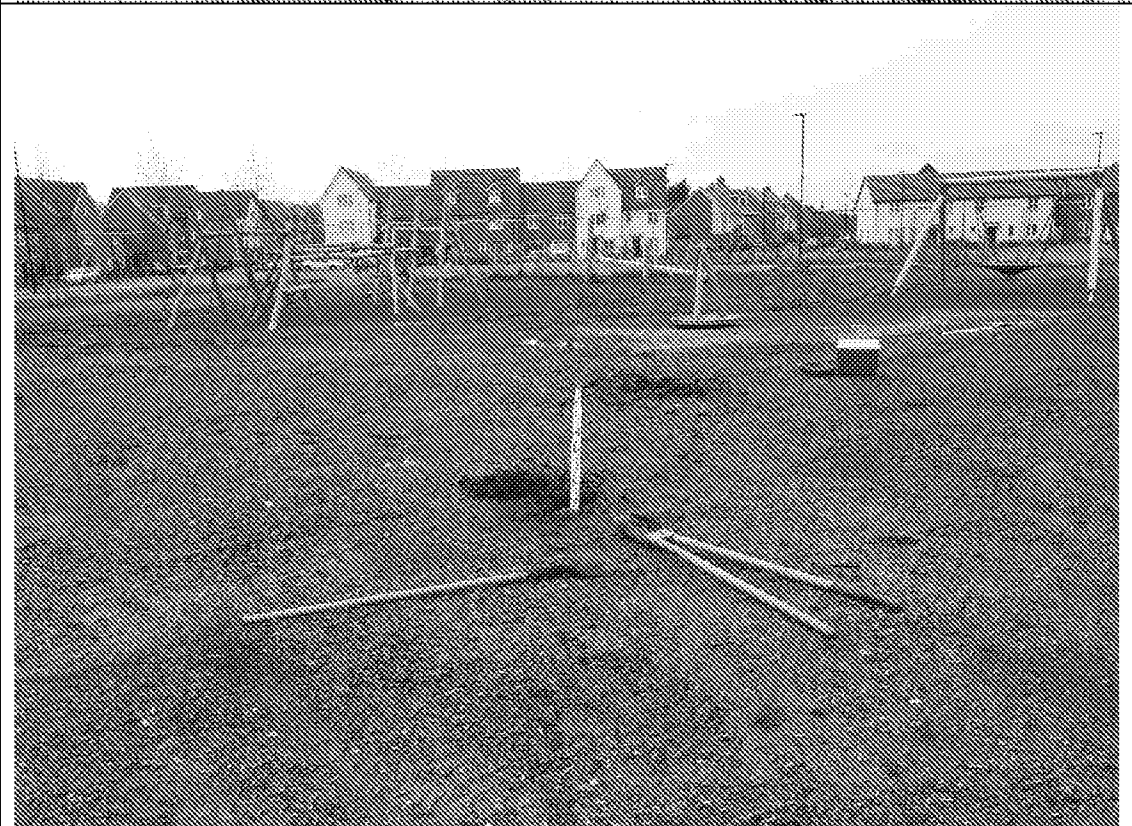
| <p><b>Photo No.</b><br/><b>30</b></p> | |

| <p>Overview of HP18.</p> | |

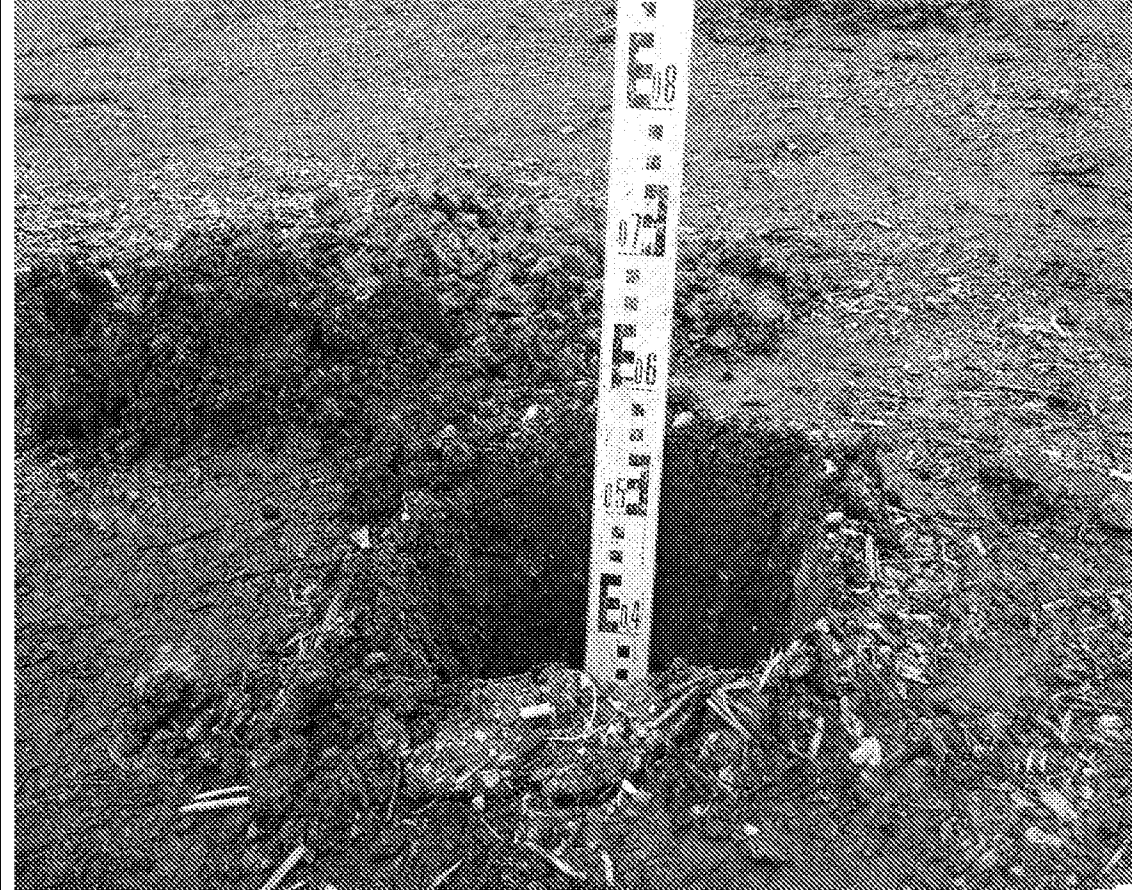
| <p><b>Photo No.</b></p> <p><b>31</b></p> | |

| <p>View of hand dug pit HP18 capping layer observed to be at least 600 mm thick.</p> | |

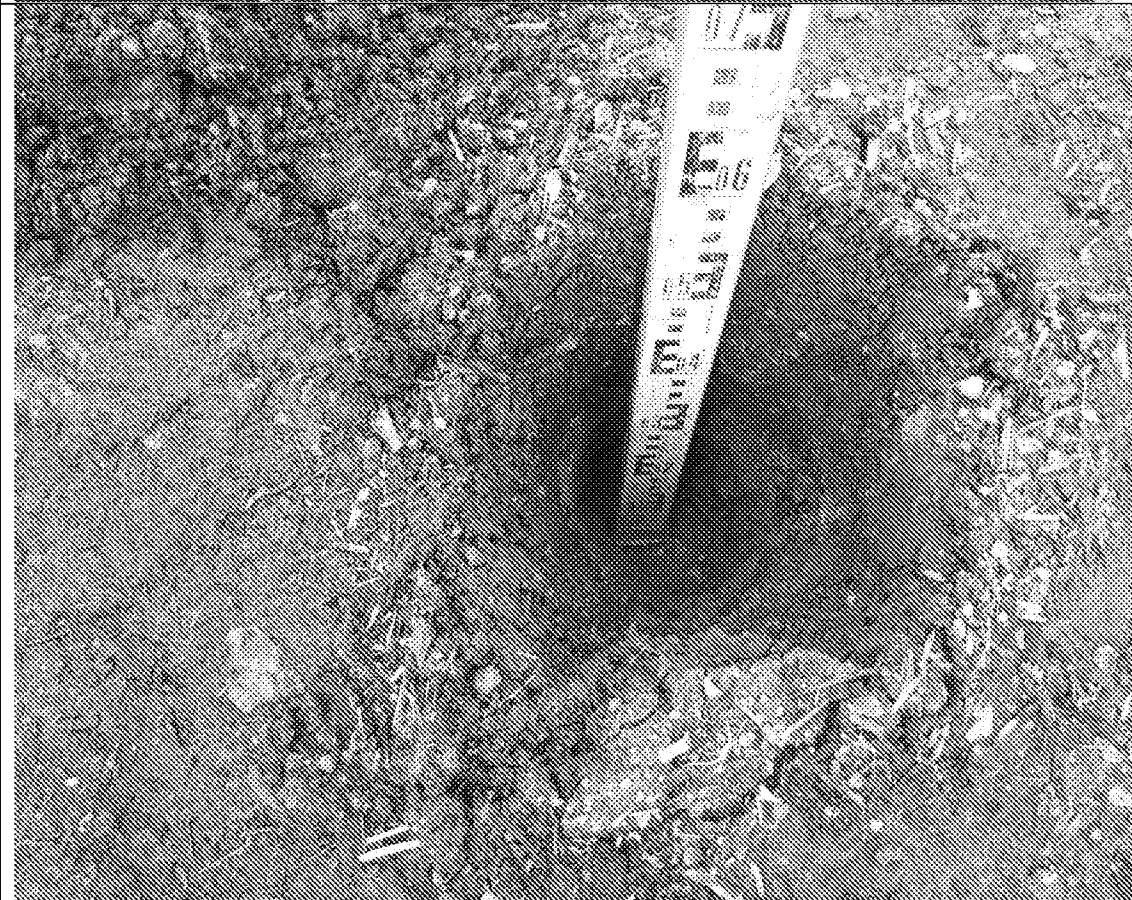
| <p><b>Photo No.</b></p> <p><b>32</b></p> | |

| <p>View of hand dug pit HP18, capping layer observed. Geo-marker membrane observed at the base of hand pit.</p> | |

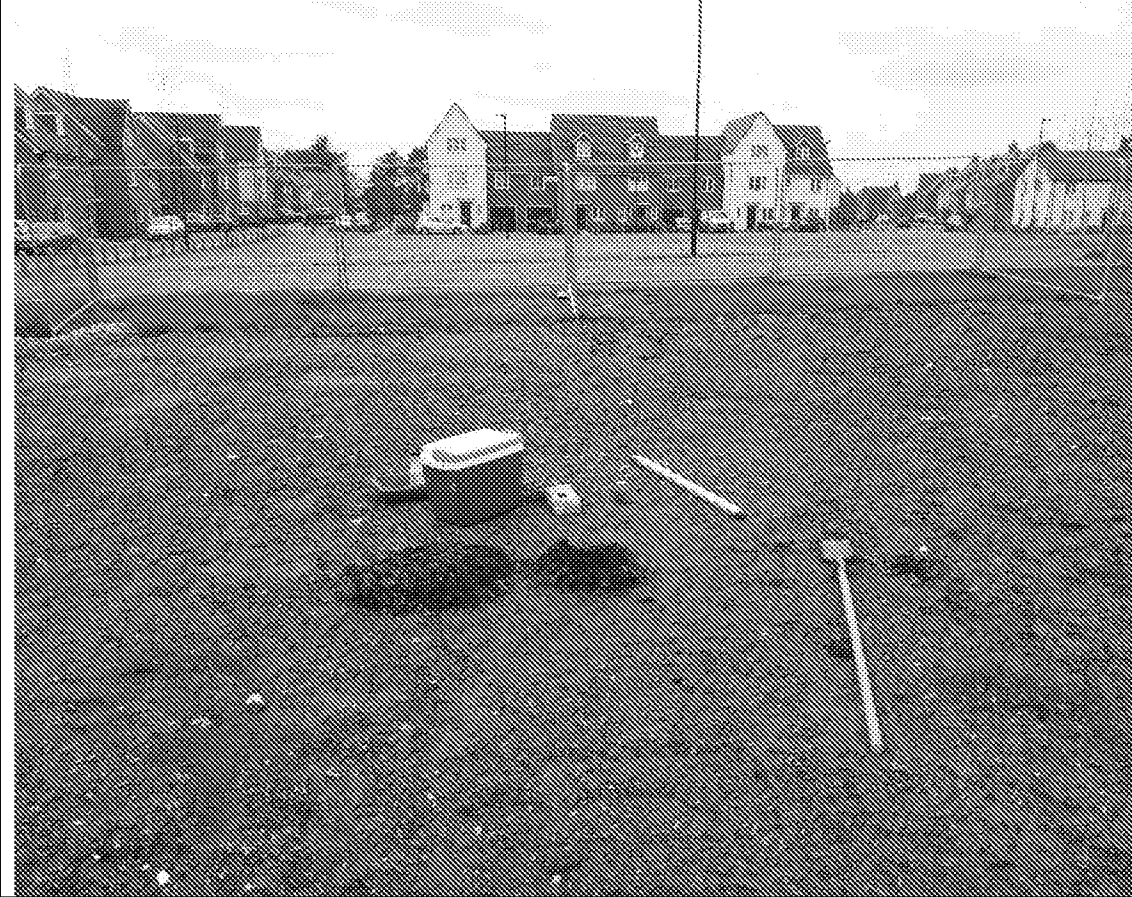
| <p>Overview of HP19</p> | |

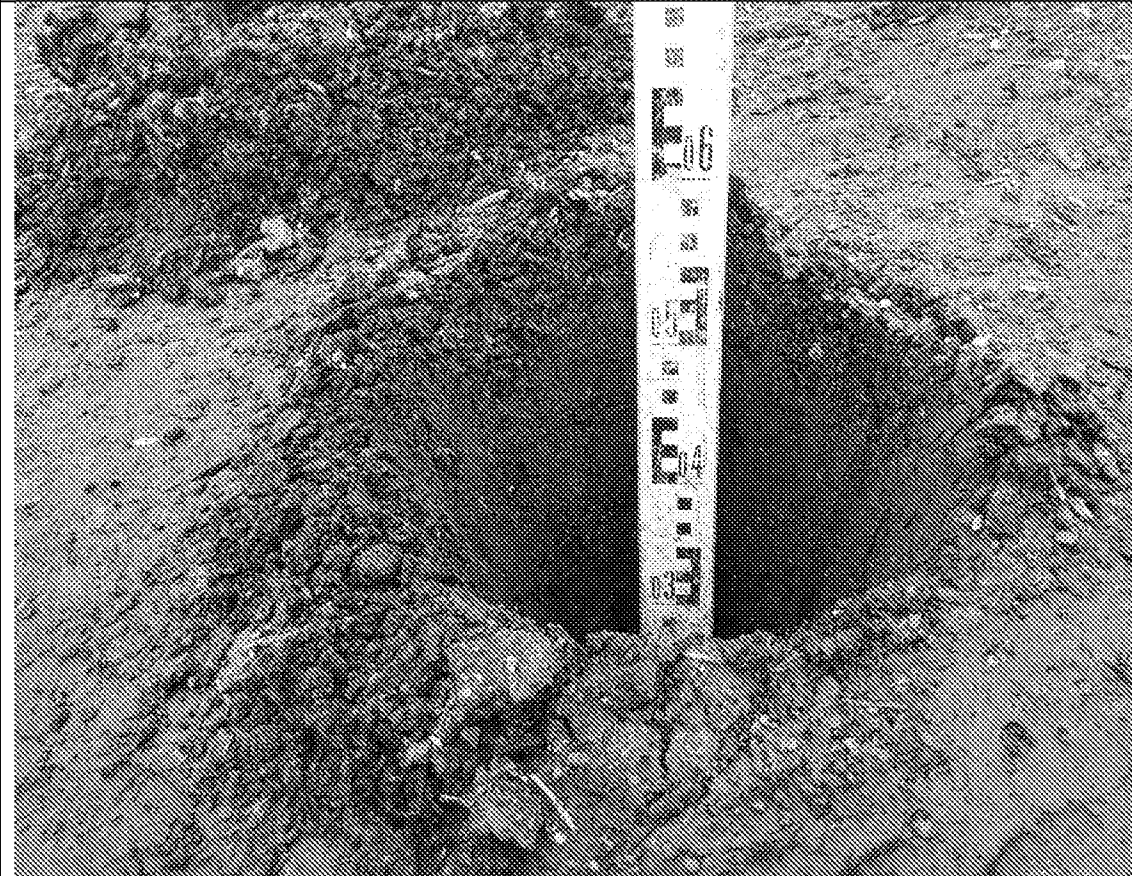
| <p>View of hand dug pit HP19 capping layer observed to be at least 600 mm thick.</p> | |
