15<sup>th</sup> June 2021

Our reference: 27621 L71 (00)

**FORMER WEST END NURSERY, ANGMERING – POST REMEDIATION VALIDATION OF SOUTH EASTERN AND CENTRAL PUBLIC OPEN SPACES, AND NORTH EASTERN BUND**

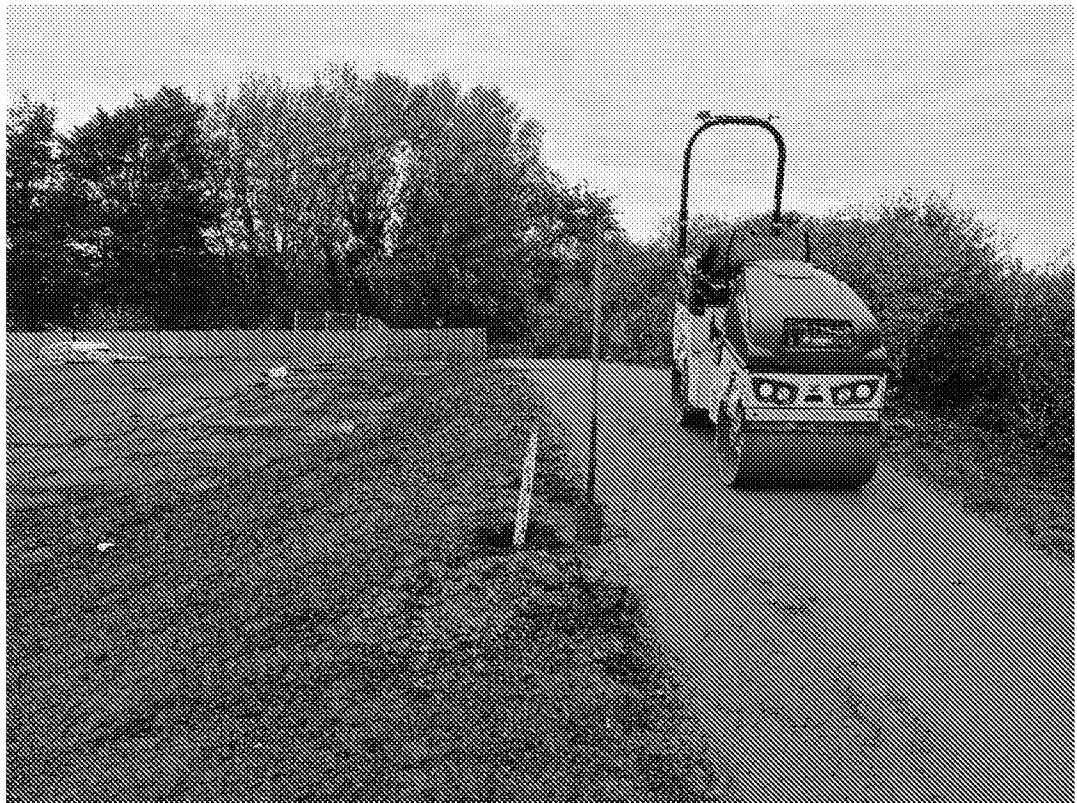
Photo No.  
1

Overview of  
P2B-NE  
Bund HP1.

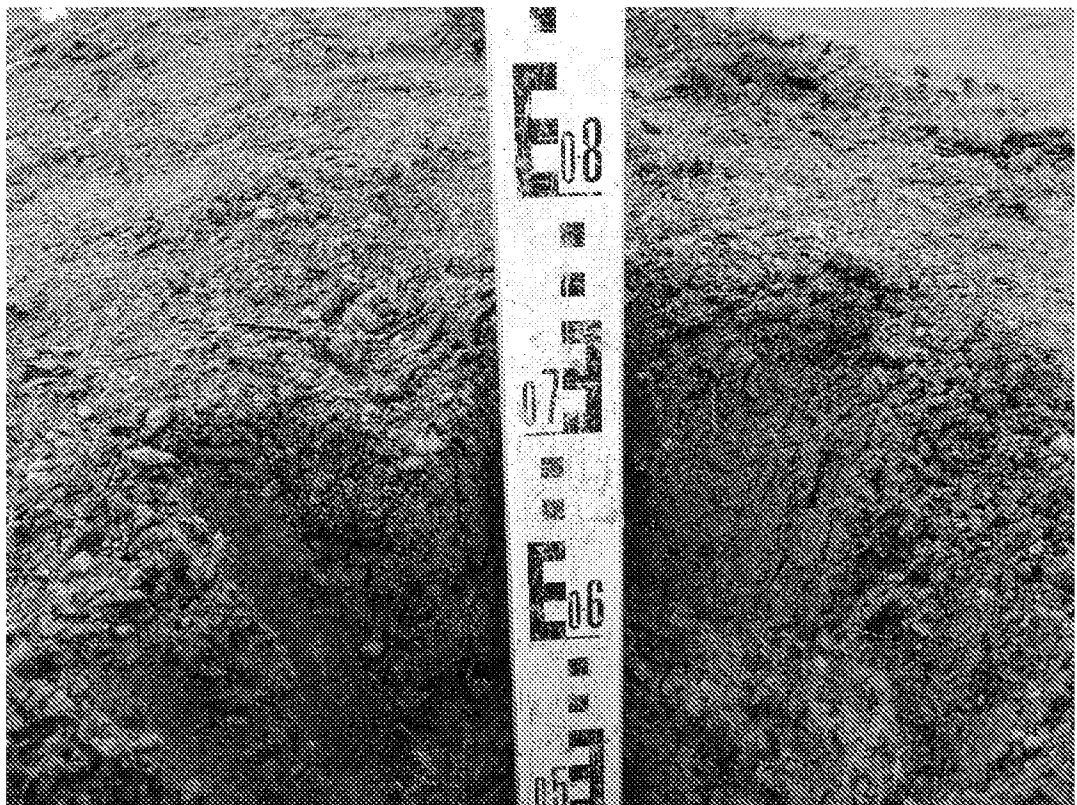
Photo No.  
2

View of hand  
dug pit P2B-  
NE Bund  
HP1, capping  
layer  
observed to  
be at least  
600 mm  
thick.

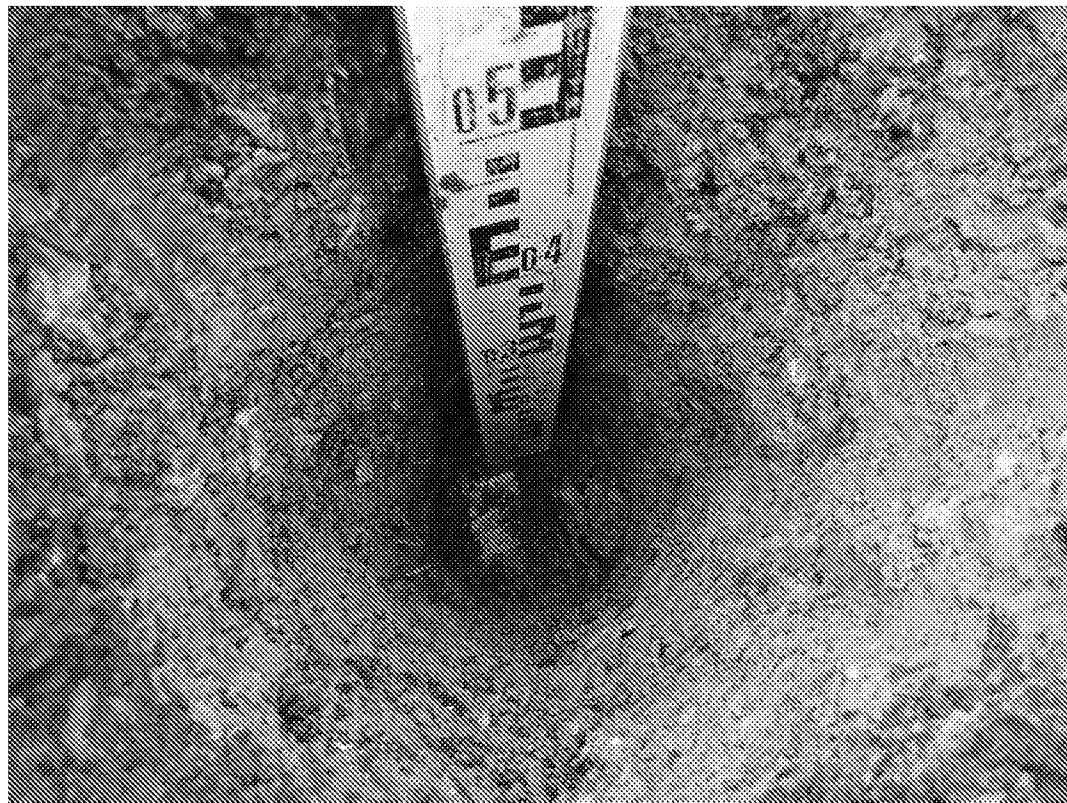
Photo No.  
3

View of hand dug pit P2B-NE Bund HP1, capping layer observed to be underlain by a geomarker membrane.

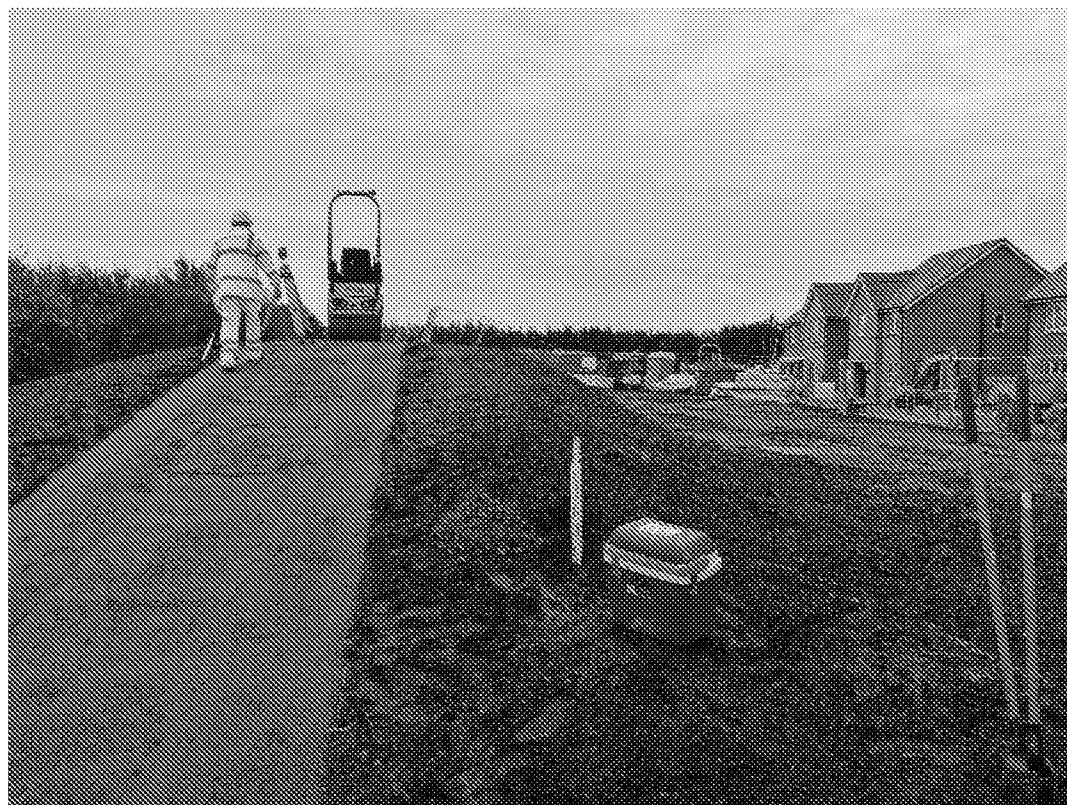
Photo No.  
4

Overview of P2B-NE Bund HP2.

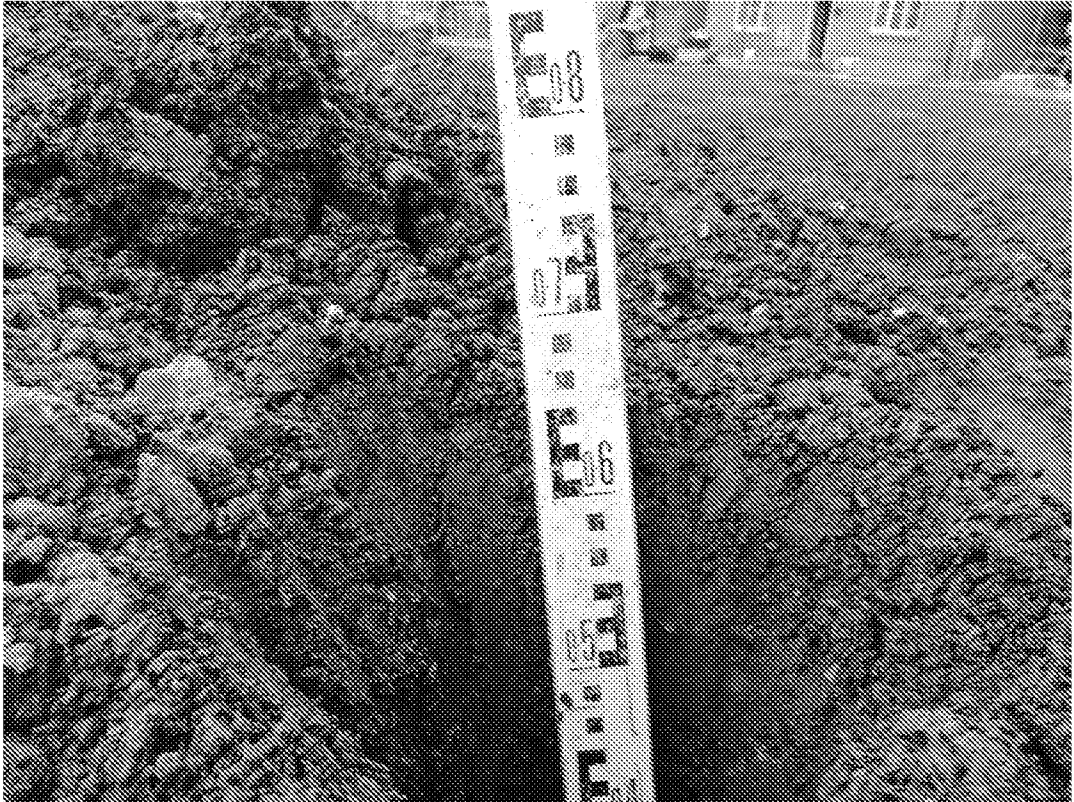
| <p><b>Photo No.</b><br/>5</p> | |

| <p>View of hand dug pit P2B-NE Bund HP2, capping layer observed to be at least 600 mm thick.</p> | |

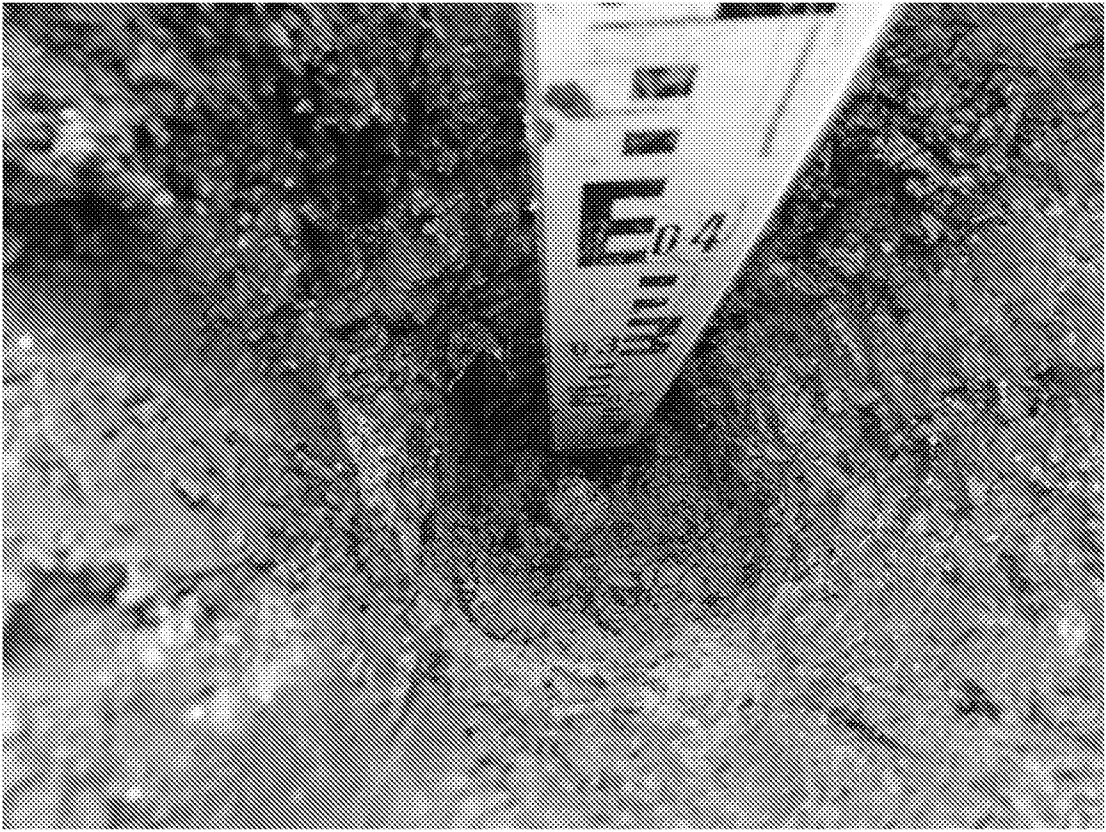
| <p><b>Photo No.</b><br/>6</p> | |

| <p>View of hand dug pit P2B-NE Bund HP2, capping layer observed to be underlain by a geomarker membrane.</p> | |

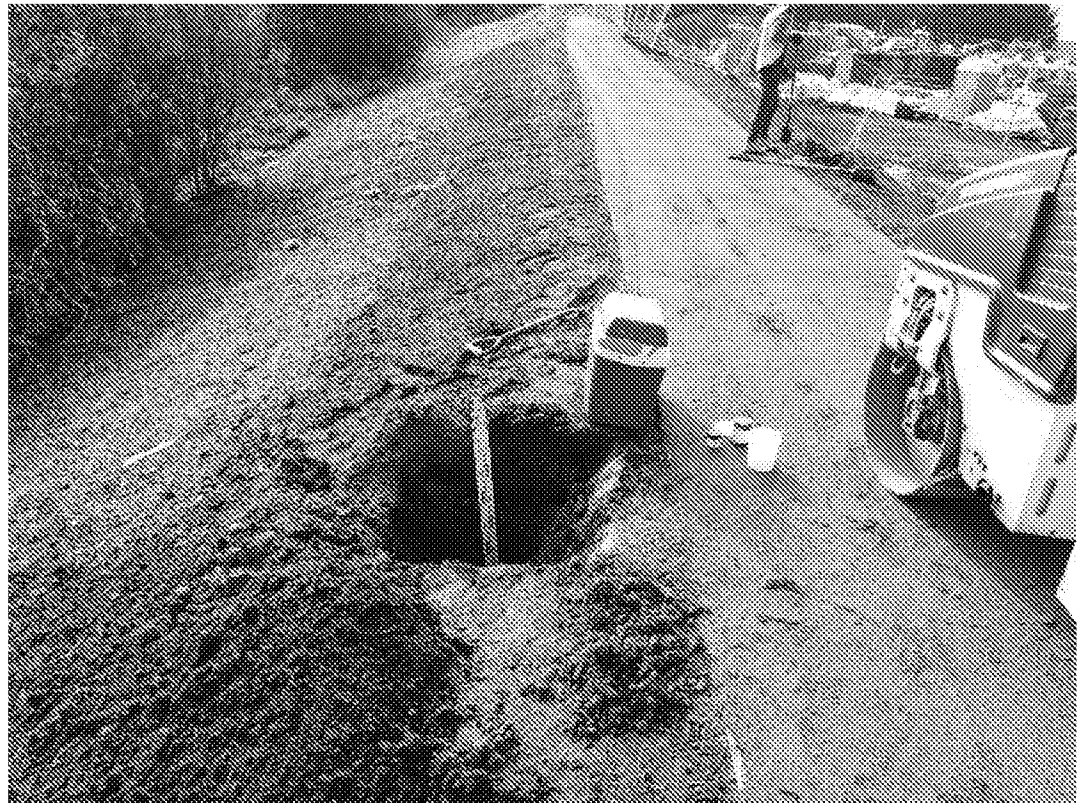
Photo No.  
7

Overview of  
P2B-NE  
Bund HP3.

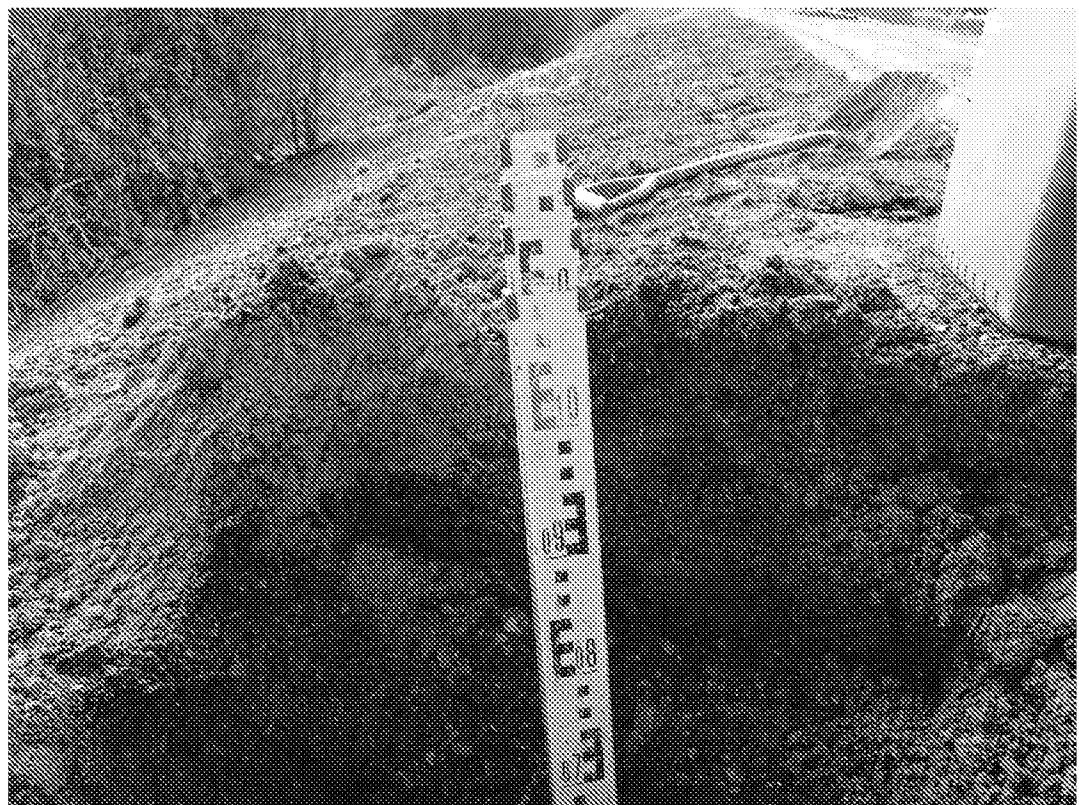
Photo No.  
8

View of hand  
dug pit P2B-  
NE Bund  
HP3, capping  
layer  
observed to  
be at least  
600 mm  
thick.

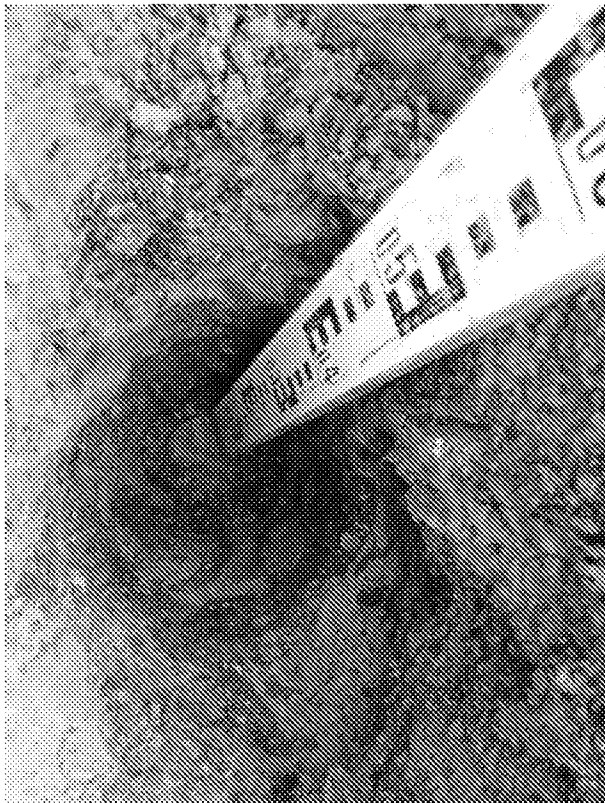
| <p><b>Photo No.</b><br/>9</p> <p><b>Date:</b><br/>08/10/2019</p> <p>View of hand dug pit P2B-NE Bund HP3, capping layer observed to be underlain by a geomarker membrane.</p> | |

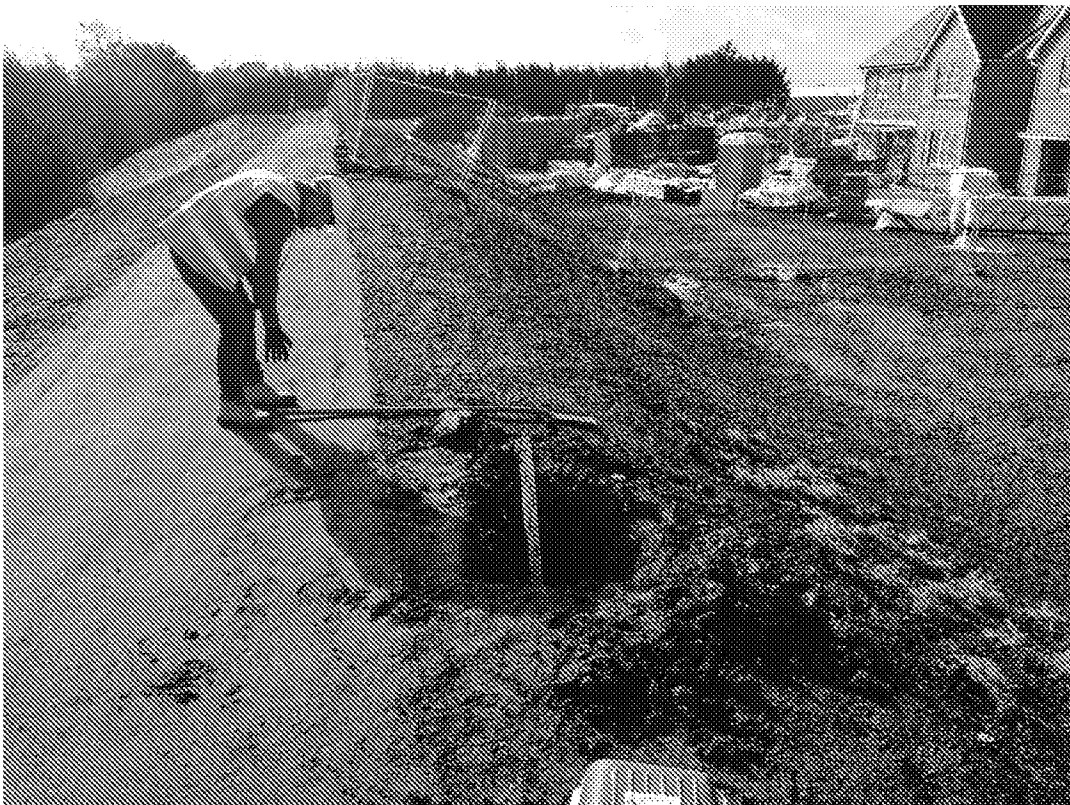
| <p><b>Photo No.</b><br/>10</p> <p><b>Date:</b><br/>08/10/2019</p> <p>Overview of P2B-NE Bund HP4.</p> | |

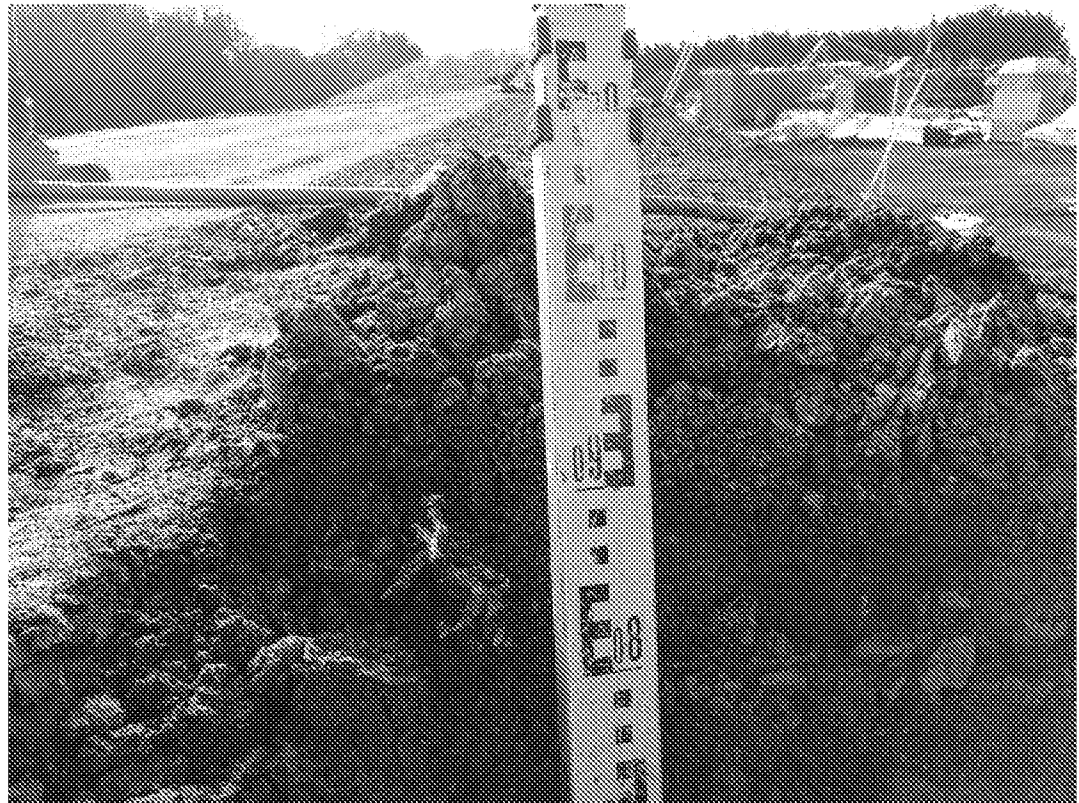
**Photo No.**  
11

View of hand dug pit P2B-NE Bund HP4, capping layer observed to be at least 600 mm thick.

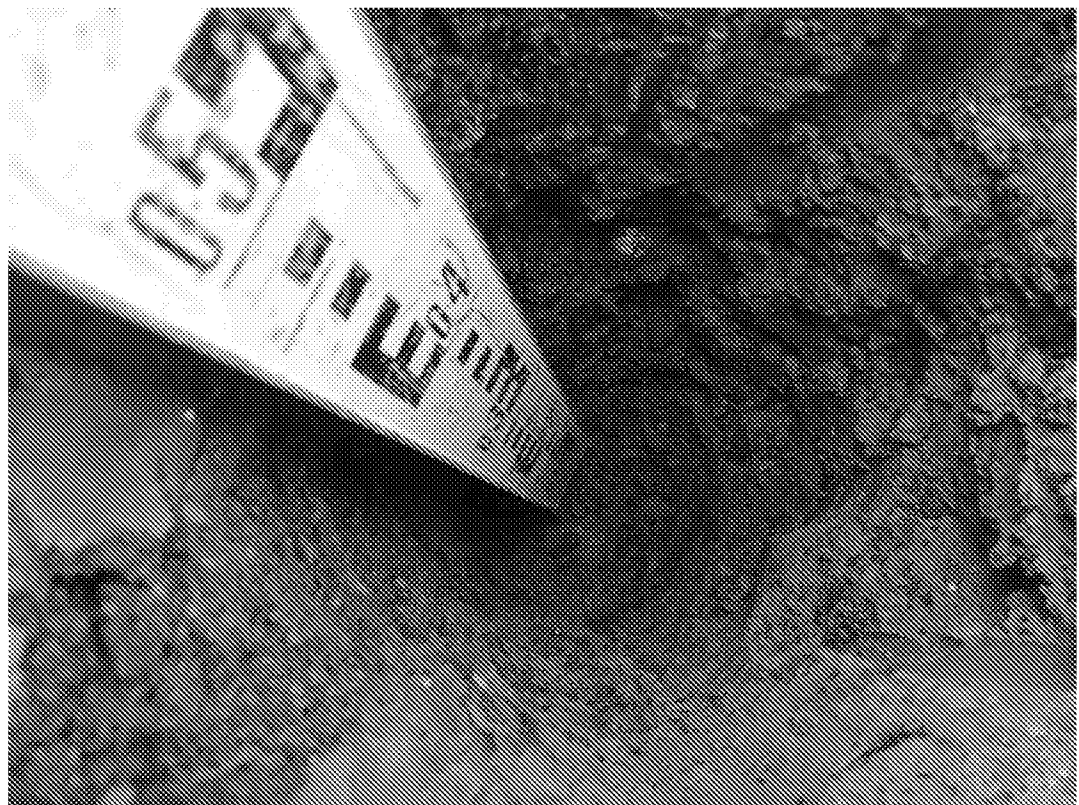
**Photo No.**  
12

View of hand dug pit P2B-NE Bund HP4, capping layer observed to be underlain by a geomarker membrane.

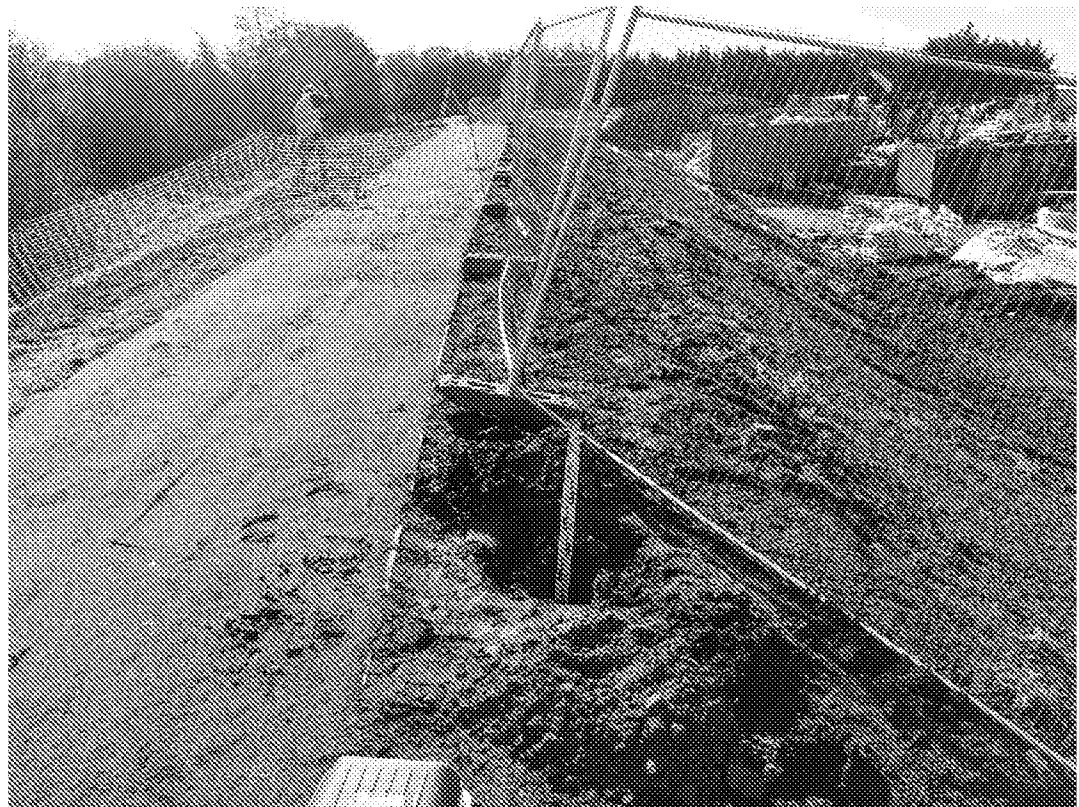
Photo No.  
13

Overview of  
P2B-NE  
Bund HP5.

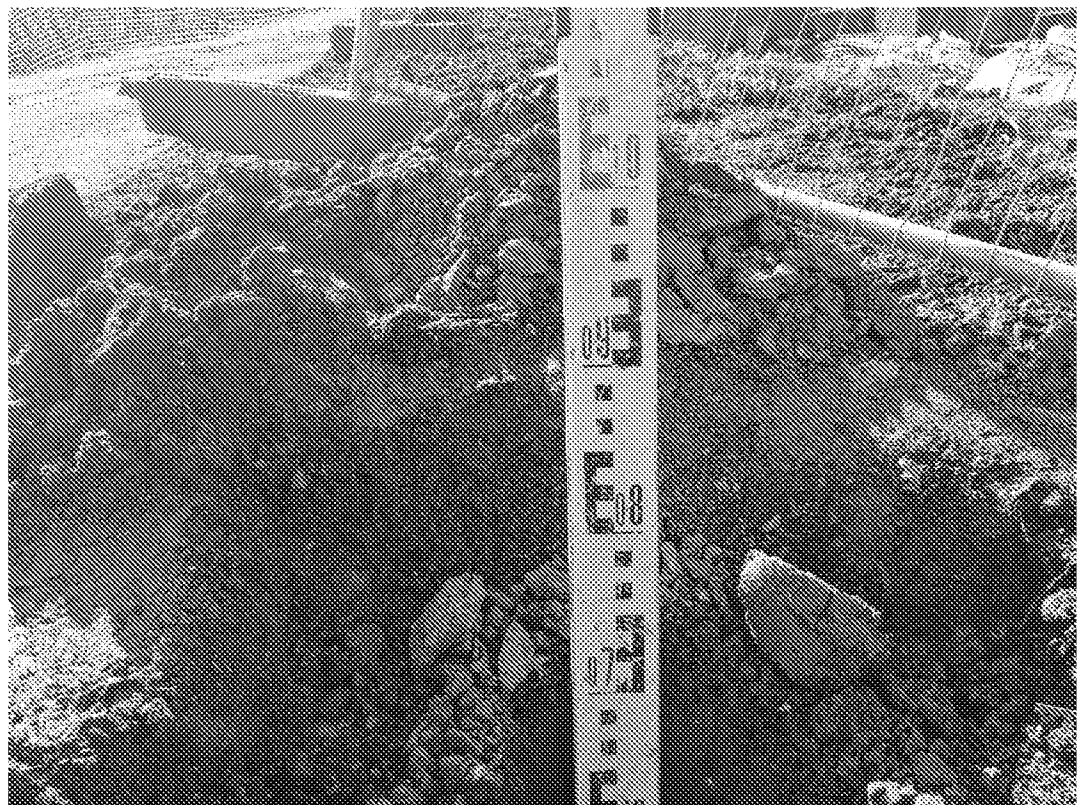
Photo No.  
14

View of hand  
dug pit P2B-  
NE Bund  
HP5, capping  
layer  
observed to  
be at least  
600 mm  
thick.

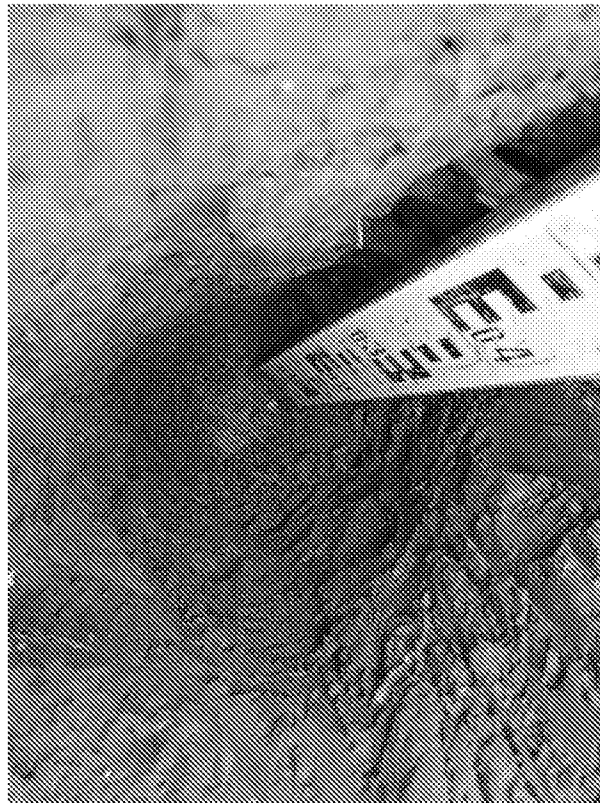
**Photo No.**  
15

View of hand dug pit P2B-NE Bund HP5, capping layer observed to be underlain by a geomarker membrane.

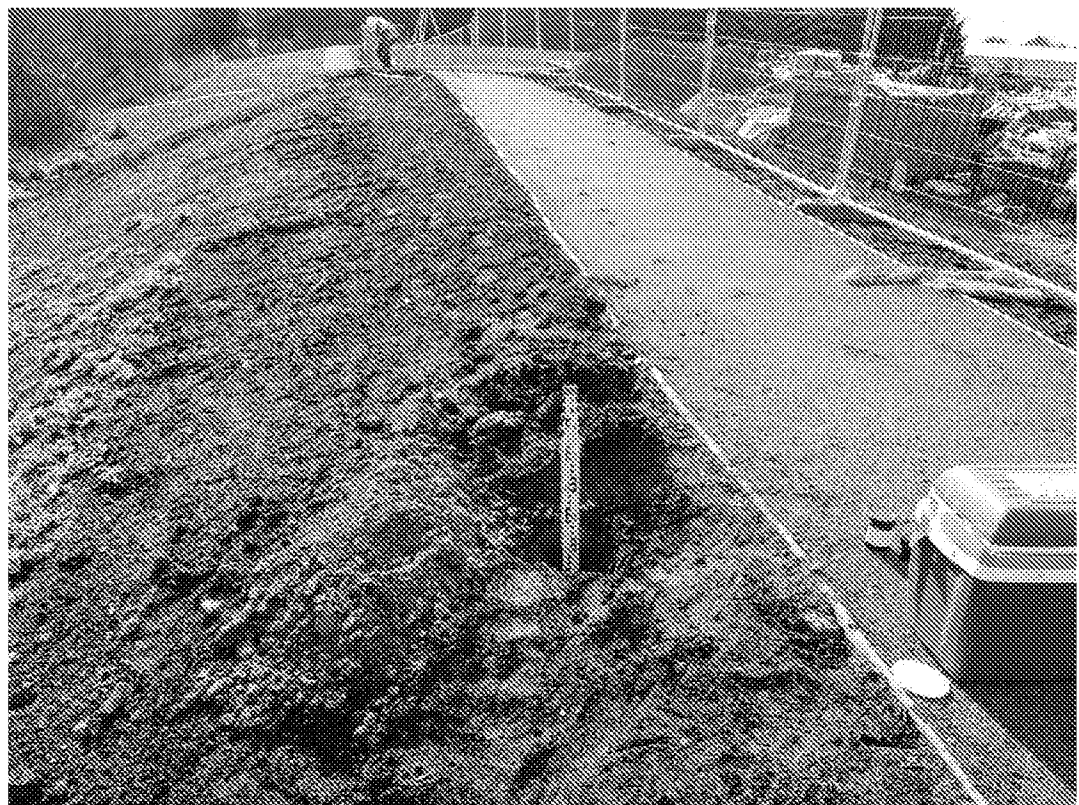
**Photo No.**  
16

Overview of P2B-NE Bund HP6.

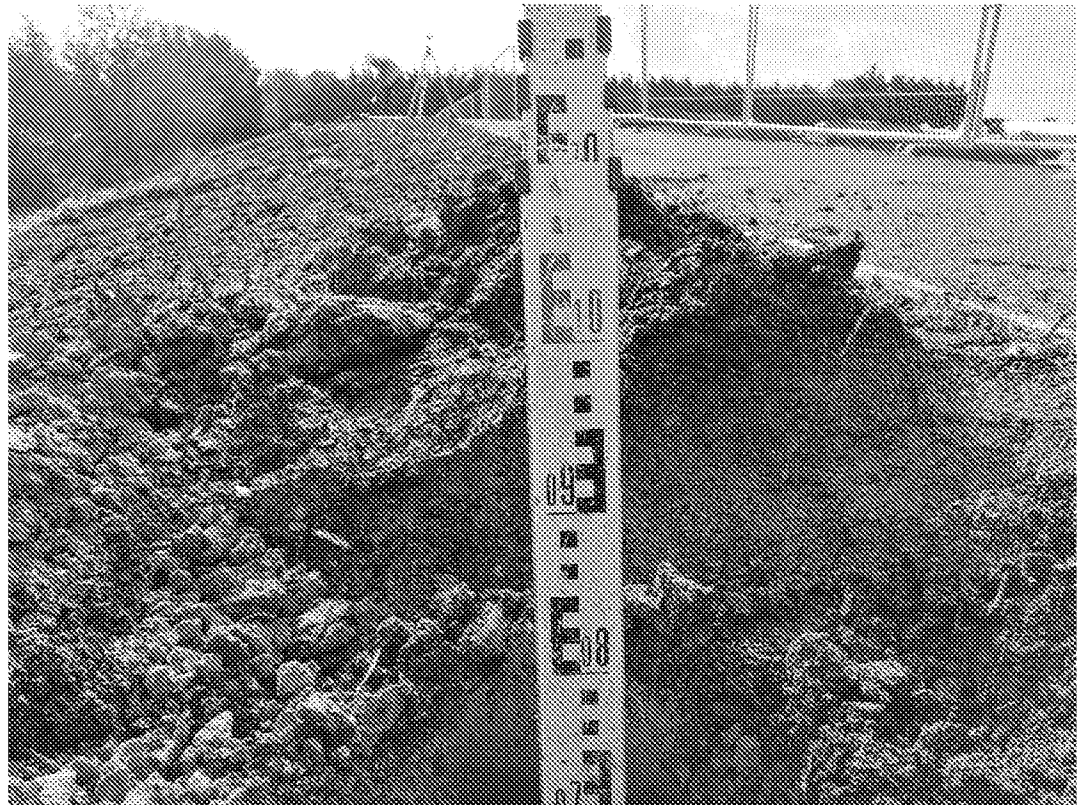
**Photo No.**  
17

View of hand dug pit P2B-NE Bund HP6, capping layer observed to be at least 600 mm thick.

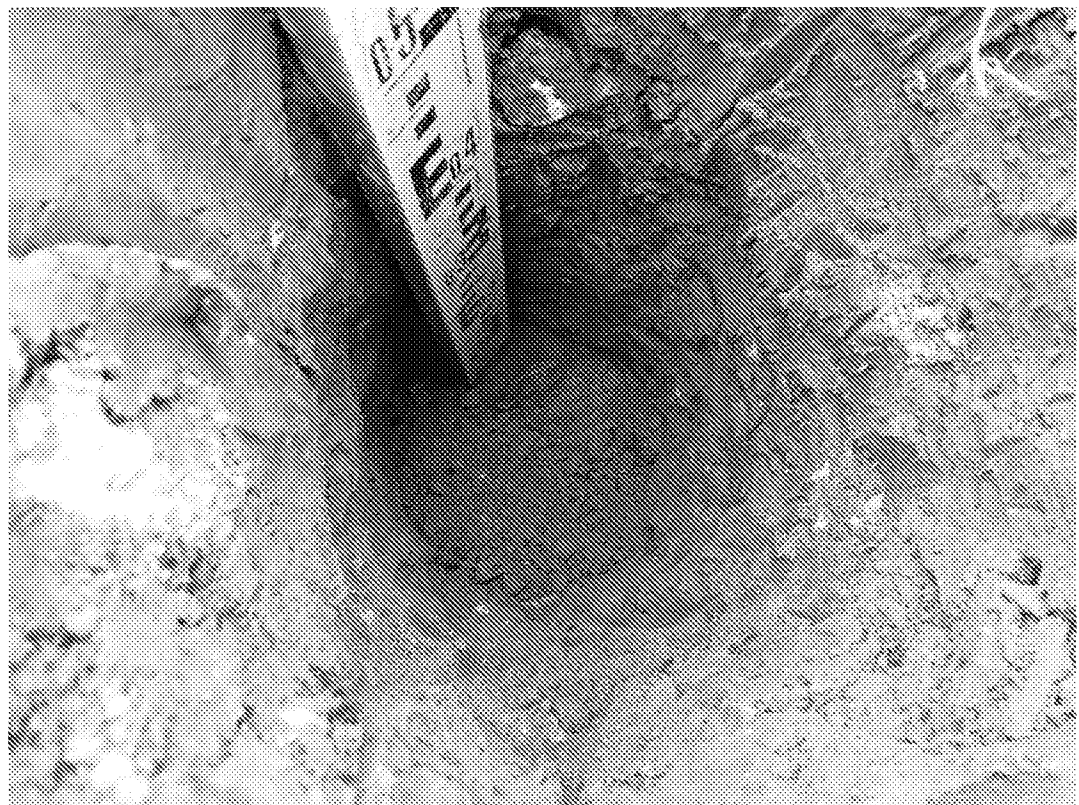
**Photo No.**  
18

View of hand dug pit P2B-NE Bund HP6, capping layer observed to be underlain by a geomarker membrane.

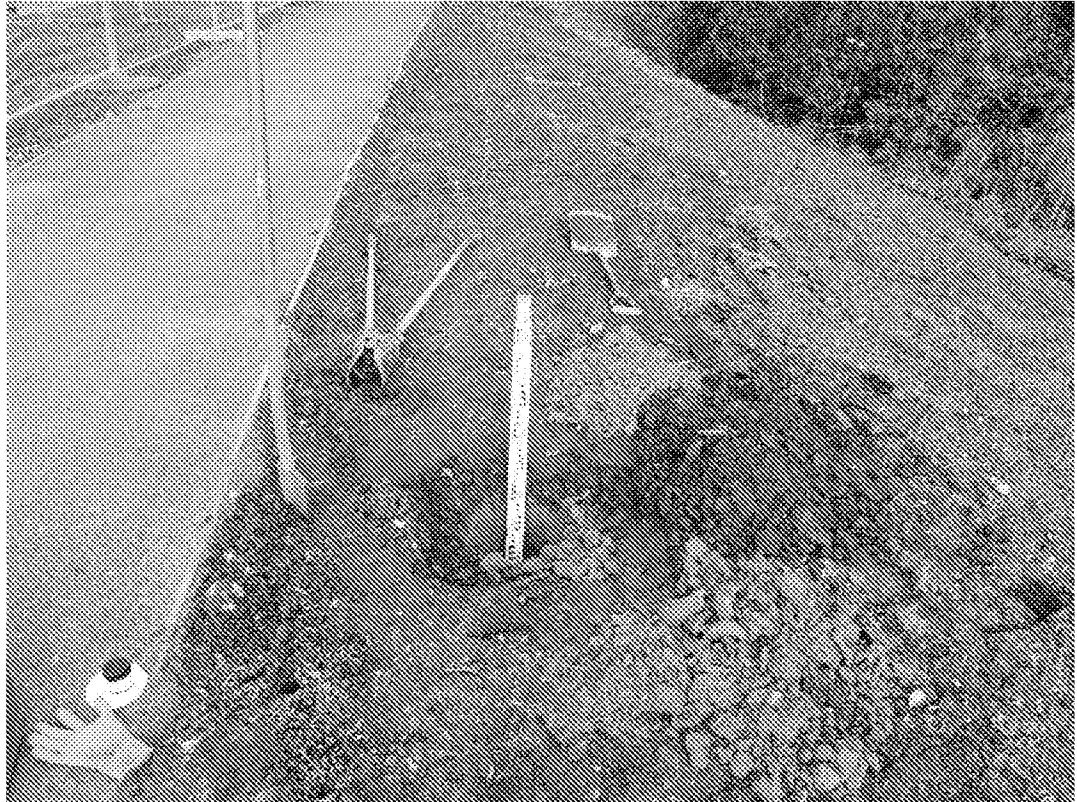
Photo No.  
19

Overview of  
P2B-NE  
Bund HP7.

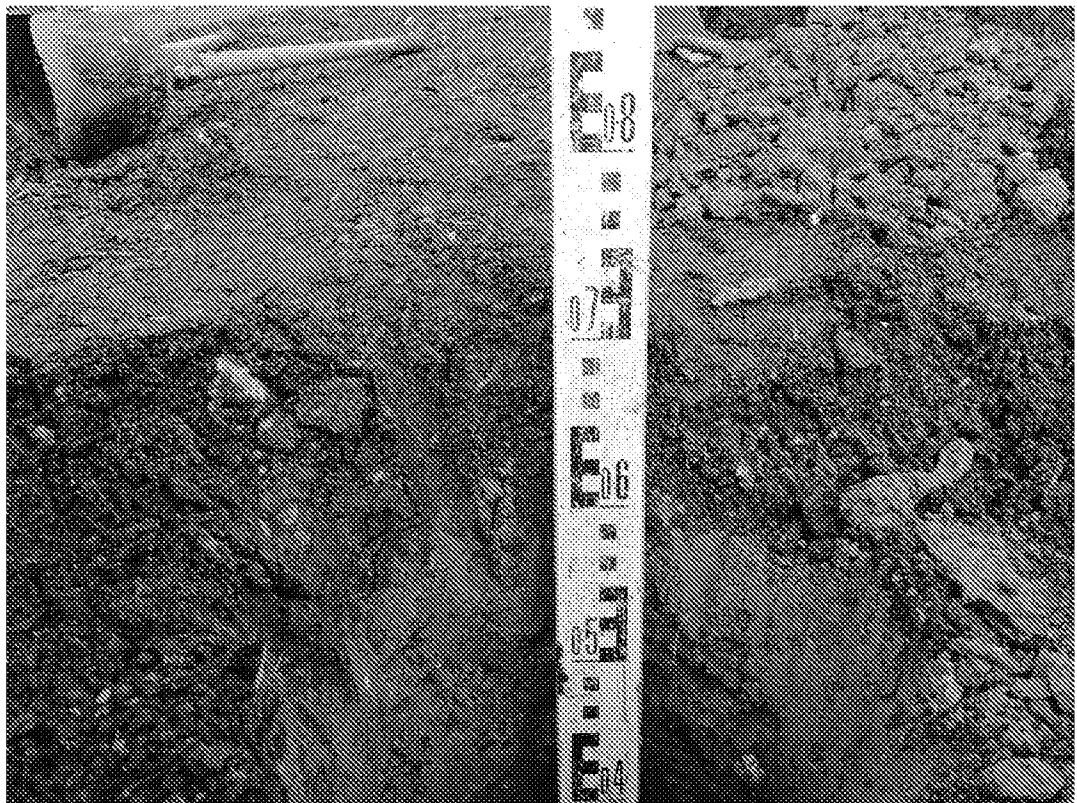
Photo No.  
20

View of hand  
dug pit P2B-  
NE Bund  
HP7, capping  
layer  
observed to  
be at least  
600 mm  
thick.

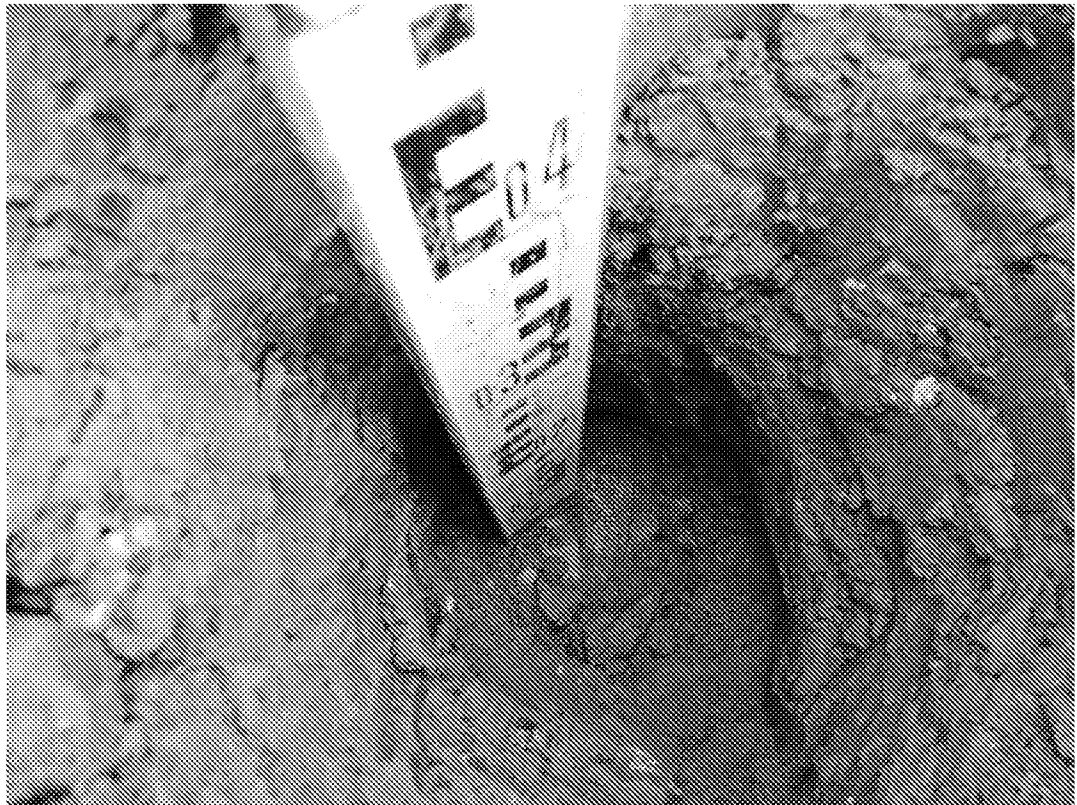
Photo No.  
21

View of hand dug pit P2B-NE Bund HP7, capping layer observed to be underlain by a geomarker membrane.
